Attachment A
ArcelorMittal Burns Harbor
Joint EPA/IDEM Inspection August 12, 2020
All photos taken by Nick Ream, IDEM Inspector

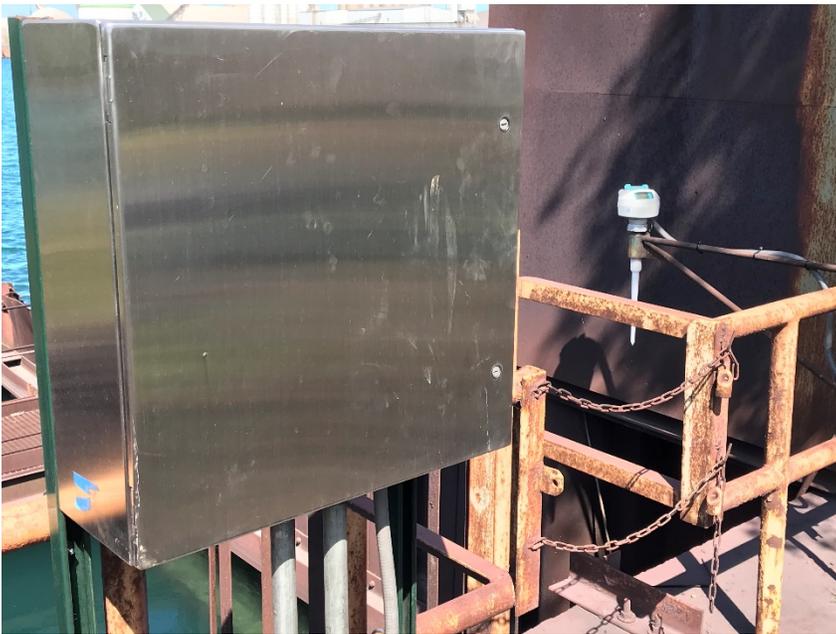
5: IMG_0830

Description: Duplicate photo as IMG_0829.
