Indiana Brownfields Program
an Indiana Finance Authority Environmental Program

Re: City of Mishawaka, St. Joseph County
Former RMG Foundry
500 South Union Street
Mishawaka, IN
Indiana Brownfields Program

**Re: Asbestos Containing Materials Abatement Proposal
Former Dodge Manufacturing Company / Former RMG Foundry Facility
500 South Union Street in Mishawaka, Indiana
Indiana Brownfields Program Site #4060054
Heartland Proposal #P2025-05-107**

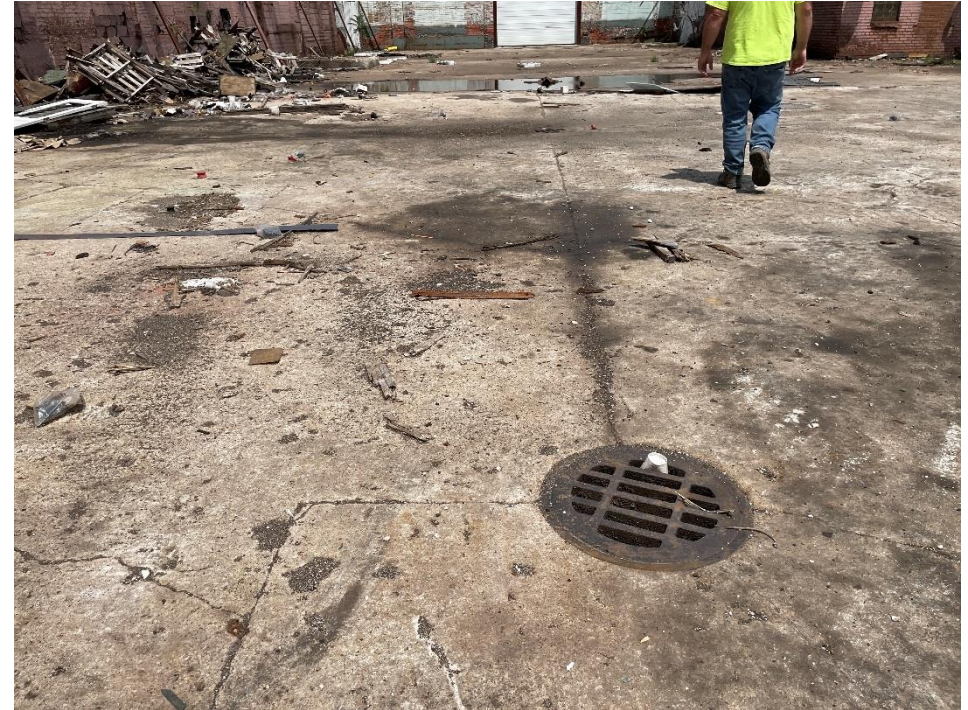
DATE: May 16, 2024
LOCATION: Former Dodge Manufacturing Company / Former RMG Foundry
SUBJECT: View of sediment around drain
PHOTOGRAPHER: Robert R. Raduchel (Heartland)
PHOTO: 9

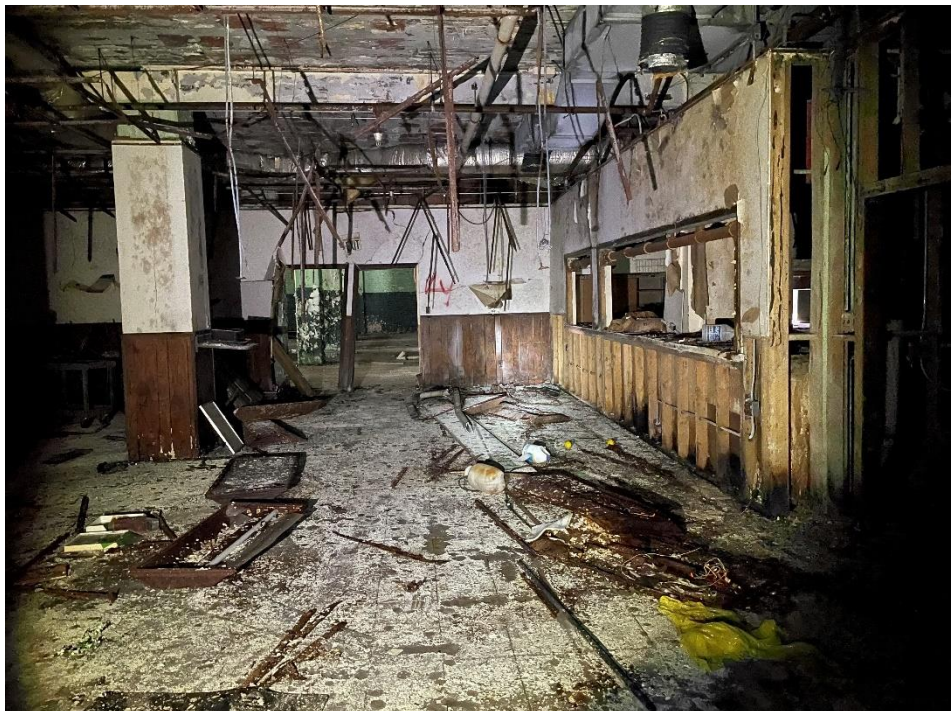
DATE: May 16, 2024
LOCATION: Former Dodge Manufacturing Company / Former RMG Foundry
SUBJECT: View of unhooked pipes in southeastern basement
PHOTOGRAPHER: Robert R. Raduchel (Heartland)
PHOTO: 26

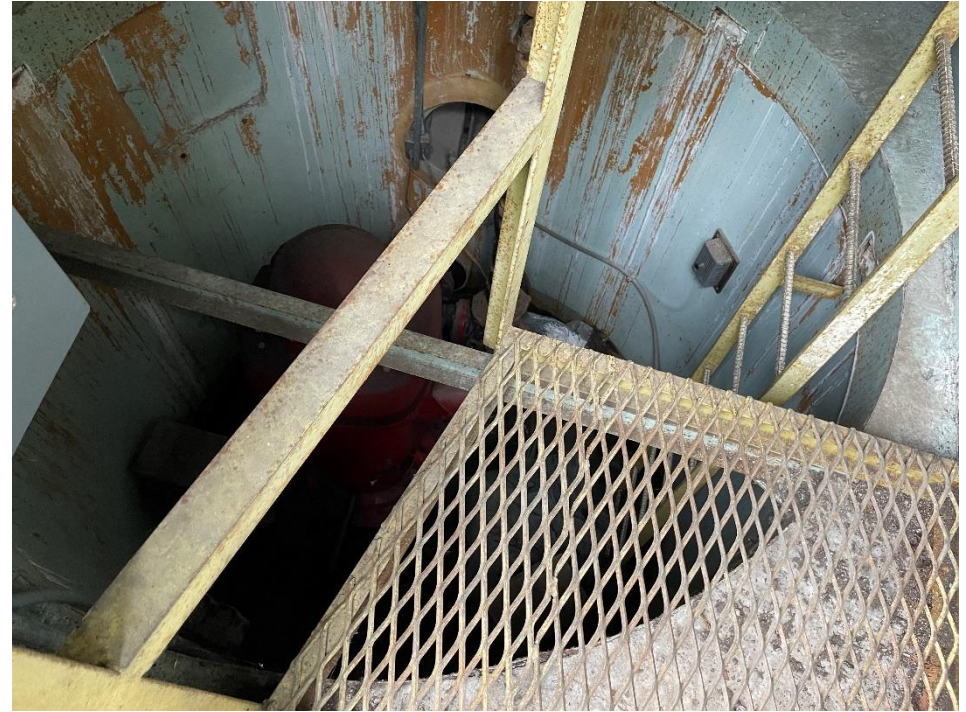
DATE: May 16, 2024
LOCATION: Former Dodge Manufacturing Company / Former RMG Foundry
SUBJECT: View of the flooded powerhouse basement
PHOTOGRAPHER: Robert R. Raduchel (Heartland)
PHOTO: 77

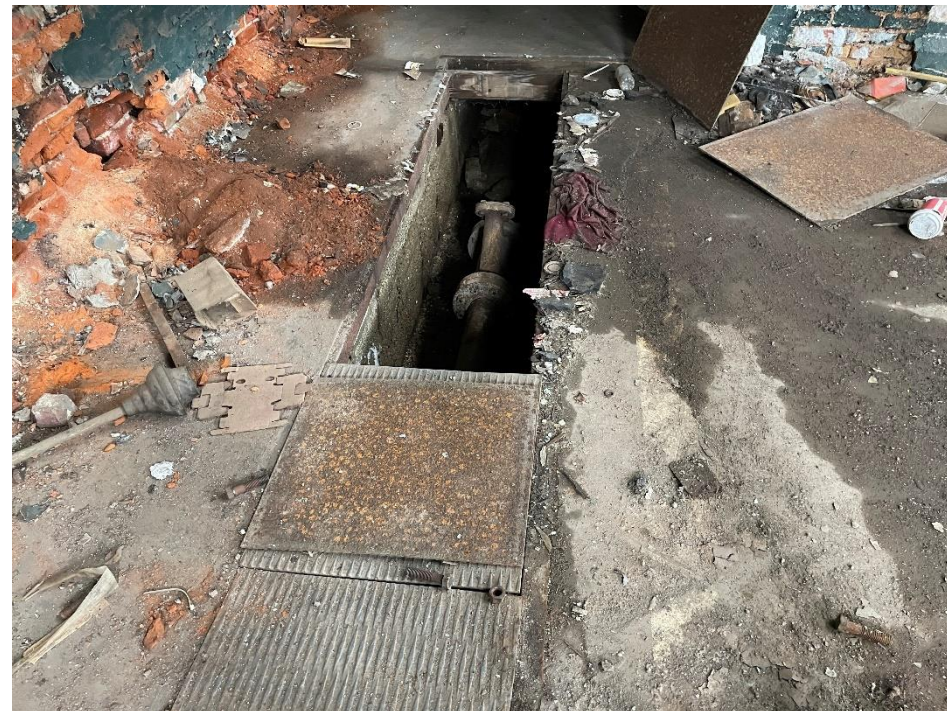
DATE: May 16, 2024
LOCATION: Former Dodge Manufacturing Company / Former RMG Foundry
SUBJECT: View of black chemical powder on concrete paved ground
PHOTOGRAPHER: Robert R. Raduchel (Heartland)
PHOTO: 83
