ANALYSIS OF BROWNFIELD CLEANUP ALTERNATIVES

Former Dodge Manufacturing Company / Former RMG Foundry Facility

500 South Union Street

Former Dodge Manufacturing Company / Former RMG Foundry
Main Foundry Building
500 Union Street
Mishawaka, Indiana 46544
Heartland Project #5306-24-01

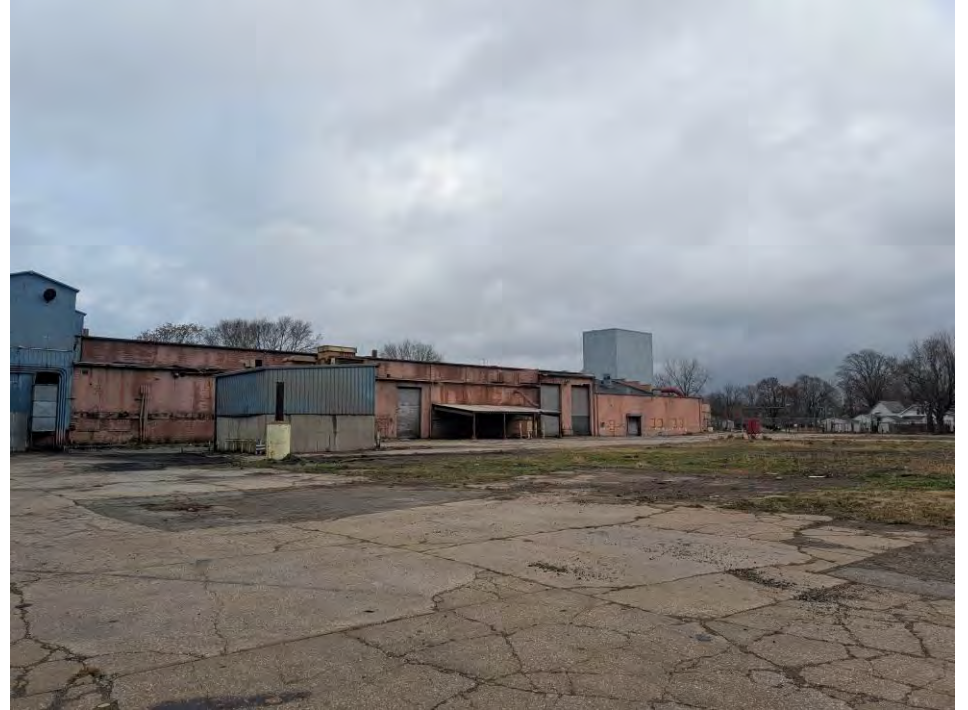
DATE: December 10, 2024
LOCATION: 500 Union Street in Mishawaka, Indiana
SUBJECT: View of south face of site building
PHOTOGRAPHER: Ryan M. Orzechowicz (Heartland)
PHOTO: 1

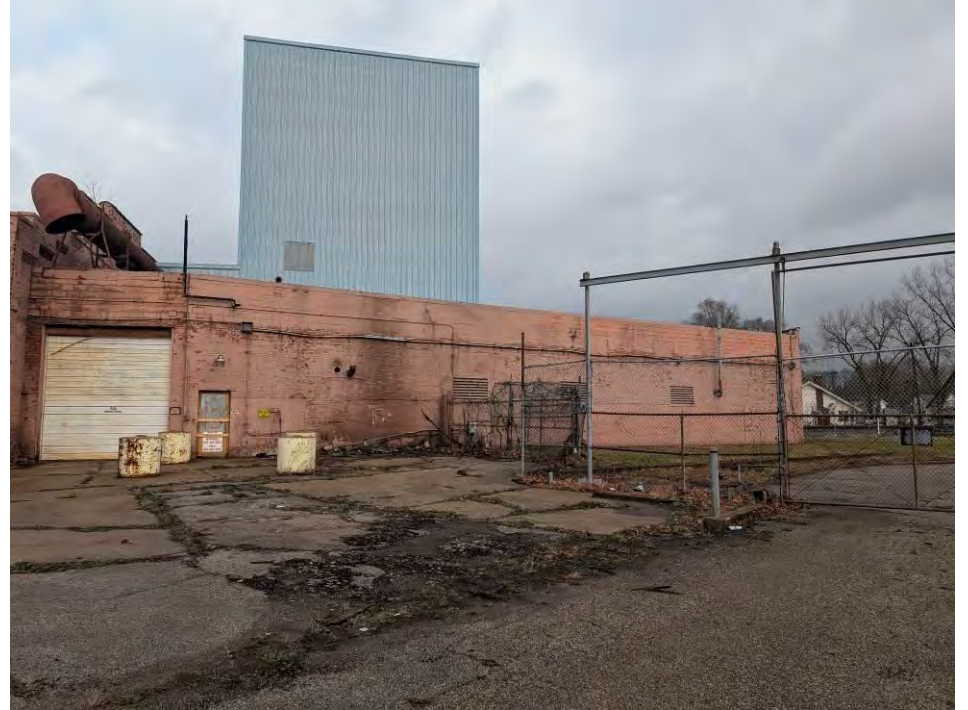
DATE: December 10, 2024
LOCATION: 500 Union Street in Mishawaka, Indiana
SUBJECT: View of central portion of site building
PHOTOGRAPHER: Ryan M. Orzechowicz (Heartland)
PHOTO: 3

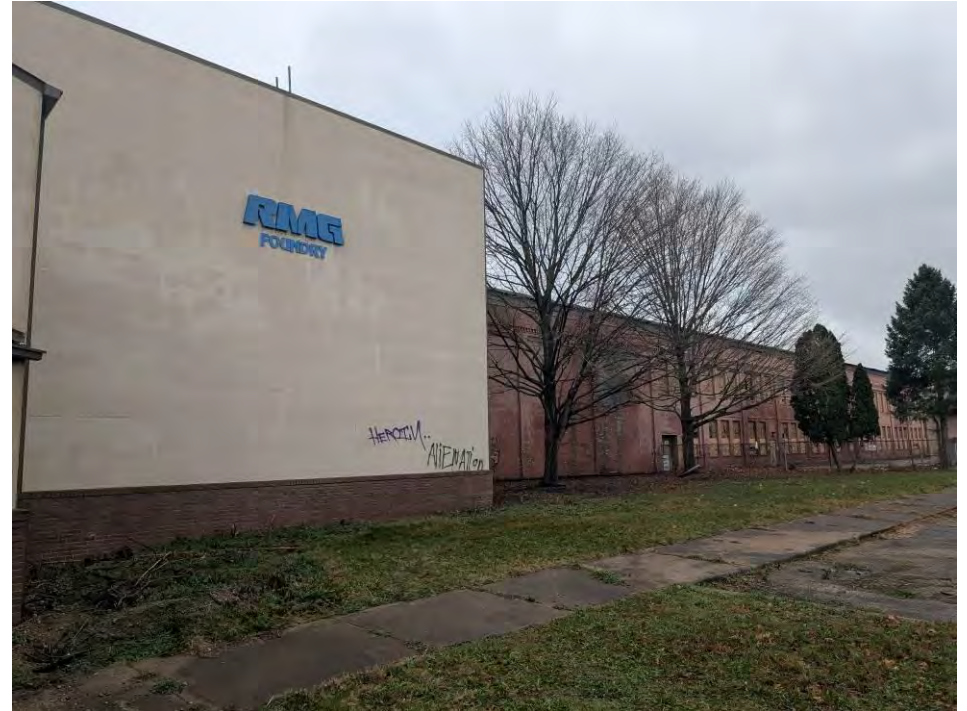
DATE: December 10, 2024
LOCATION: 500 Union Street in Mishawaka, Indiana
SUBJECT: View of northern portion of west face of site building
PHOTOGRAPHER: Ryan M. Orzechowicz (Heartland)
PHOTO: 5

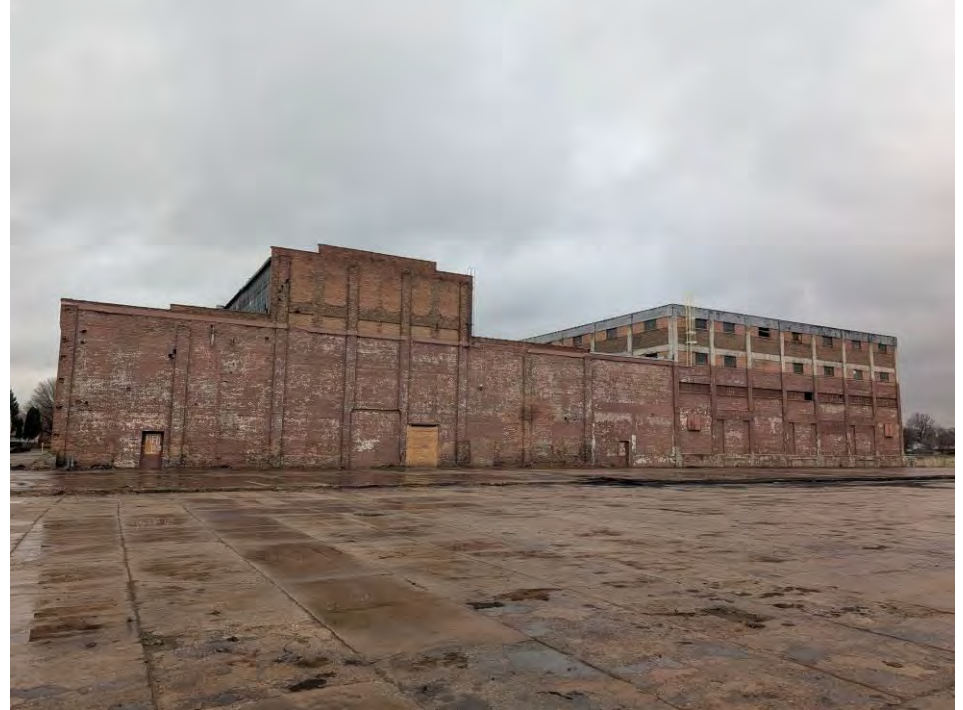
DATE: December 10, 2024
LOCATION: 500 Union Street in Mishawaka, Indiana
SUBJECT: View of west face of site building
PHOTOGRAPHER: Ryan M. Orzechowicz (Heartland)
PHOTO: 7

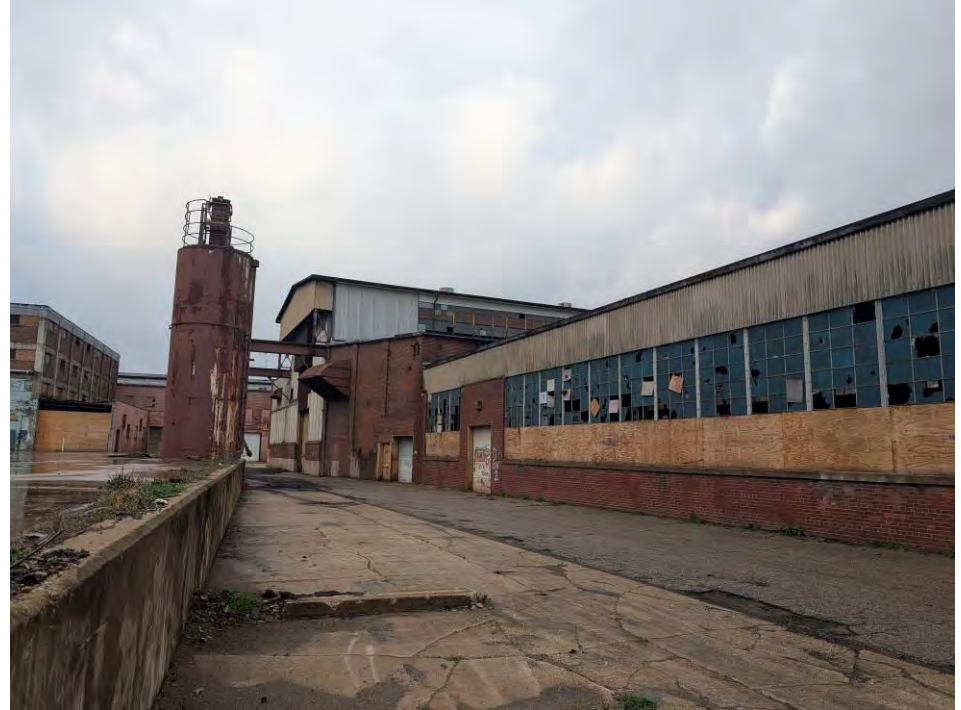
DATE: December 10, 2024
LOCATION: 500 Union Street in Mishawaka, Indiana
SUBJECT: View of east face of warehouse building
PHOTOGRAPHER: Ryan M. Orzechowicz (Heartland)
PHOTO: 9

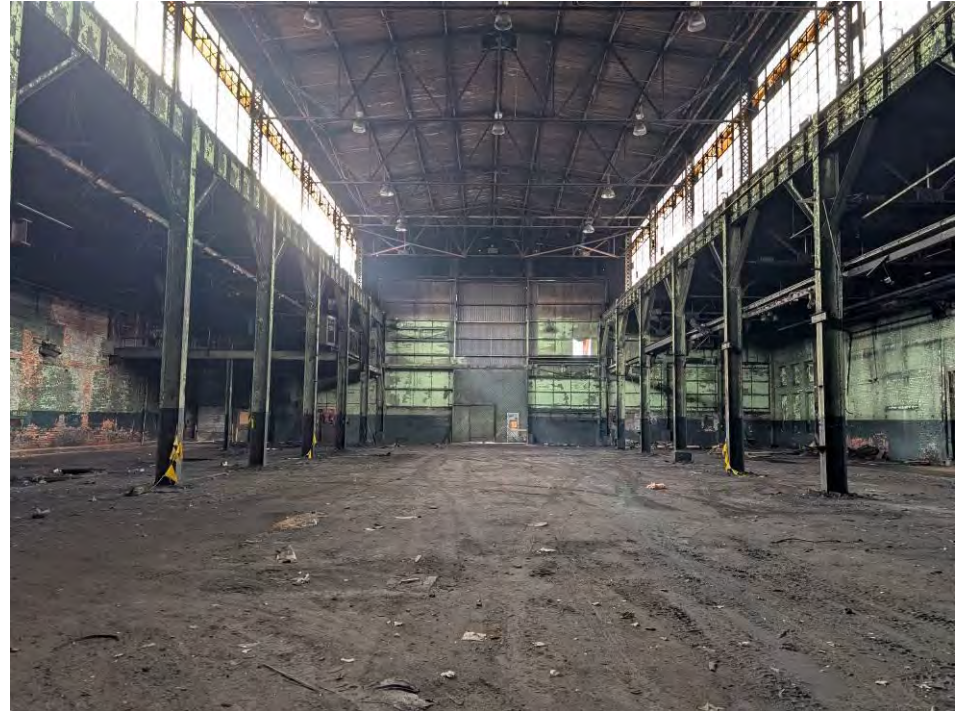
DATE: December 10, 2024
LOCATION: 500 Union Street in Mishawaka, Indiana
SUBJECT: View of interior of site building
PHOTOGRAPHER: Ryan M. Orzechowicz (Heartland)
PHOTO: 11

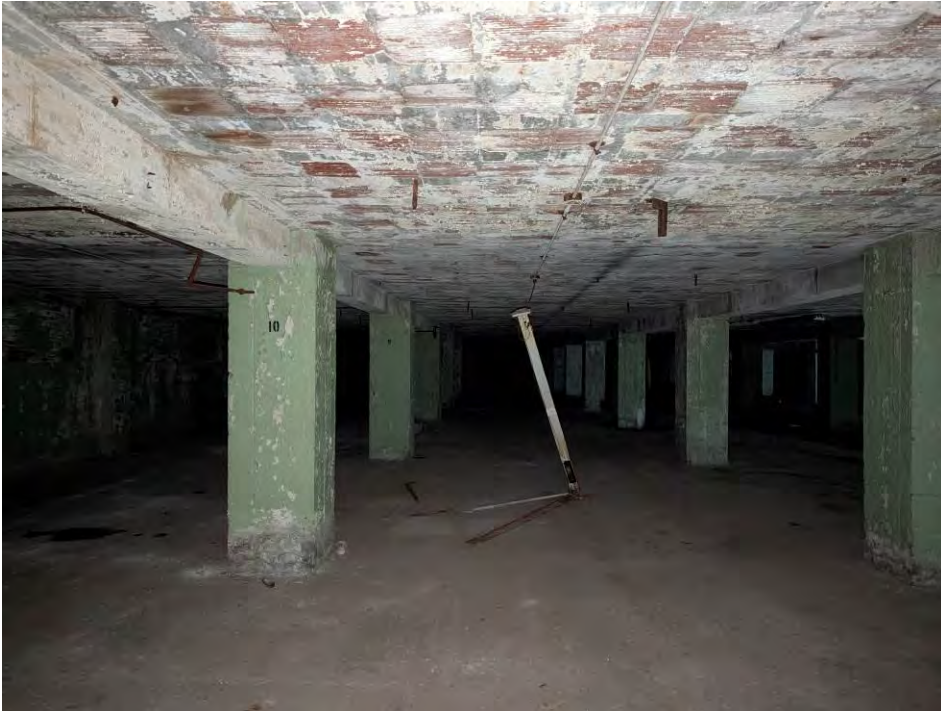
DATE: December 10, 2024
LOCATION: 500 Union Street in Mishawaka, Indiana
SUBJECT: View of interior of main foundry
PHOTOGRAPHER: Ryan M. Orzechowicz (Heartland)
PHOTO: 16

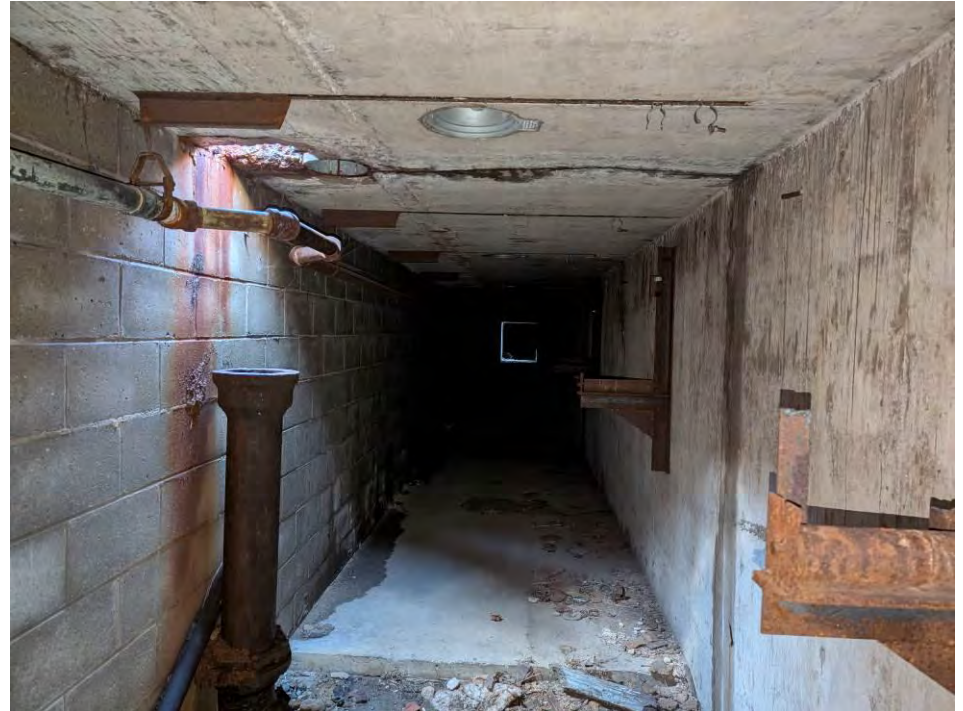
DATE: December 10, 2024
LOCATION: 500 Union Street in Mishawaka, Indiana
SUBJECT: View of basement of warehouse building
PHOTOGRAPHER: Ryan M. Orzechowicz (Heartland)
PHOTO: 17

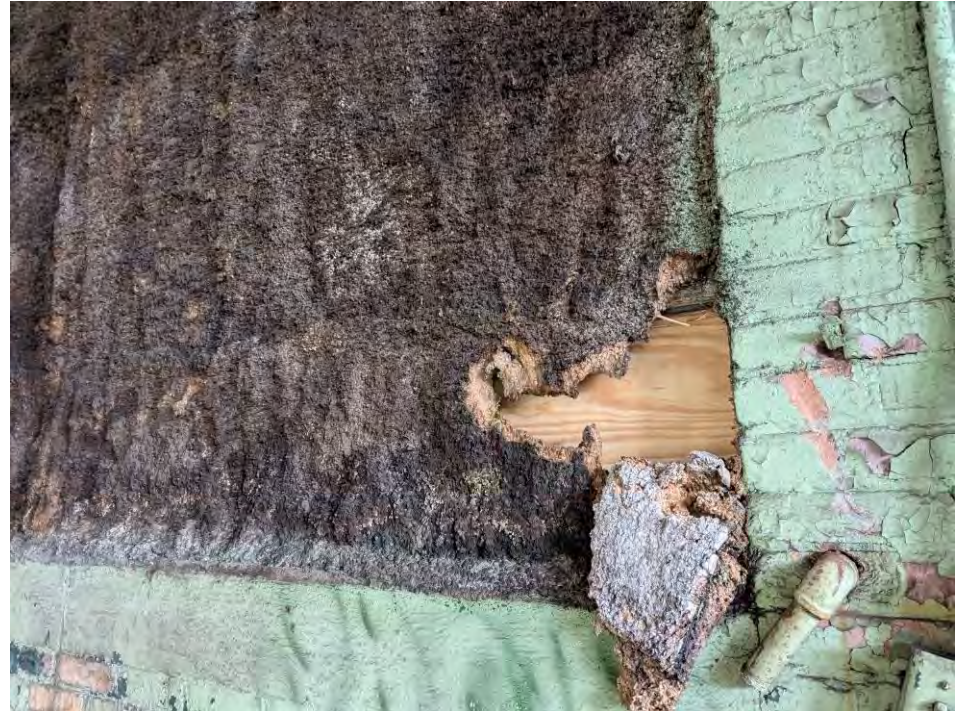
DATE: December 10, 2024
LOCATION: 500 Union Street in Mishawaka, Indiana
SUBJECT: View of 1st floor of warehouse building
PHOTOGRAPHER: Ryan M. Orzechowicz (Heartland)
PHOTO: 19

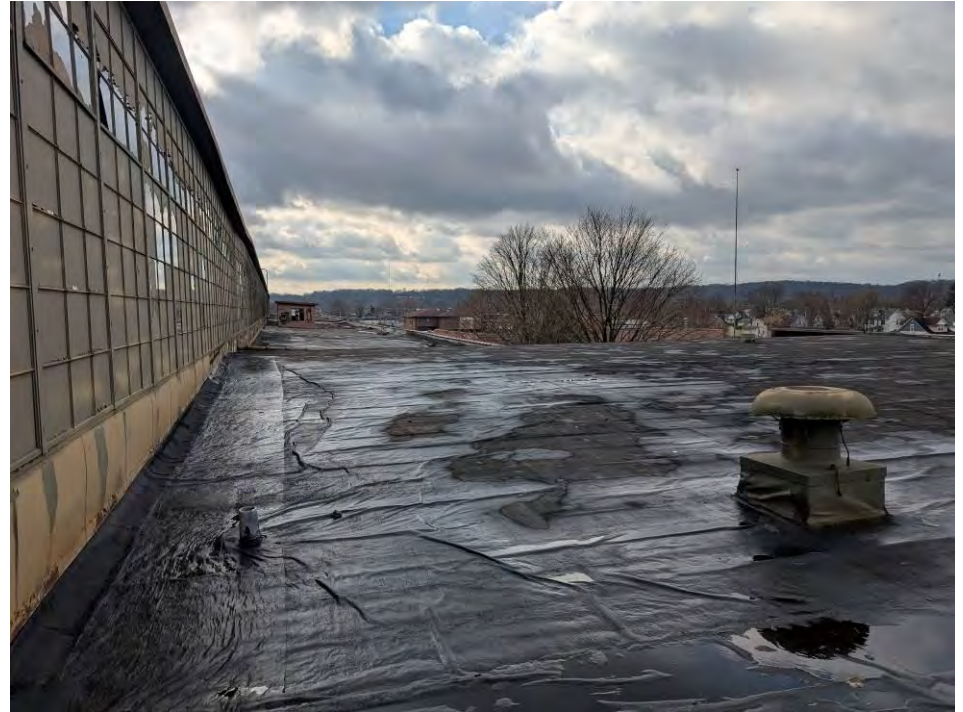
DATE: December 10, 2024
LOCATION: 500 Union Street in Mishawaka, Indiana
SUBJECT: View of sampled rolled asphalt roofing (RF-1)
PHOTOGRAPHER: Ryan M. Orzechowicz (Heartland)
PHOTO: 21

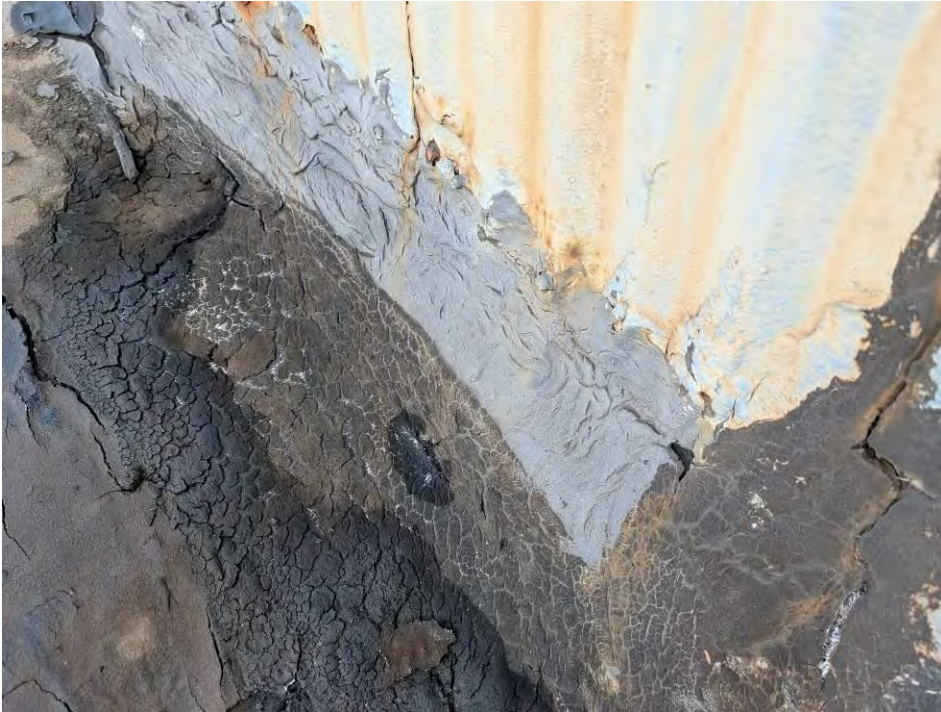
DATE: December 10, 2024
LOCATION: 500 Union Street in Mishawaka, Indiana
SUBJECT: View of sampled rubberized roofing (RF-2)
PHOTOGRAPHER: Ryan M. Orzechowicz (Heartland)
PHOTO: 22

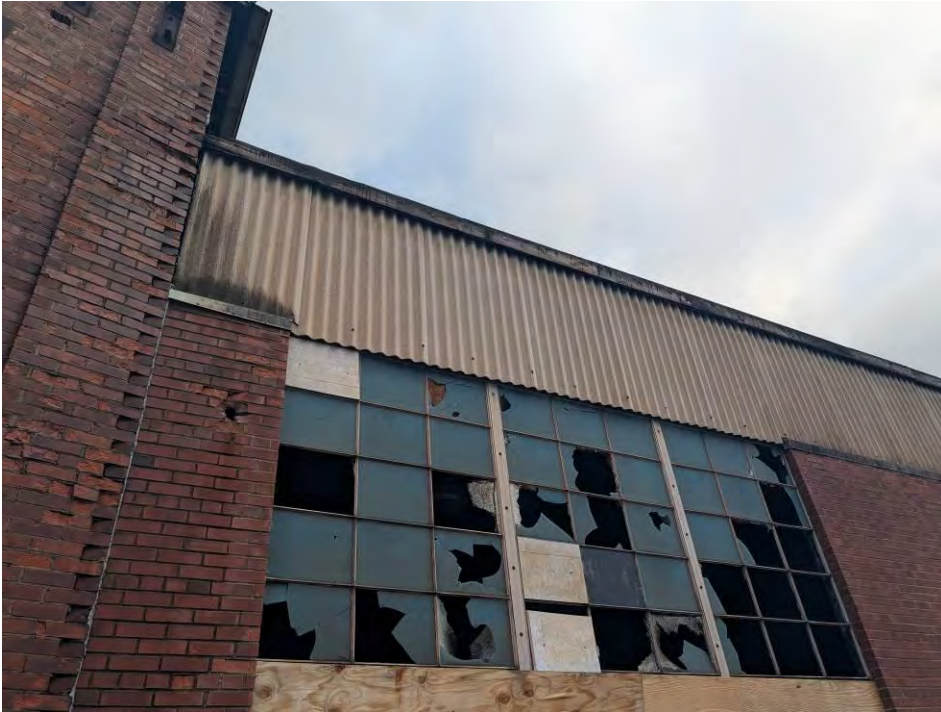
DATE: December 10, 2024
LOCATION: 500 Union Street in Mishawaka, Indiana
SUBJECT: View of sampled exterior caulking (EC-1)
PHOTOGRAPHER: Ryan M. Orzechowicz (Heartland)
PHOTO: 24

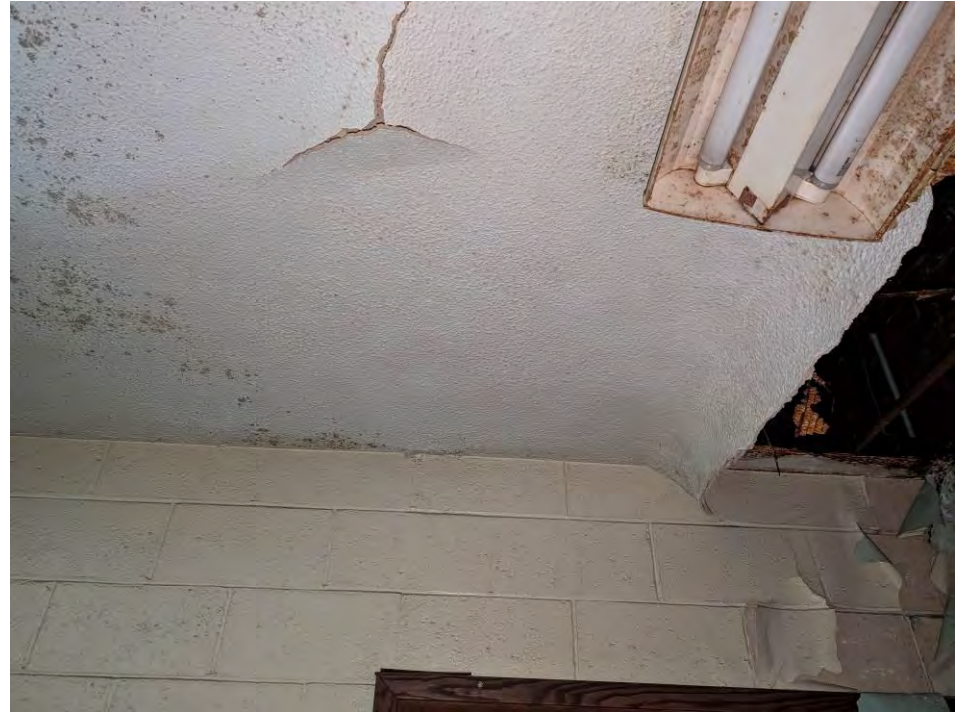
DATE: December 10, 2024
LOCATION: 500 Union Street in Mishawaka, Indiana
SUBJECT: View of sampled ceiling panels (CP-1)
PHOTOGRAPHER: Ryan M. Orzechowicz (Heartland)
PHOTO: 31

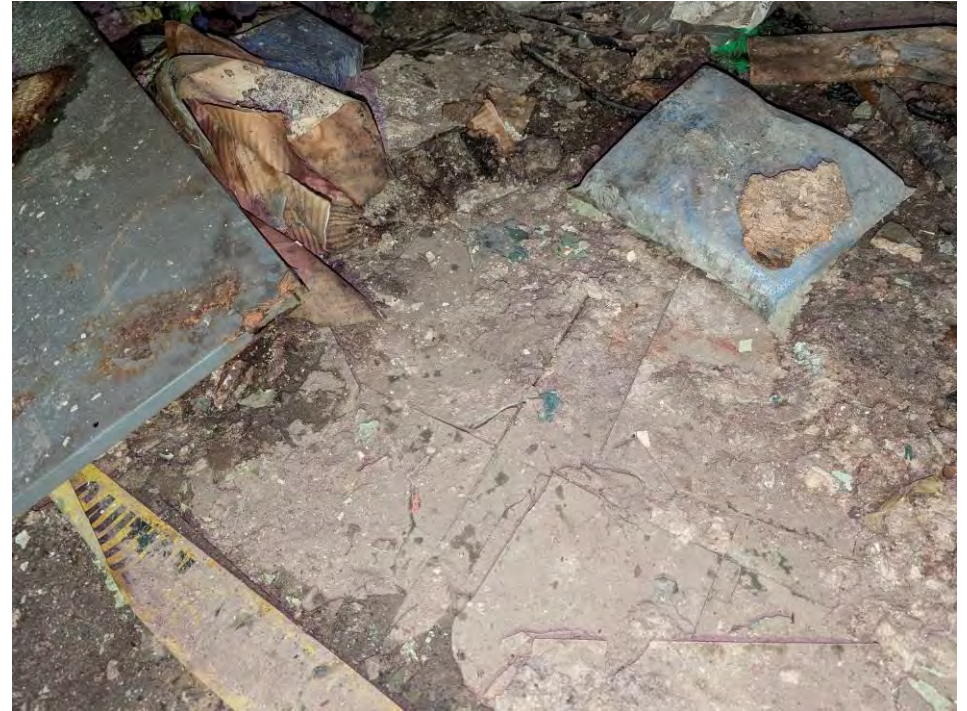
DATE: December 10, 2024
LOCATION: 500 Union Street in Mishawaka, Indiana
SUBJECT: View of sampled floor tile (FT-2)
PHOTOGRAPHER: Ryan M. Orzechowicz (Heartland)
PHOTO: 35

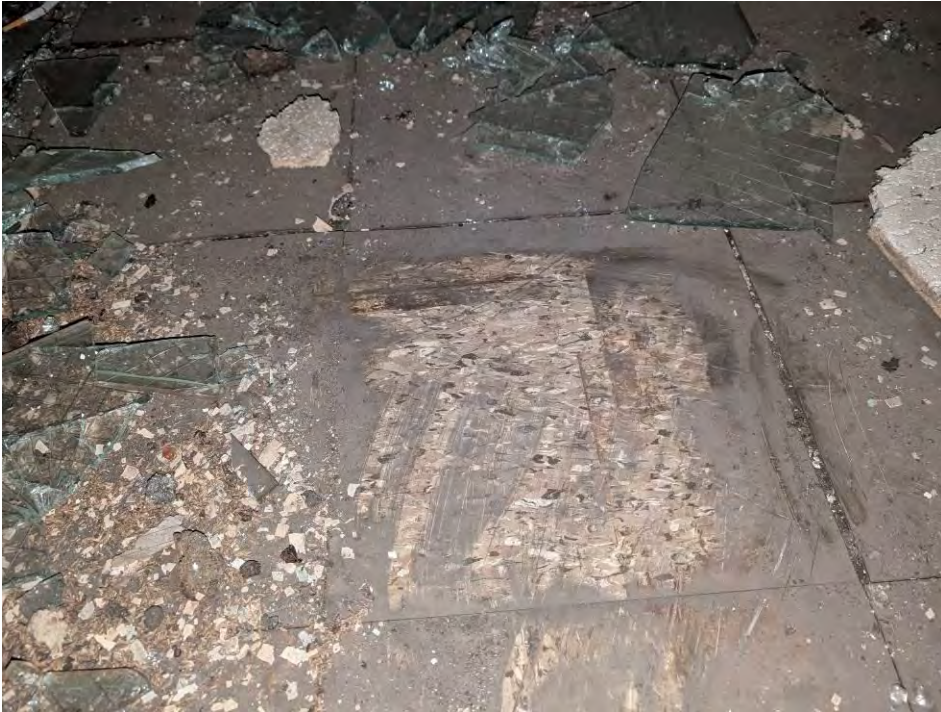
DATE: December 10, 2024
LOCATION: 500 Union Street in Mishawaka, Indiana
SUBJECT: View of sampled floor tile (FT-3)
PHOTOGRAPHER: Ryan M. Orzechowicz (Heartland)
PHOTO: 36

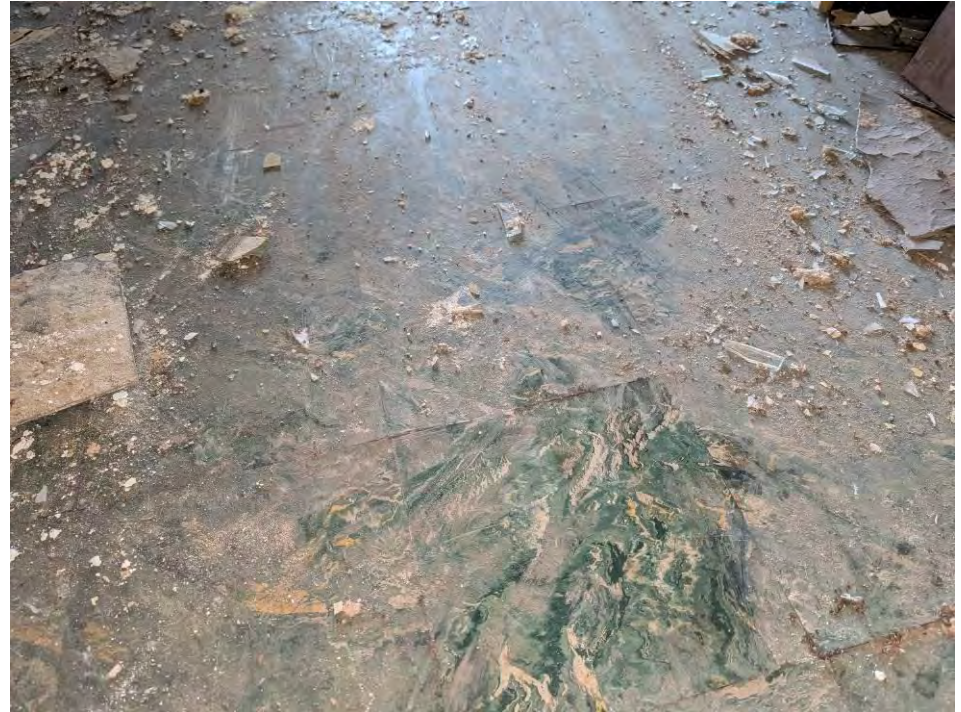
DATE: December 10, 2024
LOCATION: 500 Union Street in Mishawaka, Indiana
SUBJECT: View of sampled floor tile (FT-4)
PHOTOGRAPHER: Ryan M. Orzechowicz (Heartland)
PHOTO: 37

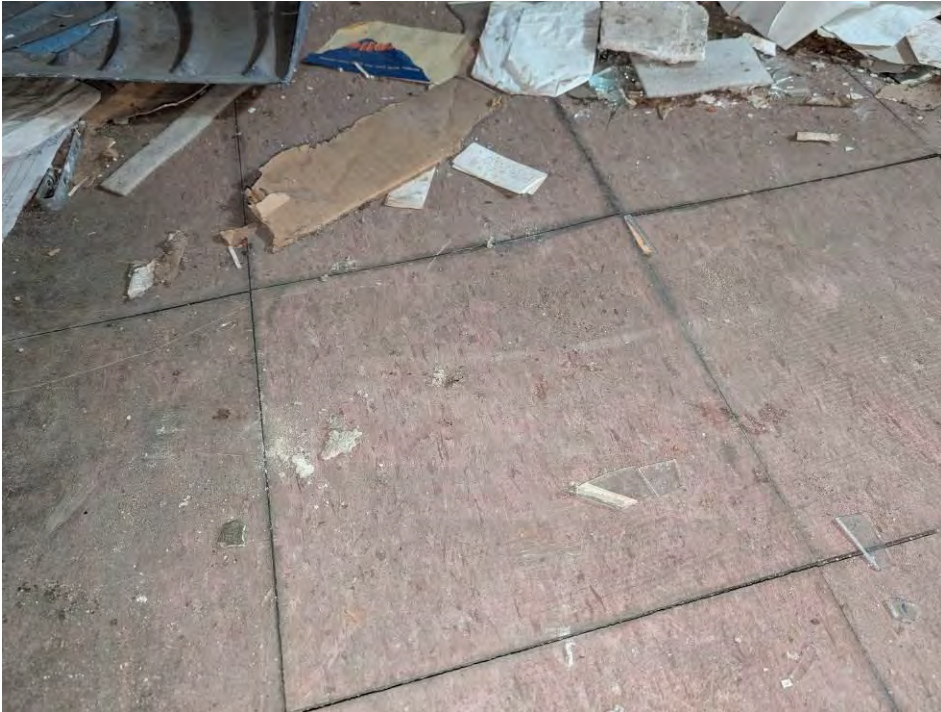
DATE: December 10, 2024
LOCATION: 500 Union Street in Mishawaka, Indiana
SUBJECT: View of sampled floor tile (FT-5)
PHOTOGRAPHER: Ryan M. Orzechowicz (Heartland)
PHOTO: 38

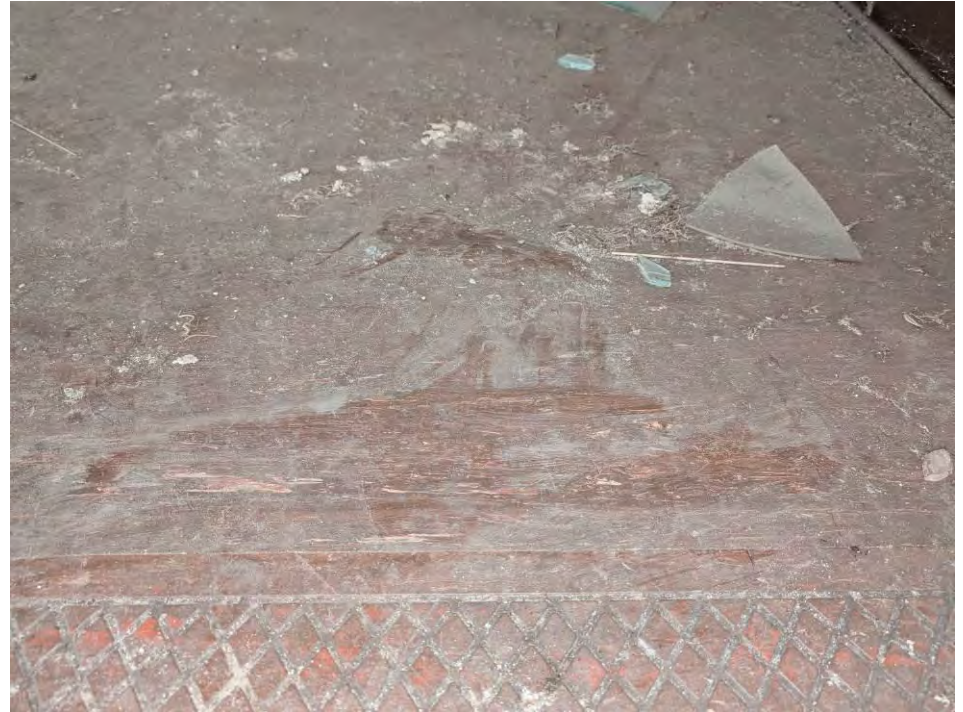
DATE: December 10, 2024
LOCATION: 500 Union Street in Mishawaka, Indiana
SUBJECT: View of sampled floor tile (FT-6)
PHOTOGRAPHER: Ryan M. Orzechowicz (Heartland)
PHOTO: 39

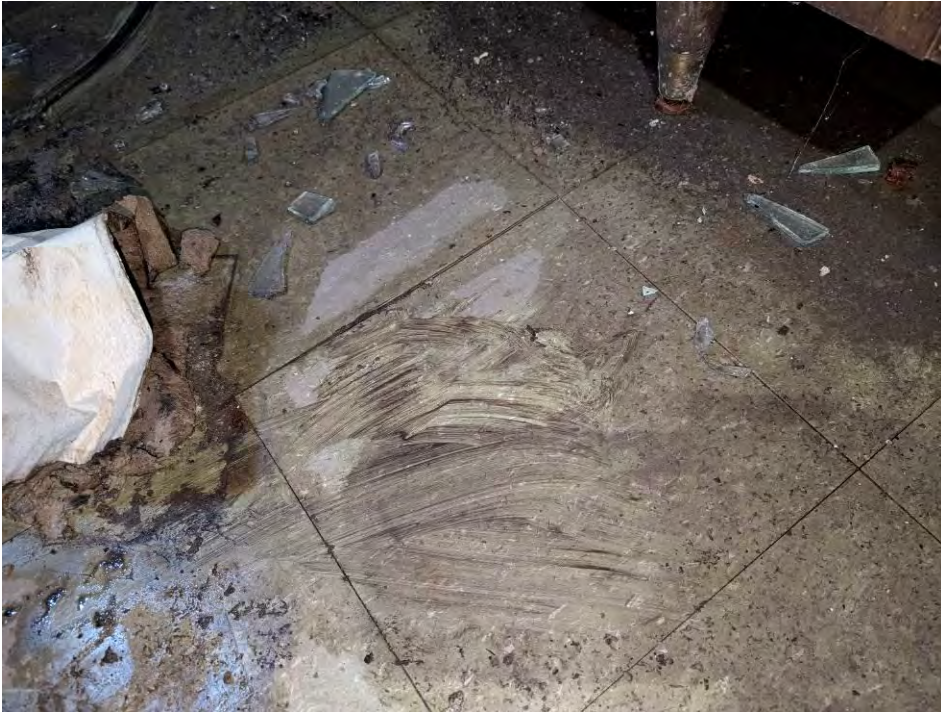
DATE: December 10, 2024
LOCATION: 500 Union Street in Mishawaka, Indiana
SUBJECT: View of sampled floor tile (FT-7)
PHOTOGRAPHER: Ryan M. Orzechowicz (Heartland)
PHOTO: 40

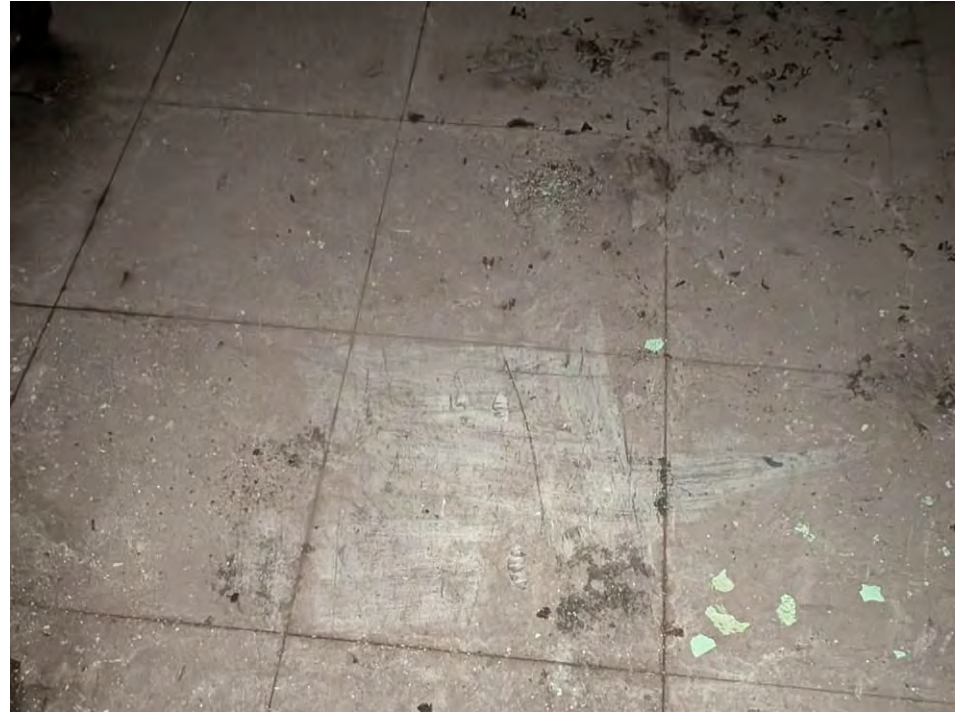
DATE: December 10, 2024
LOCATION: 500 Union Street in Mishawaka, Indiana
SUBJECT: View of sampled floor tile (FT-8)
PHOTOGRAPHER: Ryan M. Orzechowicz (Heartland)
PHOTO: 41

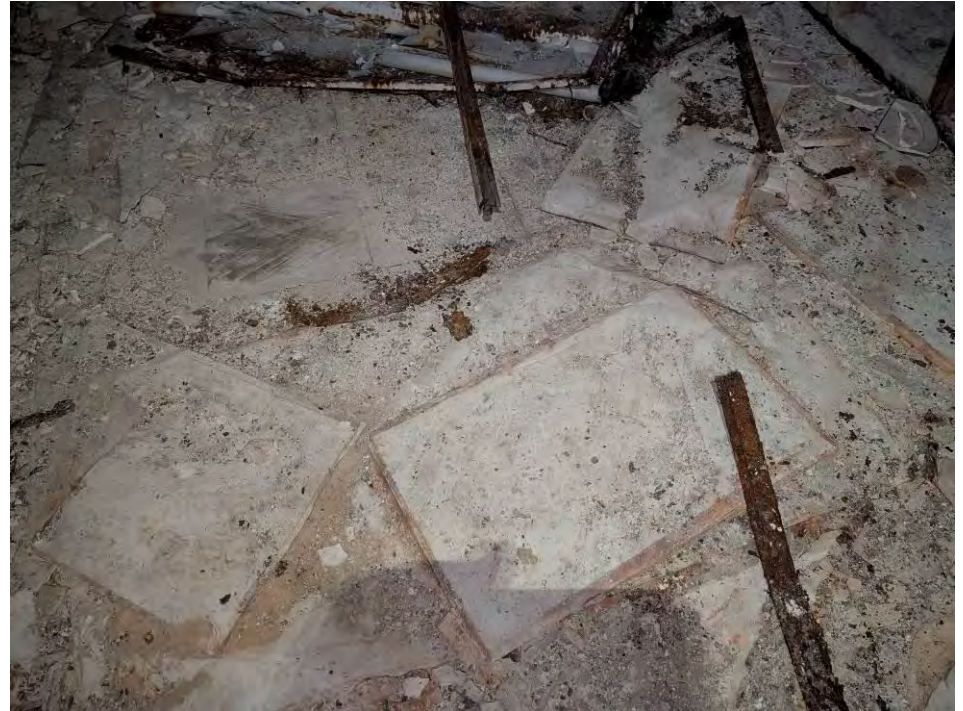
DATE: December 10, 2024
LOCATION: 500 Union Street in Mishawaka, Indiana
SUBJECT: View of sampled glue pods (GP-1)
PHOTOGRAPHER: Ryan M. Orzechowicz (Heartland)
PHOTO: 43

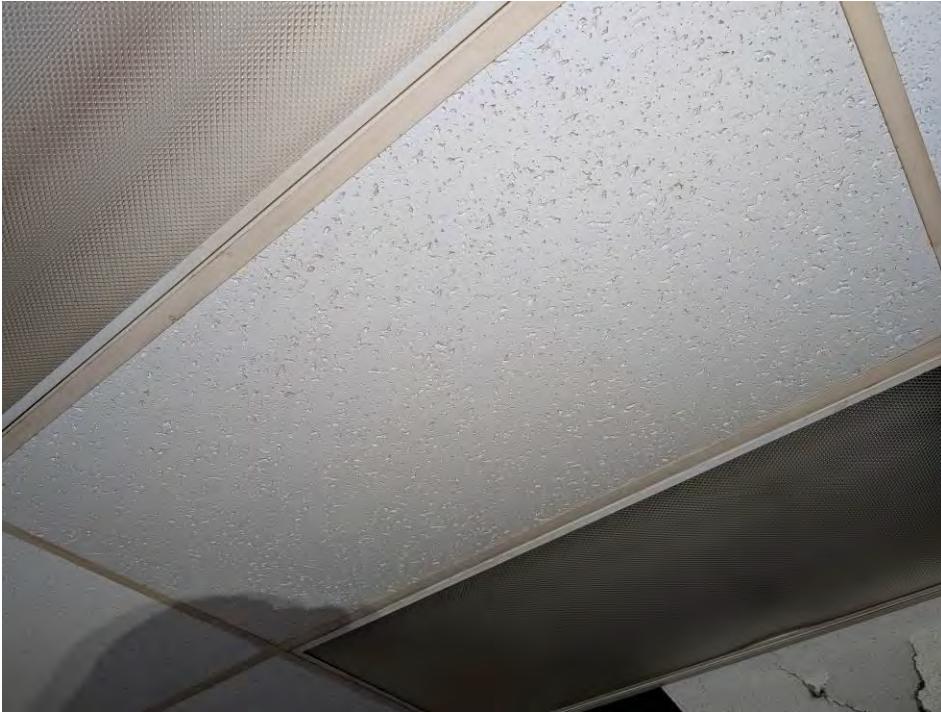
DATE: December 10, 2024
LOCATION: 500 Union Street in Mishawaka, Indiana
SUBJECT: View of sampled ceiling tile (CT-1)
PHOTOGRAPHER: Ryan M. Orzechowicz (Heartland)
PHOTO: 44

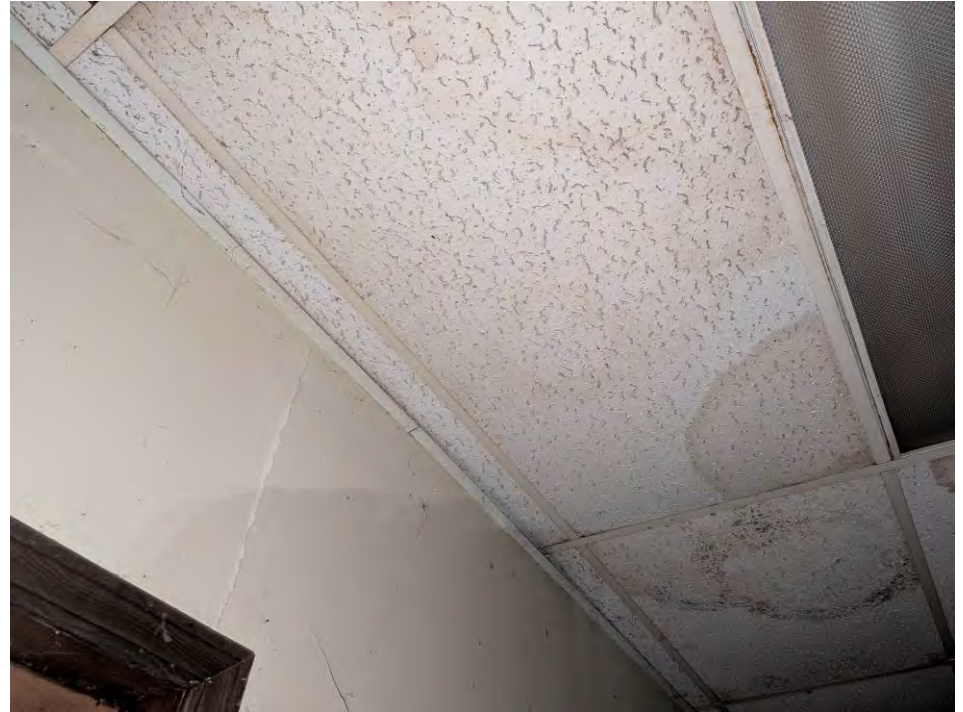
DATE: December 10, 2024
LOCATION: 500 Union Street in Mishawaka, Indiana
SUBJECT: View of sampled ceiling tile (CT-2)
PHOTOGRAPHER: Ryan M. Orzechowicz (Heartland)
PHOTO: 45

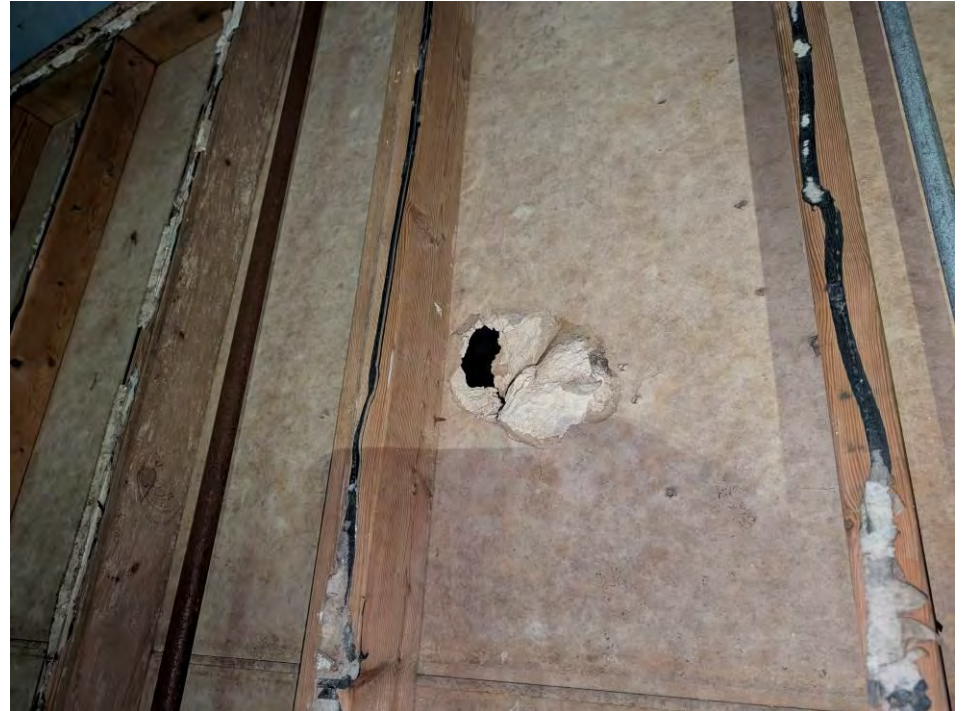
DATE: December 10, 2024
LOCATION: 500 Union Street in Mishawaka, Indiana
SUBJECT: View of sampled ceiling tile (CT-4)
PHOTOGRAPHER: Ryan M. Orzechowicz (Heartland)
PHOTO: 47

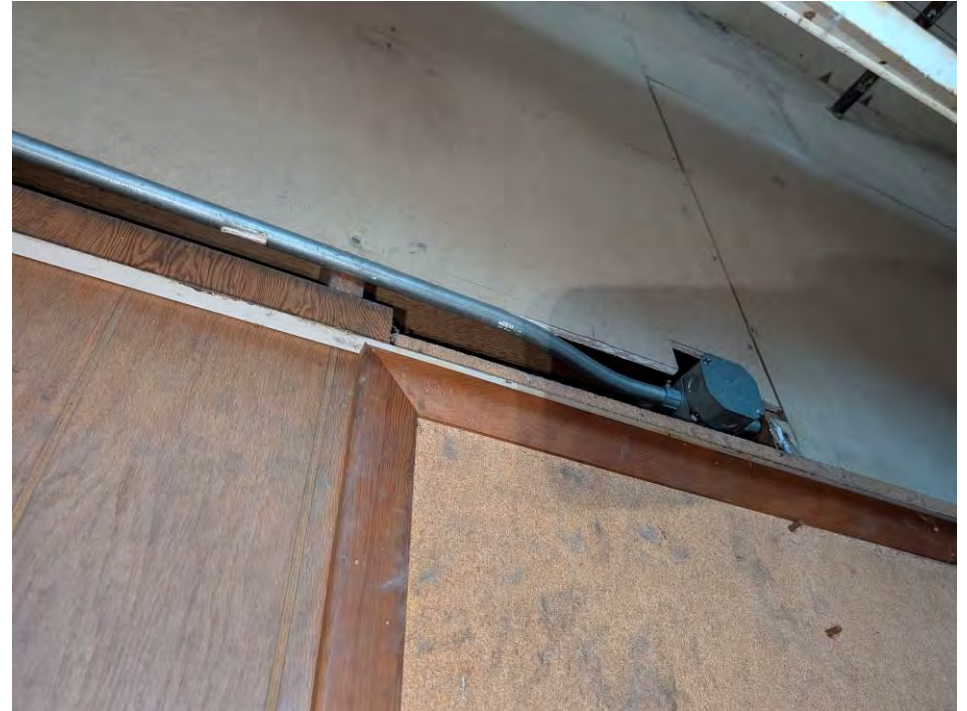
DATE: December 10, 2024
LOCATION: 500 Union Street in Mishawaka, Indiana
SUBJECT: View of sampled drywall (DW-2)
PHOTOGRAPHER: Ryan M. Orzechowicz (Heartland)
PHOTO: 49

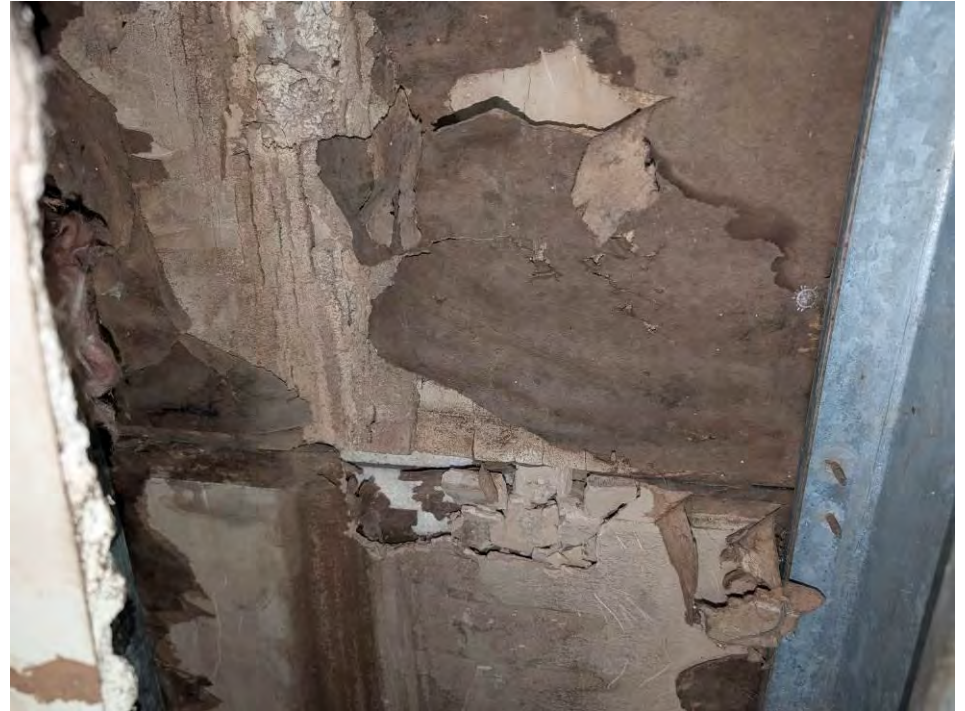
DATE: December 10, 2024
LOCATION: 500 Union Street in Mishawaka, Indiana
SUBJECT: View of sampled drywall (DW-4)
PHOTOGRAPHER: Ryan M. Orzechowicz (Heartland)
PHOTO: 51

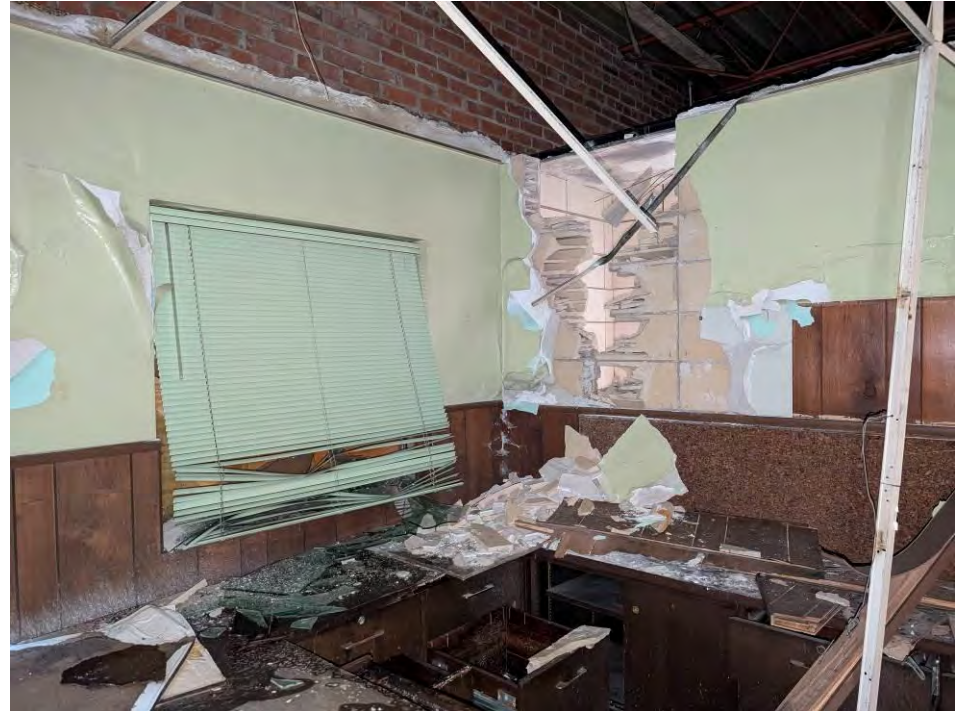
DATE: December 10, 2024
LOCATION: 500 Union Street in Mishawaka, Indiana
SUBJECT: View of sampled plaster (PL-1)
PHOTOGRAPHER: Ryan M. Orzechowicz (Heartland)
PHOTO: 53

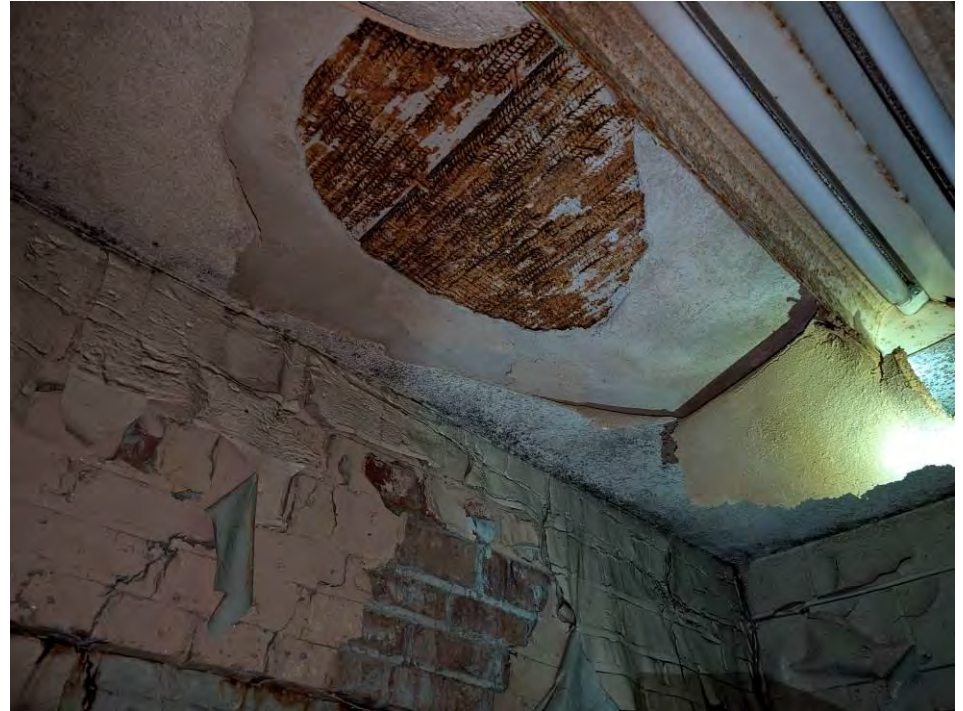
DATE: December 10, 2024
LOCATION: 500 Union Street in Mishawaka, Indiana
SUBJECT: View of sampled plaster (PL-3)
PHOTOGRAPHER: Ryan M. Orzechowicz (Heartland)
PHOTO: 55

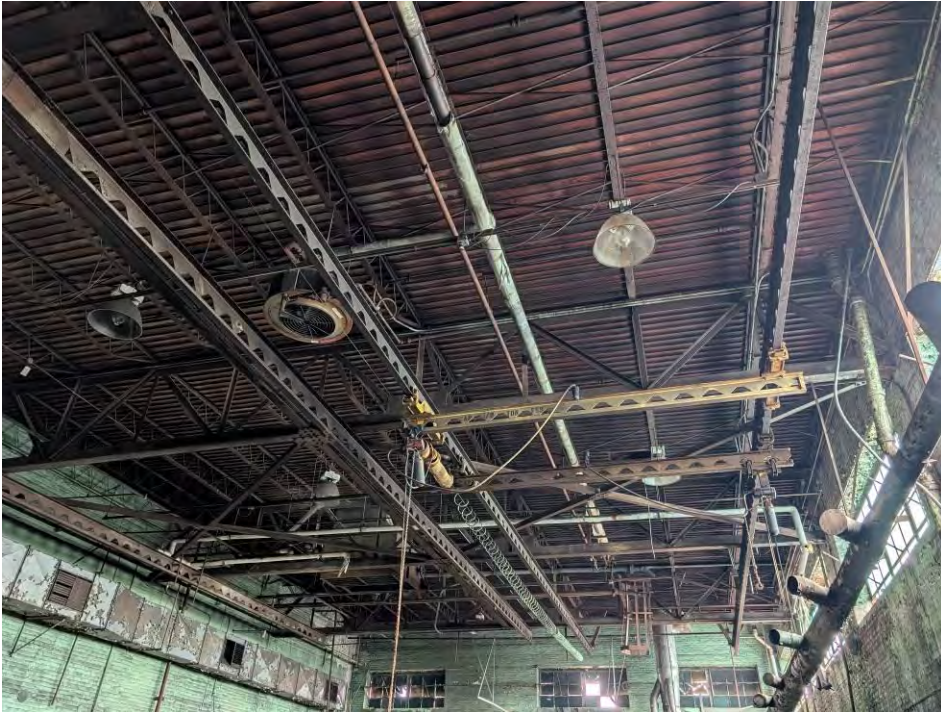
DATE: December 10, 2024
LOCATION: 500 Union Street in Mishawaka, Indiana
SUBJECT: View of sampled plaster (PL-4)
PHOTOGRAPHER: Ryan M. Orzechowicz (Heartland)
PHOTO: 56

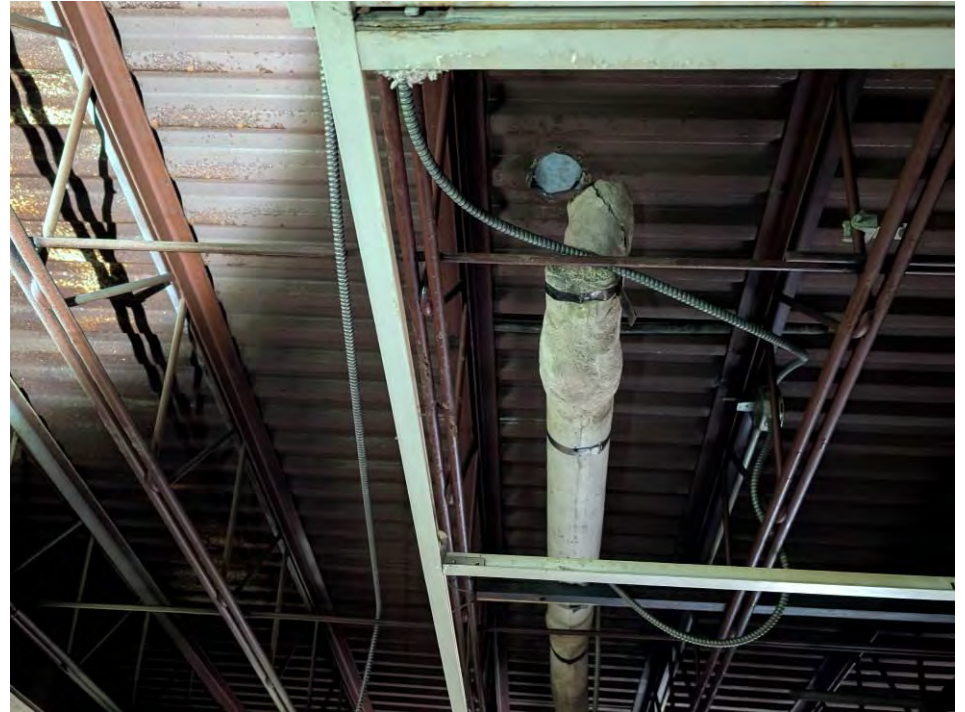
DATE: December 10, 2024
LOCATION: 500 Union Street in Mishawaka, Indiana
SUBJECT: View of sampled TSI pipe wrap (PW-1)
PHOTOGRAPHER: Ryan M. Orzechowicz (Heartland)
PHOTO: 57

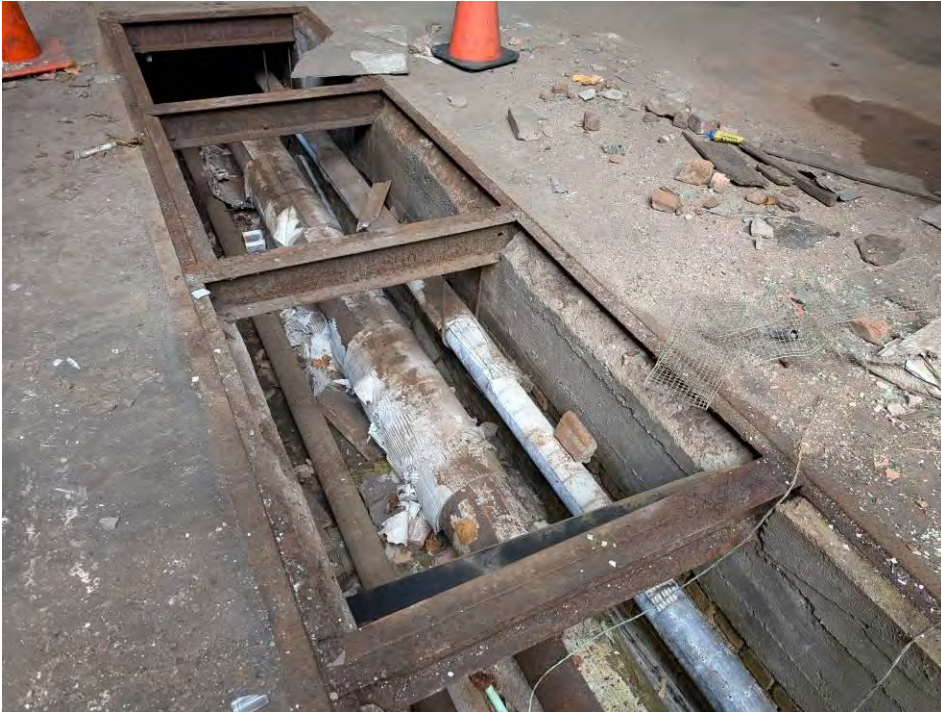
DATE: December 10, 2024
LOCATION: 500 Union Street in Mishawaka, Indiana
SUBJECT: View of ACM TSI pipe wrap
PHOTOGRAPHER: Ryan M. Orzechowicz (Heartland)
PHOTO: 58
