ANALYSIS OF BROWNFIELD CLEANUP ALTERNATIVES

Former Dodge Manufacturing Company / Former RMG Foundry Facility

500 South Union Street

Former Dodge Manufacturing Company / Former RMG Foundry
Main Foundry Building
500 Union Street
Mishawaka, Indiana 46544
Heartland Project #5306-24-01

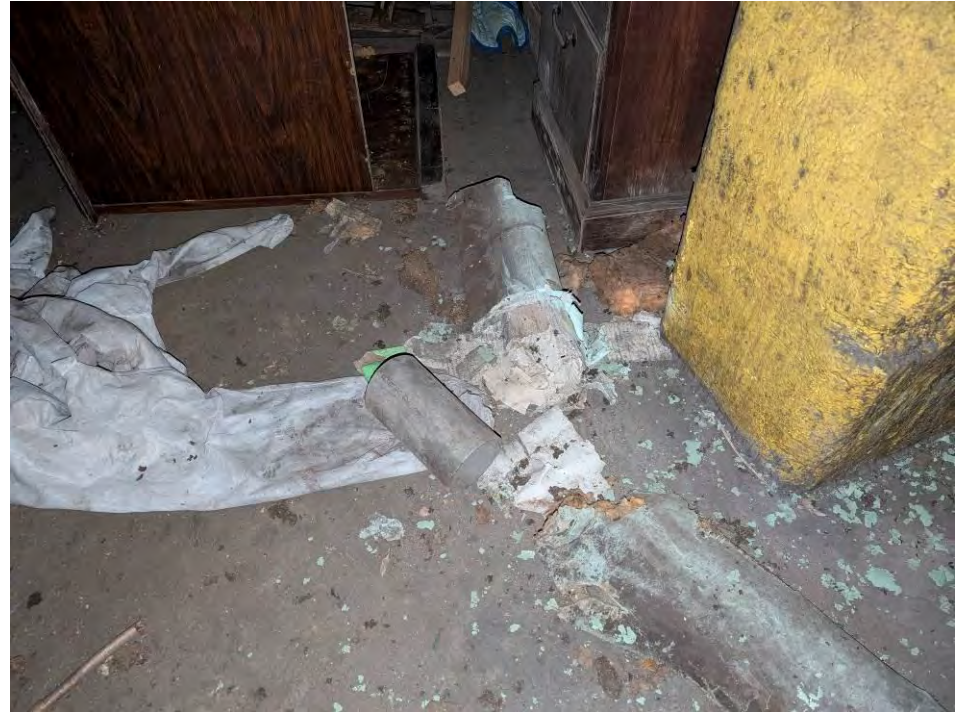
DATE: December 10, 2024
LOCATION: 500 Union Street in Mishawaka, Indiana
SUBJECT: View of ACM TSI pipe wrap
PHOTOGRAPHER: Ryan M. Orzechowicz (Heartland)
PHOTO: 59

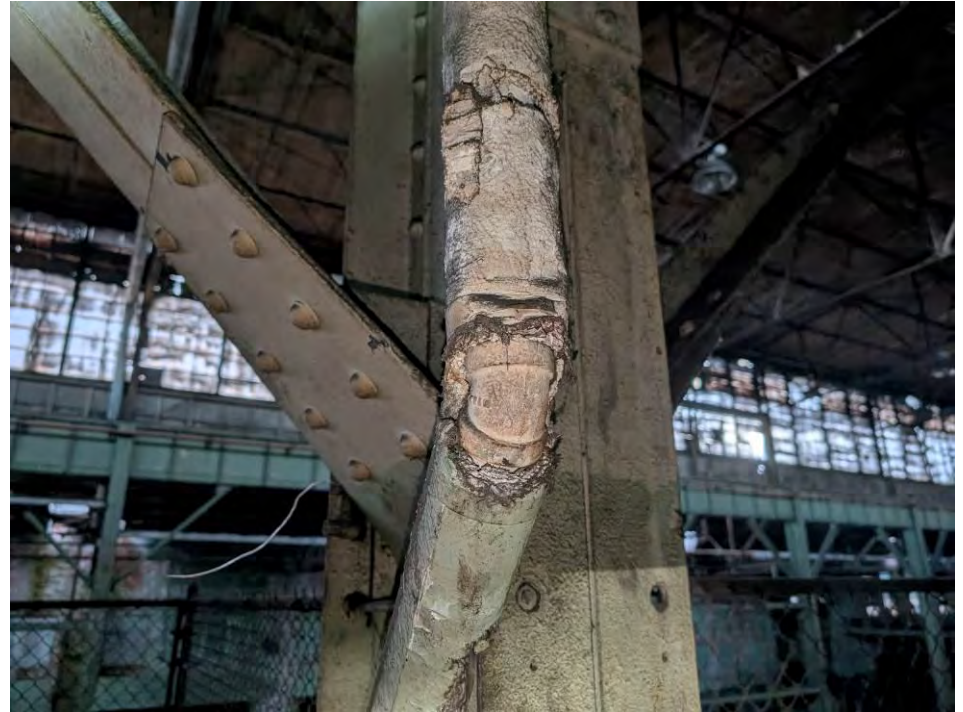
DATE: December 10, 2024
LOCATION: 500 Union Street in Mishawaka, Indiana
SUBJECT: View of sampled TSI mudded joint (MJ-1)
PHOTOGRAPHER: Ryan M. Orzechowicz (Heartland)
PHOTO: 61

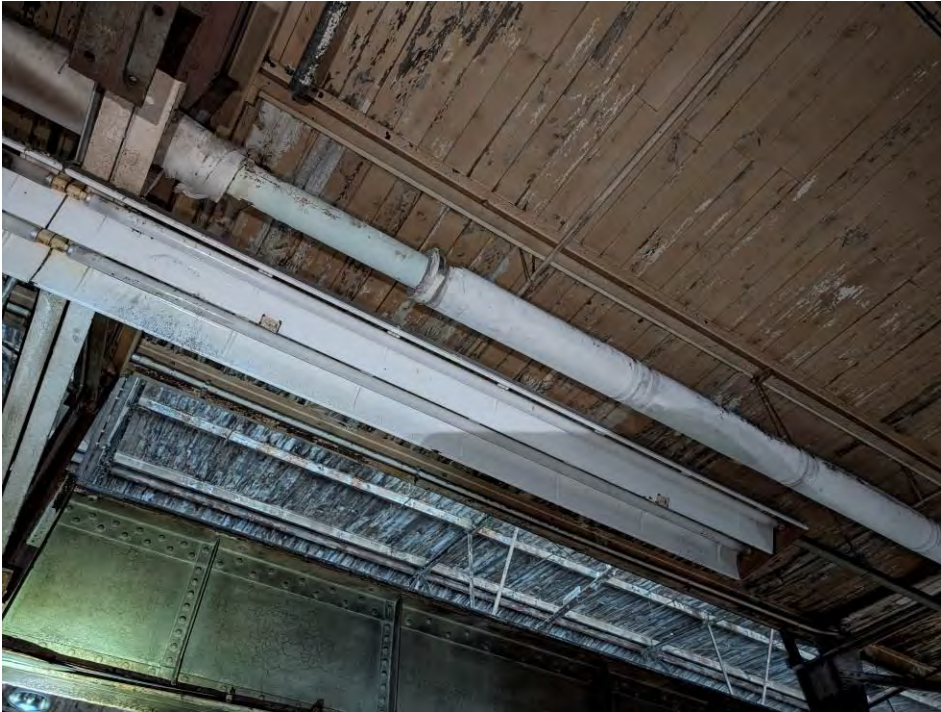
DATE: December 10, 2024
LOCATION: 500 Union Street in Mishawaka, Indiana
SUBJECT: View of damaged ACM TSI pipe wrap
PHOTOGRAPHER: Ryan M. Orzechowicz (Heartland)
PHOTO: 62

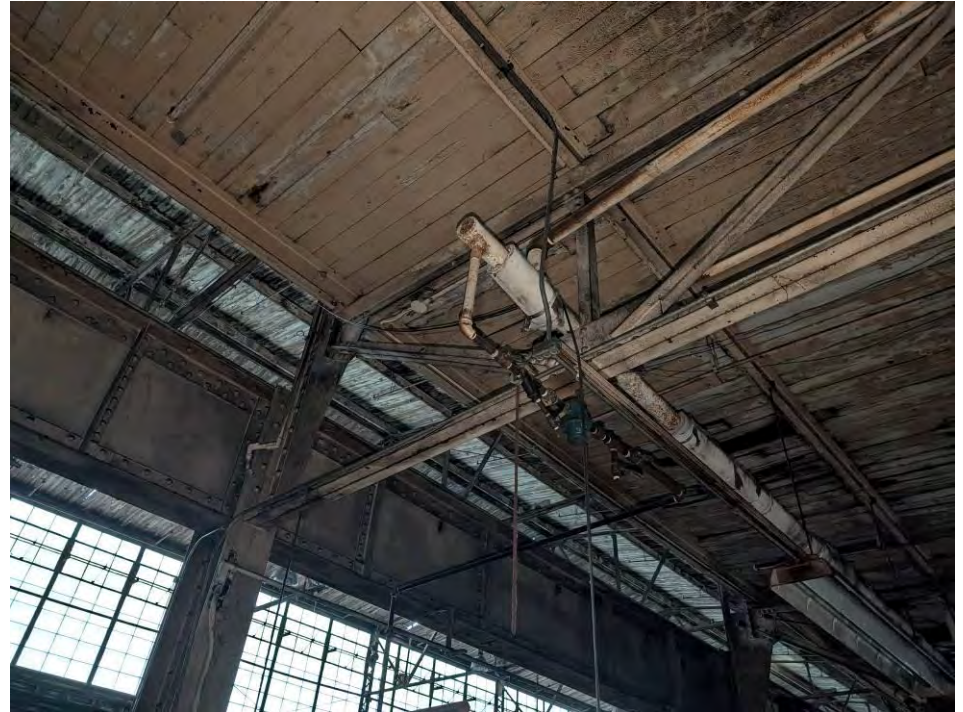
DATE: December 10, 2024
LOCATION: 500 Union Street in Mishawaka, Indiana
SUBJECT: View of ACM TSI pipe wrap
PHOTOGRAPHER: Ryan M. Orzechowicz (Heartland)
PHOTO: 63

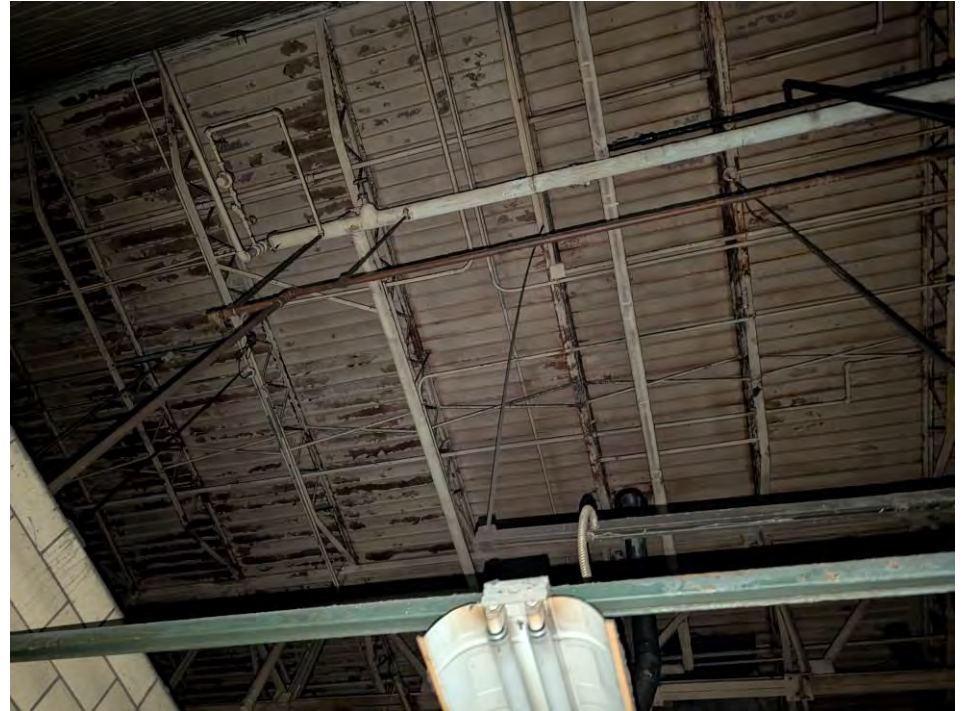
DATE: December 10, 2024
LOCATION: 500 Union Street in Mishawaka, Indiana
SUBJECT: View of ACM TSI pipe wrap
PHOTOGRAPHER: Ryan M. Orzechowicz (Heartland)
PHOTO: 65

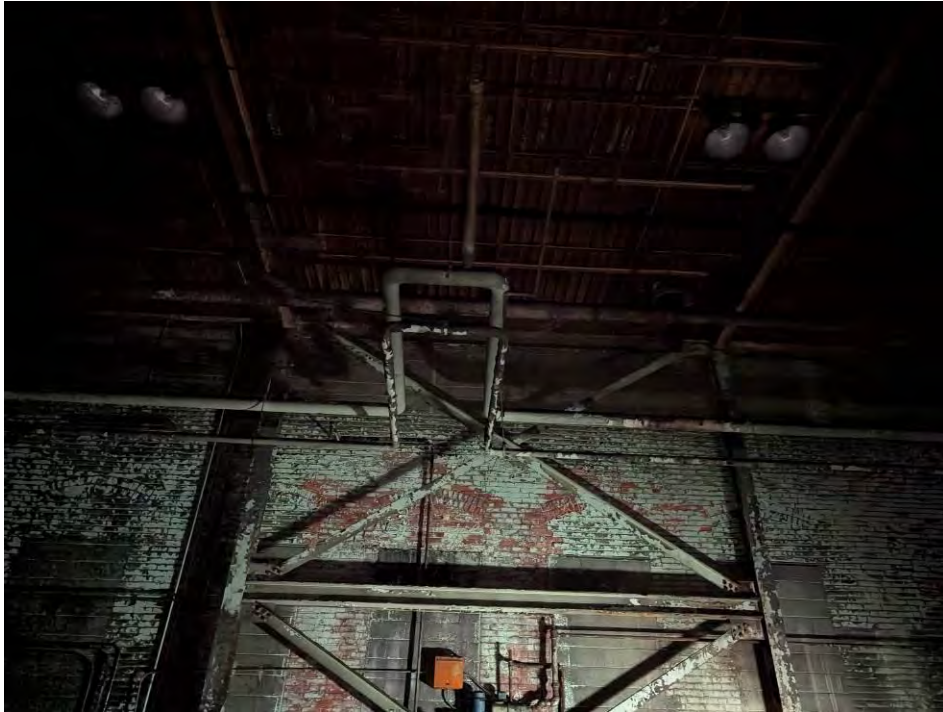
DATE: December 10, 2024
LOCATION: 500 Union Street in Mishawaka, Indiana
SUBJECT: View of ACM TSI pipe wrap
PHOTOGRAPHER: Ryan M. Orzechowicz (Heartland)
PHOTO: 66

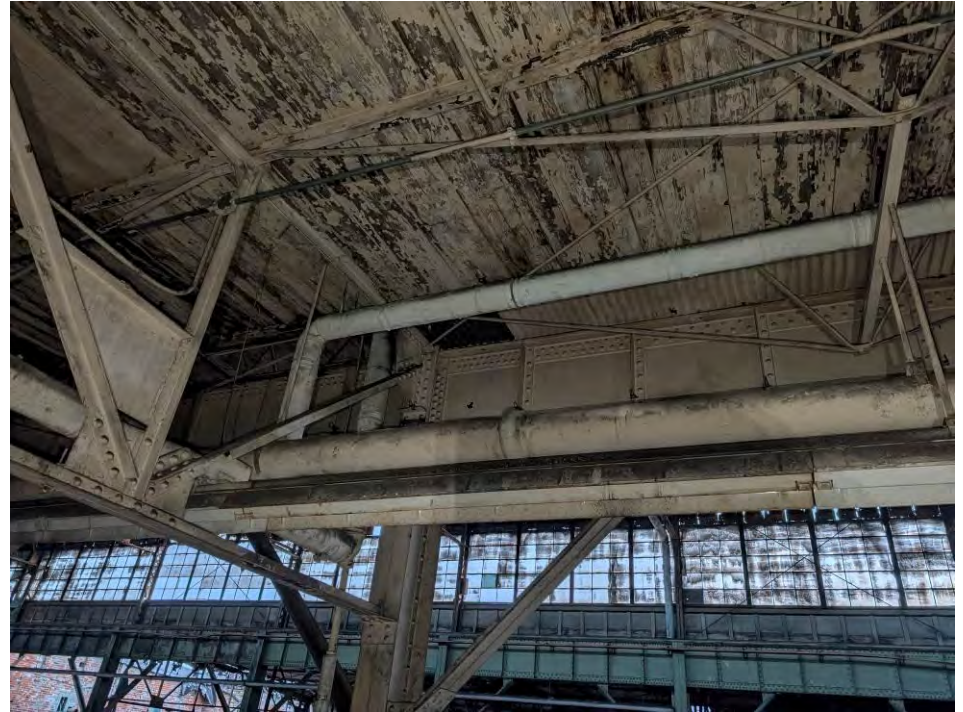
DATE: December 10, 2024
LOCATION: 500 Union Street in Mishawaka, Indiana
SUBJECT: View of ACM TSI pipe wrap
PHOTOGRAPHER: Ryan M. Orzechowicz (Heartland)
PHOTO: 67

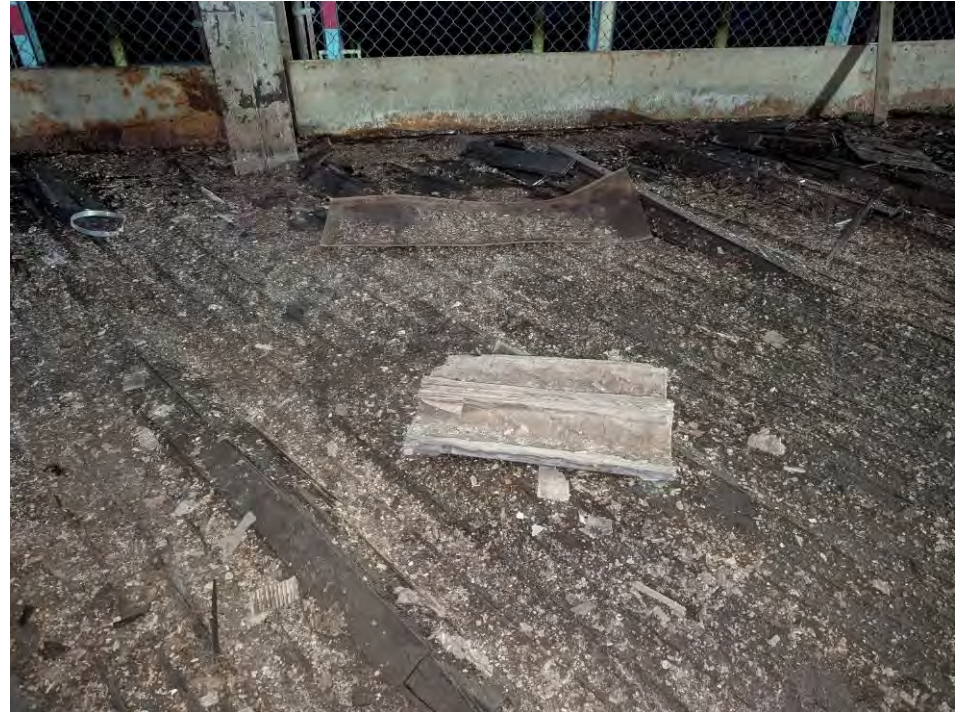
DATE: December 10, 2024
LOCATION: 500 Union Street in Mishawaka, Indiana
SUBJECT: View of ACM TSI pipe wrap
PHOTOGRAPHER: Ryan M. Orzechowicz (Heartland)
PHOTO: 69
