**Re: Final Remediation Work Plan for Asbestos Containing Materials Abatement
Former Dodge Manufacturing Company / Former RMG Foundry Facility
500 South Union Street in Mishawaka, Indiana
Indiana Brownfields Program Site #4060054
USEPA Revolving Loan Fund Cooperative Agreement #4B-00E03232
Heartland Project #5113-26-04**

**Former Dodge Manufacturing Company / Former RMG Foundry
Main Foundry Building
500 South Union Street
Mishawaka, Indiana 46544**

Former Dodge Manufacturing Company / Former RMG Foundry
Main Foundry Building
500 Union Street
Mishawaka, Indiana 46544
Heartland Project #5306-24-01

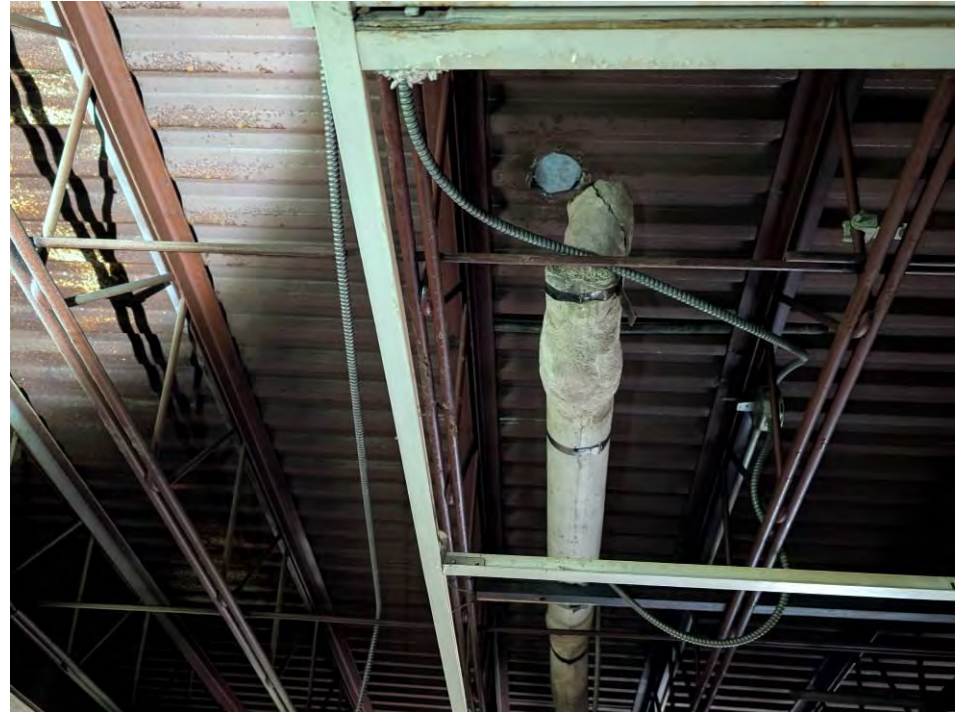
DATE: December 10, 2024
LOCATION: 500 Union Street in Mishawaka, Indiana
SUBJECT: View of sampled TSI pipe wrap (PW-1)
PHOTOGRAPHER: Ryan M. Orzechowicz (Heartland)
PHOTO: 57

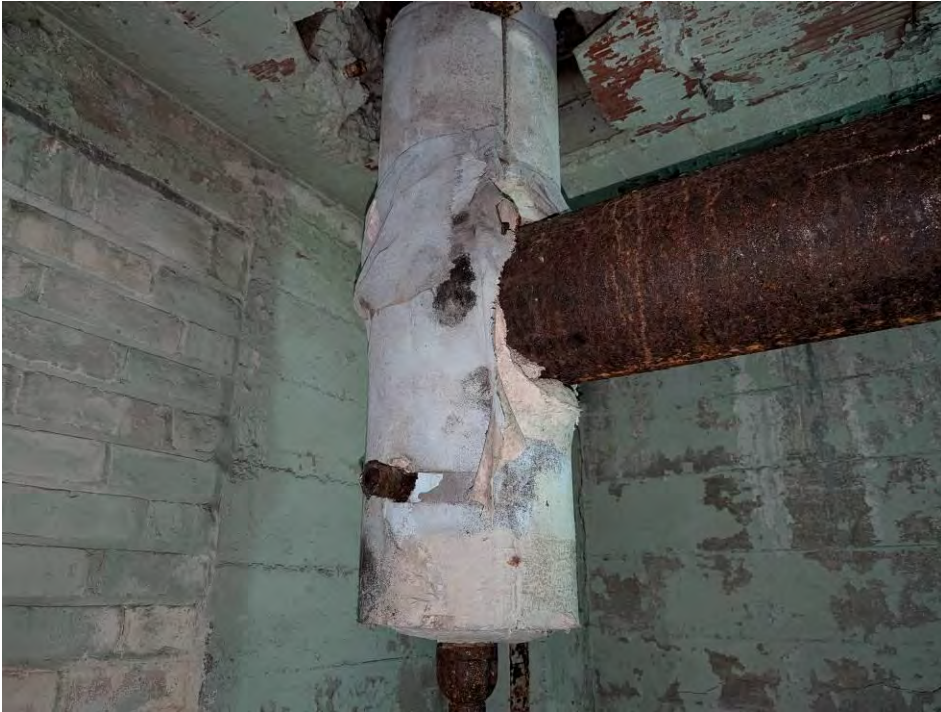
In general, the RACMs were encountered in fair to poor condition, with several sections of TSI pipe wrap and pipe fittings encountered either intact or slightly damaged. However, significant amounts of TSI were observed to be damaged or significantly damaged. Additionally, several sections of TSI were scattered on the floor as debris. This included areas in the basement portion of the main site building, where asbestos containing debris was strewn. Potential exposure to damaged and friable RACMs was determined to be a concern, particularly in the basement where strewn TSI was observed on the floors in several areas.

DATE: December 10, 2024
LOCATION: 500 Union Street in Mishawaka, Indiana
SUBJECT: View of ACM TSI pipe wrap scattered as debris
PHOTOGRAPHER: Ryan M. Orzechowicz (Heartland)
PHOTO: 60

The abatement of strewn TSI located on the floors of the basement of the site building where damaged, friable TSI materials were observed, and a full decontamination and cleaning of these areas to ensure that all friable ACMs have been properly removed, is included in this scope of services. A full, negative air containment will be required to be set up in this area prior to the onset of abatement in the basement so as to eliminate the potential for asbestos fibers to be released during abatement activities. All personnel will be required to wear appropriate PPE when entering the containment area. The containment area cannot be taken down until a visual clearance inspection is conducted.
