## **Traders Point Lake Dam Inspection**

July 2020 Dam Inspection and Repair Report December 2020

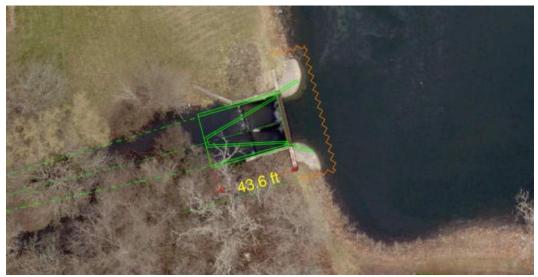
Figure No. 4 - Single Labyrinth Spillway Option

CEI estimated that a labyrinth 27 ft. wide at the existing 30 ft. wide spillway would have to extend approximately 44 ft. below the existing spillway wall, or 13.75 ft. beyond the ends of the existing abutment walls. Two new abutment walls would need to be constructed adjacent to the existing abutment walls, and a base slab would also be needed. See **Figure No. 4** below.

Based on our most recent analysis presented above, we would still recommend a similar single labyrinth as a replacement structure for the current spillway for the Traders Point Lake Dam.

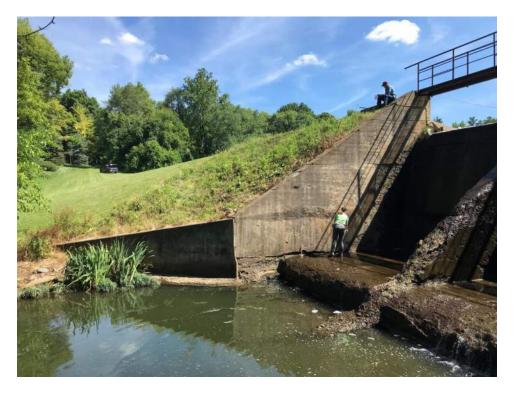
**Photo A3:** View looking East at the downstream Rt spillway abutment wall and additional retaining wall.

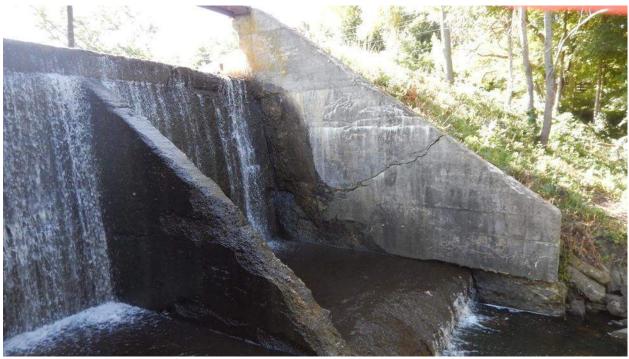
**Photo A4:** View looking South at the downstream LT spillway abutment wall and the center buttress wall.

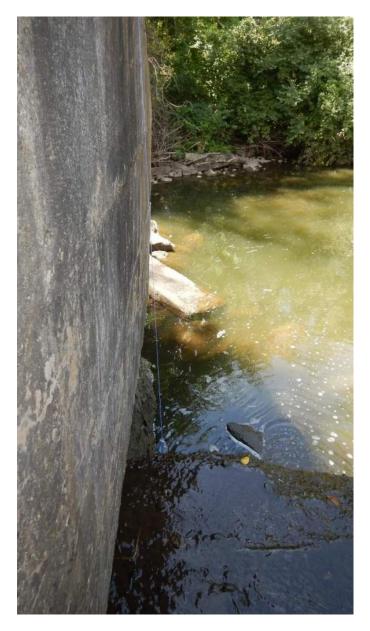
Photo A5: View of a measurement of the LT spillway abutment wall tilt.

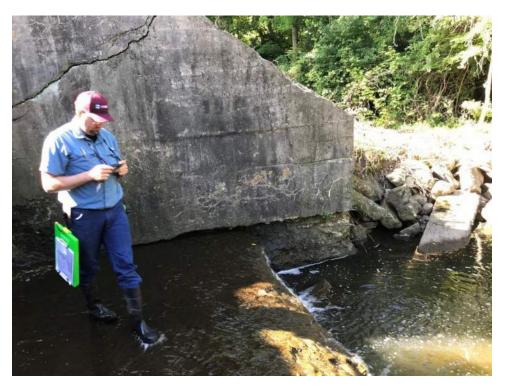
**Photo A6:** View of the lower portion of the LT spillway abutment wall looking South.

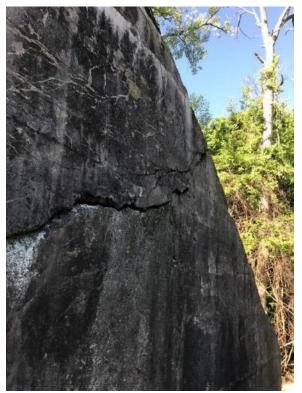
**Photo A7:** View of the lower portion of the LT spillway abutment wall; crack noted.

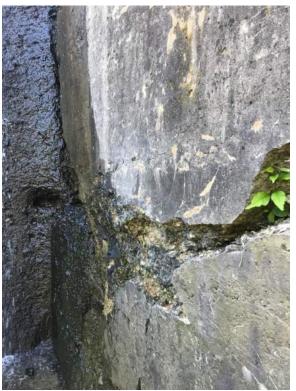
**Photo A8:** View of the lower portion of the LT spillway abutment wall; widening crack noted.

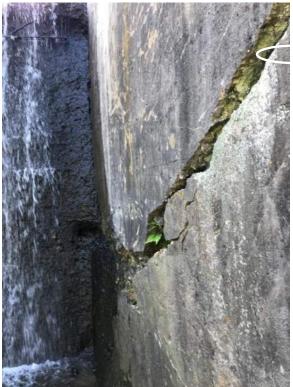
**Photo A9:** View of the lower portion of the LT spillway abutment wall; large crack noted.

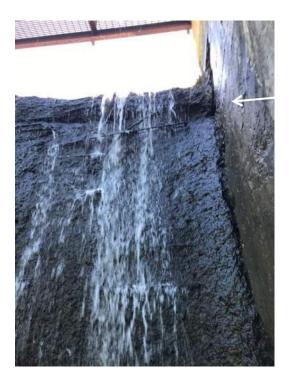
**Photo A10:** View of the connection of the spillway wall and the LT spillway abutment wall. Note spillway wall shows erosion of the concrete, exposing horizontal reinforcing (plates)

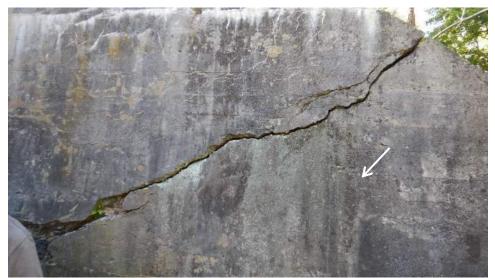
**Photo A14:** Close-up view lower portion of the LT spillway abutment wall; crack noted.

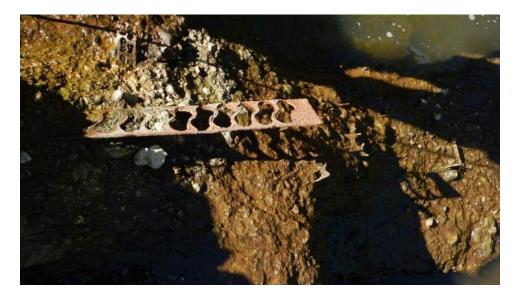
**Photo A15:** View of what appears to be stamped metal plates that were used as reinforcing.

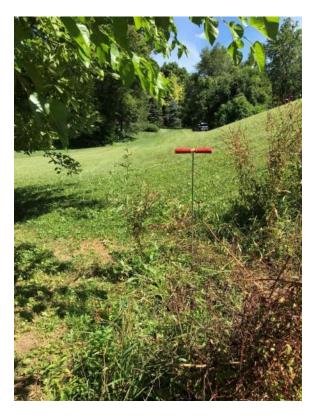
**Photo A26:** View of the RT downstream embankment toe area just below the end of the retaining wall just beyond the RT spillway abutment wall. Note probe is where some soft wet soil was found. Adjacent plants in the channel.

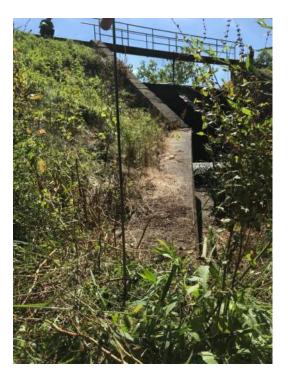
**Photo A27:** View of the end of the retaining wall below the RT spillway abutment wall. Note probe is where some soft wet soil was found. Adjacent plants in the channel.

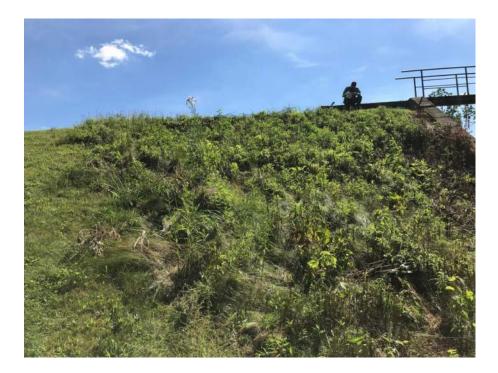
Photo A28: View of the RT downstream embankment just RT of the RT spillway abutment

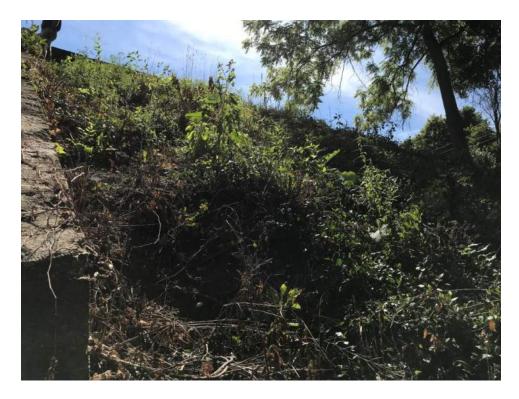
**Photo A34:** View of the left, downstream embankment just left of the spillway abutment wall. This area is very steep and has trees that need to be removed.

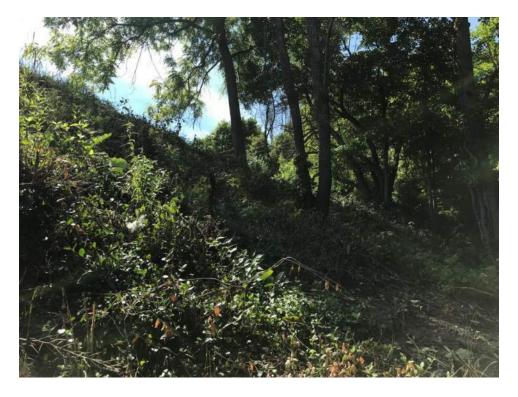
**Photo A35:** View of the left, downstream embankment. Note trees need to be removed.

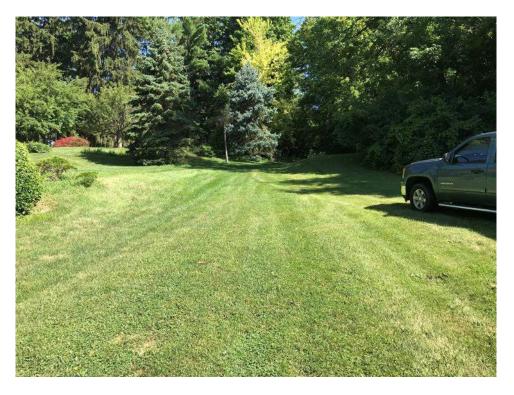
**Photo A39:** View of the crest at the North abutment of the dam. This is also the access to the dam.

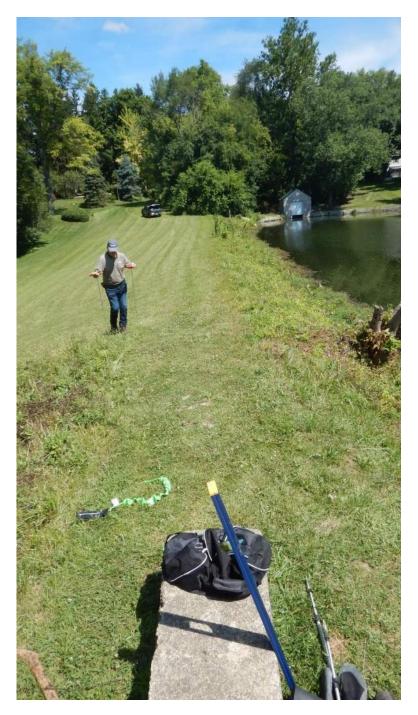
**Photo A45:** View looking north along the crest from the RT. spillway abutment wall. Note width of crest varies.

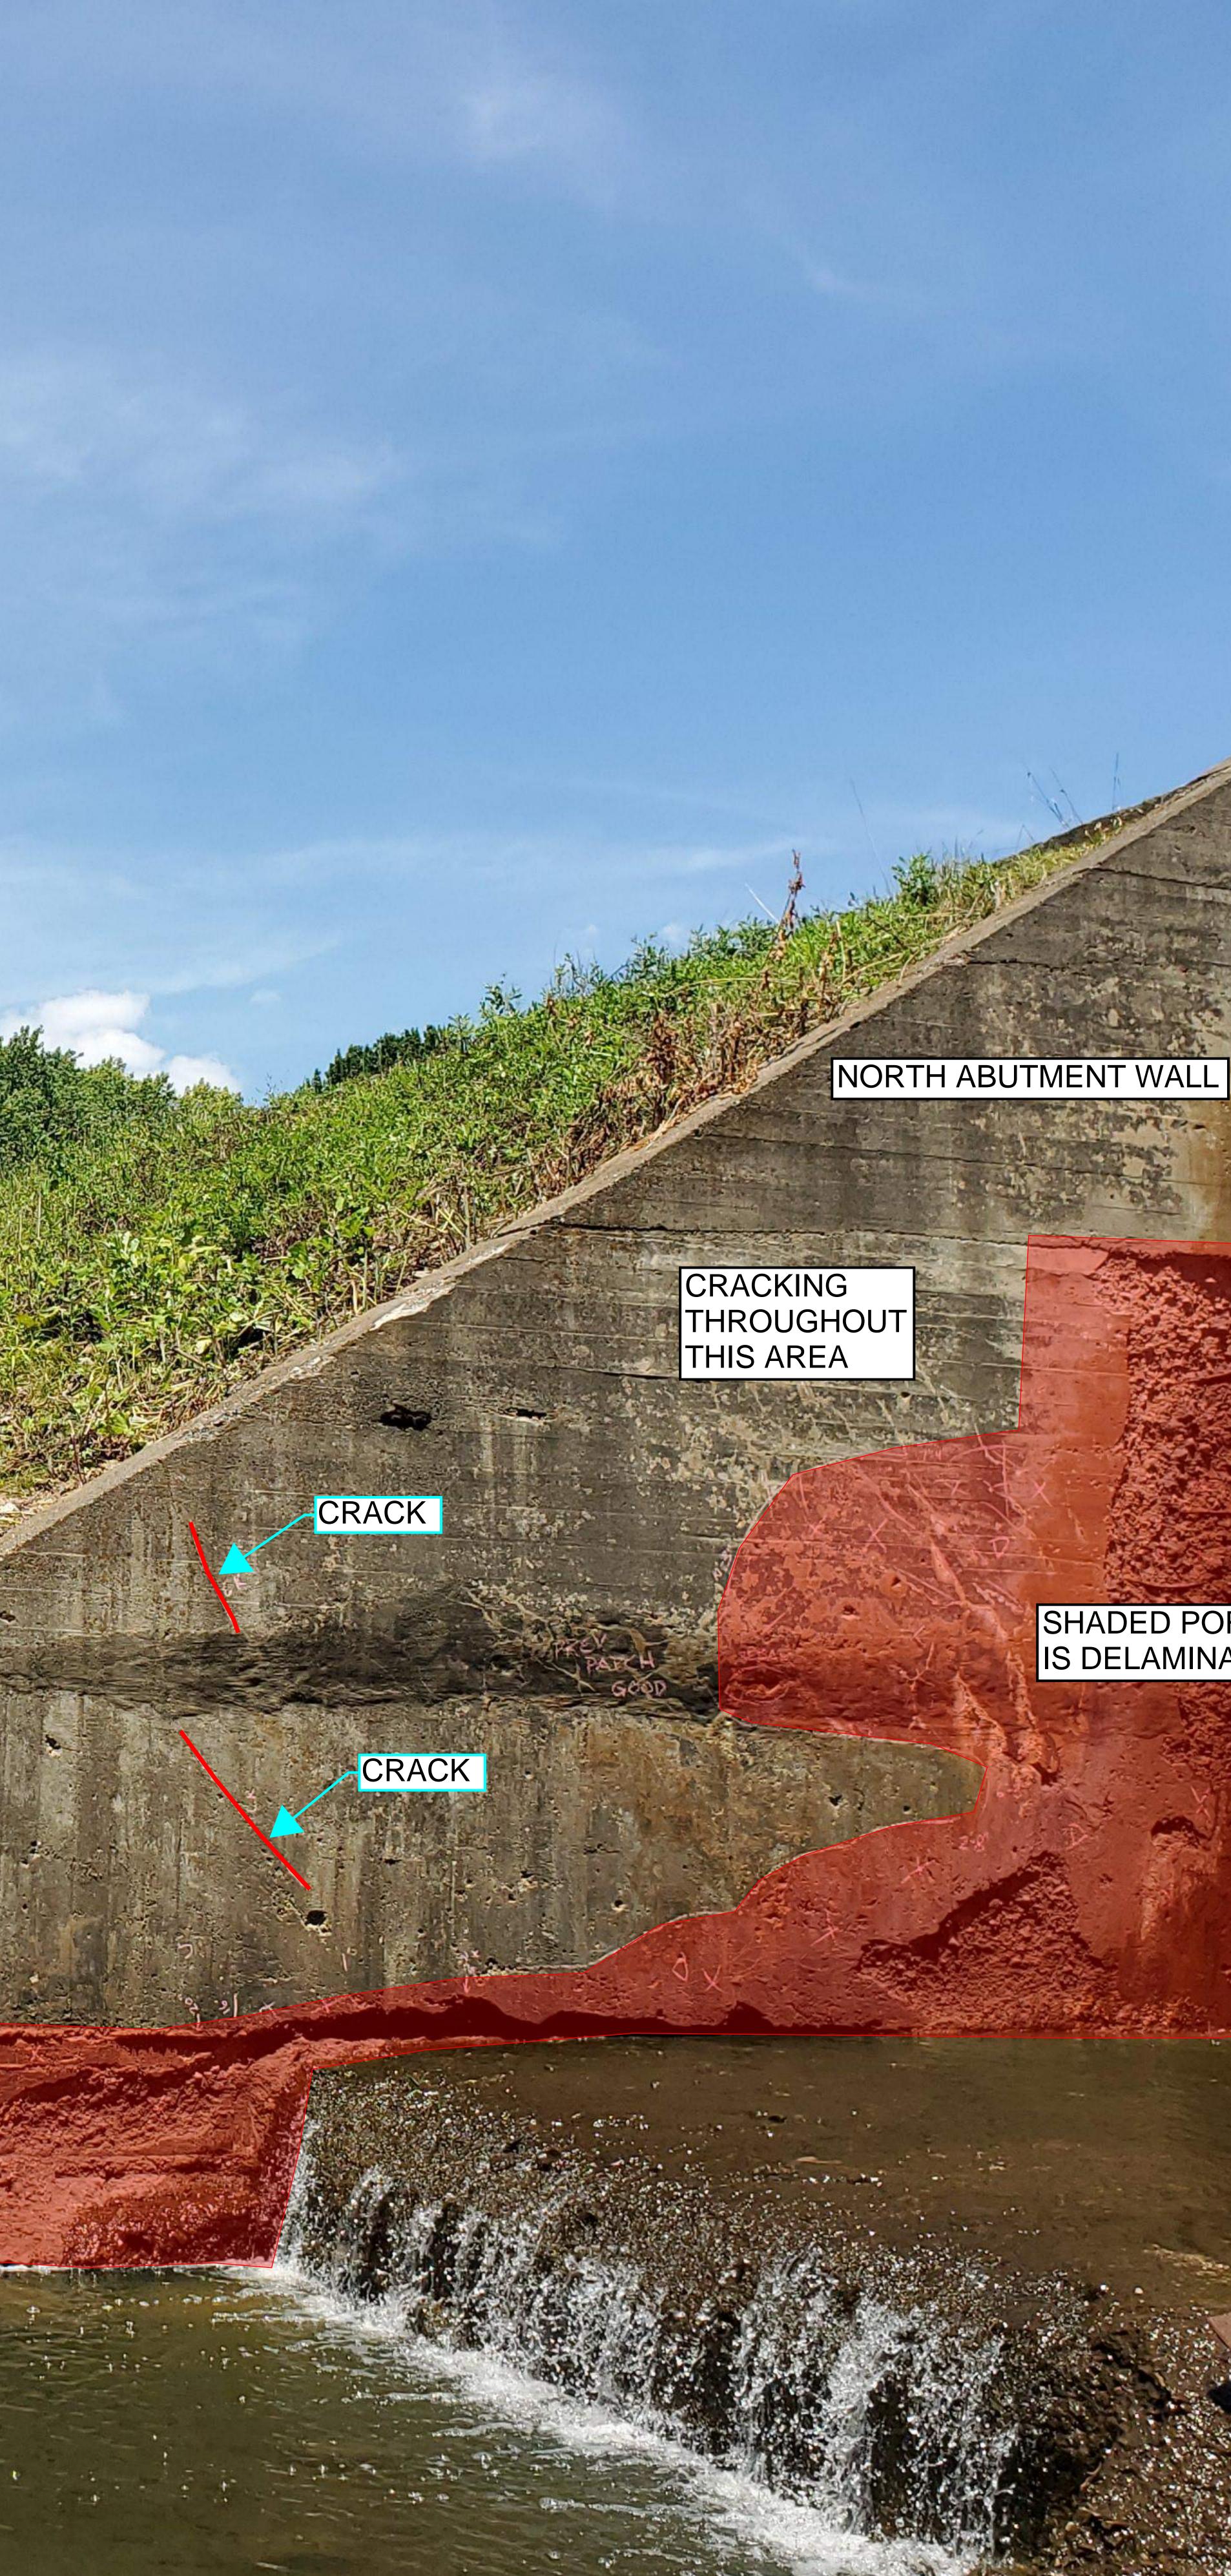
## SHADED PORTION IS DELAMINATED

DETERIORATION IS APPROX. 10" DEEP ALONG INTERSECTION WITH SPILLWAY WALL SOUTH ABUTMENT WALL
