**Indiana  
TOLL ROAD**

January 2021 to December 2021

**ANNUAL STATE OF THE ITR REPORT**

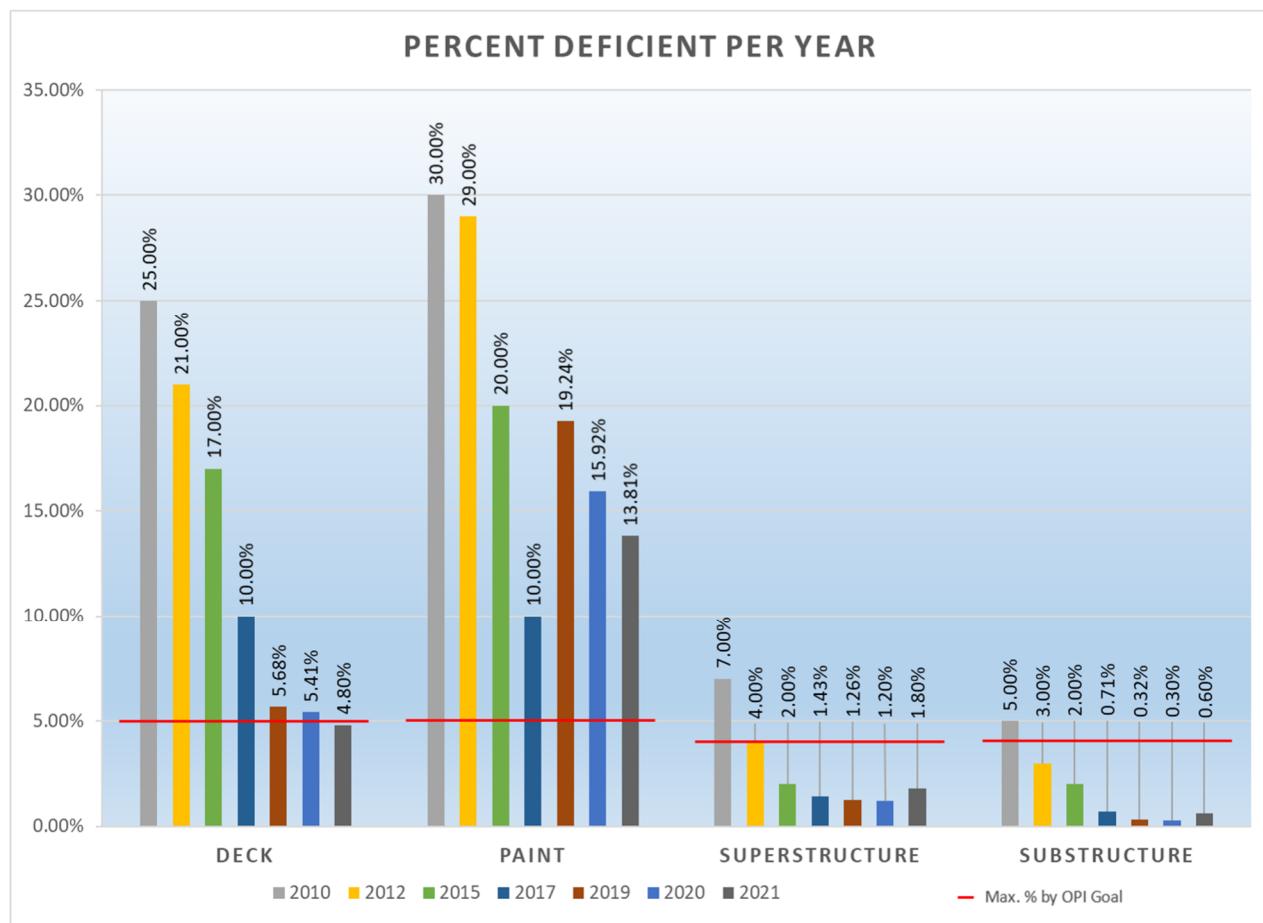
Figure 1.1: Bridge Condition Ratings

The 2021 inspections for the state of the ITR structures has maintained relatively consistent with the 2020 inspection data. There were minor increases to the Wearing Surface, Superstructure, and Substructure deficiency ratings, while lower deficiency ratings were reported for the Deck and Paint. PUSH 3, was delivered in 2021 which included six bridge deck replacements with bridge widening, two bridge deck overlays, nine structures with substructure patching and joint replacement, and bridge paintings on multiple structures.

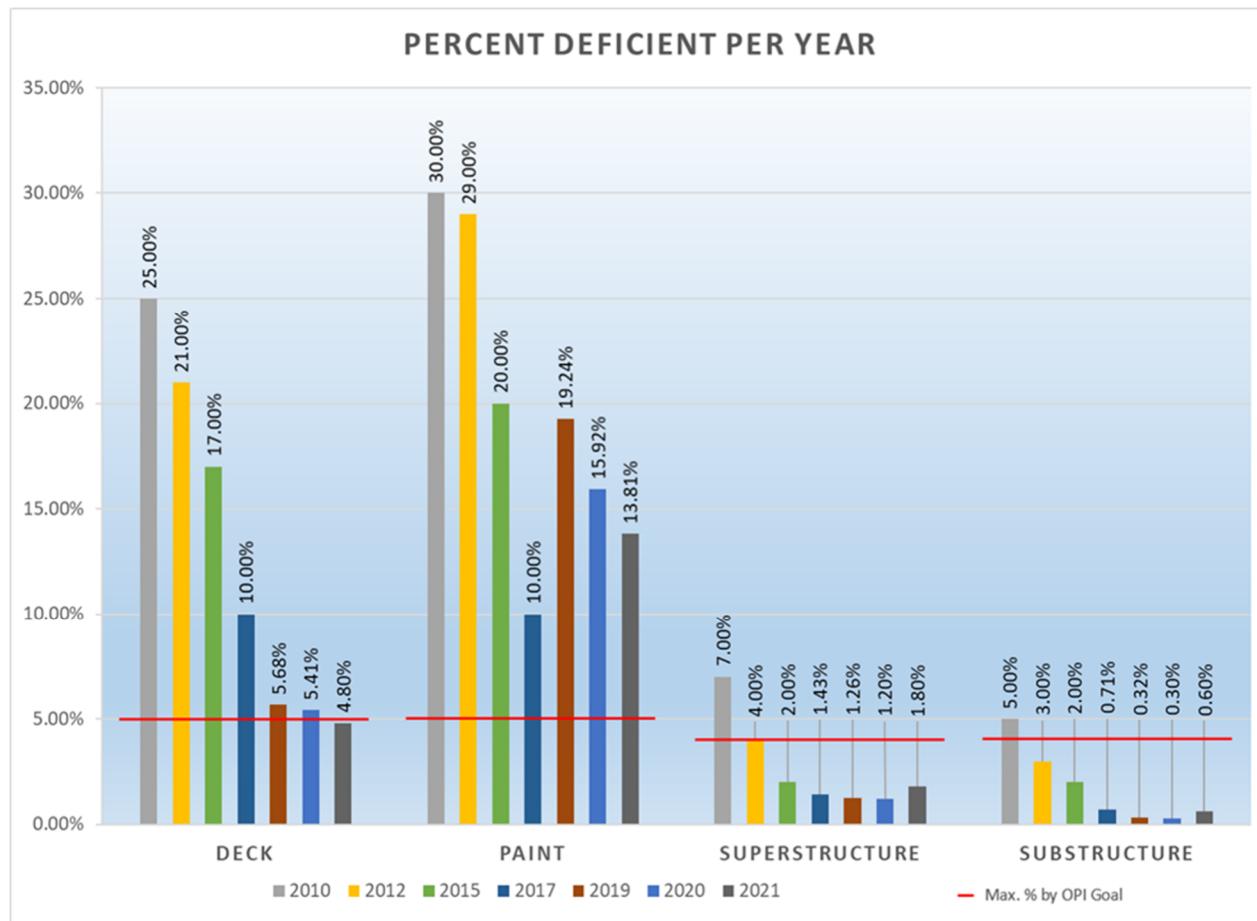
*Figure 3.1: Bridge Condition Ratings*

Figure 3.1: Bridge Condition Ratings illustrates that there has been an overall slight increase in deficiencies in several of the individual items compared to previous years. Decreases in deficiencies for Deck and Paint are due to the implementation of the PUSH projects and additional job order contracts. The three phases of PUSH have addressed over 25% of the structures within the ITR corridor.

The ITRCC has implemented a preventive maintenance plan to address additional annual cleanings and maintenance across all 333 structures. The plan includes annual bridge washing of the deck, superstructure, and substructures from travel debris and winter maintenance residuals, along with correcting minor drainage, joint, and patching needs.
