July 1st 2017 to August 1st 2018

ANNUAL STATE OF THE ITR REPORT

This 2017-2018 Indiana Toll Road (ITR) *Annual State of the ITR Report* has been prepared in accordance with the Amended and Restated *Concession and Lease Agreement (“CLA”) for the Indiana Toll Road*.

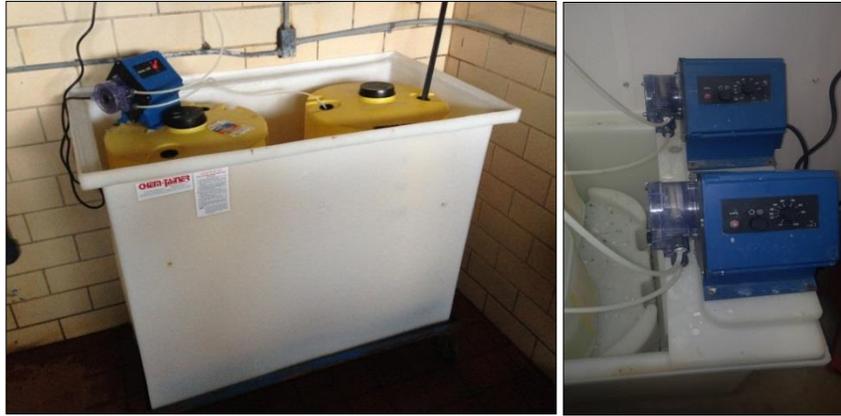
Figure 7.2: Sodium Hypochlorite with Dosing Pumps at TRP 7 and TRP 3

The water treatment plant at Travel Plaza 3 makes use of liquid sodium hypochlorite for disinfection.

ITRCC should continue its efforts to maintain a free chlorine residual above 0.2 mg/L and below 4 mg/L to ensure proper disinfection and satisfy PWS regulations. According to 327 IAC 8-2-8.6 (3),
