# Pavement Condition Report

## Columbus Municipal Airport

Project 1480370

**January 2014**

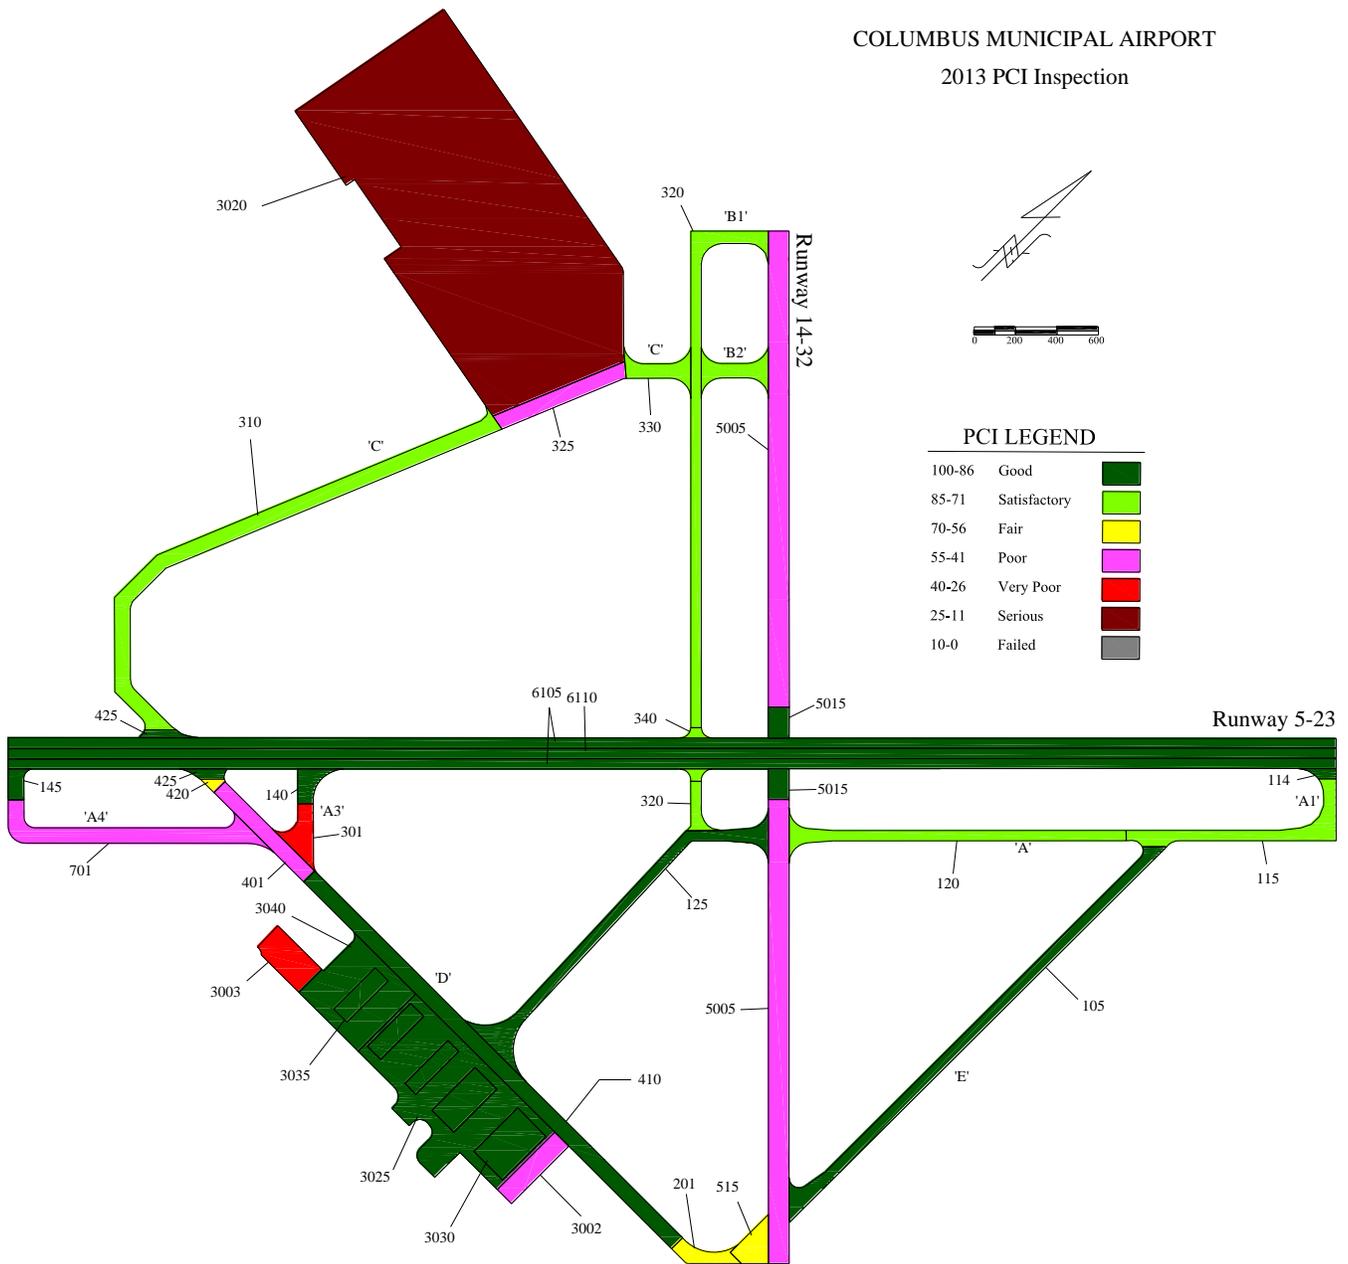
Figure 2-1. Inspected Pavement Condition

The pavement within each of the PCI condition categories is shown in Figure 2-1. The inspected PCI is summarized by branch use in Figure 2-2, and the photographs in Figure 2-3 through Figure 2-7 provide examples of the condition categories.
