Pavement Condition Report

Delphi Municipal Airport

Project 1480370

January 2014

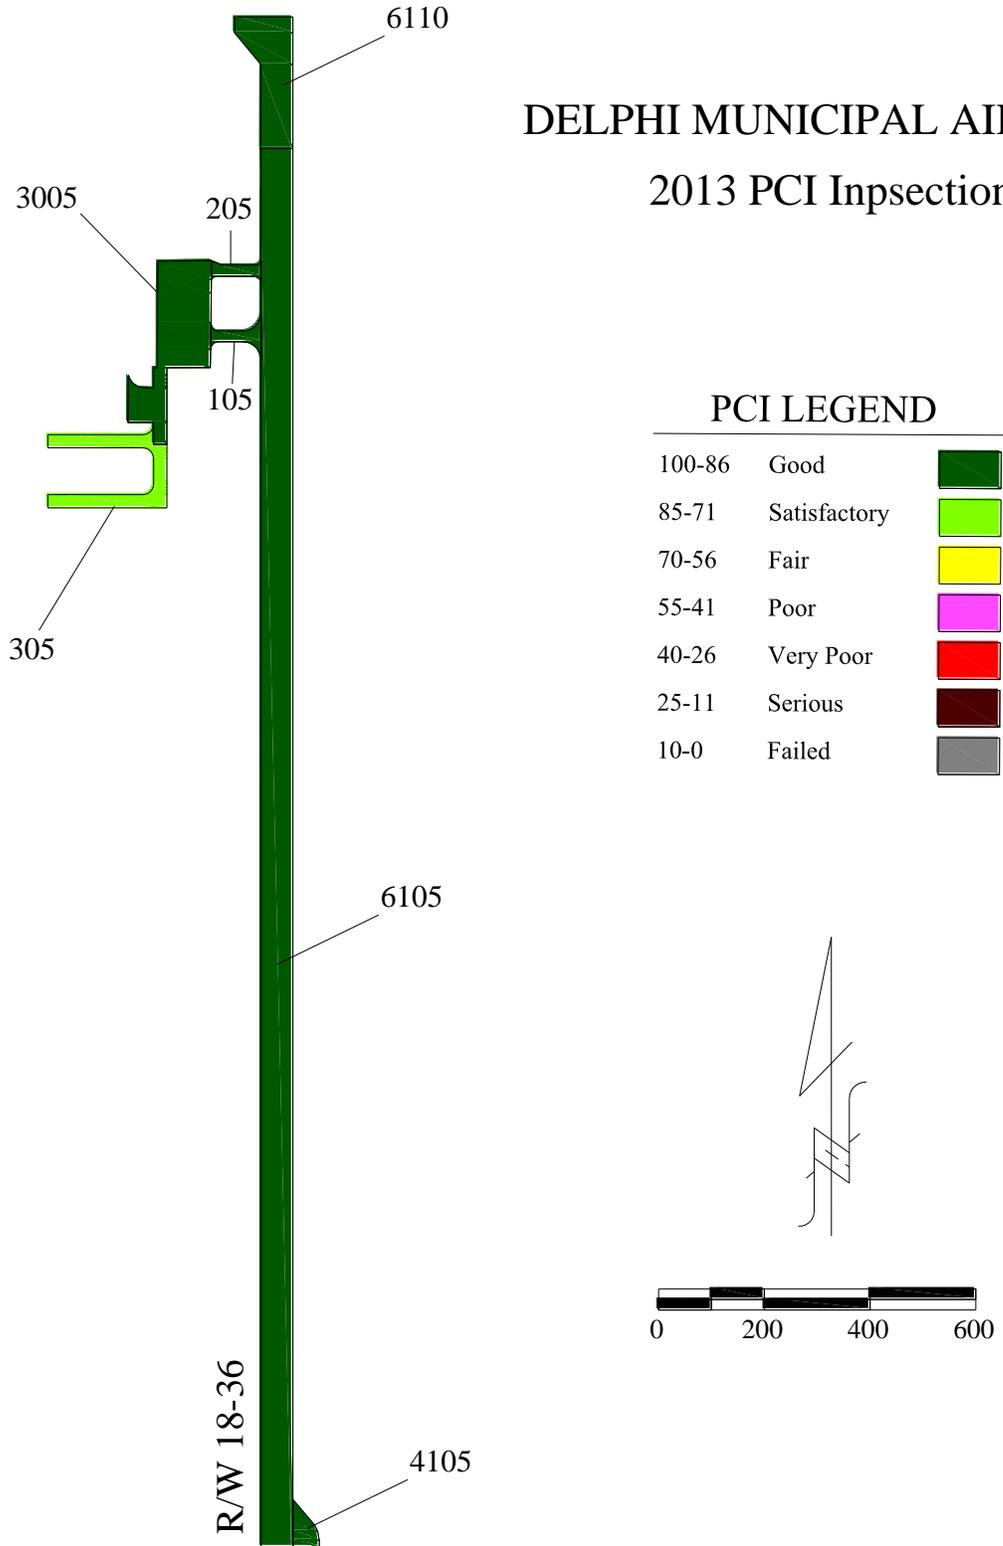
Figure 2-1. Inspected Pavement Condition

The overall Pavement Condition Index (PCI) for the airfield pavements was 98. Runways had an average inspected PCI of 99 and were above the desired MSL of 55. Taxiways had an average inspected PCI of 90, and ramps had an average inspected PCI of 100.

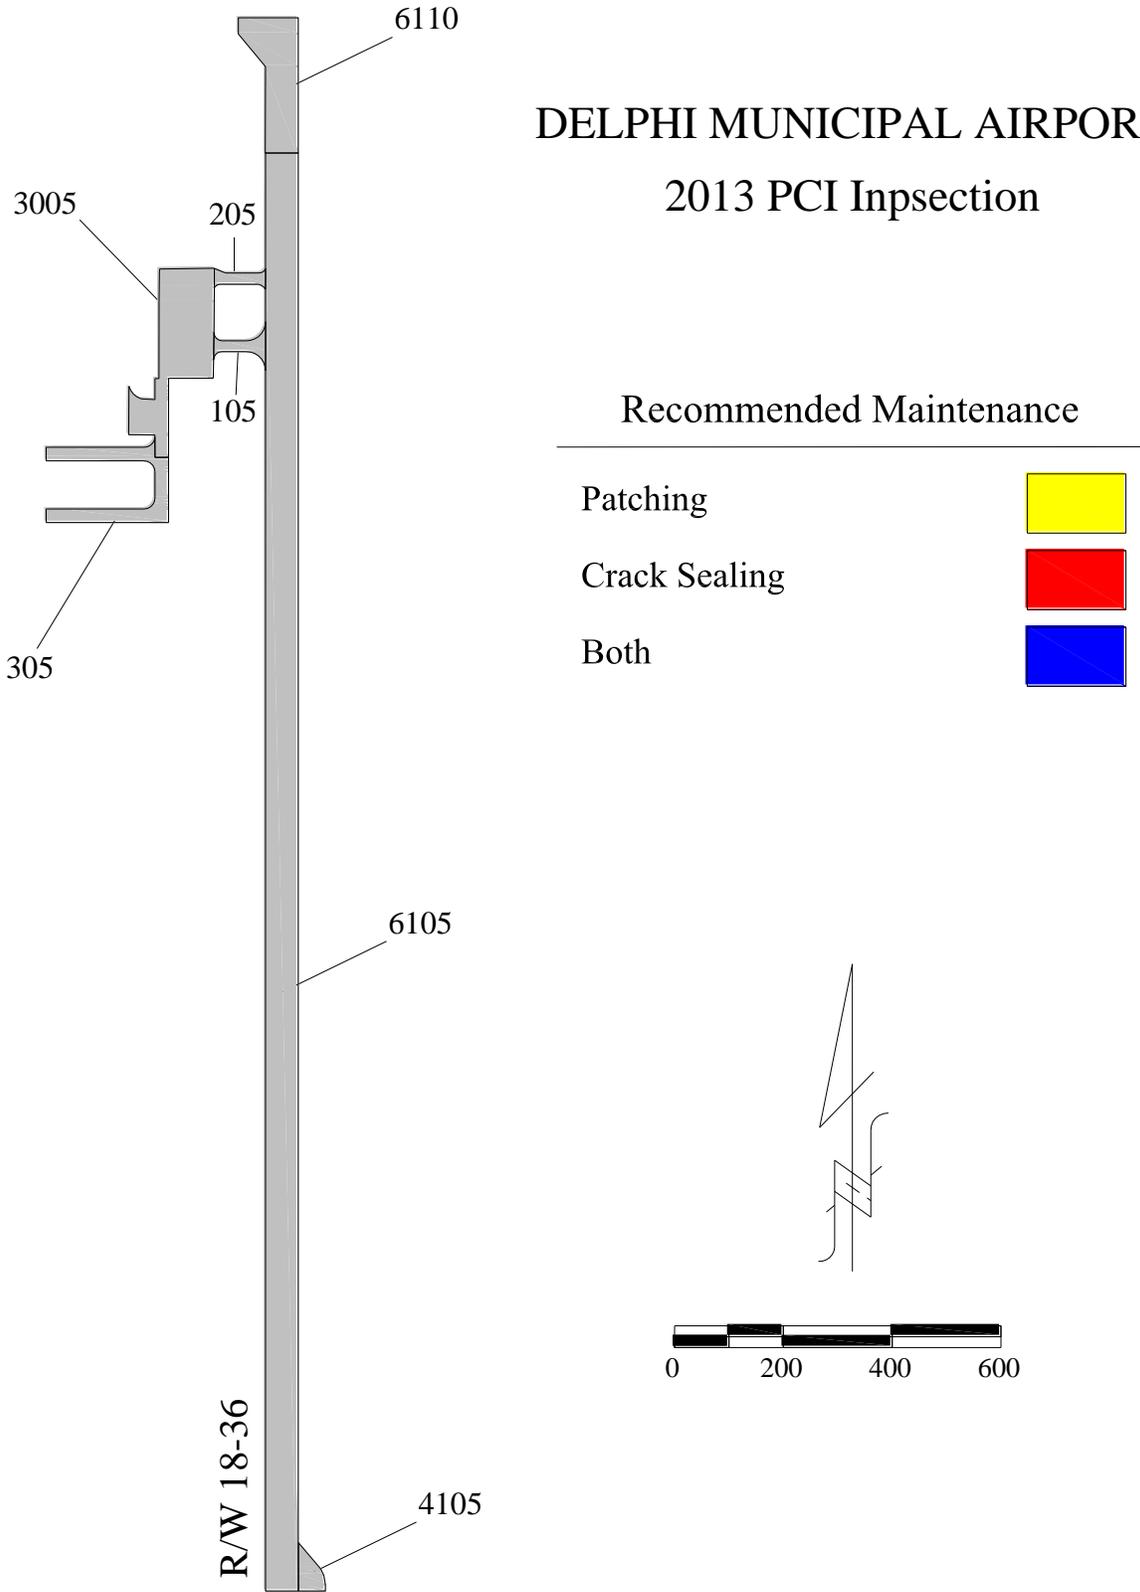
Figure 4-1. Recommended Maintenance

Analysis of potential maintenance projects did not identify any needs at this time.
