# Pavement Condition Report

## Elkhart Municipal Airport

Project 15805741

**February 2015**

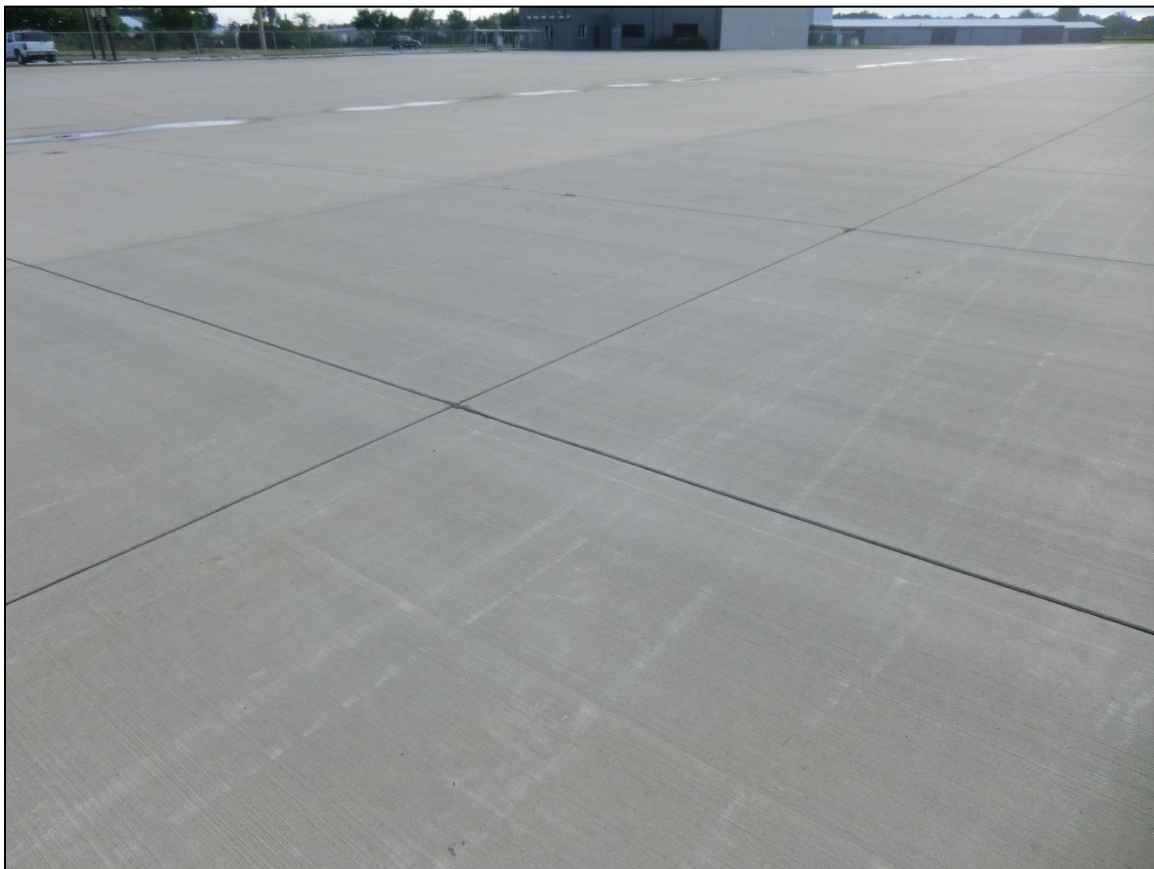
Figure 2-3. Typical Good PCC Pavement (Feature 3105)

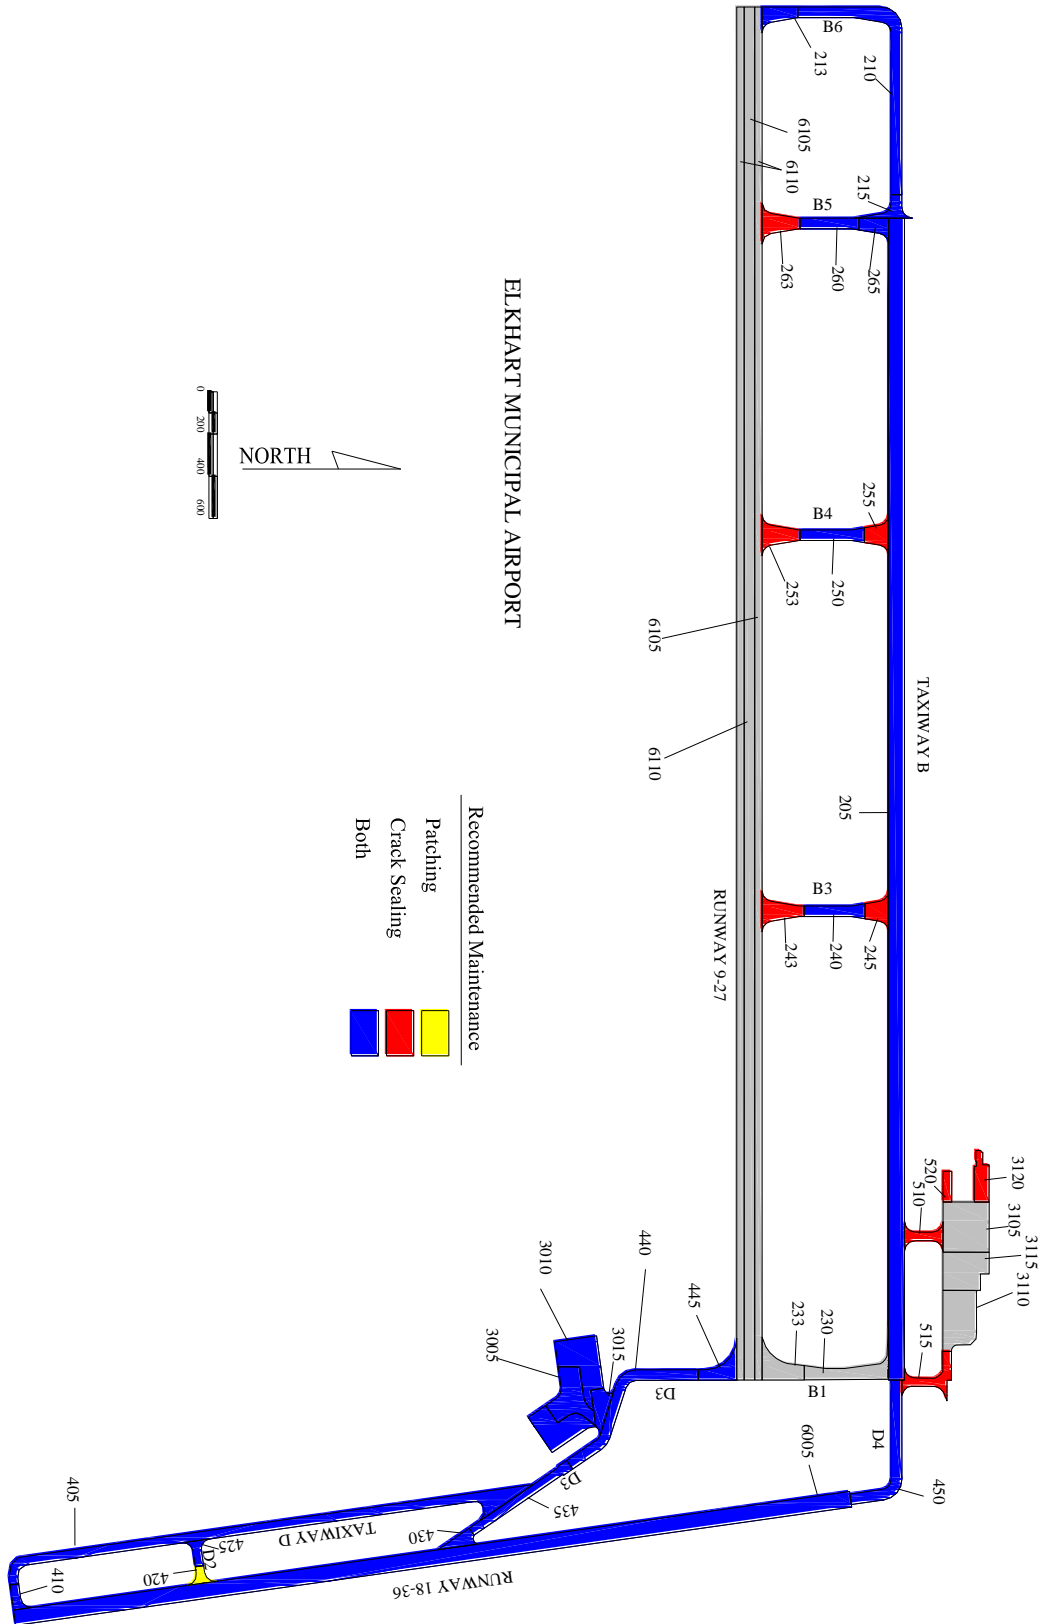
Figure 4-1. Recommended Maintenance

Feature	Work Item	Amount	Insp. PCI	Change	Est. PCI
205	AC SUSTAINING CRACK REPAIR	3,787	78	-	N/A
210	AC SUSTAINING CRACK REPAIR	629	63	-	N/A
215	AC SUSTAINING CRACK REPAIR	120	60	-	N/A
243	AC SUSTAINING CRACK REPAIR	147	82	-	N/A
253	AC SUSTAINING CRACK REPAIR	228	74	-	N/A
405	AC SUSTAINING CRACK REPAIR	1,503	70	-	N/A
410	AC SUSTAINING CRACK REPAIR	161	56	-	N/A
425	AC SUSTAINING CRACK REPAIR	81	61	-	N/A
430	AC SUSTAINING CRACK REPAIR	75	65	-	N/A
435	AC SUSTAINING CRACK REPAIR	241	68	-	N/A
440	AC SUSTAINING CRACK REPAIR	1,482	54	-	N/A
445	AC SUSTAINING CRACK REPAIR	140	72	-	N/A
450	AC SUSTAINING CRACK REPAIR	536	64	-	N/A
3120	AC SUSTAINING CRACK REPAIR	84	85	-	N/A
	TOTAL:	9,221	L.F.		
EQUIPMENT: AIR COMPRESSOR, HEATING KETTLE, HAND TOOLS					
EST. MATERIALS: 1,844 POUNDS ASTM D3405 SEALANT OR EQUIVALENT					
EST. MATERIAL COST: \$1,844					
EST. CREW HOURS: 40.1					
EST. CREW COST: \$6,134					
<b>EST. PROJECT COST: \$7,978</b>
