Pavement Condition Report

Huntington Municipal Airport

Project 15805741

February 2015

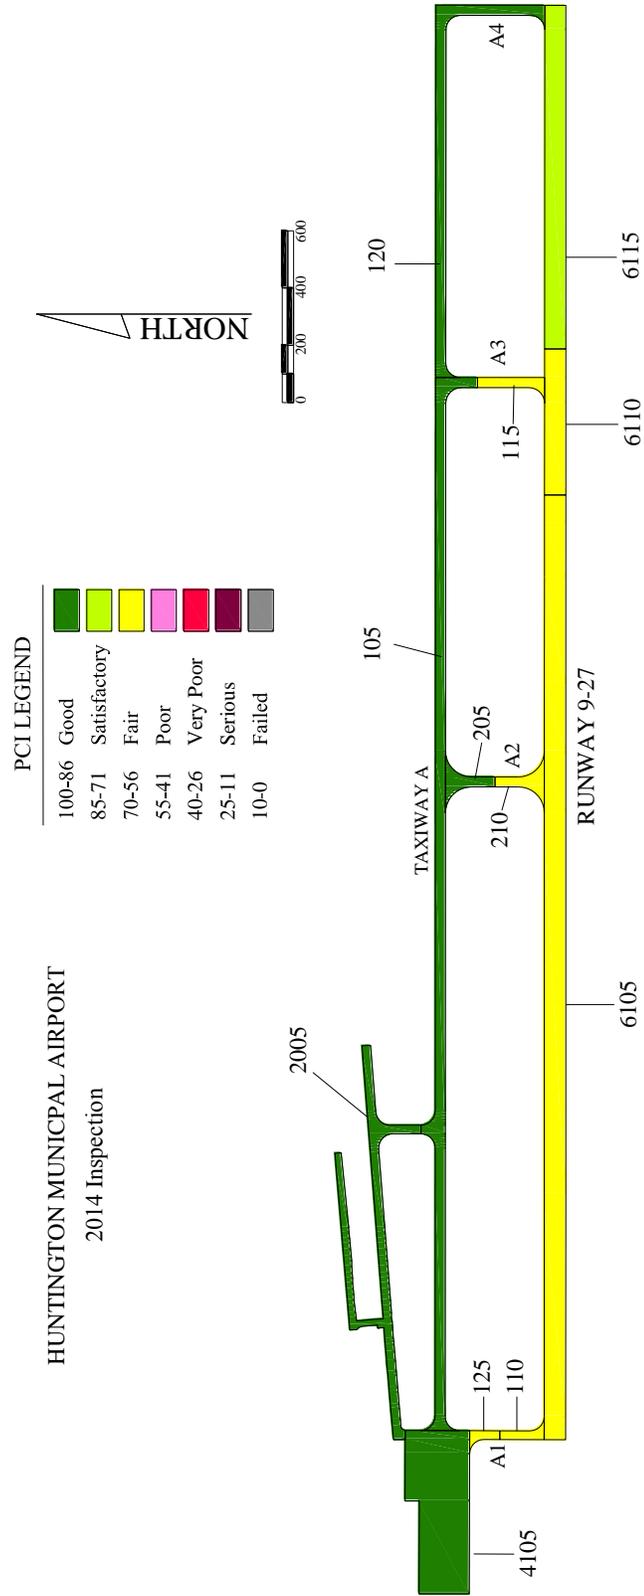
Figure 2-1. Inspected Pavement Condition

The pavement within each of the PCI condition categories is shown in Figure 2-1. The inspected PCI is summarized by branch use in Figure 2-2, and the photographs in Figure 2-3 through Figure 2-5 provide examples of the condition categories.

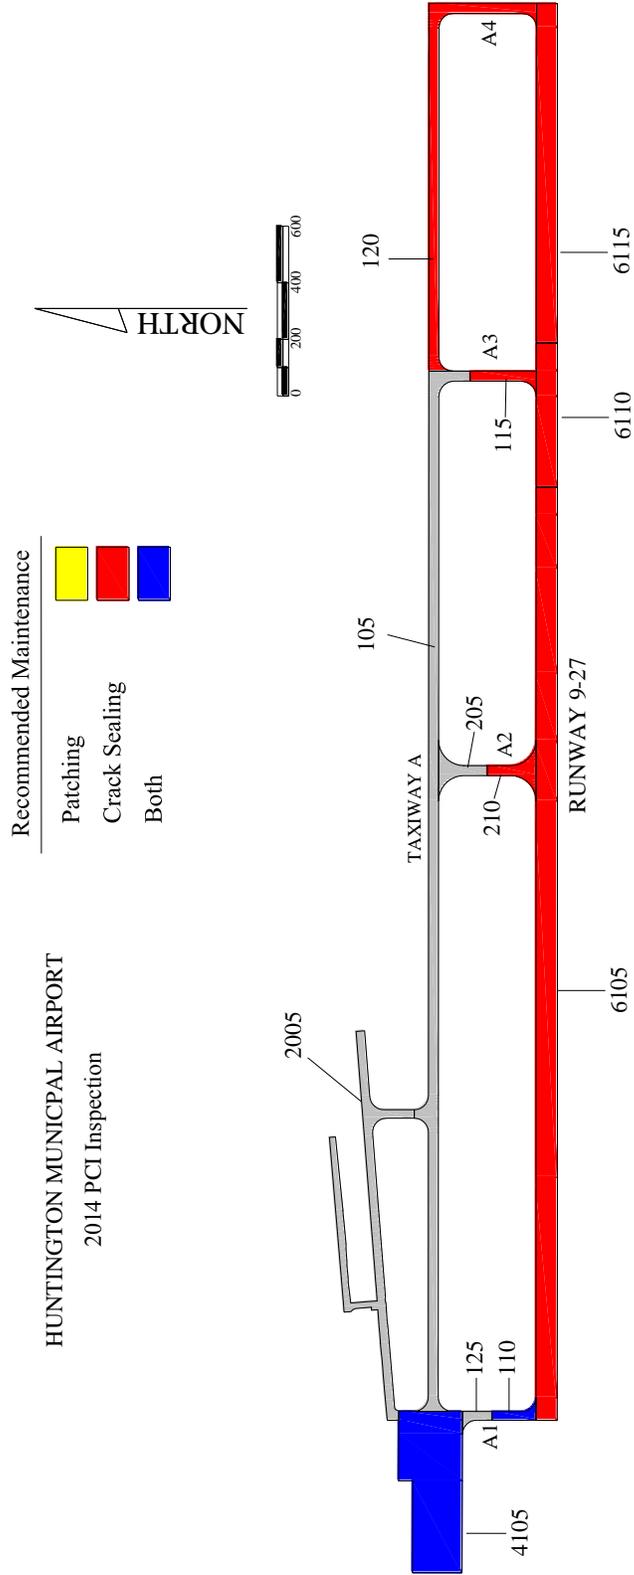
Figure 4-1. Recommended Maintenance

Feature	Work Item	Amount	Insp. PCI	Change	Est. PCI
4105	PCC SUSTAINING SEAL REPAIR	2,457	97	-	N/A
EQUIPMENT: AIR COMPRESSOR, HEATING KETTLE, HAND TOOLS					
EST. MATERIALS: 491 POUNDS ASTM D3405 SEALANT OR EQUIVALENT					
EST. MATERIAL COST: \$491					
EST. CREW HOURS: 10.7					
EST. CREW COST: \$1,634					
EST. PROJECT COST: \$2,126

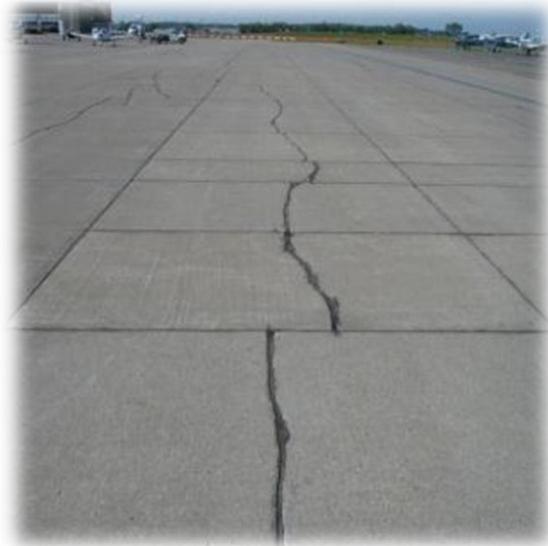
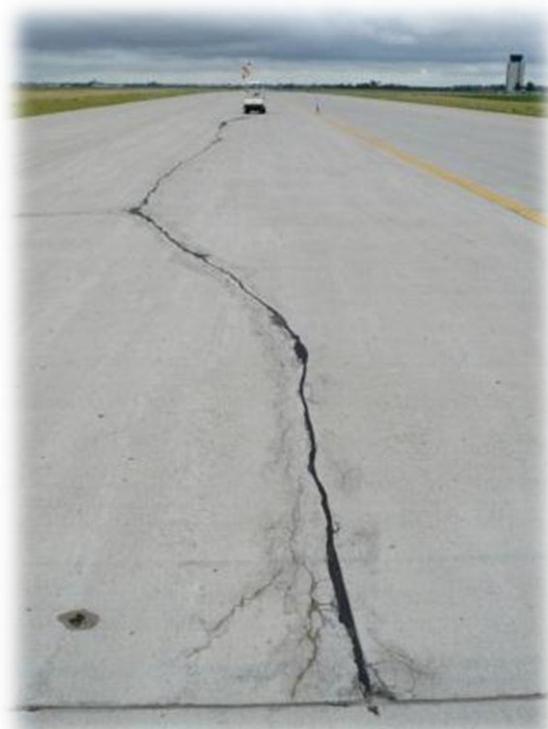
A slab divided into four or more pieces is said to be “divided” or “shattered.” Shattered slab is a separate distress category and indicates a significant structural failure. A shattered slab has lost its ability to distribute loads. Shattered slabs are rated in three severities, but the recommended action in any case is slab replacement.

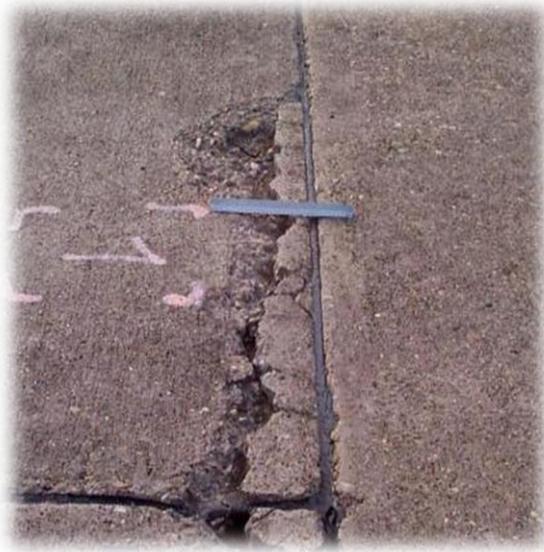
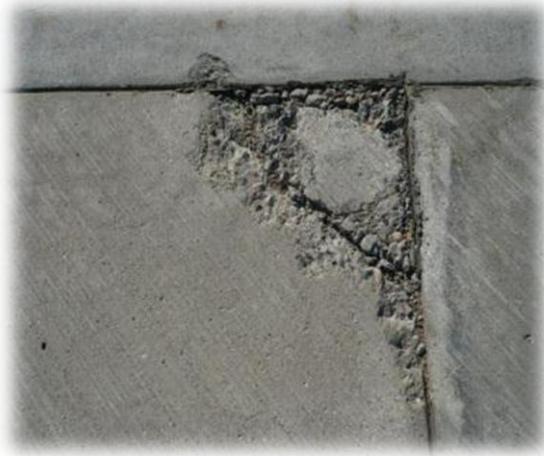
Patches, Large and Small

Large patches also may be the result of spall repair, but they often indicate more serious deficiencies, such as corner breaks or other full-depth failure smaller than panel size.

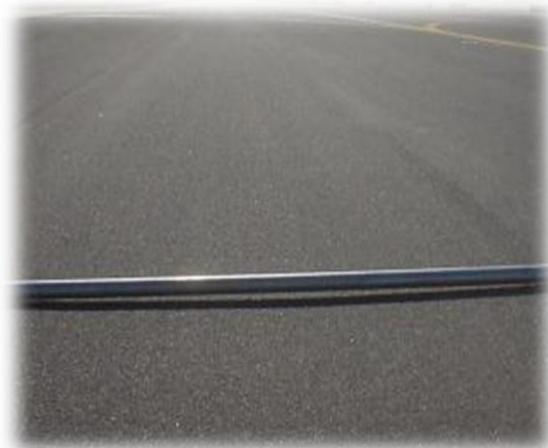
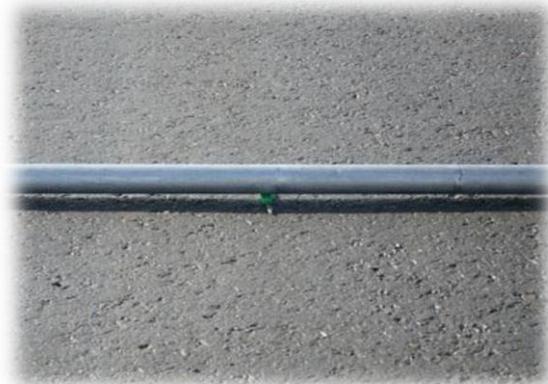
Appendix E. Feature Analysis

At low severity, ruts have an average depth of ¼ to ½ inches. At medium severity, ruts have an average depth of ½ to 1 inch. At high severity, ruts have an average depth greater than 1 inch. Patching is the appropriate repair for ruts.
