Pavement Condition Report

Indianapolis Greenwood Municipal Airport

Project 15805741

February 2015

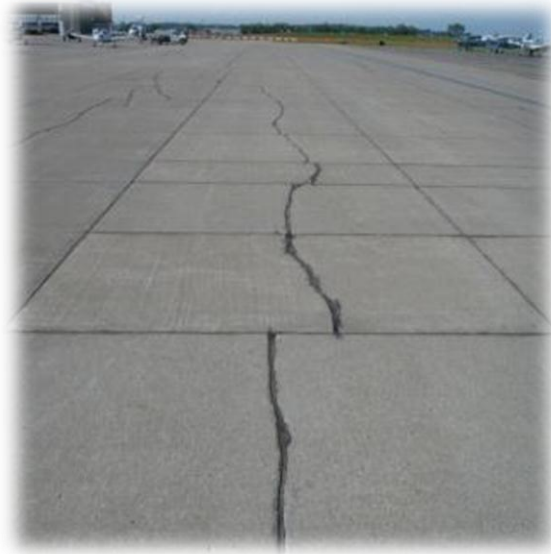
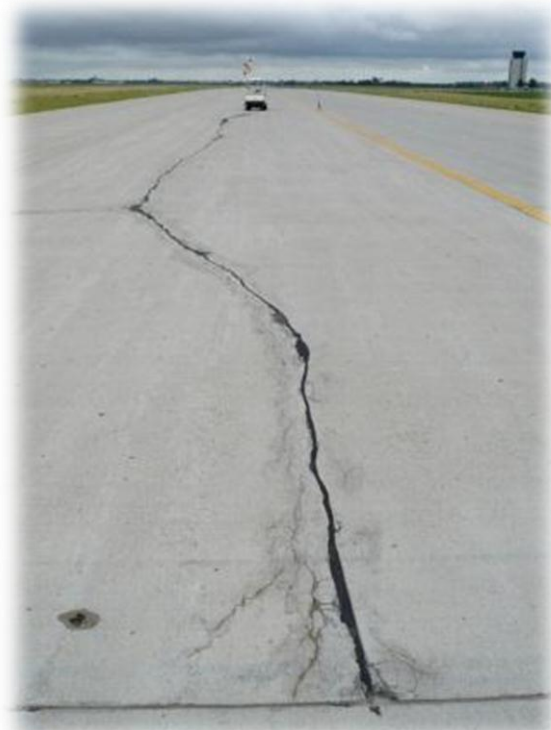
A slab divided into four or more pieces is said to be “divided” or “shattered.” Shattered slab is a separate distress category and indicates a significant structural failure. A shattered slab has lost its ability to distribute loads. Shattered slabs are rated in three severities, but the recommended action in any case is slab replacement.

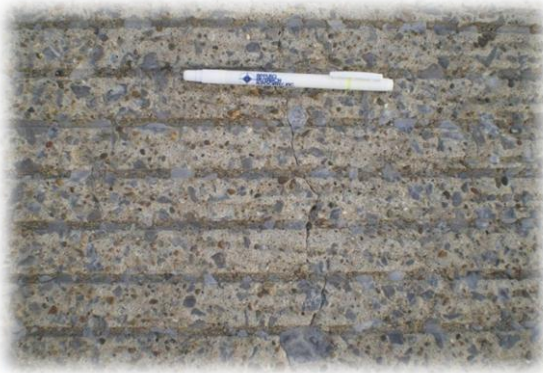
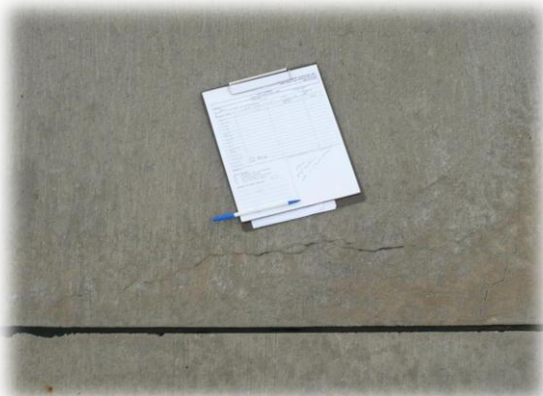
Shrinkage Cracking

Shrinkage cracks are usually so small that they are not visible until staining or loss of material at crack edges begins to take place. Shrinkage cracks do not represent structural weakness, and no corrective action is prescribed.

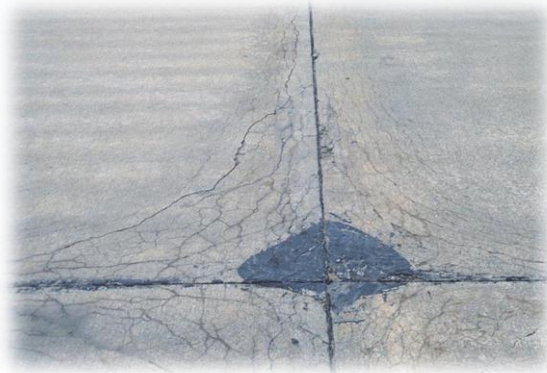
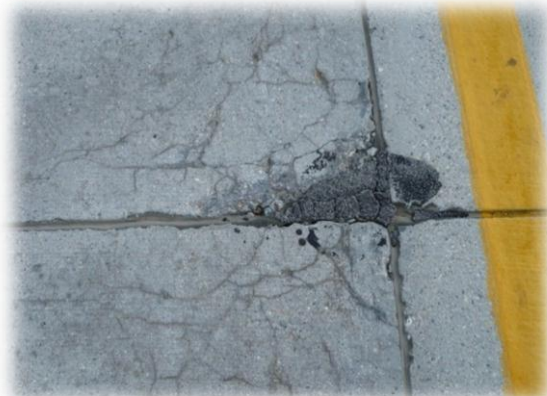
Durability Cracking

At low severity, D-cracking is evident, but no disintegration has occurred. Medium severity is evident over a significant area of the slab, and some disintegration and FOD potential exist. High-severity D-cracking is evidenced by extensive cracking with loose and missing pieces and significant FOD potential.

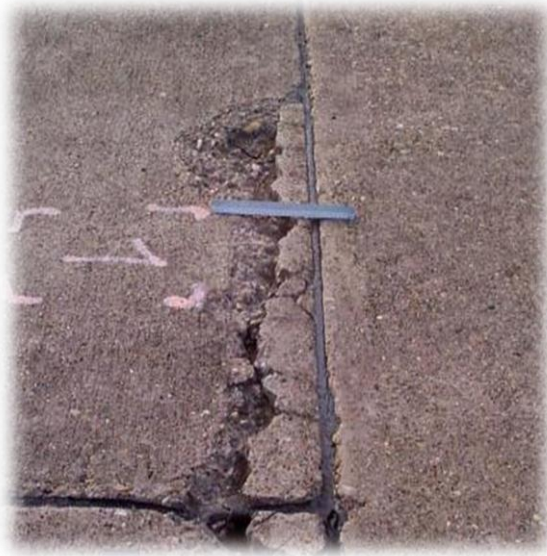
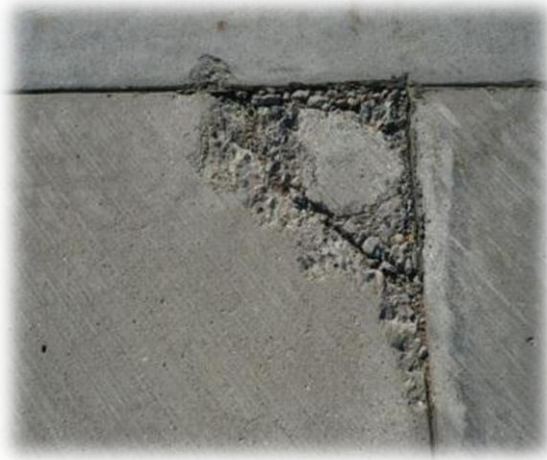
Joint Spall and Corner Spall

Spall repair requires patching. The extent and severity of spalling suggests the appropriate action. At low severity, spalled concrete remains securely in place in the slab. A low-severity spall should be monitored closely for further deterioration and should be patched when spalled particles become loose, or during the next scheduled patching activity. Medium- and high-severity spalls should be repaired immediately to prevent FOD. If the pavement can be restored to serviceable condition, spalls should be patched for long-term service. If the pavement is beyond repair, temporary patching should be considered to control FOD.

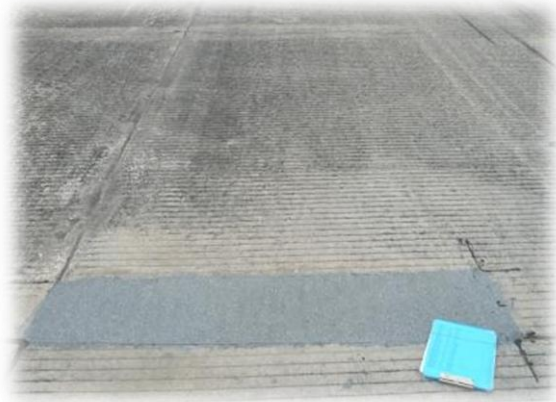
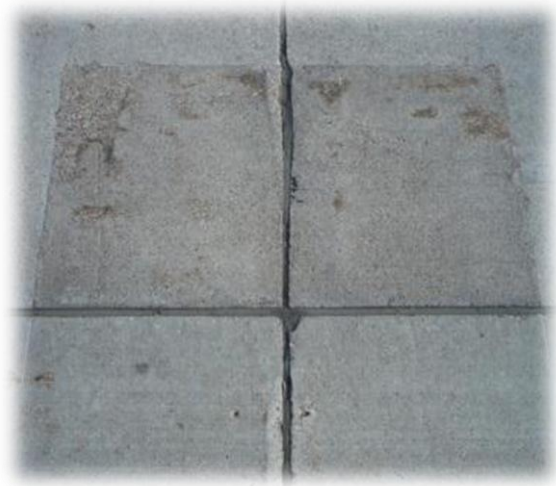
Patches, Large and Small

Large patches also may be the result of spall repair, but they often indicate more serious deficiencies, such as corner breaks or other full-depth failure smaller than panel size.

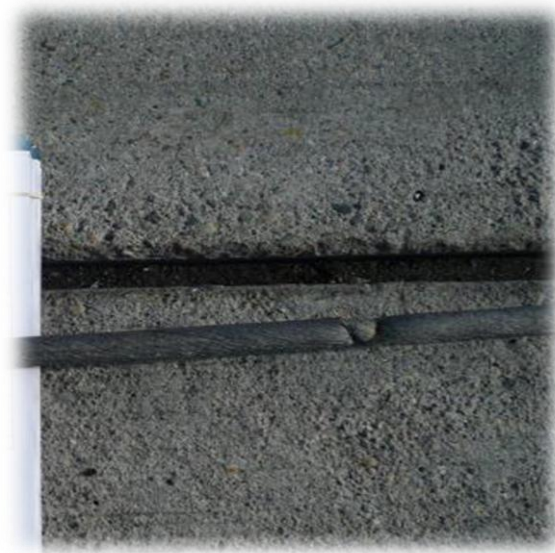
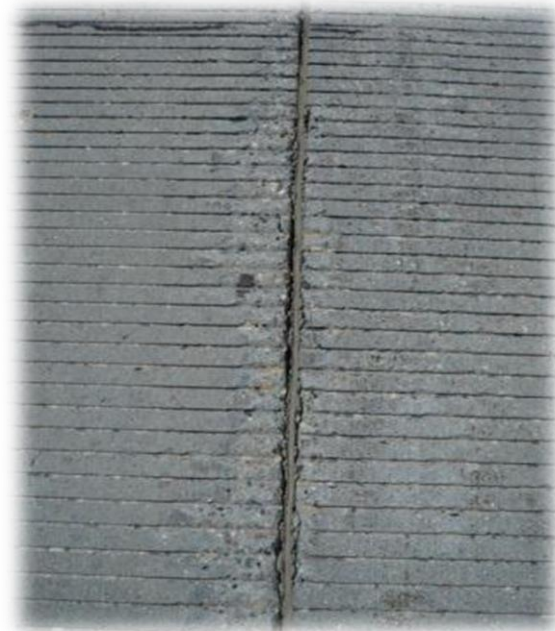
Joint Seal Damage

On serviceable pavement, deteriorated joint sealant should be repaired or replaced to preserve pavement and subgrade integrity and prolong service life. The issue is not so clear-cut with unserviceable pavement. Pavement that can be restored to serviceable condition by maintenance activities such as patching and joint seal repair, or by slab replacement, should be so maintained as long as the process is cost-effective. However, when age and condition preclude economical return to serviceable condition by such means, joint seal repair would no longer be cost-effective and should be suspended except for an interim maintenance program to control FOD potential.

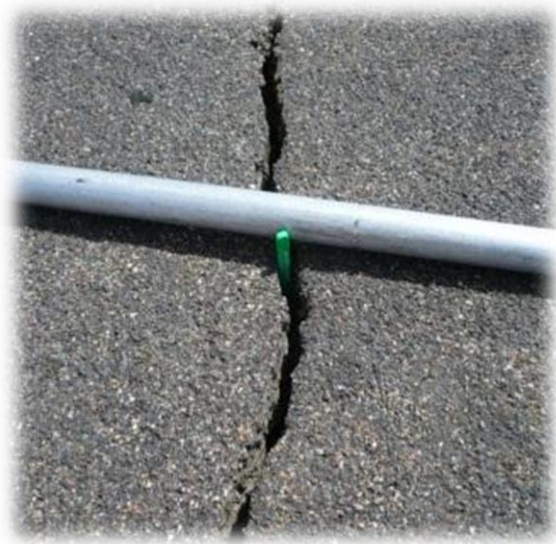
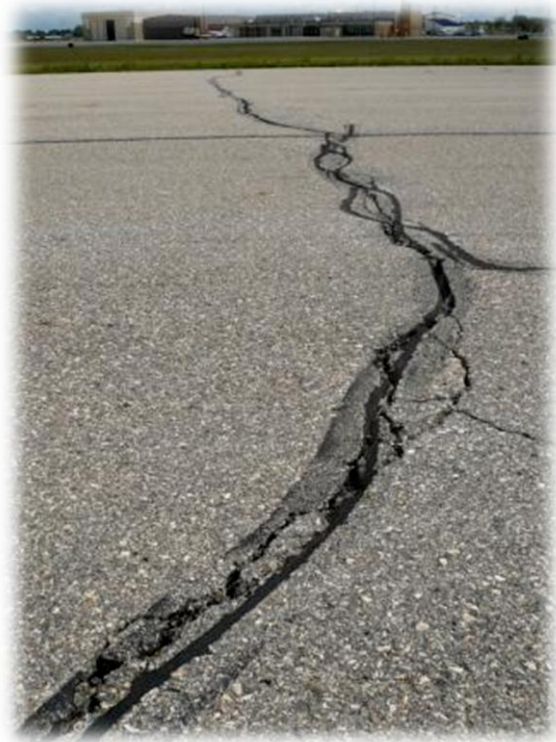
Low-severity L&T cracks are less than $\frac{1}{4}$ inch wide, or if sealed with suitable filler material in satisfactory condition can be any width less than 3 inches, if they are not spalled. Maintenance usually is not indicated for low-severity cracking. Moderately spalled cracks and cracks wider than $\frac{1}{4}$ inch which are not satisfactorily sealed are at medium severity. Medium-severity cracks should be sealed with a high-quality crack filling material. Severely spalled cracks and cracks wider than 3 inches are at high severity. High-severity L&T cracks normally require patching.

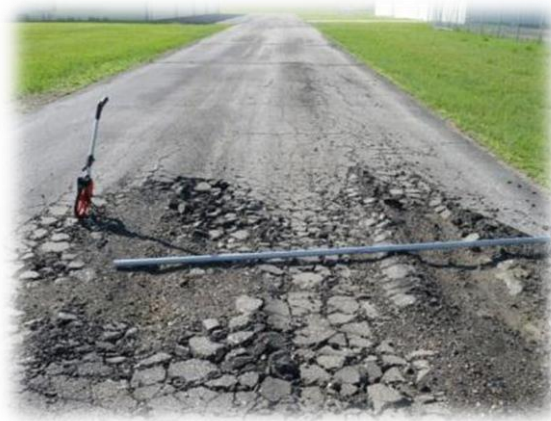
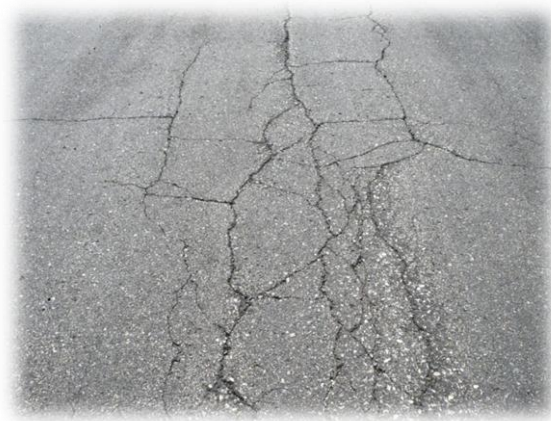
Alligator Cracking

Alligator cracking is a serious structural failure that cannot be repaired with sealant. The proper repair is patching.

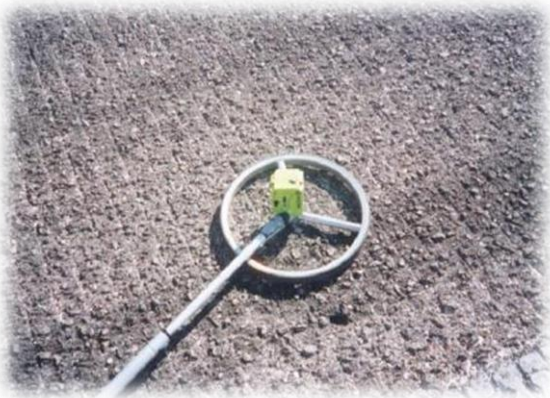
Raveling/Weathering

Weathering: At low severity, edges of coarse aggregate are exposed less than 1 mm. At medium severity, loss of fine aggregate is noticeable and edges of coarse aggregate are exposed up to 6 mm (1/4 inch). High severity weathering has edges of coarse aggregate exposed > 6 mm, with considerable loss of fine aggregate matrix and potential for loss of coarse aggregate.

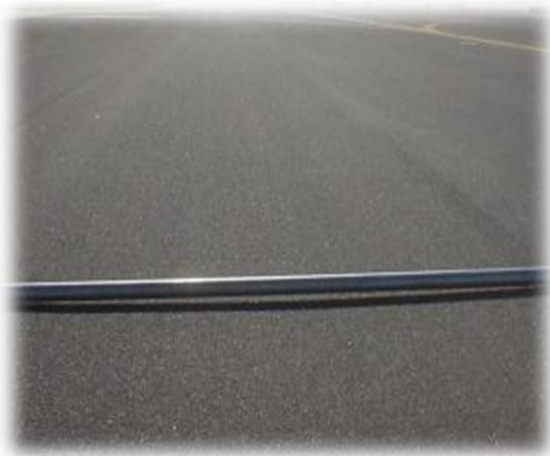
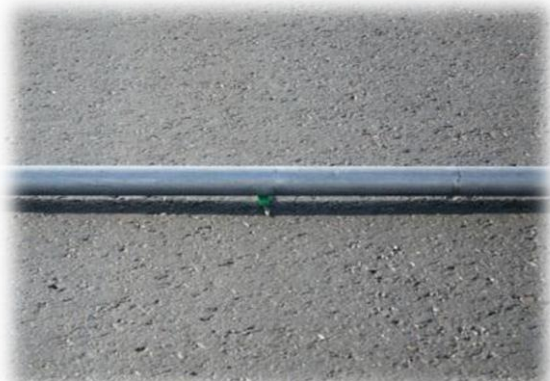
Rutting

At low severity, ruts have an average depth of 1/4 to 1/2 inches. At medium severity, ruts have an average depth of 1/2 to 1 inch. At high severity, ruts have an average depth greater than 1 inch. Patching is the appropriate repair for ruts.
