Pavement Condition Report

Indianapolis Downtown Heliport

Project 15805741

February 2015

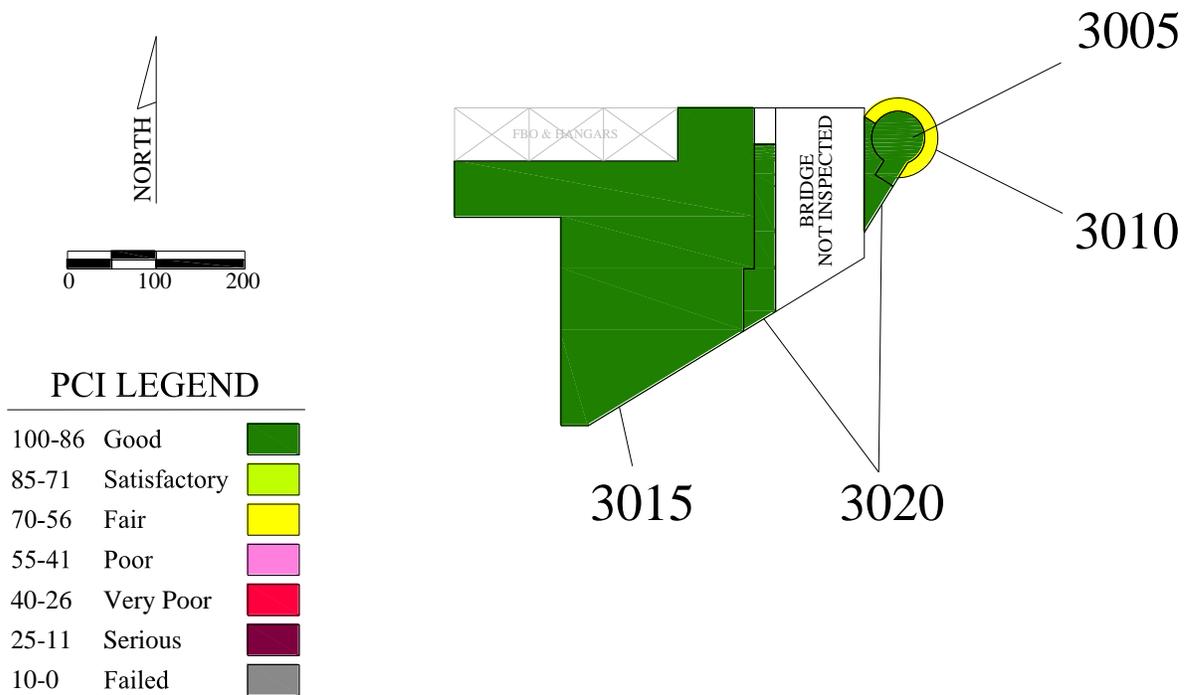
Figure 2-1. Inspected Pavement Condition

The average inspected Pavement Condition Index (PCI) for all the airfield pavements was 97.

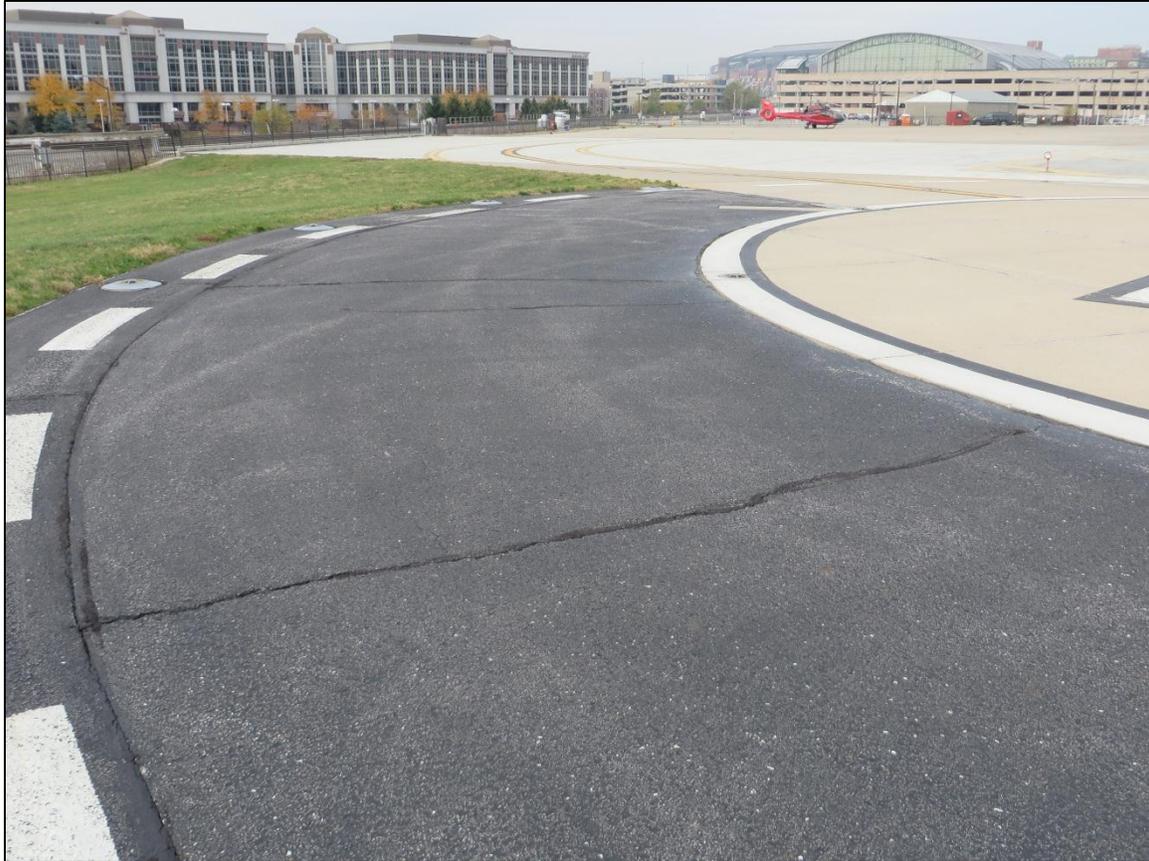
Figure 2-4. Typical Fair AC Pavement (Feature 3010)

The inspectors surveyed approximately 2,900 ft² of AC pavement. The frequency of each distress type is shown in Table 2-2. The recorded distress types included longitudinal and transverse (L&T) cracking, patching, and ravelling. L&T cracking is an age-related distress. Ravelling is a climate-related distress.
