Pavement Condition Report

Lafayette-Purdue University Airport

Project 15805741

February 2015

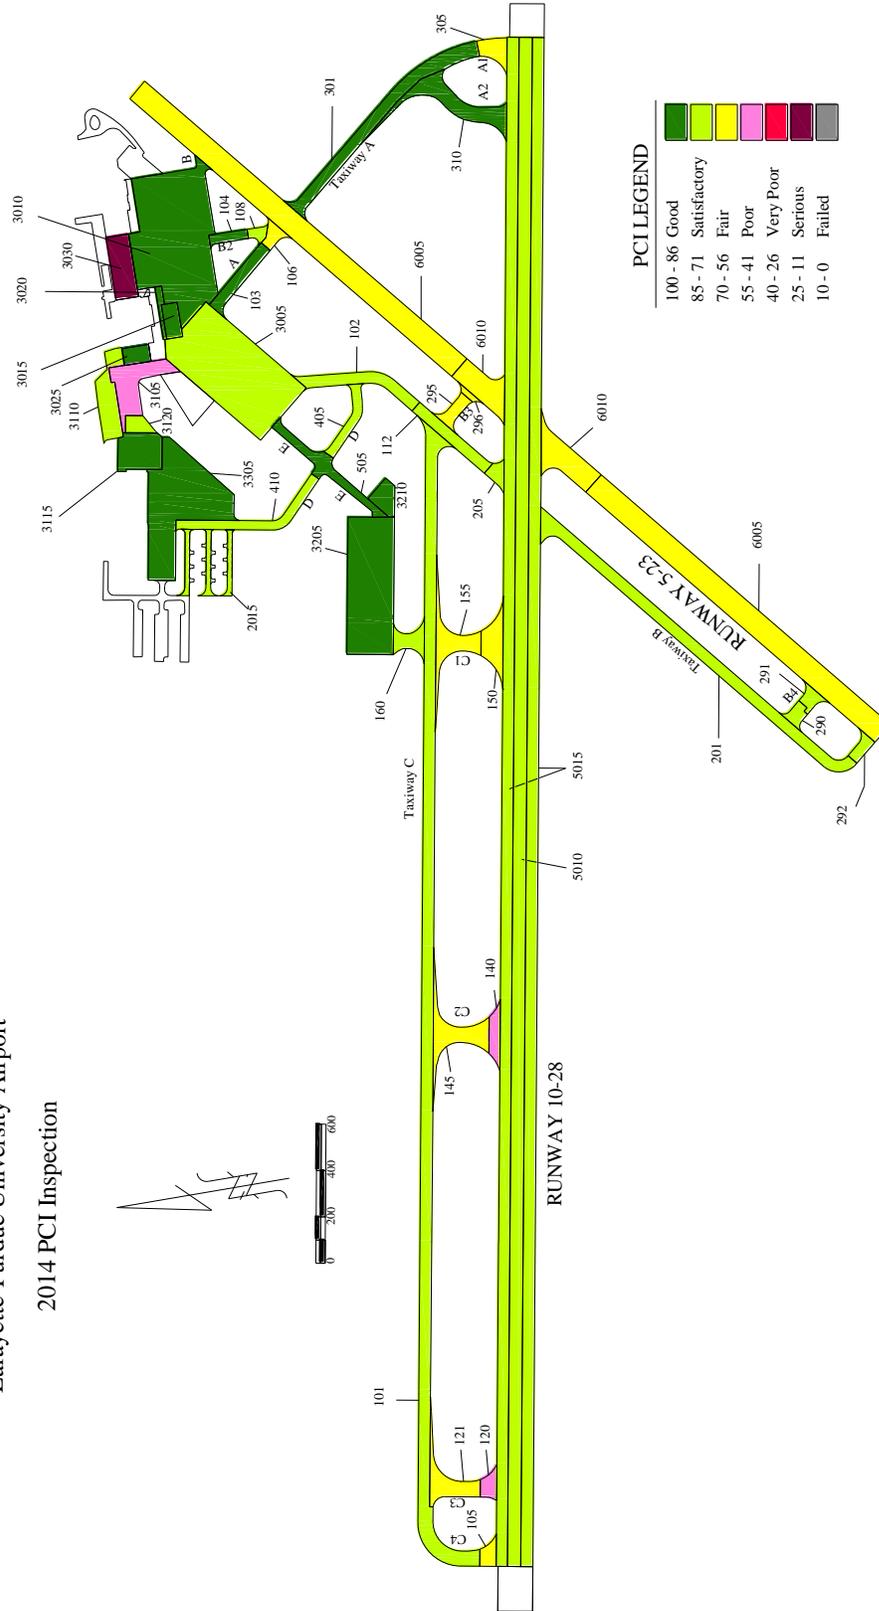
Figure 2-1. Inspected Pavement Condition

The pavement within each of the PCI condition categories is shown in Figure 2-1. The inspected PCI is summarized by branch use in Figure 2-2, and the photographs in Figure 2-3 through Figure 2-7 provide examples of the condition categories.

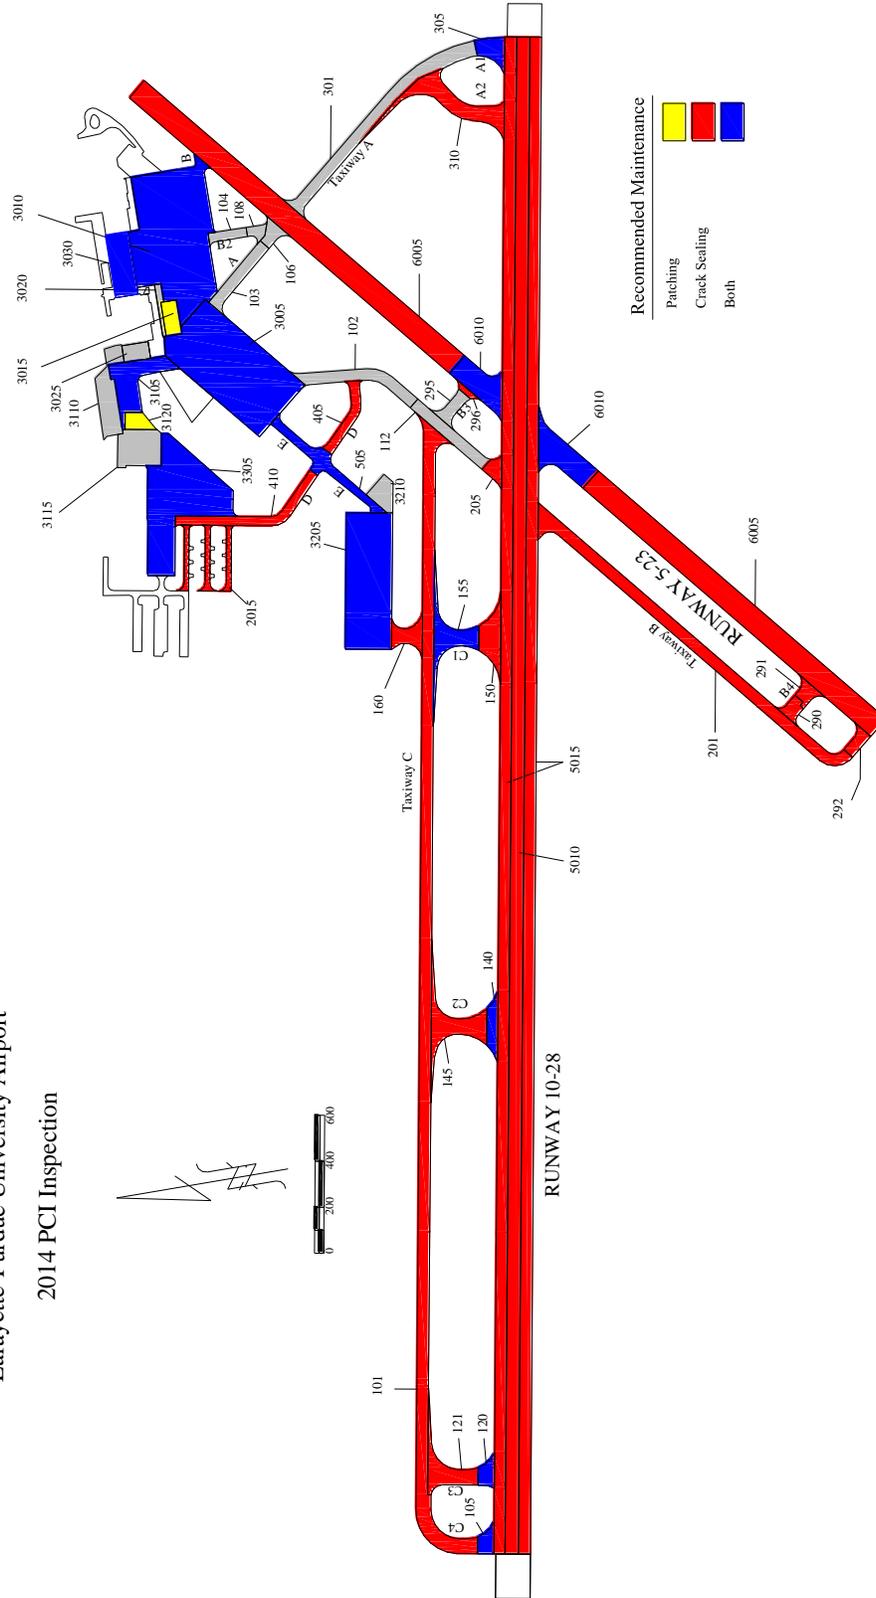
Figure 4-1. Recommended Maintenance

Analysis of potential maintenance projects identified approximately 5,400 square feet of patching needs and approximately 130,000 linear feet of crack sealing and crack repair needs, at an estimated total cost of approximately \$310,000.

Specific recommendations to help prioritize airfield maintenance are found in chapter 4 of this report. A summary of all identified maintenance needs is shown in the table below and in the figure on the following page.
