Pavement Condition Report

Rochester-Fulton County Airport

Project 1480370

January 2014

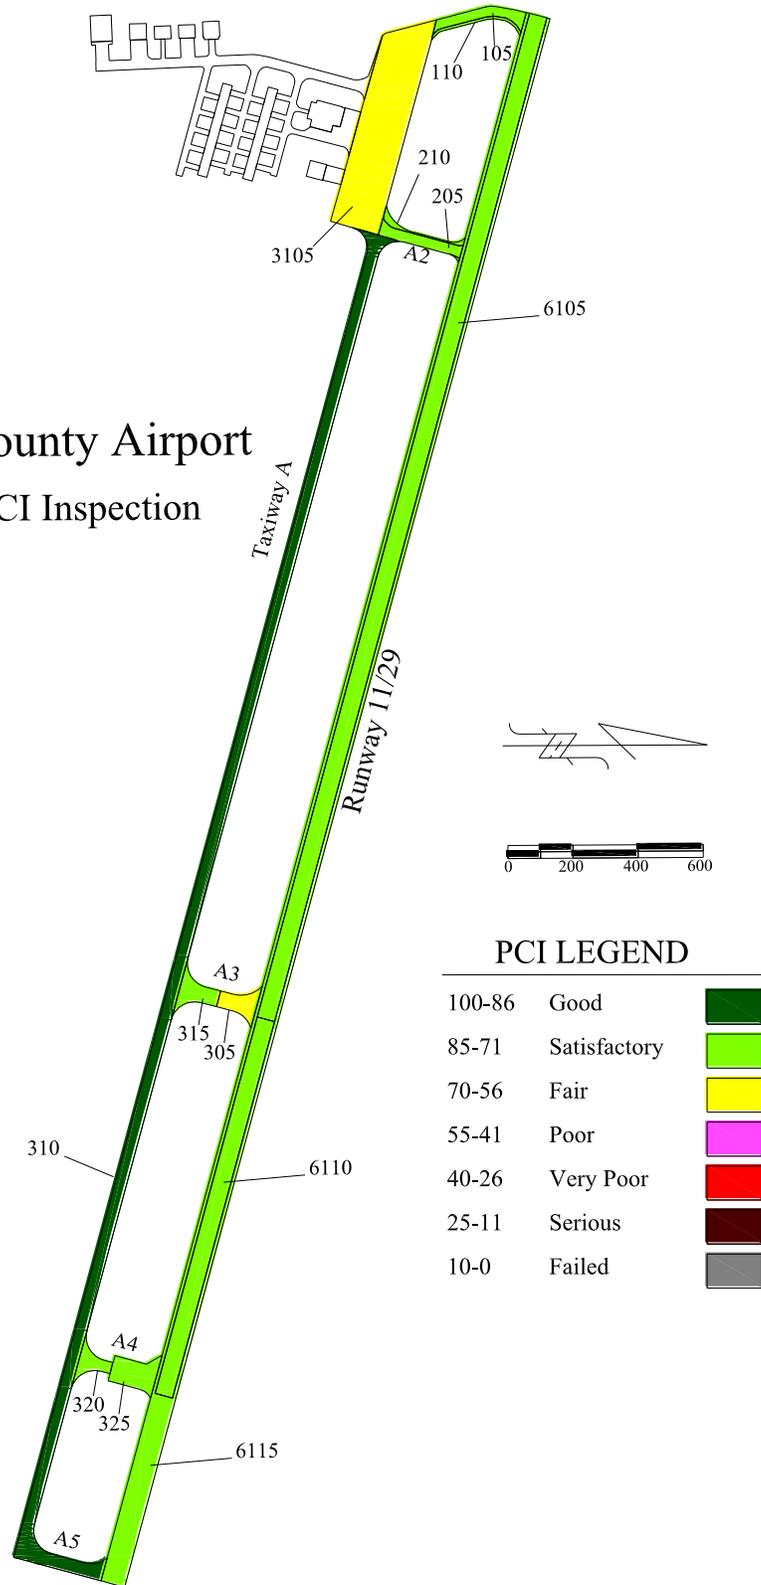
Figure 2-1. Inspected Pavement Condition

The overall Pavement Condition Index (PCI) for the airfield pavements was 79. Runways had an average inspected PCI of 76 and were above the desired MSL of 60. Taxiways had an average inspected PCI of 87, and ramps had an average inspected PCI of 70.

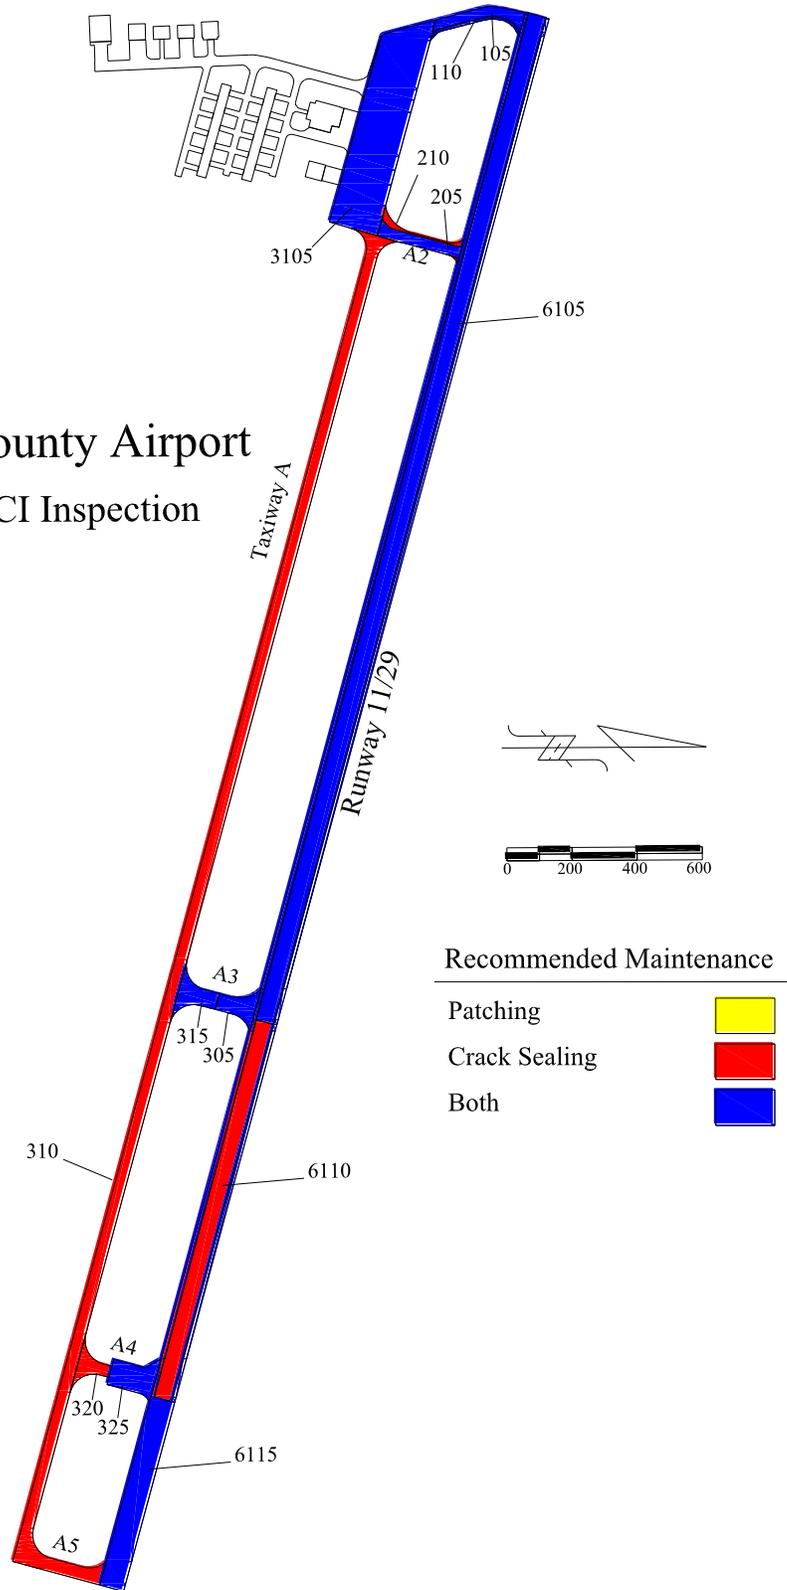
Figure 4-1. Recommended Maintenance

Analysis of potential maintenance projects identified approximately 710 square feet of patching needs and approximately 30,000 linear feet of crack sealing and crack repair needs, at an estimated total cost of approximately \$42,000.
