# Pavement Condition Report

## Seymour-Freeman Municipal Airport

Project 1480370

**January 2014**

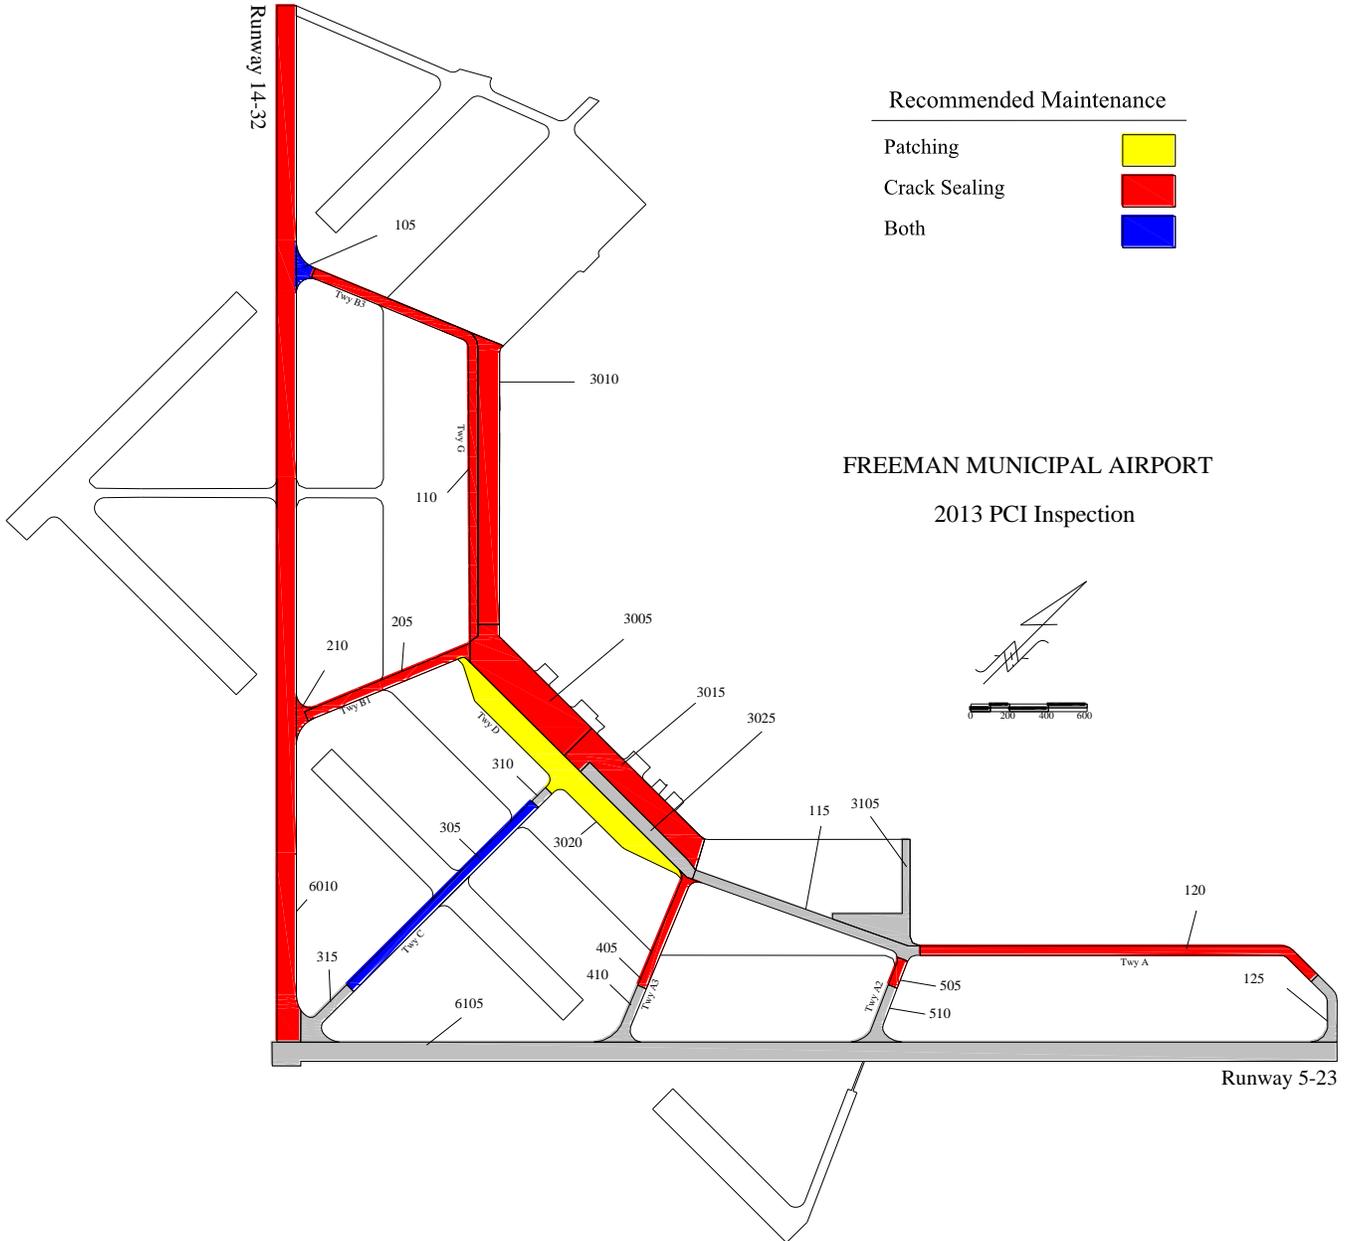
Analysis of potential maintenance projects identified approximately 210 square feet of patching needs and approximately 72,000 linear feet of crack sealing and crack repair needs, at an estimated total cost of approximately \$88,000.

Specific recommendations to help prioritize airfield maintenance are found in chapter 4 of this report. A summary of all identified maintenance needs is shown in the table below and in the figure on the following page.

Work Item	Quantity	Unit	Cost
AC PATCH	87	SF	\$754
AC RESTORATIVE CRACK REPAIR	63,015	LF	\$78,138
AC SUSTAINING CRACK REPAIR	8,650	LF	\$7,484
PCC PATCHING	123	SF	\$2,055
<b>Total:</b>			<b>\$88,431</b>

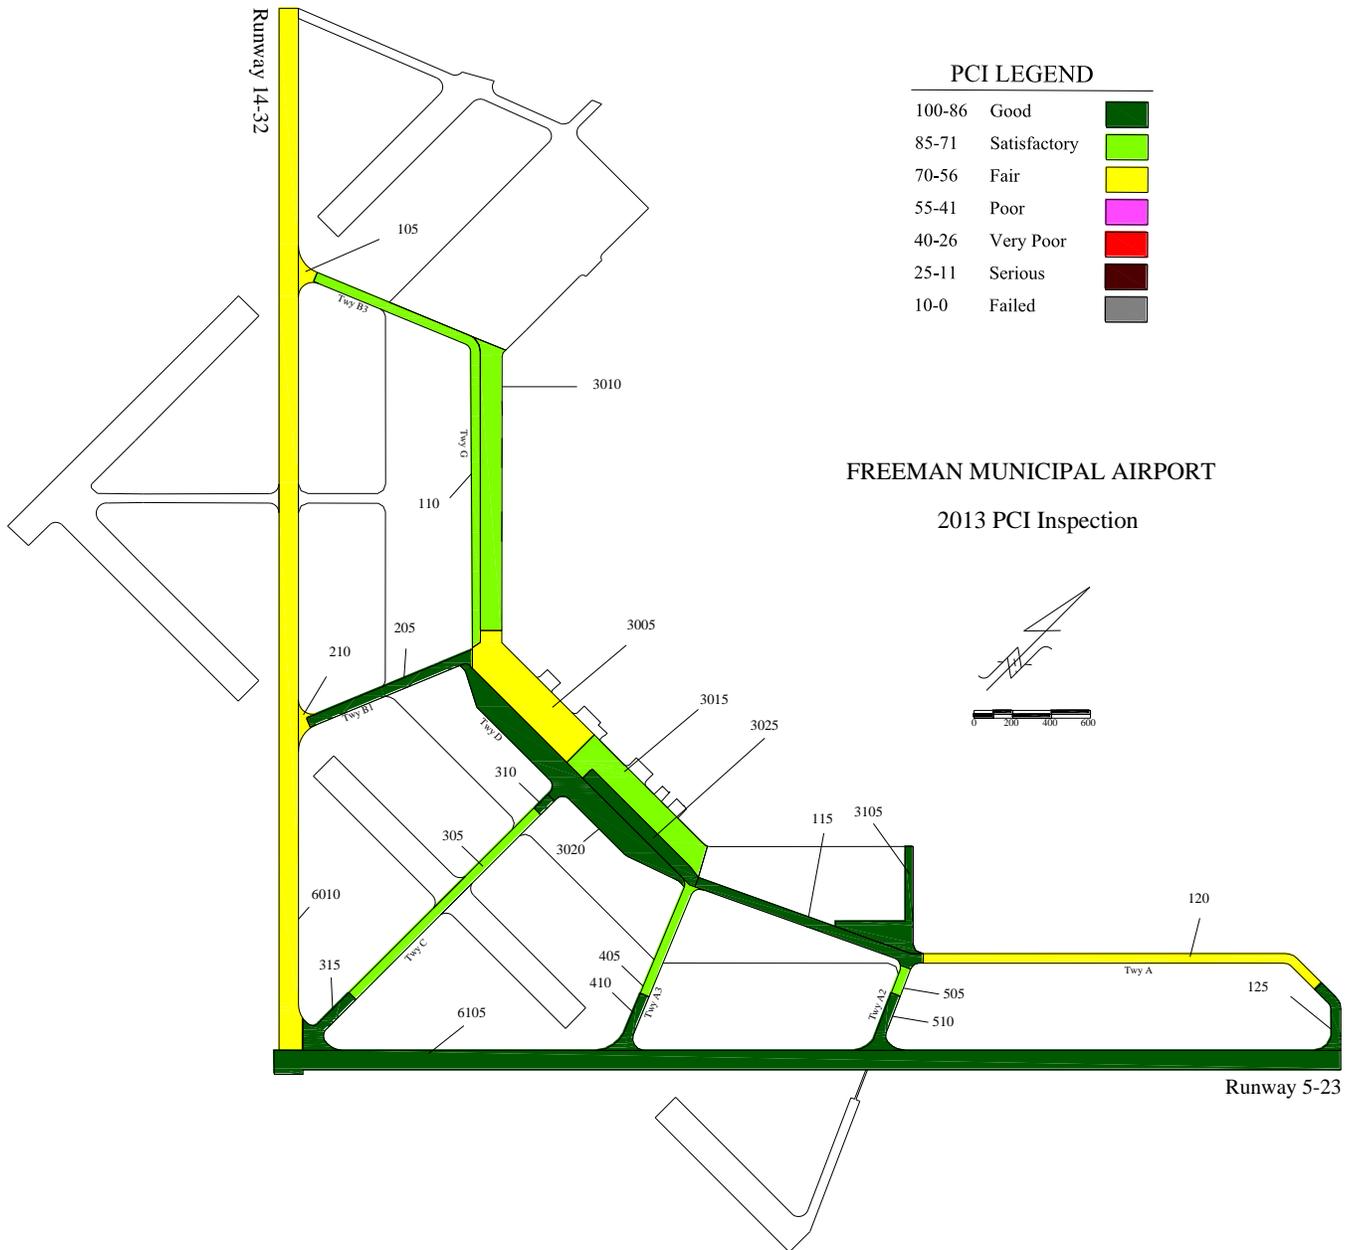
Figure 2-1. Inspected Pavement Condition

The pavement within each of the PCI condition categories is shown in Figure 2-1. The inspected PCI is summarized by branch use in Figure 2-2, and the photographs in Figure 2-3 through Figure 2-5 provide examples of the condition categories.

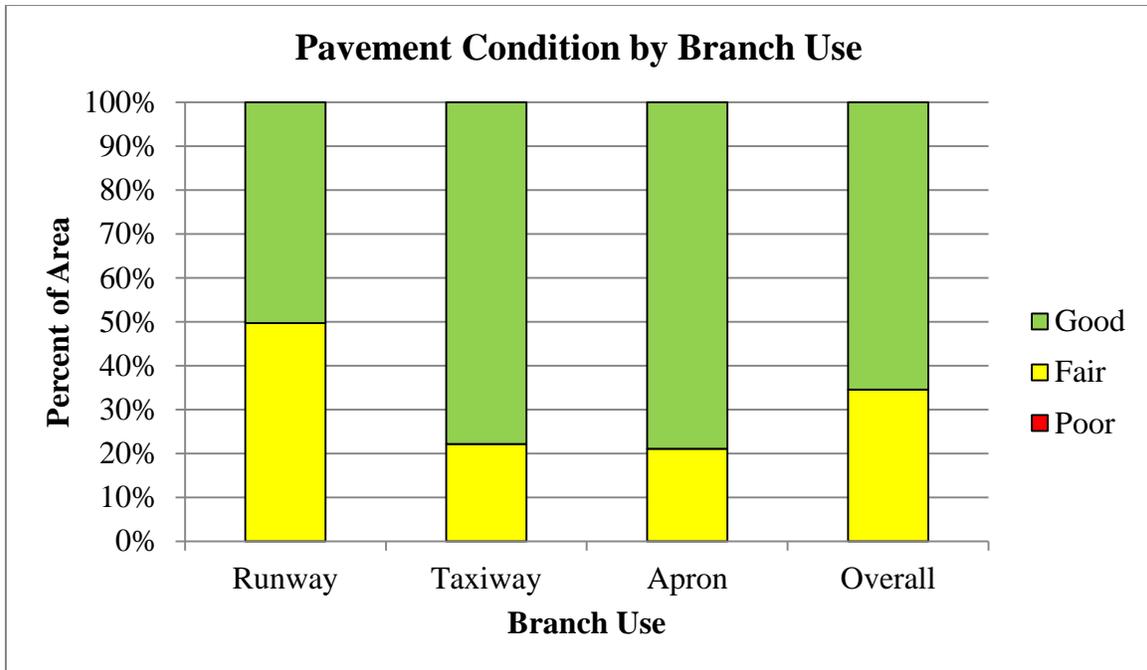
Figure 2-2. Pavement Condition by Branch Use

The overall Pavement Condition Index (PCI) for the airfield pavements was 83. Runways had an average inspected PCI of 85 and were above the desired MSL of 60. Taxiways had an average inspected PCI of 81, and ramps had an average inspected PCI of 82.
