Pavement Condition Report

Bedford-Grissom Municipal Airport

Project 16801839

January 2016

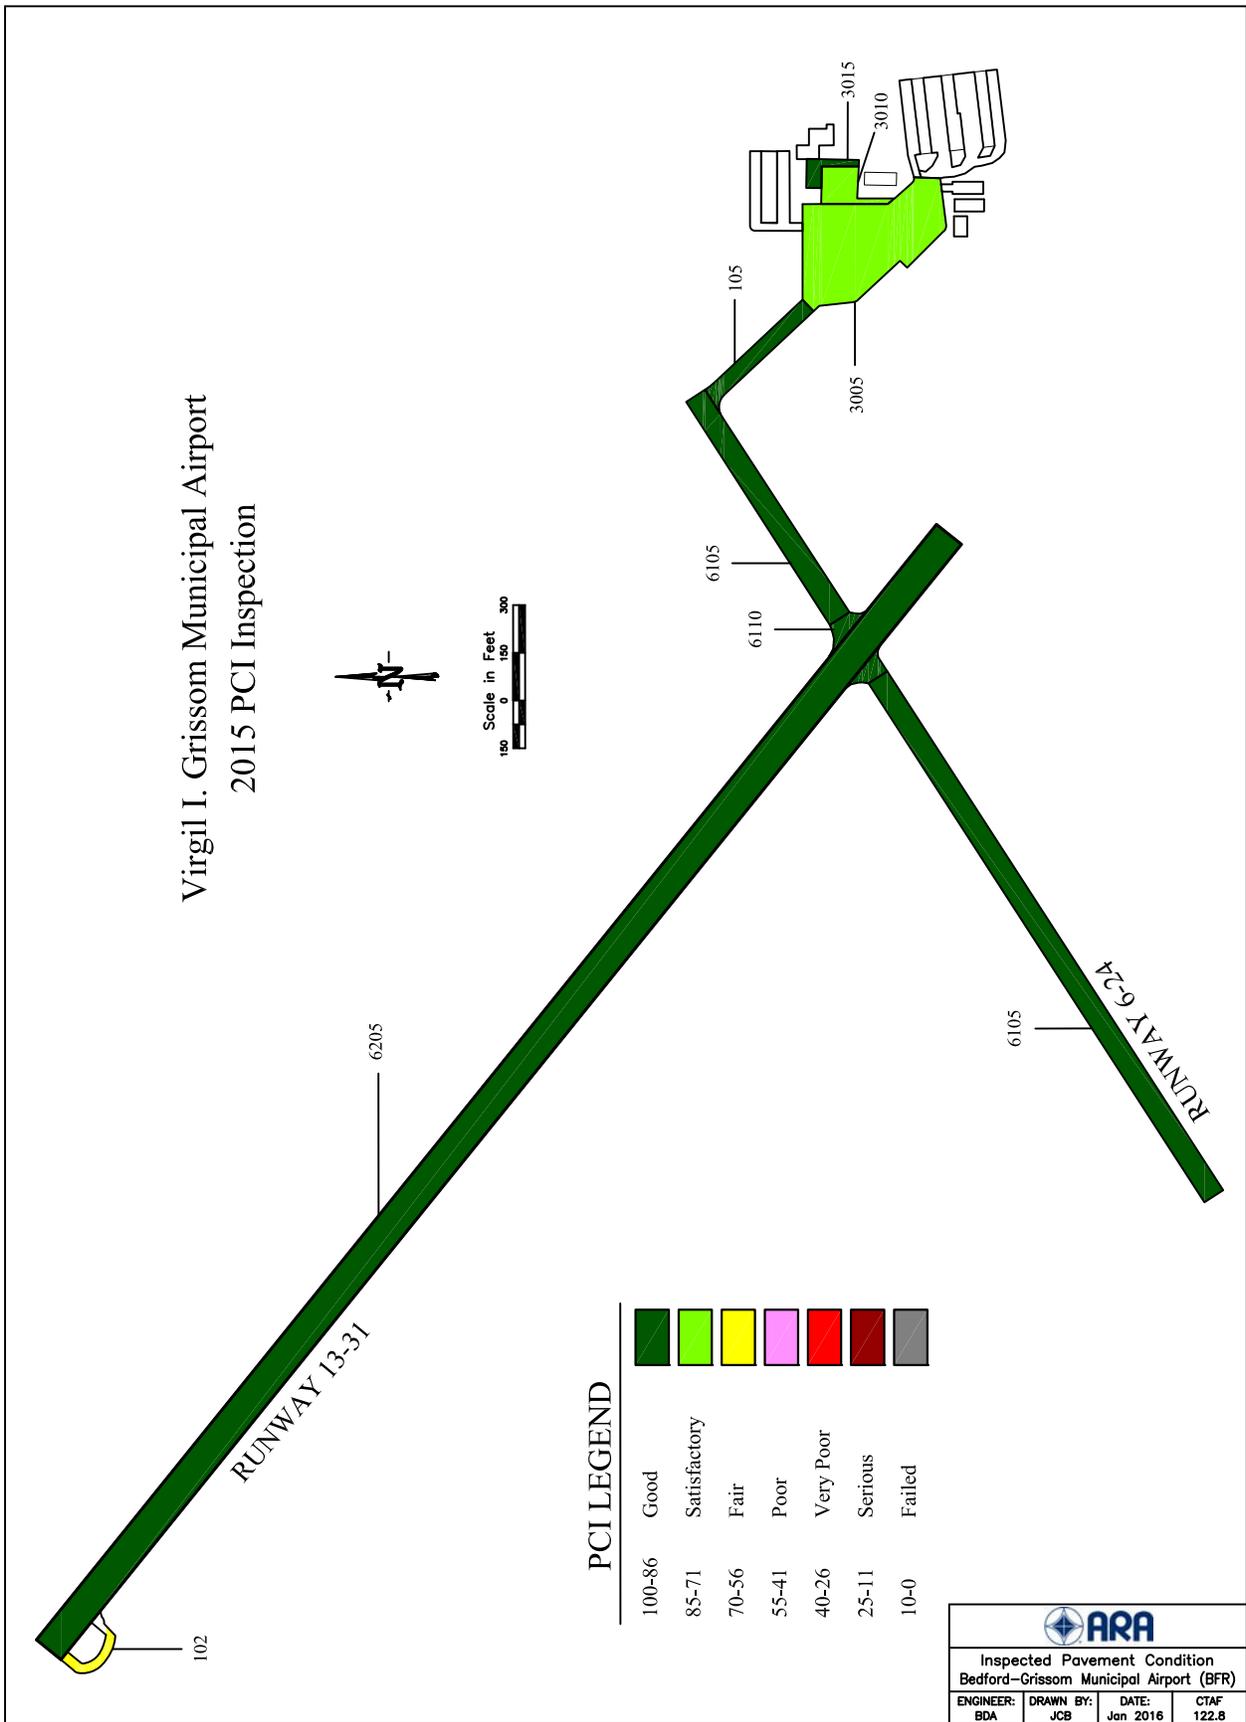
Figure 2-1. Inspected Pavement Condition at Bedford-Grissom Municipal Airport (BFR).

The pavement within each of the PCI condition categories is shown in Figure 2-1. The inspected PCI is summarized by branch use in Figure 2-2, and the photographs in Figure 2-3 through Figure 2-5 provide examples of the condition categories.

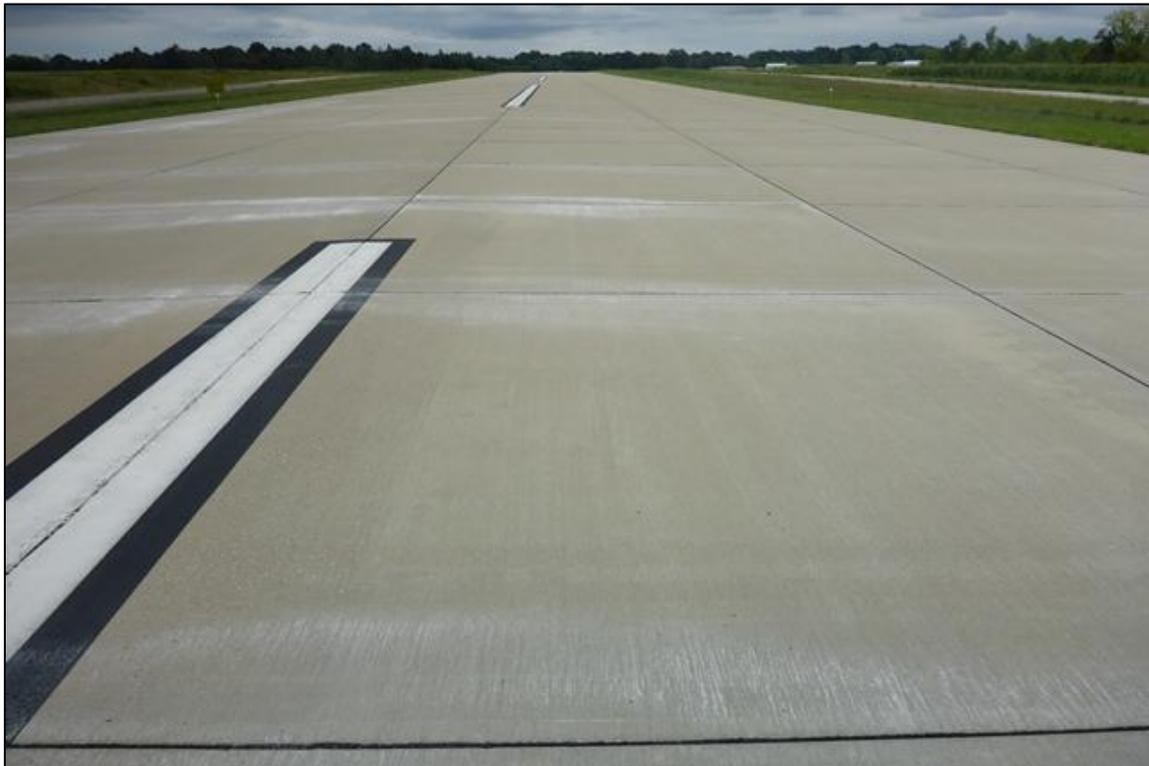
Figure 2-3. Typical PCC Pavement in Good Condition (Feature 6105)

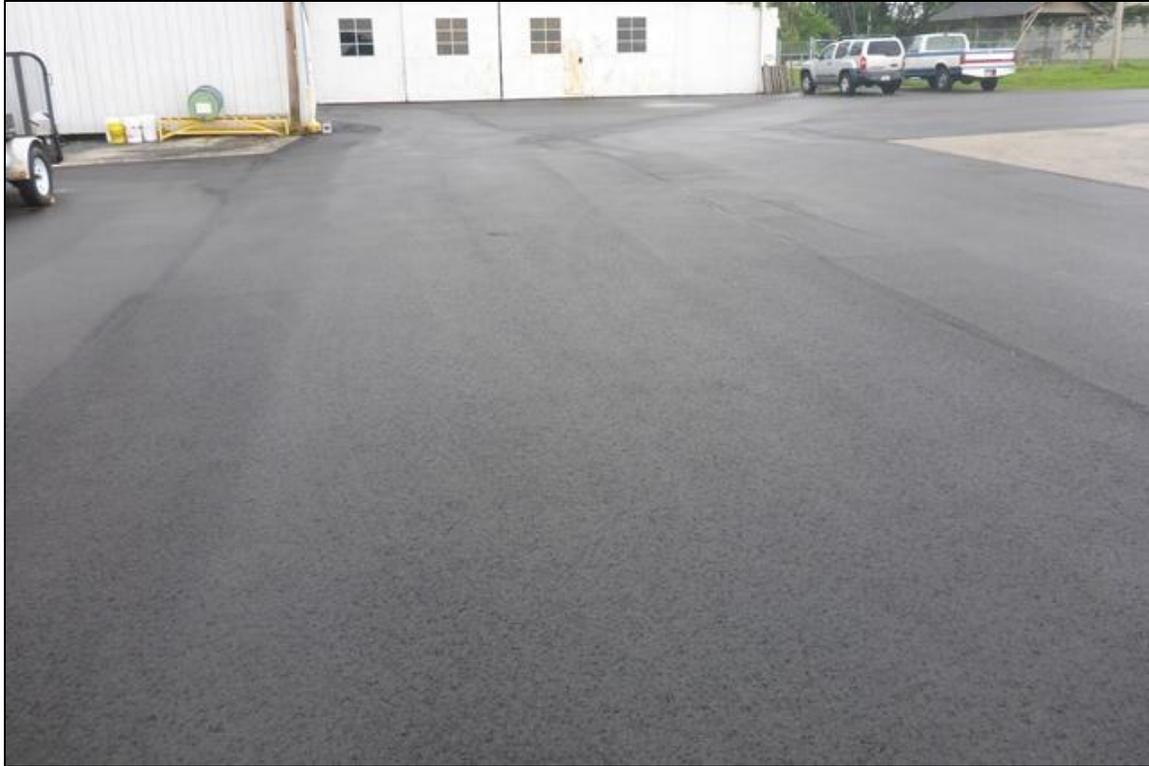
Figure 2-4. Typical AC Pavement in Good Condition (Feature 3015)

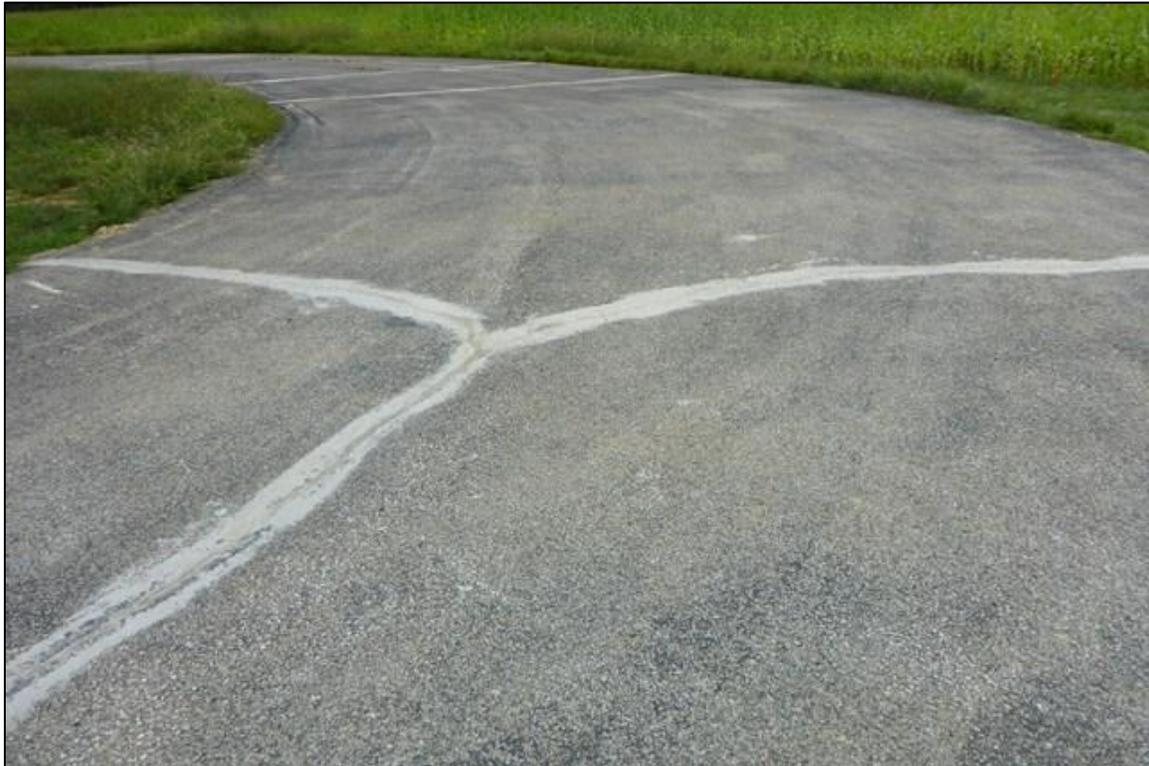
Figure 2-5. Typical AC Pavement in Fair Condition (Feature 102)
