HISTORIC BRIDGE ALTERNATIVES ANALYSIS

BRIDGE NUMBER: 027-38-06182 C

ROUTE IDENTIFICATION AND FEATURE CROSSED:
US 27 over Salamonie River

DATE: December 16, 2019

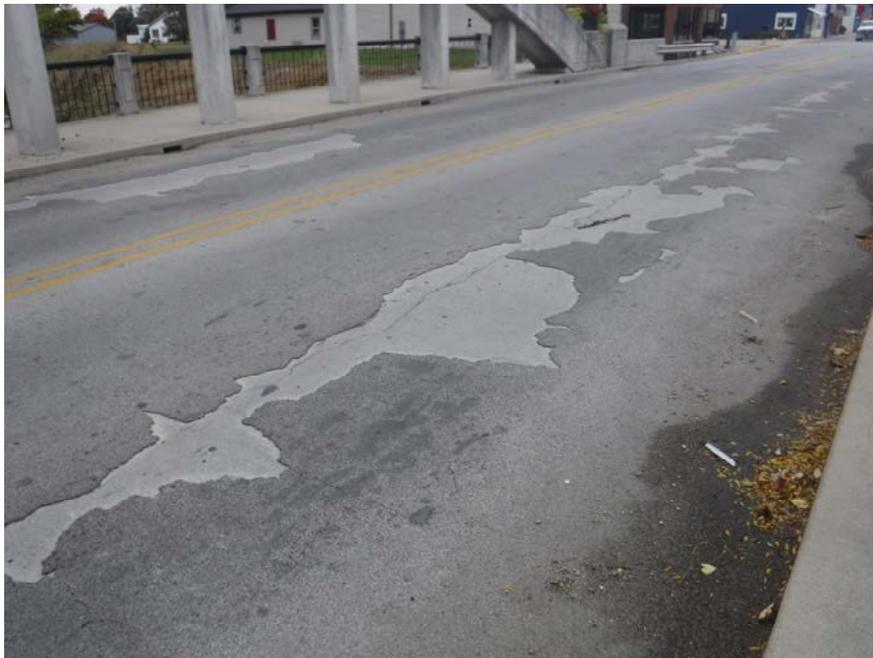
Photo 9:

1. General. The overall condition of the bridge deck is good (rated 7 out of 9).
2. Overlay. The existing “Flexogrid” epoxy overlay was installed in 2012 and is in poor condition (rated 4 out of 9). Transverse and longitudinal hairline cracks are present throughout the surface. Large portions of the overlay have spalled. Transverse reflective cracks are present above each floor beam and at the longitudinal joints between precast concrete panels. See Photo 9 and 10 in Appendix B.

- a. Southeast Corner of Bridge Deck
- b. Looking Northwest
- c. Deterioration of existing bridge deck overlay in northbound lane. Overlay is cracked and spalled.

The existing bridge thin deck overlay will be removed by a milling operation. All unsound concrete on the deck will be removed and patched with partial depth patching. A new flexible polymeric concrete bridge deck overlay will be installed.

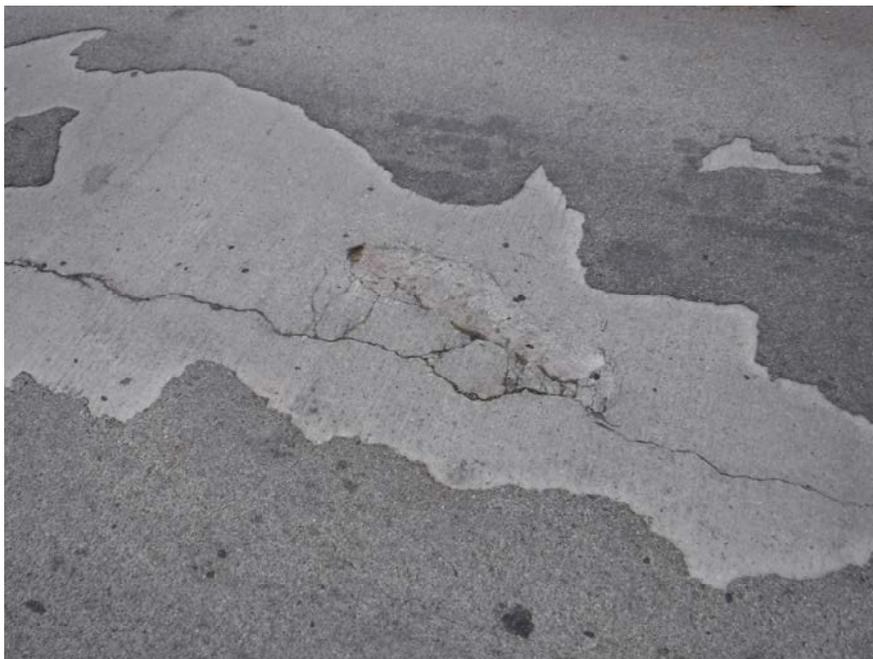
Photo 10:

3. Surface Condition. Hairline longitudinal cracks can be seen through the spalled areas of the overlay. Closely spaced transverse hairline cracks are present at the sidewalks over the floor beams.

- a. Bridge Deck
- b. Looking Down
- c. Typical longitudinal and transverse cracks and spalls in the deck underneath spalled wearing surface.

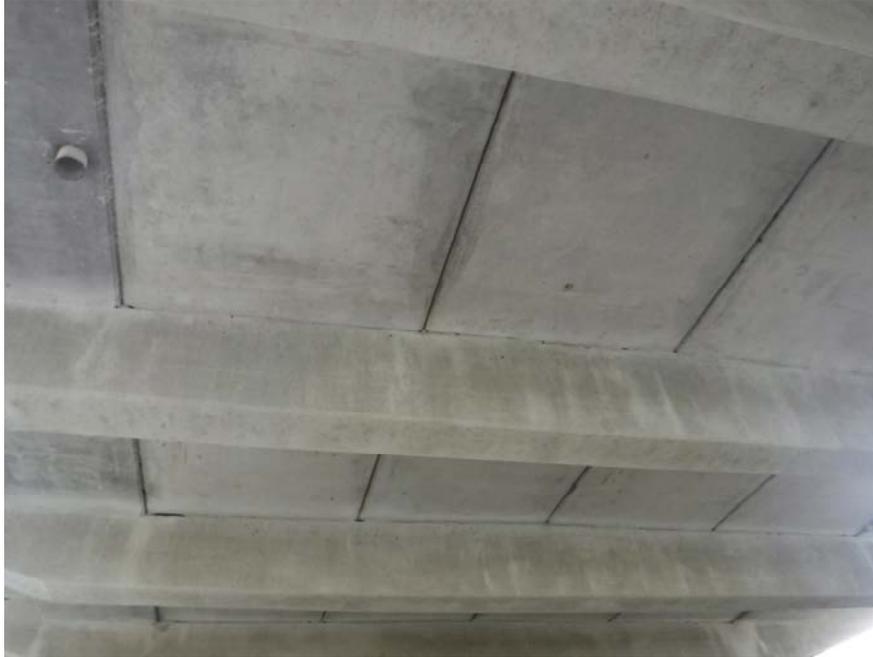
Photo 11:

4. Underside Condition. Prestressed concrete deck panels are in good condition (rated 7 out of 9). There is minor leakage and efflorescence present between the exterior and first interior panel. See Photo 11 in Appendix B.

- a. From Underside of Bridge
- b. Looking Up at Bottom of Structure
- c. Typical condition of precast deck panels, no deterioration present.

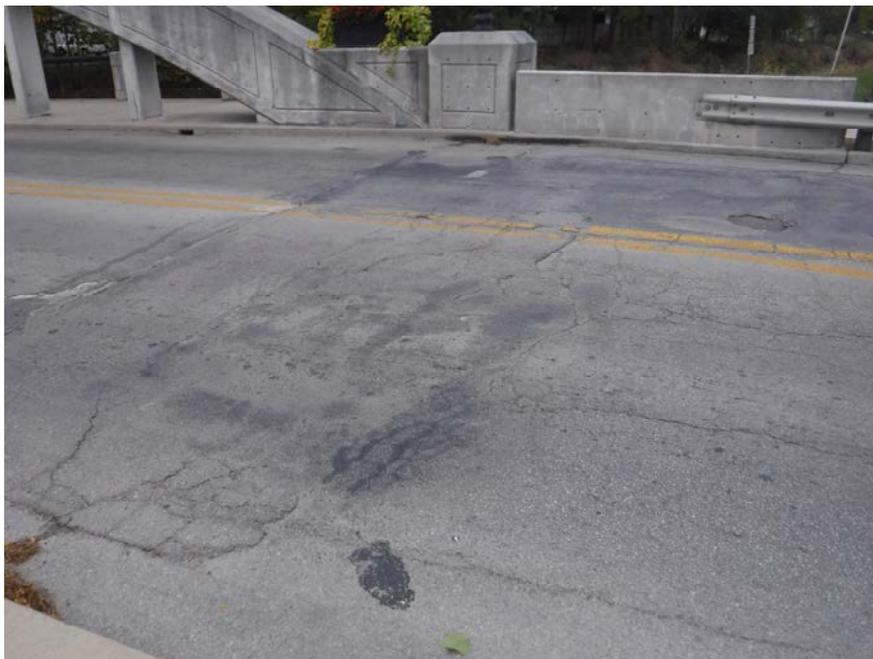
Photo 12:

1. General. The overall condition of the approach pavement is satisfactory with longitudinal and transverse unsealed cracks. See Photo 12 in Appendix B. The approach pavement will undergo an HMA overlay as part of the HMA overlay, preventative maintenance project on US 27 Des. No. 1700811.

- a. North Approach
- b. Looking West
- c. Typical longitudinal and transverse cracks and settlement in approach pavement at ends of bridge.

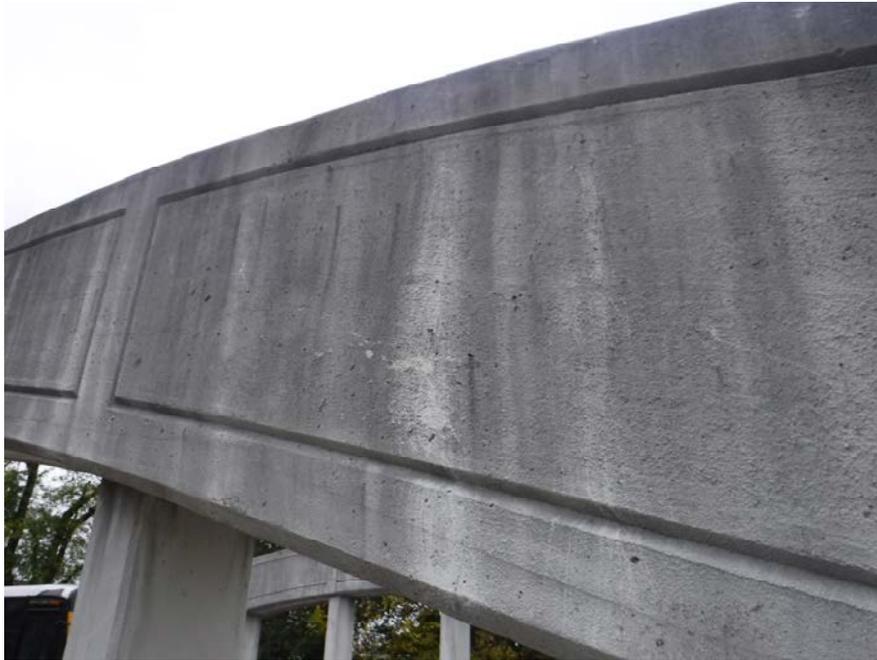
Photo 13:

1. General. Overall, the reinforced concrete through arch superstructure is in satisfactory condition (rated 6 out of 9) with minor longitudinal cracks, scalling and small spalls. See Photo 13 and 14 in Appendix B. The existing masonry coating is discolored, cracked and starting to peel on the arch ring. There is an existing concrete patch on the third column from the north on the east arch. The patch material is inconsistent with the original concrete material, porous and poorly bonded along its edges. See Photo 16 in Appendix B.
2. Fracture-Critical Member or Low-Fatigue-Life Details. None.

- a. From East Sidewalk
- b. Looking West
- c. Typical stained condition of masonry coating on arch surface.

The existing masonry coating on the arch, columns, and concrete portion of the railing will be cleaned using a masonry cleaner and hand tools, following the National Park Service U.S. Department of the Interior Preservation Brief No. 15, Preservation of Historic Concrete. The existing concrete patch on the east arch column will be removed along with any deteriorated concrete on the other columns, arch or concrete portion of the railing. Patching concrete structures, with a special microsilica concrete mix, and welded steel wire reinforcement will be used to patch the areas of removed concrete. A patch material consisting of a concrete mix with microsilica will match the texture and color of the existing concrete components.

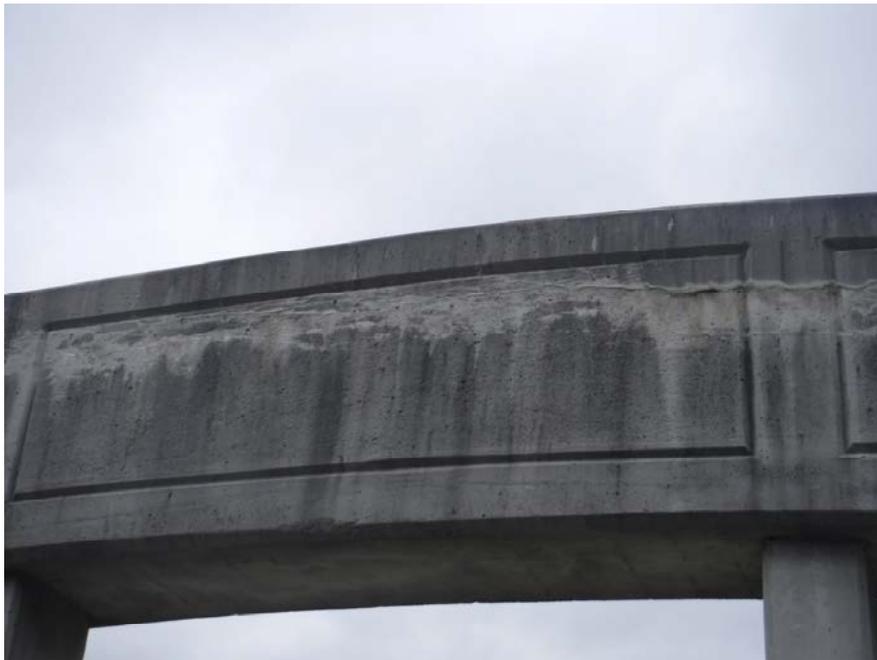
Photo 14:

- a. Roadway
- b. Looking East
- c. Cracking with efflorescence near top of east arch west face.

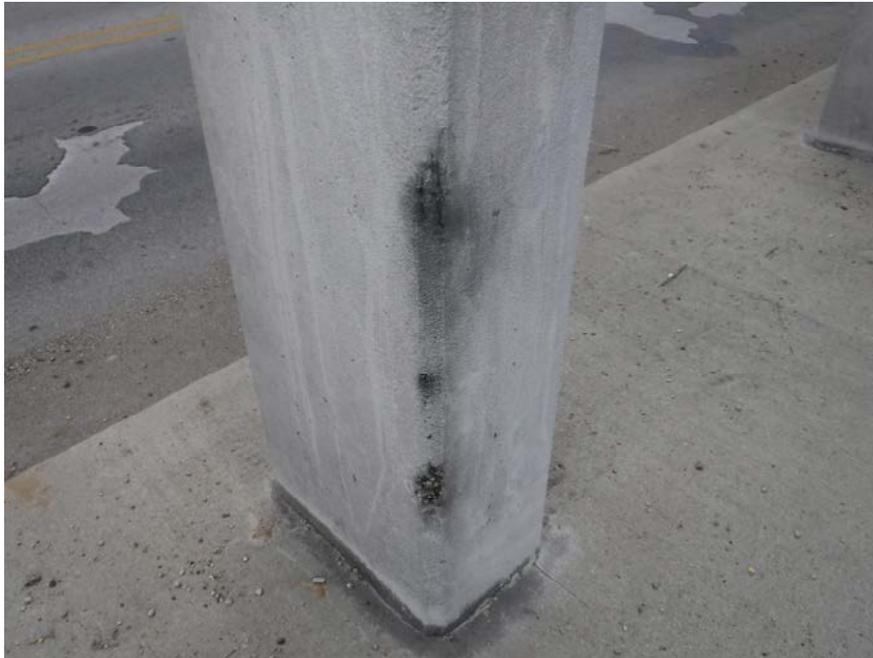
Photo 15:

- a. From West Sidewalk
- b. Looking East
- c. Typical stained condition of masonry coating, honeycombing and cracks on column surface.

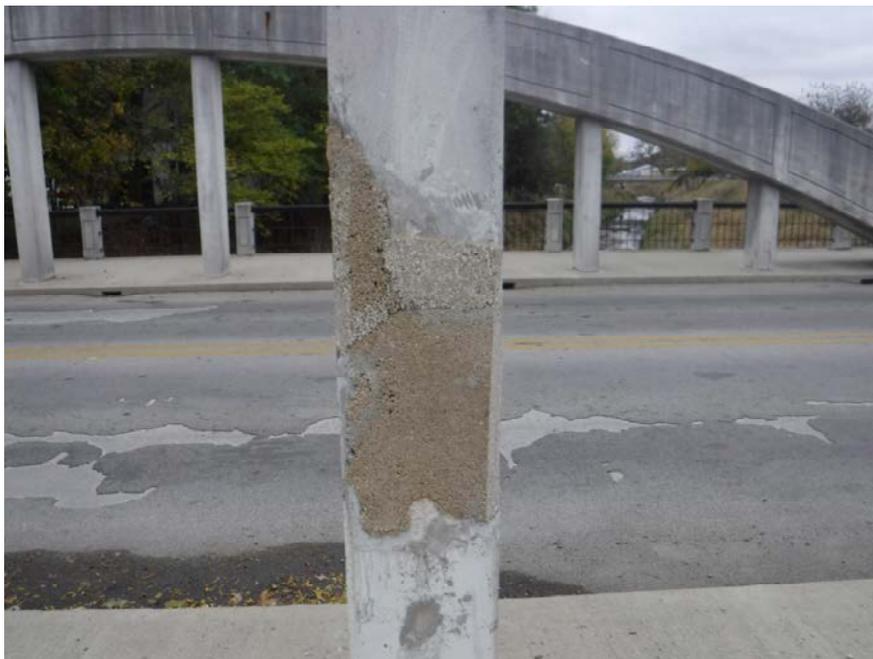
Photo 16:

- a. From East Sidewalk
- b. Looking West
- c. Existing patch on third column from north at east arch. Patch material is inconsistent with original concrete, porous and poorly bonded along its edges.

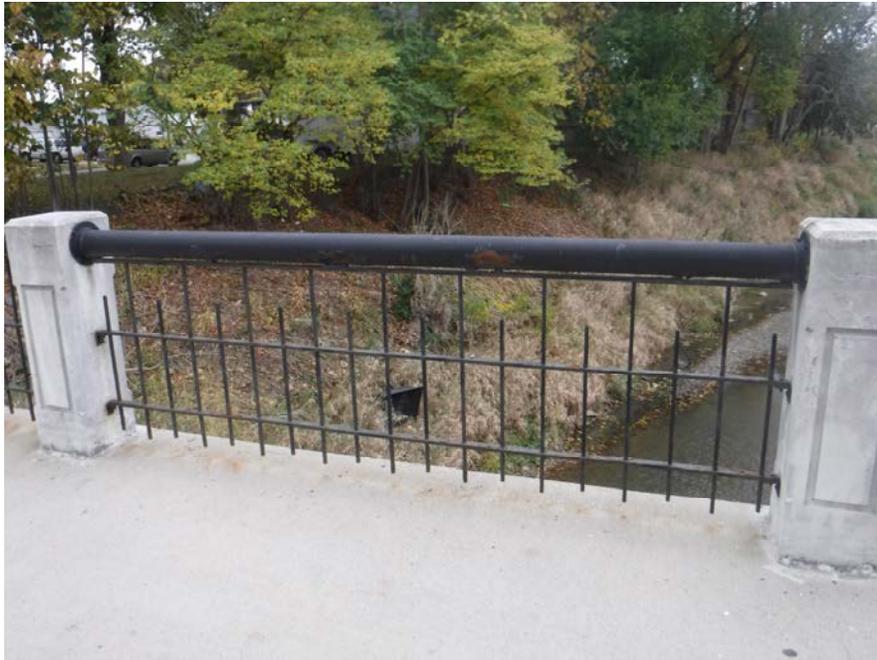
Photo 17:

7. Bridge Railing. The existing bridge railing consists of concrete posts with steel railing. There is some peeling of the paint, surface rust and pitting, without significant section loss, on the steel railings. There is no protection of the arch rings from traffic. See Photo 17 and 18 in Appendix B.

- a. From West Sidewalk
- b. Looking West
- c. Typical railing.

The existing steel railing components and light fixtures will be removed from the bridge. The existing paint system will be completely removed. The steel components will be shop galvanized and then painted using a powder coating

method in a black matte finish to match the original appearance. The newly painted steel components will be reinstalled on the bridge with all new steel hardware.

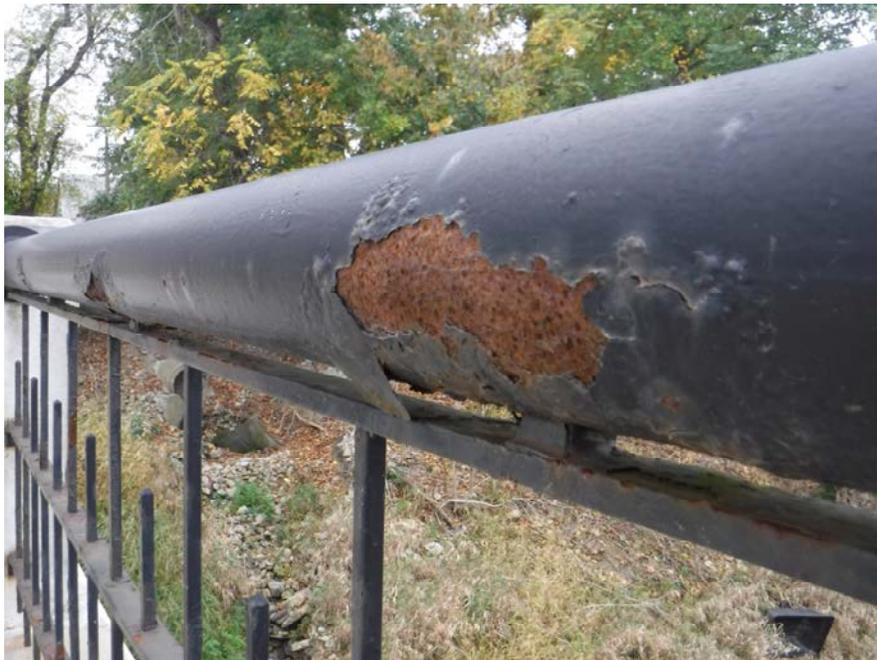
Photo 18:

- a. From West Sidewalk
- b. Looking West
- c. Typical condition of steel portion of railing. Paint is peeling. The exposed steel railing exhibits surface rust with minor pitting.

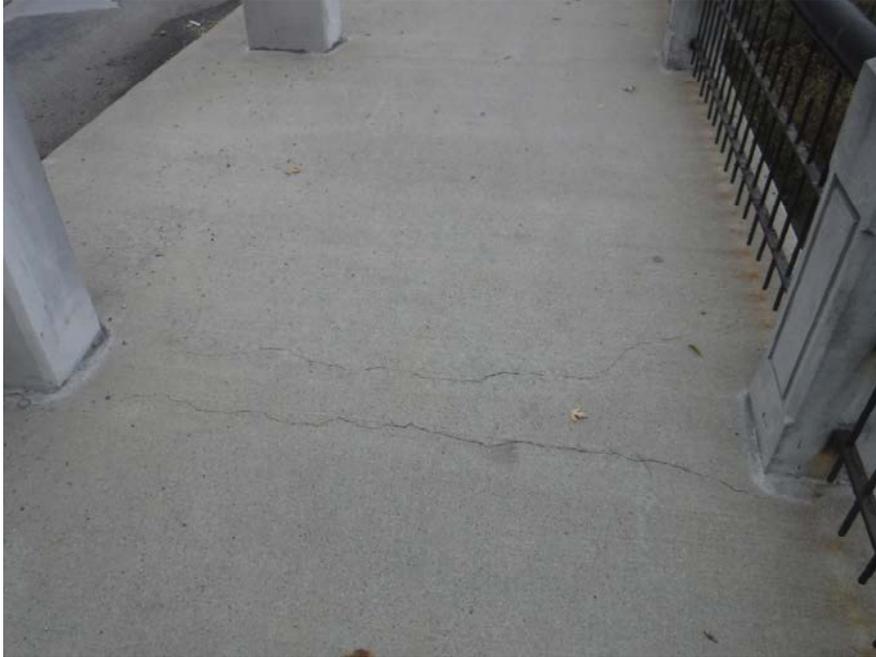
Photo 19:

8. Curbs or Sidewalks. There are two 6'-2" (clear) sidewalks, curbs, arches and railings. The sidewalk and curb exhibit transverse reflective cracking over each floor beam. See Photo 19 in Appendix B.

- a. From West Sidewalk
- b. Looking South
- c. Typical transverse cracks on sidewalk.

The surface of the sidewalk, curbs and face of the curbs will be surface sealed with a sealer/healer coating. This will repair existing open cracks, preventing the underlying bridge deck floor system from penetrating chloride infiltration, slowing future deterioration.

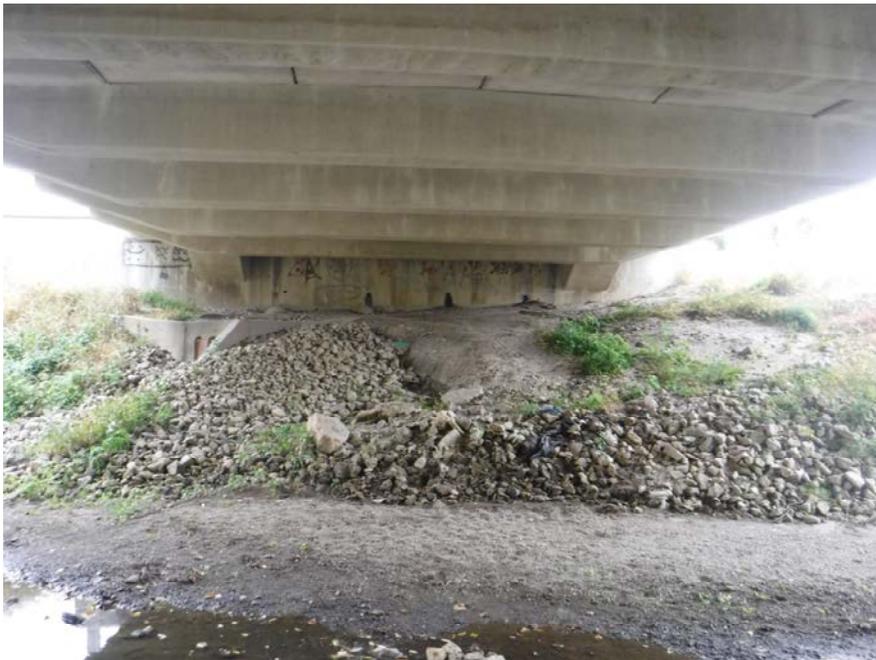
Photo 20:

1. General. Overall, the condition of the reinforced concrete abutments is satisfactory (rated 6 out of 9) with map cracking and light to moderate efflorescence on the face of the abutments.
2. Scour. The bridge is considered stable for scour conditions. The banks are well vegetated with scattered riprap. The channel/channel protection is in satisfactory condition (rated 6 out of 9). There is localized erosion at both spill slopes resulting in exposure of existing gas and sewer utility lines. See Photo 20 in Appendix B.

- a. From South Spill Slope
- b. Looking North
- c. Localized erosion on north spill slope exposing existing gas and sewer utilities.
