# Pavement Condition Report

## Greensburg Municipal Airport

Project 16801839

**January 2016**

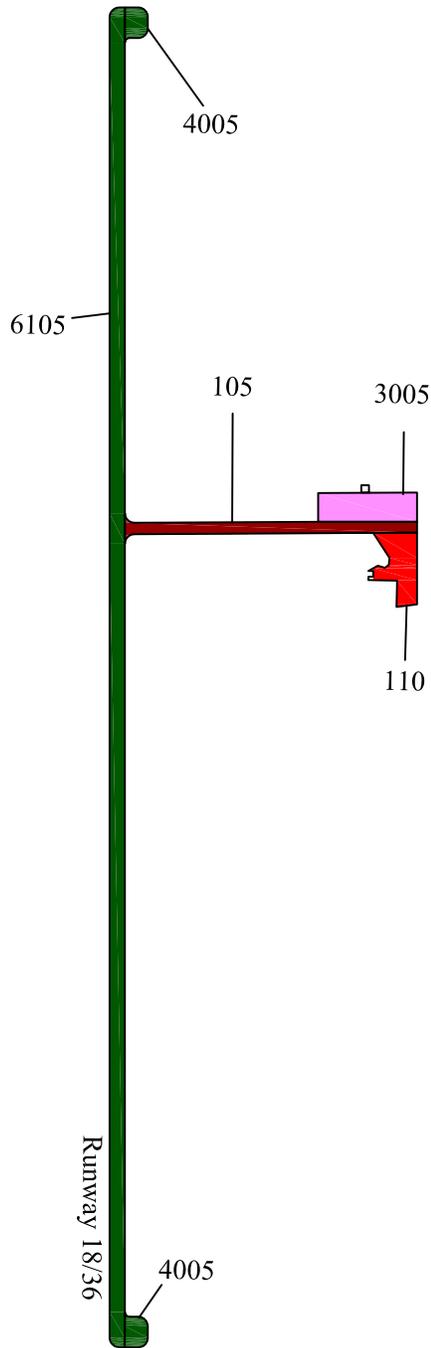
Figure 2-1. Inspected Pavement Condition at Greensburg Municipal Airport (I34).

The average inspected Pavement Condition Index (PCI) for all the airfield pavements was 74. Runways had an average inspected PCI of 89 and were above the desired MSL of 60. Taxiways had an average inspected PCI of 26, and ramps had an average inspected PCI of 67.

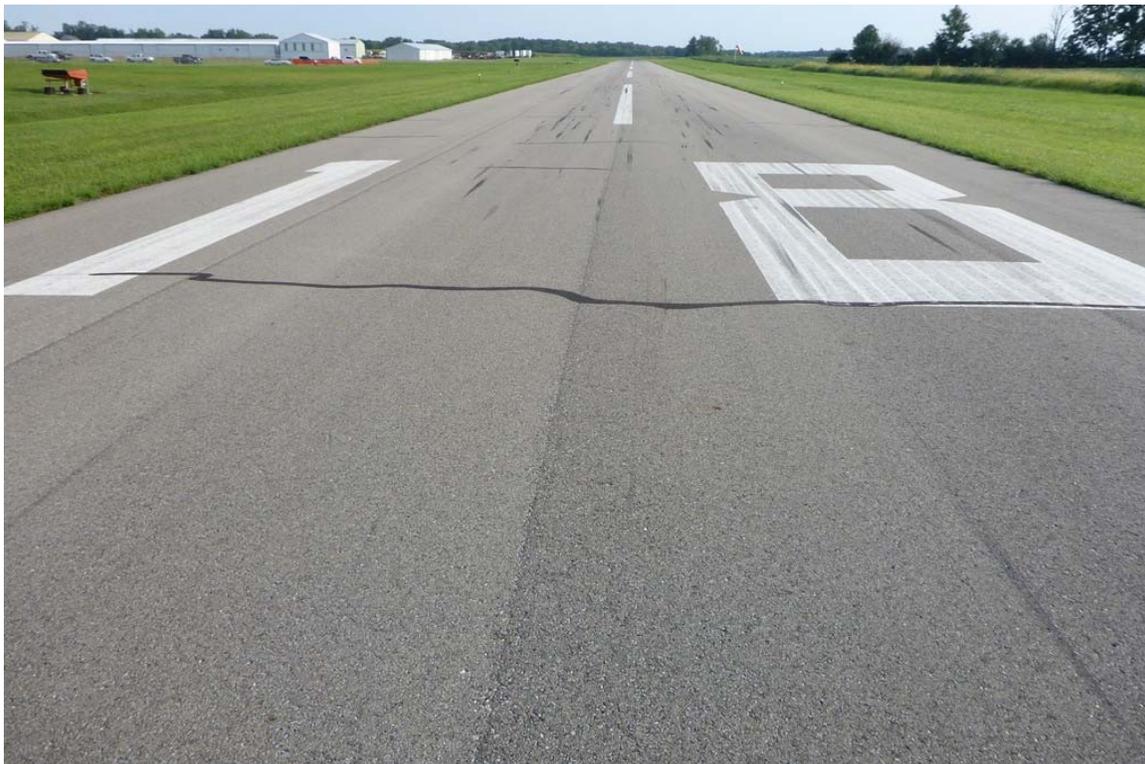
Figure 2-3. Typical AC Pavement in Good Condition (Feature 6105)

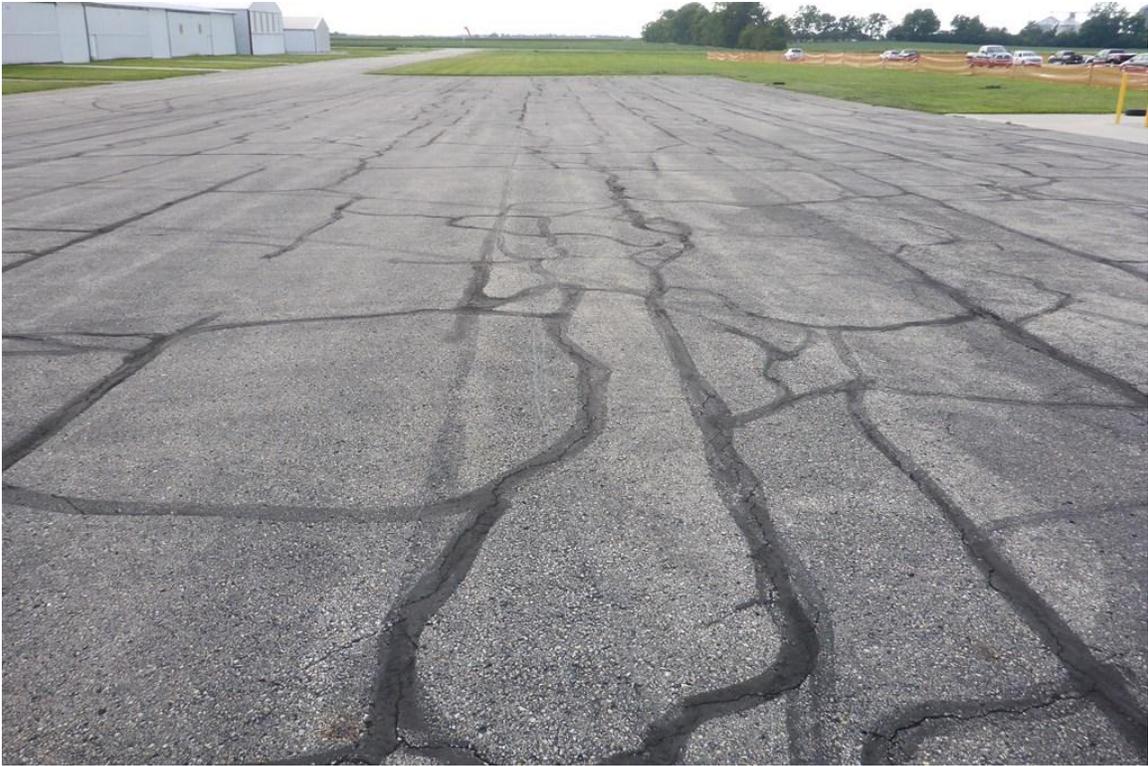
Figure 2-4. Typical AC Pavement in Poor Condition (Feature 3005)

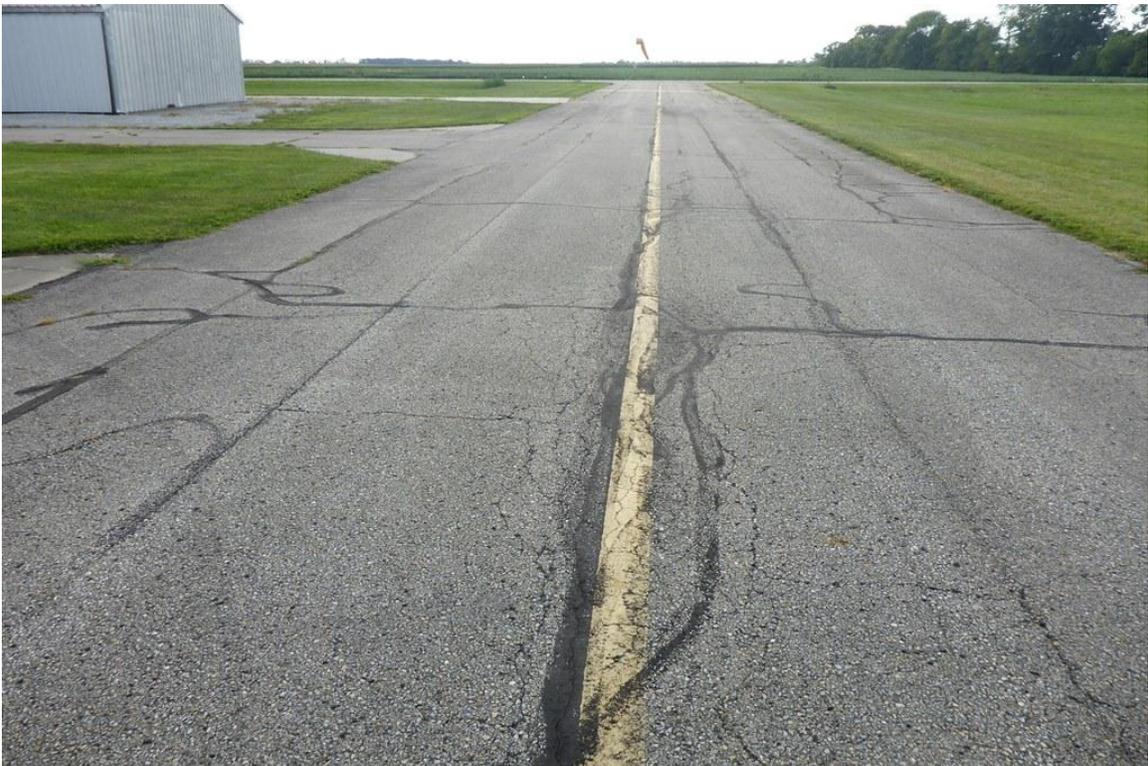
Figure 2-5. Typical AC Pavement in Poor Condition (Feature 105)

The taxiway consisted of two sections of AC pavement. The total area of the taxiway was 38,587 ft<sup>2</sup>. The AC taxiway pavement was in poor condition with load and age related distresses (alligator, rutting and raveling) being the main causes of deterioration. Taxiway pavement distribution by PCI range is shown in Table 2-5.

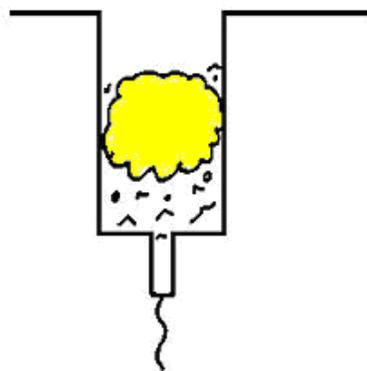
Typical failed joint sealant, w/ debris and incompressibles.
