Pavement Condition Report

North Vernon Airport

Project 16801839

January 2016

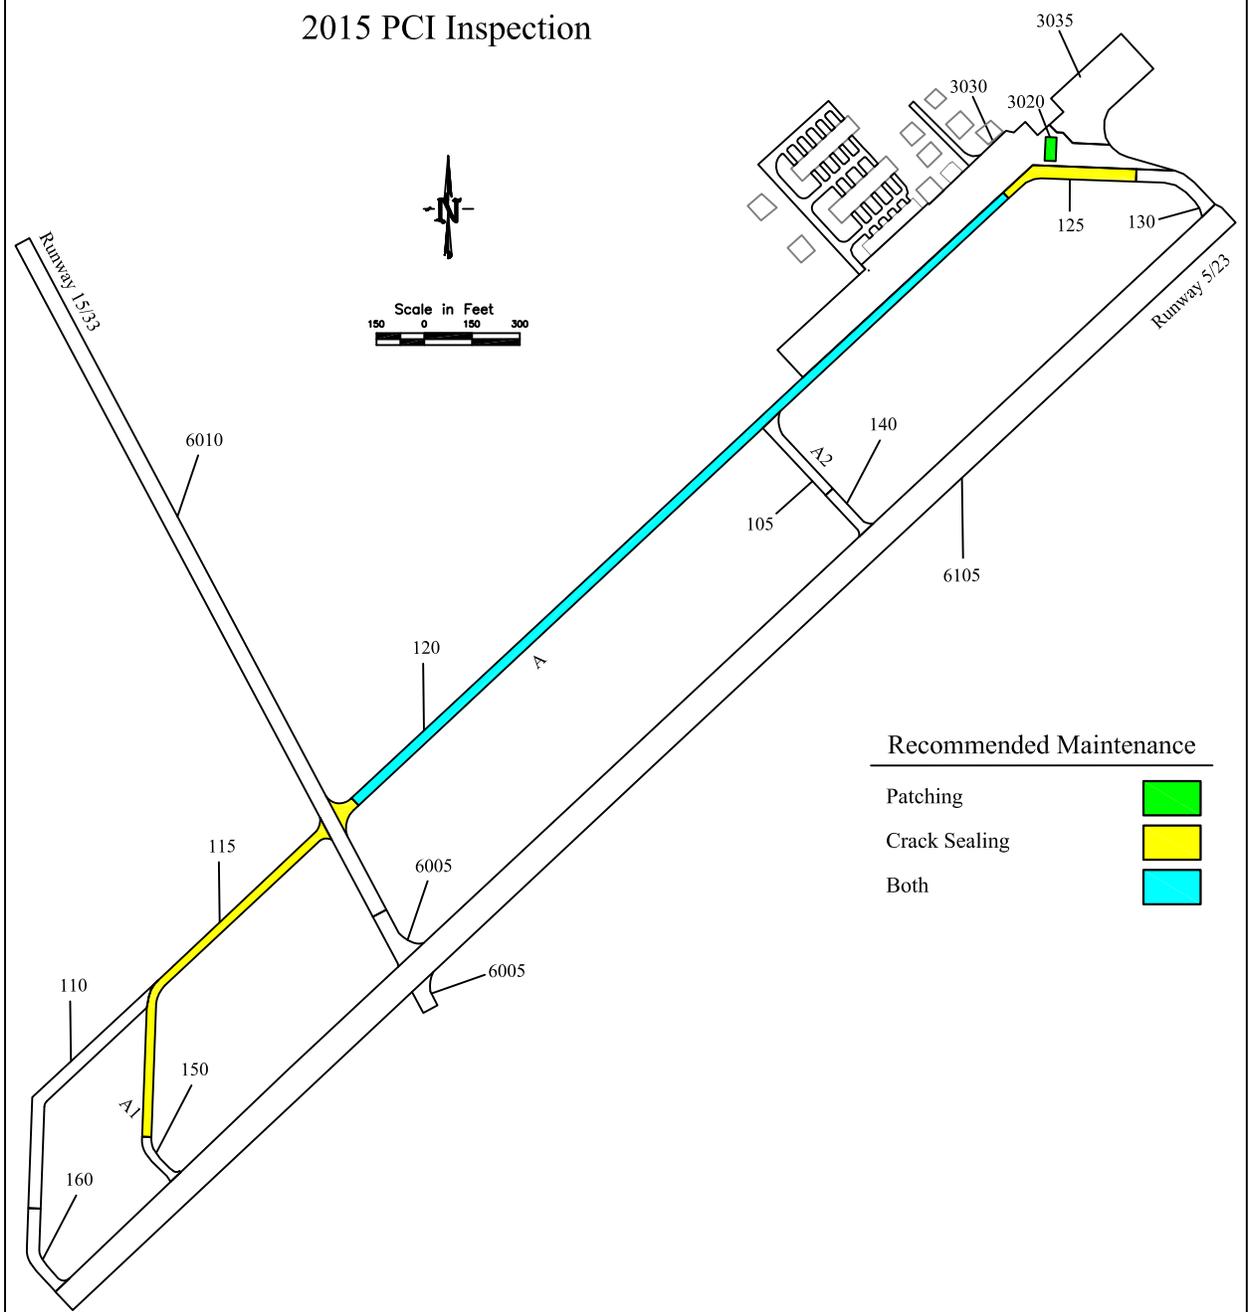
Analysis of potential maintenance projects identified approximately 1,200 linear feet of crack sealing and crack repair needs and nearly 100 square feet of patching, at an estimated total cost of approximately \$2,000.

Recommended Maintenance	
Patching	
Crack Sealing	
Both

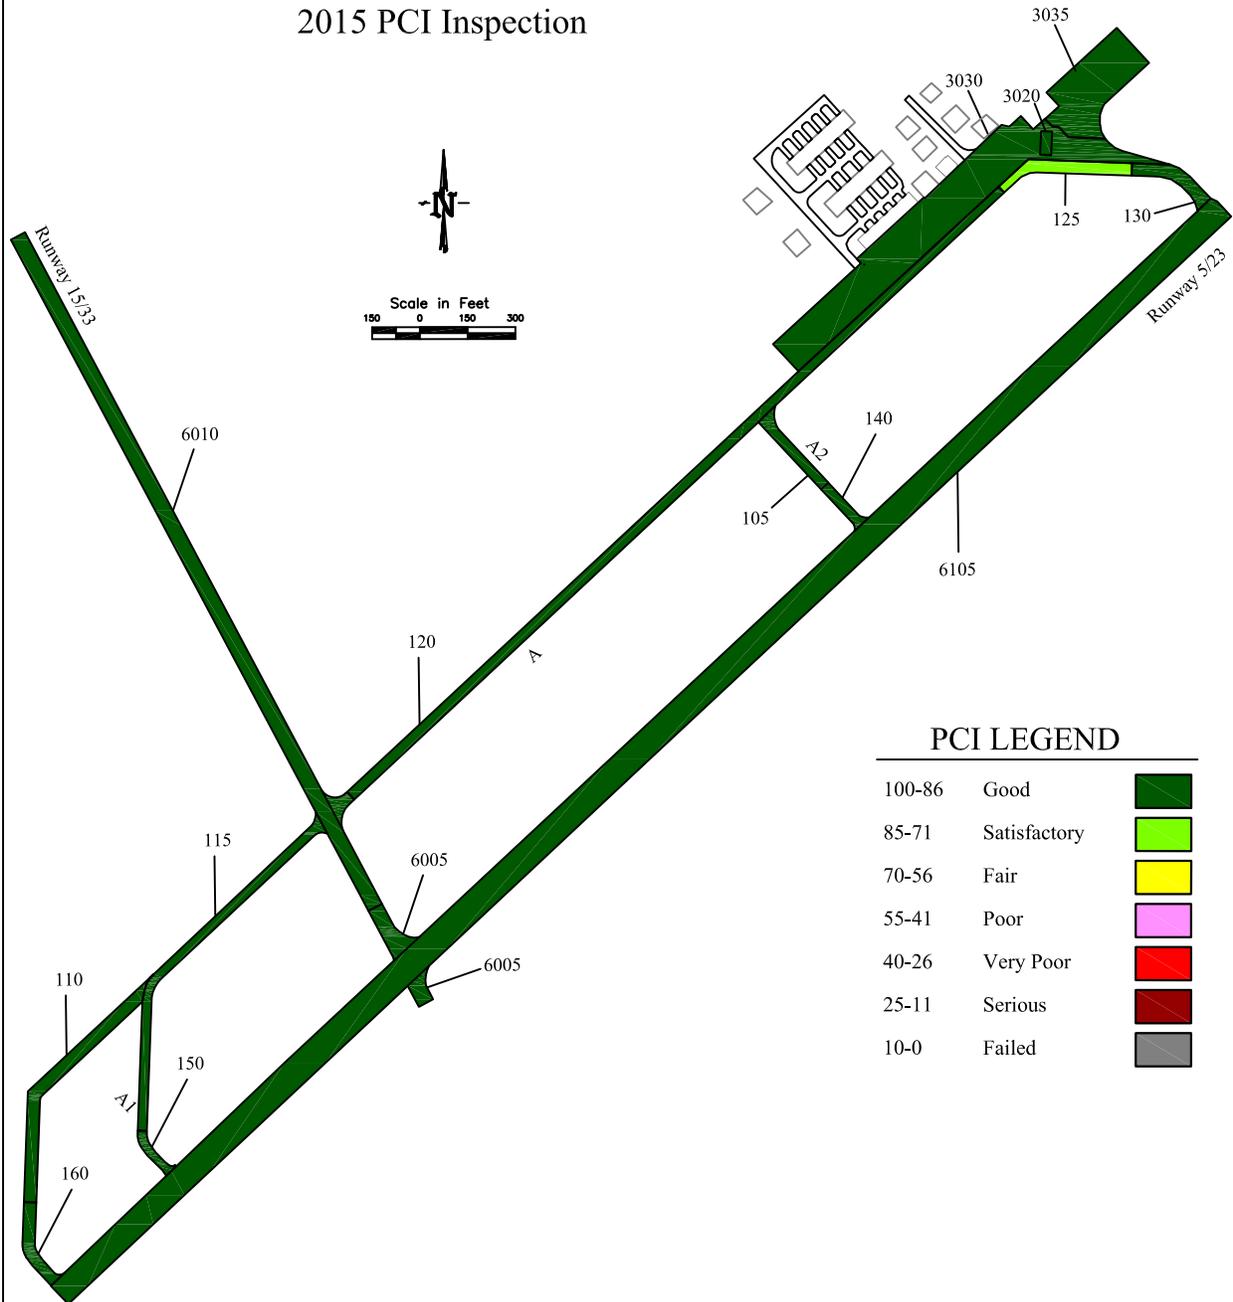
Figure 2-1. Inspected Pavement Condition at North Vernon Airport (OVO).

The pavement within each of the PCI condition categories is shown in Figure 2-1. The inspected PCI is summarized by branch use in Figure 2-2, and the photographs in Figure 2-3 through Figure 2-5 provide examples of the condition categories.

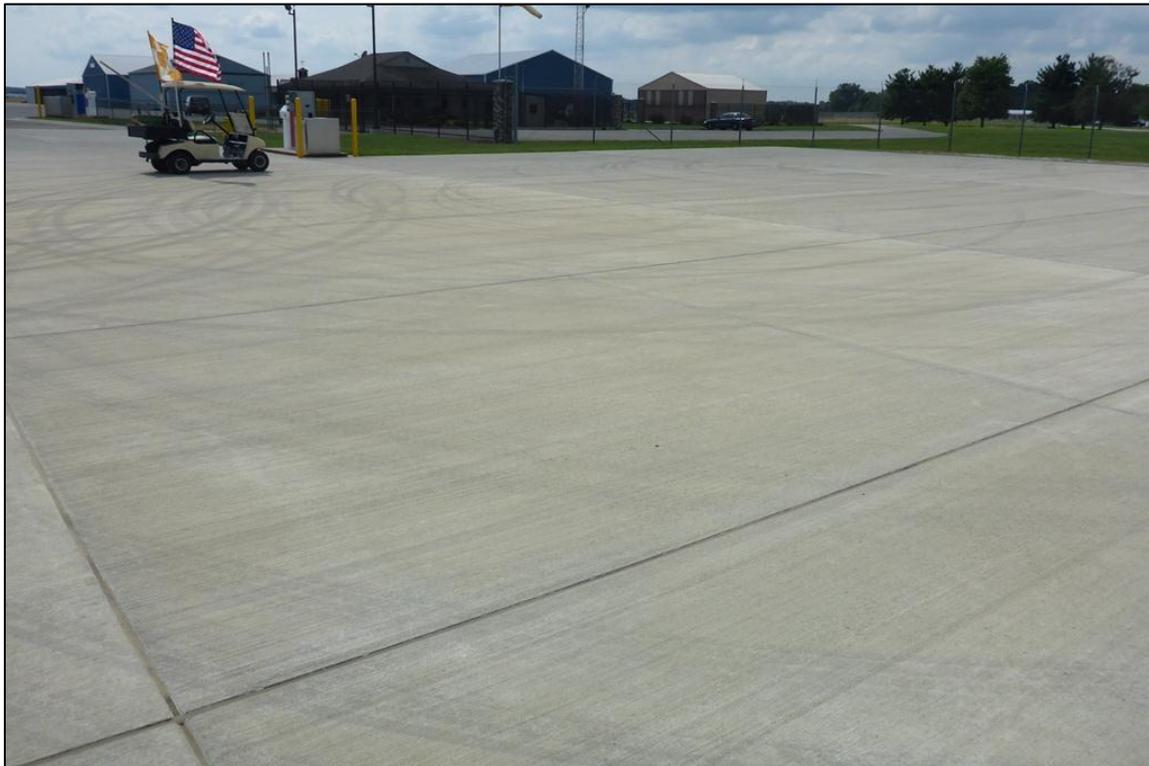
Figure 2-3. Typical PCC Pavement in Good Condition (Feature 3035)

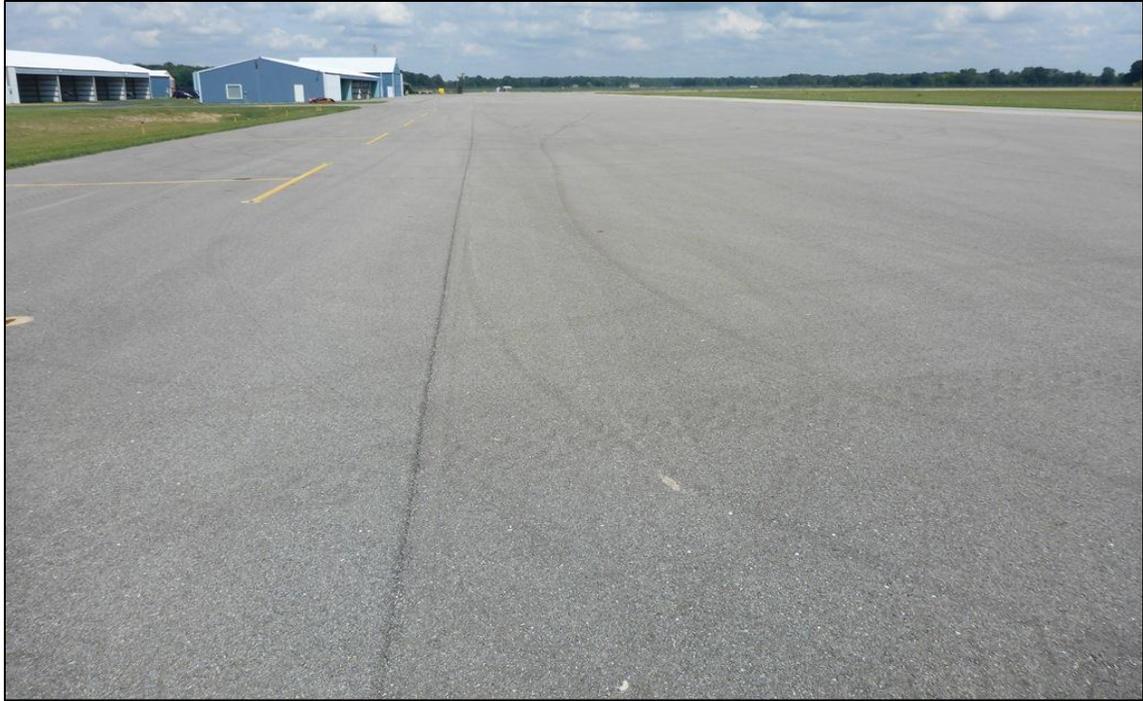
Figure 2-4. Typical AC Pavement in Good Condition (Feature 3030)

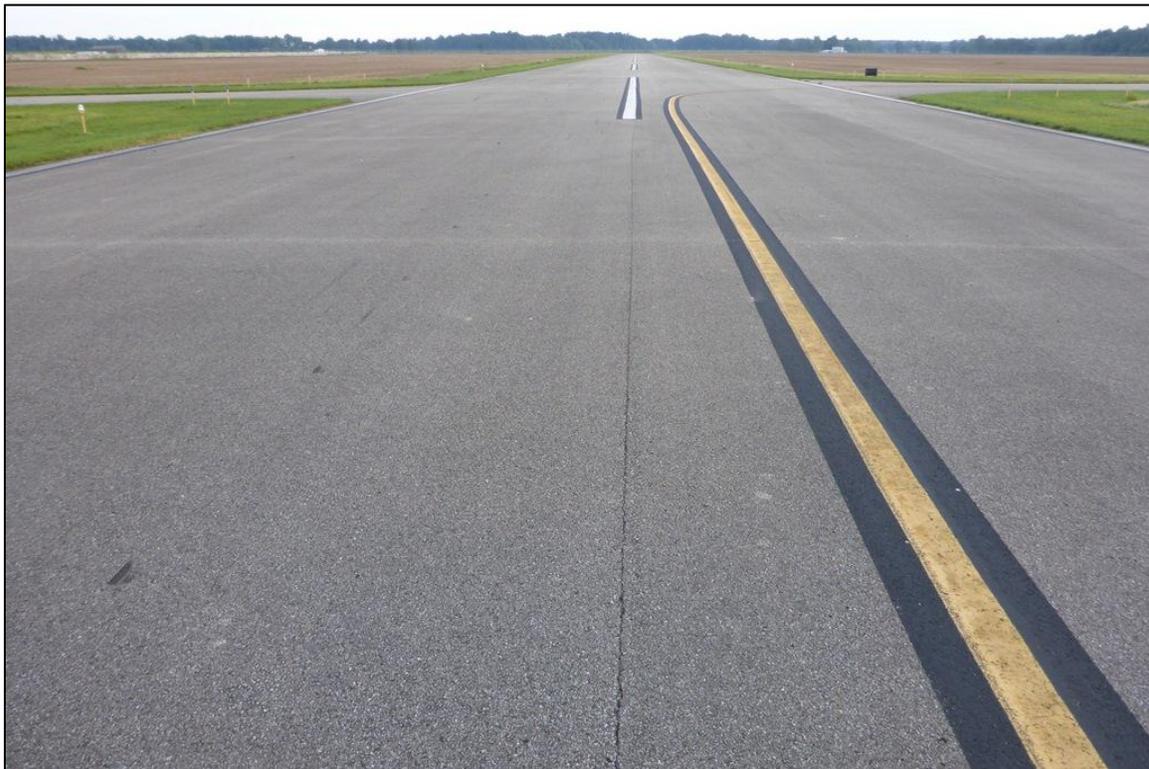
Figure 2-5. Typical AC Pavement in Good Condition (Feature 6010)
