PLAN

TREATMENT

May 18, 2009

Subject: BSHCT Recommendation on Grocers Ice and Cold Storage Company Building Treatment Plan

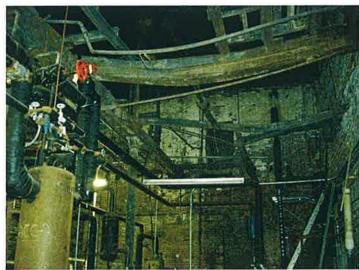
To the north and east of Cooler E are two rooms that contain refrigeration equipment to maintain the cooler temperatures and for the ice tanks. It is unclear which equipment still functions. In Room A, an upper level catwalk system and stairs to connect the two levels (identified on 1952 drawings) are no longer extant. This room has a concrete floor and steel beams

Mechanical Room A

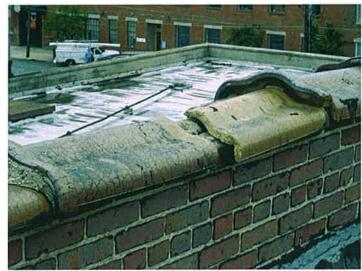
Clay Tile Coping Deterioration

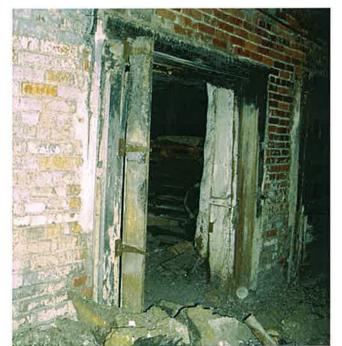
The 1991 fire destroyed two elevators and stairways that provided access to upper levels. Therefore a large portion of the building square footage is currently not accessible for any use and can only be reached by climbing ladders and traversing roofs. New stairs and elevators would be required to restore access to these spaces.

Fire Damage at Cooler G, Third Floor

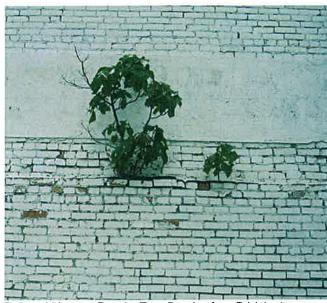
The building's brick masonry and clay tile coping have suffered severe deterioration. There are large areas of spalled brick at all facades caused by water infiltration. Much of this water may be coming from large sections of wall that do not have any coping or have deteriorated coping - allowing precipitation to enter into walls from the top. The walls are in need of tuck-pointing. The deteriorated wall joints allow water to infiltrate into areas of the walls. There are major cracks and coursing shifts caused by settlement. The team also observed several masonry openings that did not have lintels to support the masonry above.

Deferred Masonry Repair - Tree Growing from Brick Ledge

Improvements should include the removal of all non-functioning/non-essential equipment from within all remaining spaces and on the roofs. Repair of all remaining exposed masonry to include tuck-pointing, the replacement of cracked or spalled brick and the installation of proper lintels at openings, installation of new roof membranes, updates to refrigeration equipment in all levels of Cooler E and the upper levels of Cooler F, and upgrades to electrical systems to power the newer refrigeration equipment, lighting and office equipment.
