November 3, 2014

ROOT CAUSE ANALYSIS REPORT

Downtown Underground Network Event on August 13, 2014

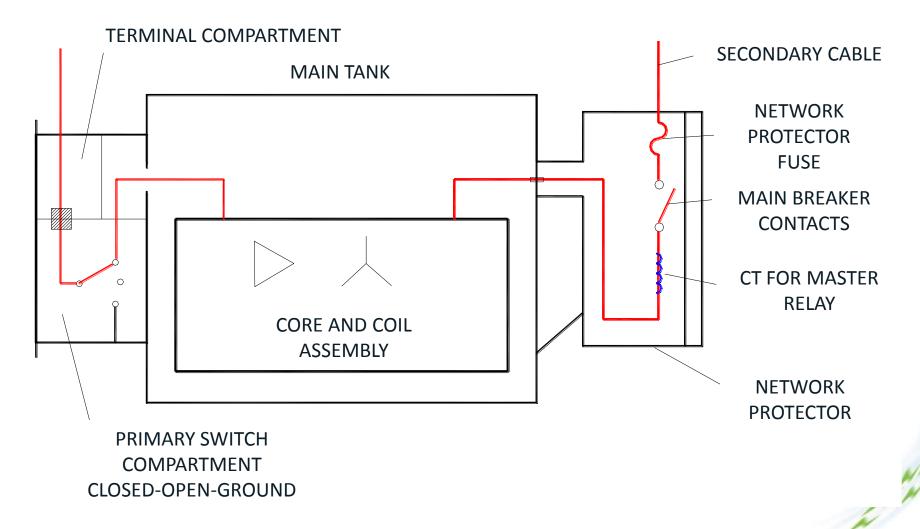
IPL'S ROOT CAUSE ANALYSIS IDENTIFIED THE TWO POSSIBLE EVENT SCENARIOS

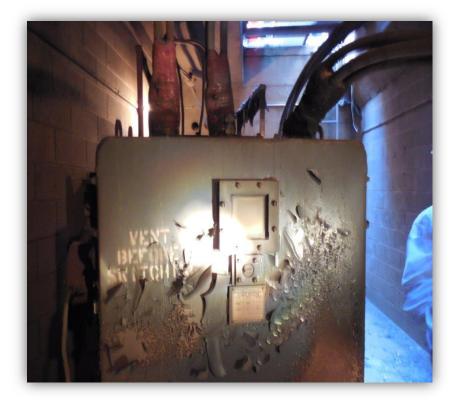
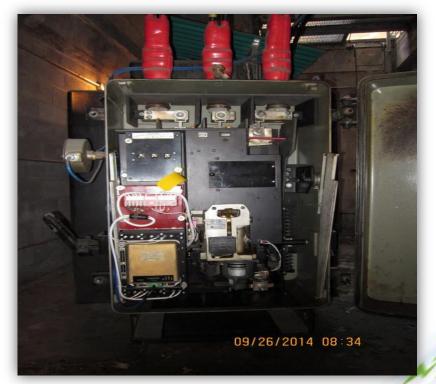
THE EVENT WAS COMPLETELY CONTAINED IN THE NETWORK PROTECTOR

- The Network Protector door remained closed which reduced damage to other vault equipment

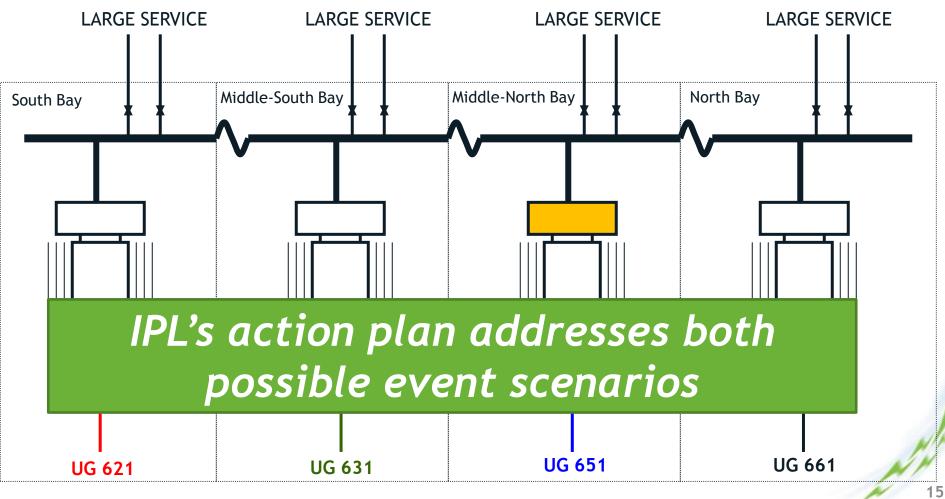
26 S Meridian Street 480-Volt Spot Network Vault

IPL'S ROOT CAUSE ANALYSIS IDENTIFIED THE TWO POSSIBLE EVENT SCENARIOS
