# HAZARDOUS AND REGULATED MATERIALS INSPECTION REPORT

Gordon's Annex  
810 Massachusetts Street  
Parcel ID: 45-08-03-355-005  
Gary, 46402

Northwest Indiana Regional Development Authority  
9800 Connecticut Drive  
Crown Point, Indiana 46307  
Client Reference: Gary Blight Elimination Program

Egis  
48797 Alpha Drive, Suite 130  
Wixom, MI 48393  
Egis Project ID: 240100  
April 22, 2025

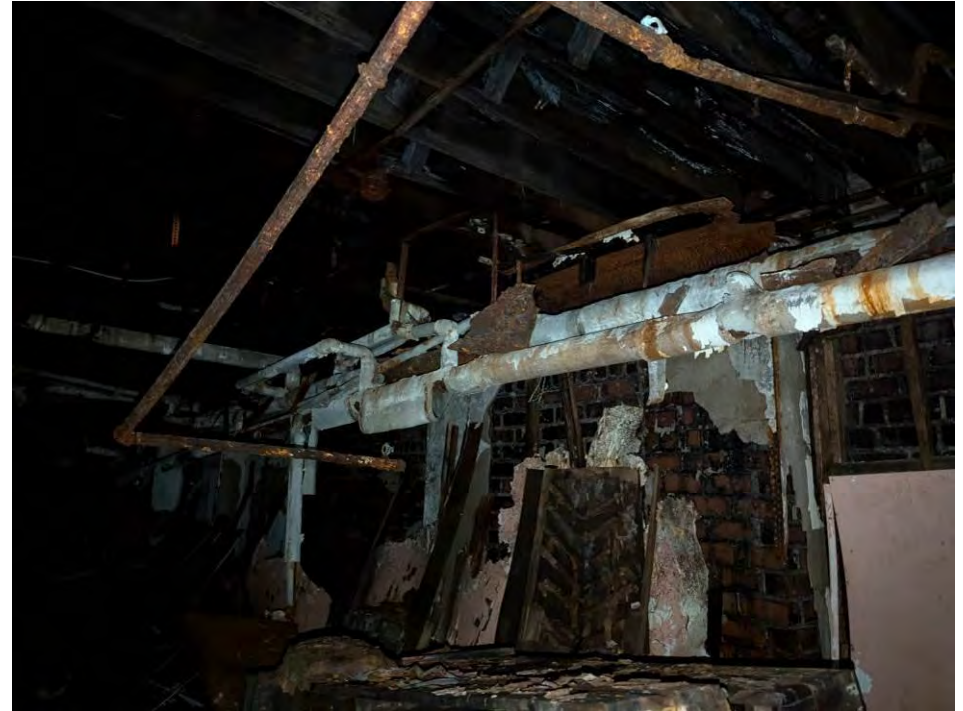
DATE: September 23, 2024  
LOCATION: 801-811 Broadway Street in Gary, Indiana  
SUBJECT: View of damaged TSI pipe wrap and mudded joints  
PHOTOGRAPHER: Ryan M. Orzechowicz (Heartland)  
PHOTO: 42

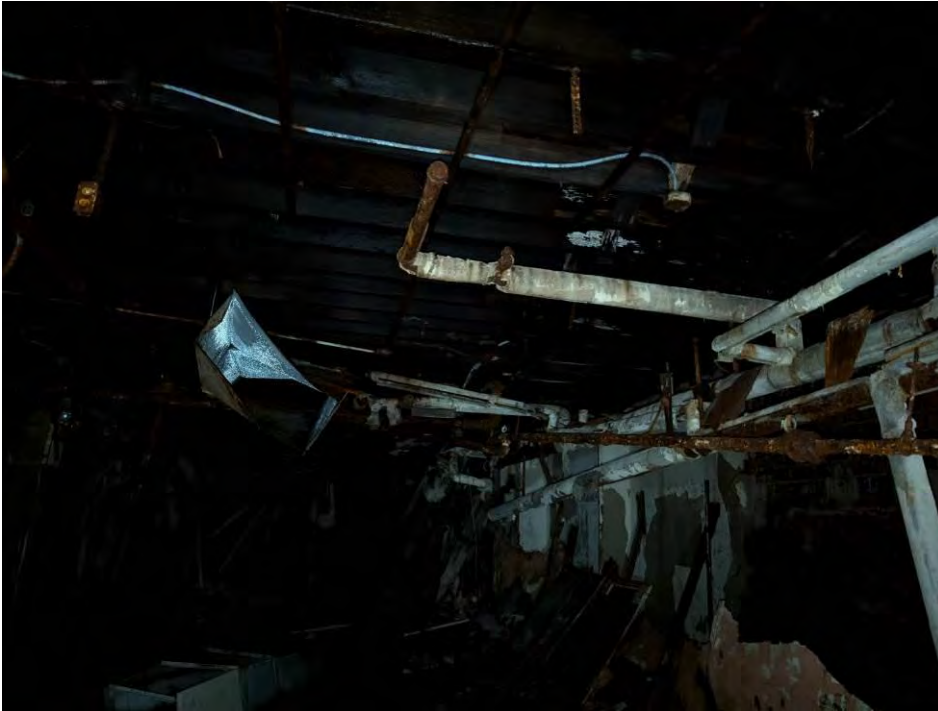
DATE: September 23, 2024  
LOCATION: 801-811 Broadway Street in Gary, Indiana  
SUBJECT: View of damaged TSI pipe wrap and mudded joints  
PHOTOGRAPHER: Ryan M. Orzechowicz (Heartland)  
PHOTO: 43

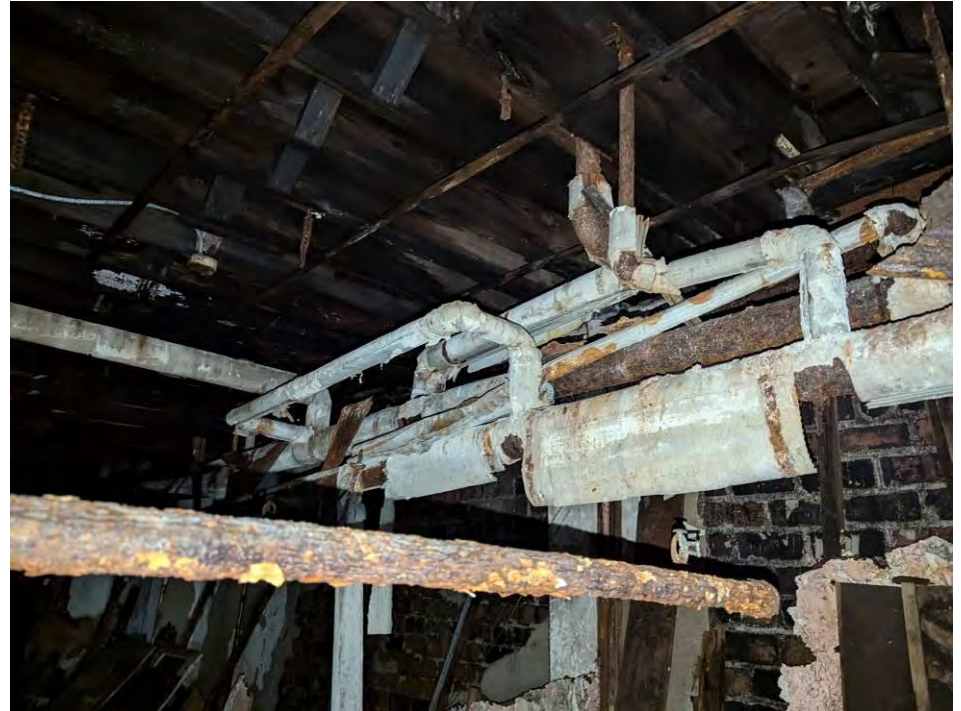
DATE: September 23, 2024  
LOCATION: 801-811 Broadway Street in Gary, Indiana  
SUBJECT: View of damaged TSI pipe wrap and mudded joints  
PHOTOGRAPHER: Ryan M. Orzechowicz (Heartland)  
PHOTO: 44

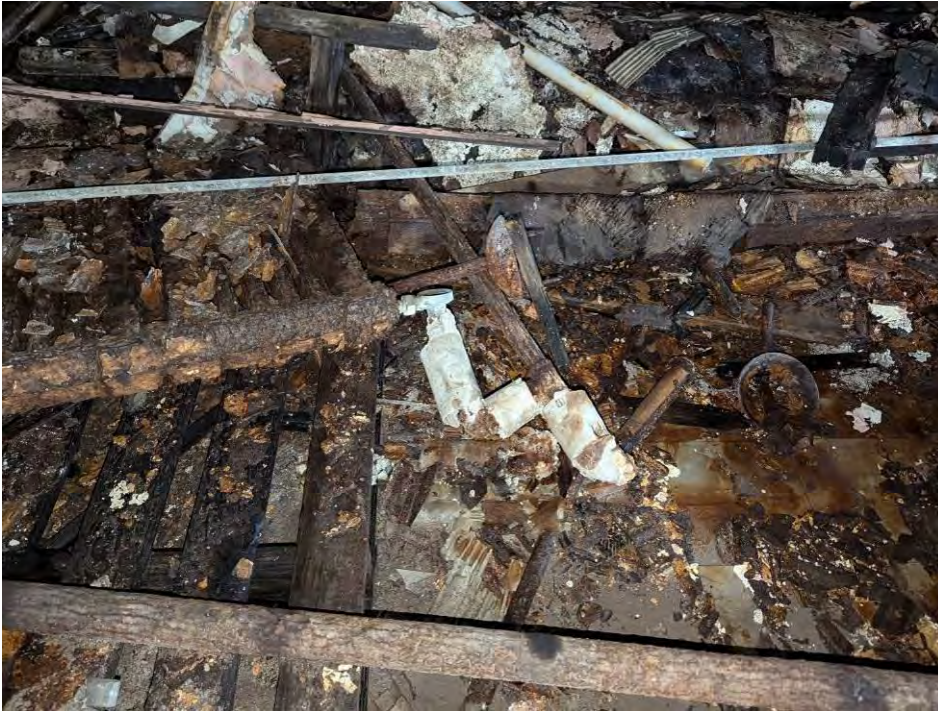
DATE: September 23, 2024  
LOCATION: 801-811 Broadway Street in Gary, Indiana  
SUBJECT: View of damaged TSI pipe wrap on floor as debris  
PHOTOGRAPHER: Ryan M. Orzechowicz (Heartland)  
PHOTO: 45

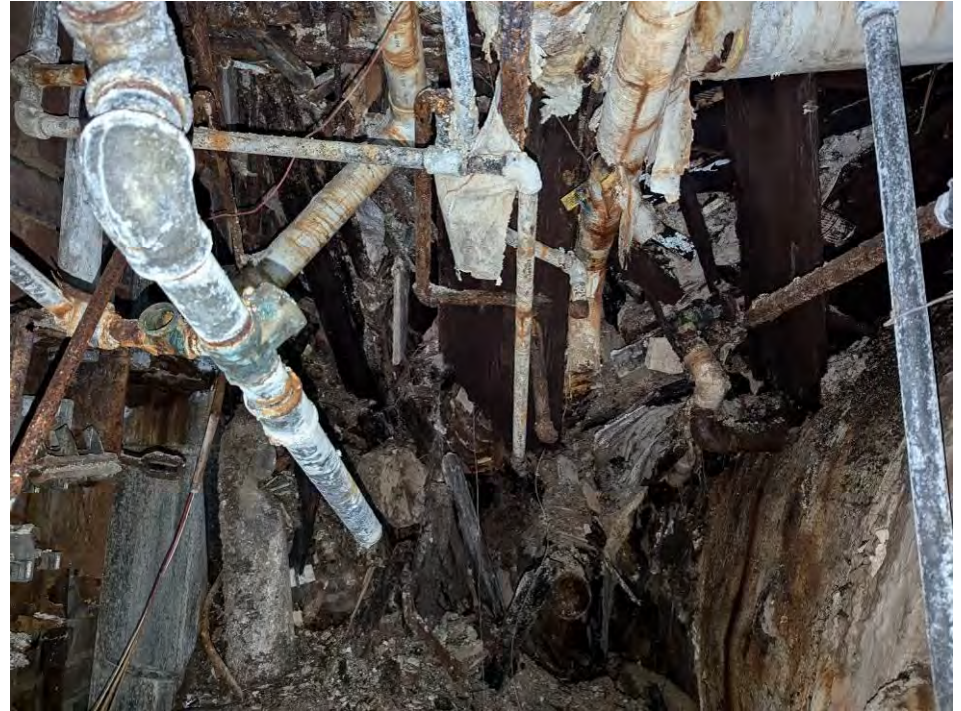
DATE: September 23, 2024  
LOCATION: 801-811 Broadway Street in Gary, Indiana  
SUBJECT: View of damaged TSI pipe wrap and mudded joints  
PHOTOGRAPHER: Ryan M. Orzechowicz (Heartland)  
PHOTO: 46

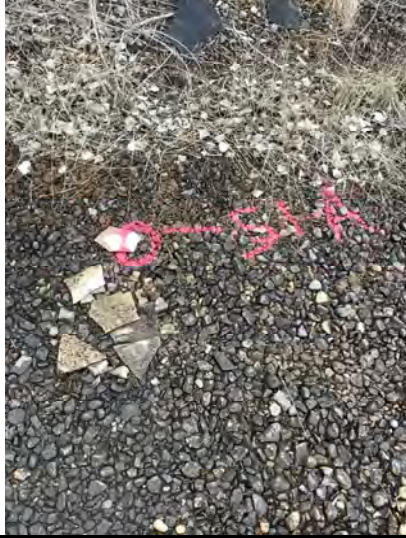
<p>Sample # 51</p>	<p>Transite - Debris found</p>

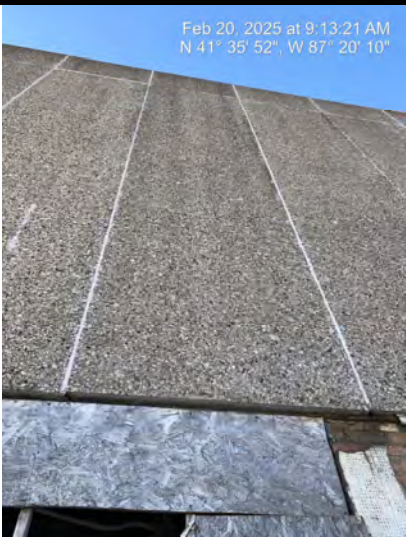
<p>Assumed Material # A-1</p>	<p>Exterior Caulk - on concrete panel siding</p>
