# HAZARDOUS AND REGULATED MATERIALS INSPECTION REPORT

Former H. Gordon & Sons Department Store  
813 Broadway  
Parcel ID: 45-08-03-355-002  
Gray, IN 46402

Egis  
48797 Alpha Drive, Suite 130  
Wixom, MI 48393  
Egis Project ID: 240100  
April 22, 2025

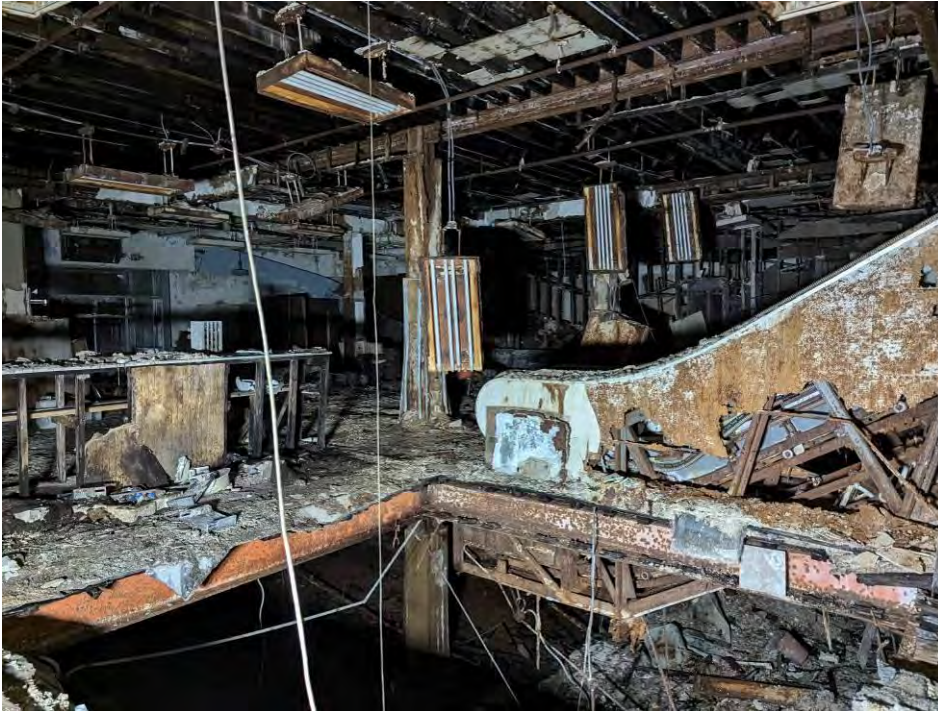
DATE: September 23, 2024  
LOCATION: 801-811 Broadway Street in Gary, Indiana  
SUBJECT: View of collapsed floor  
PHOTOGRAPHER: Ryan M. Orzechowicz (Heartland)  
PHOTO: 9

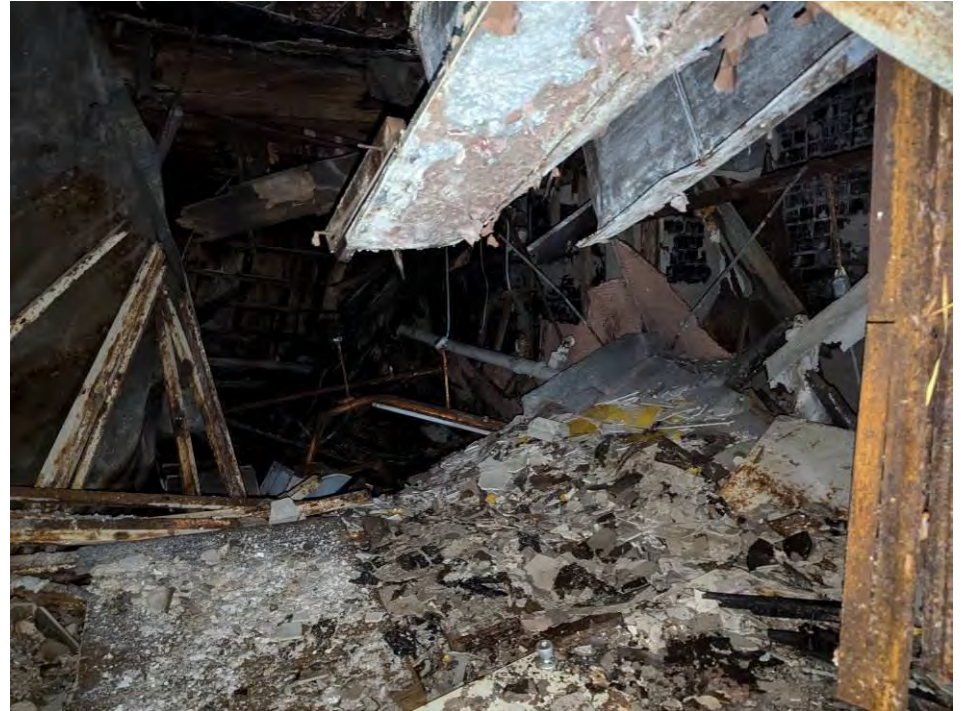
DATE: September 23, 2024  
LOCATION: 801-811 Broadway Street in Gary, Indiana  
SUBJECT: View of collapsed floor and ceiling  
PHOTOGRAPHER: Ryan M. Orzechowicz (Heartland)  
PHOTO: 10

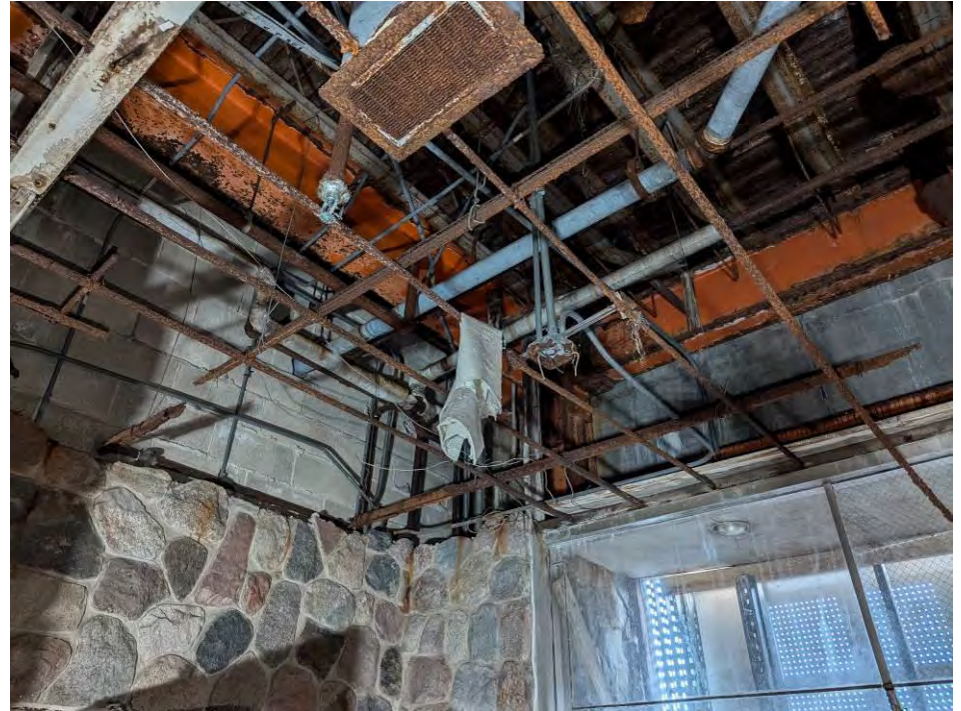
DATE: September 23, 2024  
LOCATION: 801-811 Broadway Street in Gary, Indiana  
SUBJECT: View of sampled TSI pipe wrap (PW-1)  
PHOTOGRAPHER: Ryan M. Orzechowicz (Heartland)  
PHOTO: 28

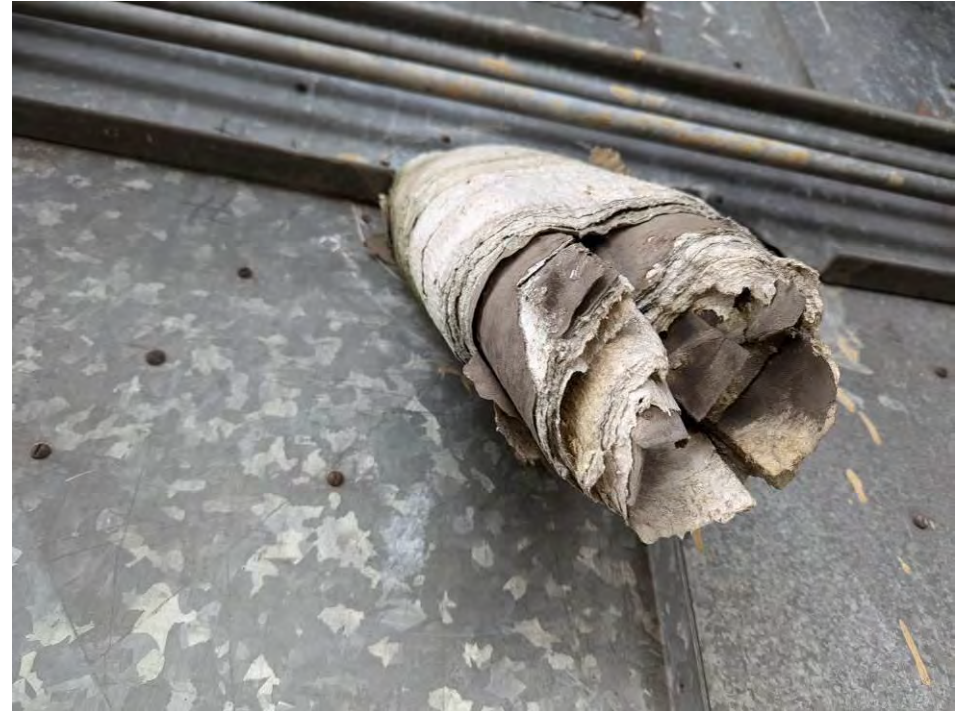
DATE: September 23, 2024  
LOCATION: 801-811 Broadway Street in Gary, Indiana  
SUBJECT: View of damaged TSI pipe wrap  
PHOTOGRAPHER: Ryan M. Orzechowicz (Heartland)  
PHOTO: 32

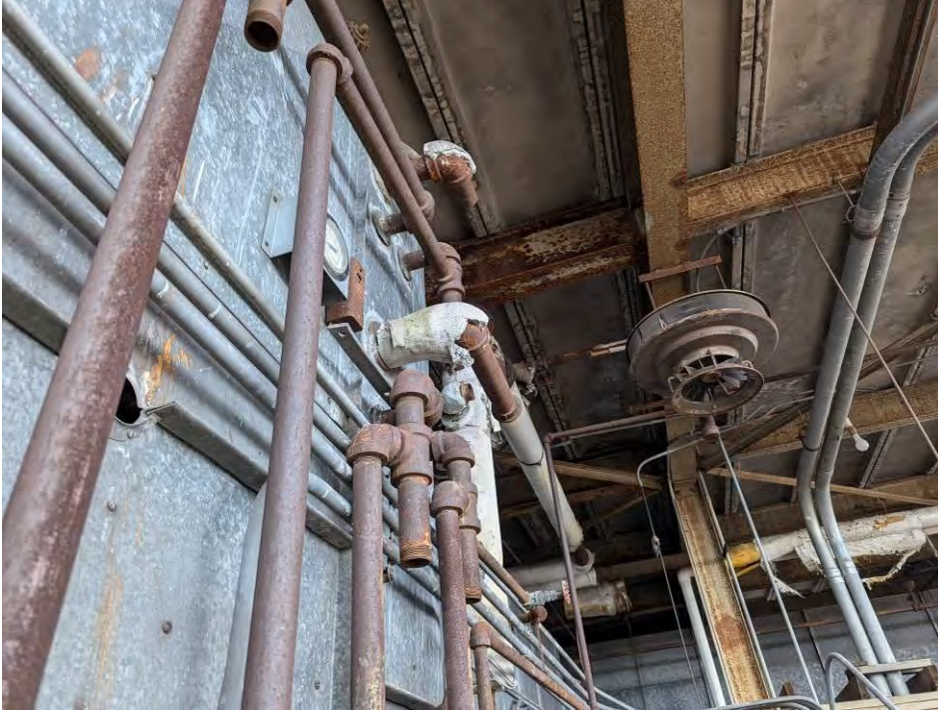
DATE: September 23, 2024  
LOCATION: 801-811 Broadway Street in Gary, Indiana  
SUBJECT: View of damaged TSI mudded joint  
PHOTOGRAPHER: Ryan M. Orzechowicz (Heartland)  
PHOTO: 33

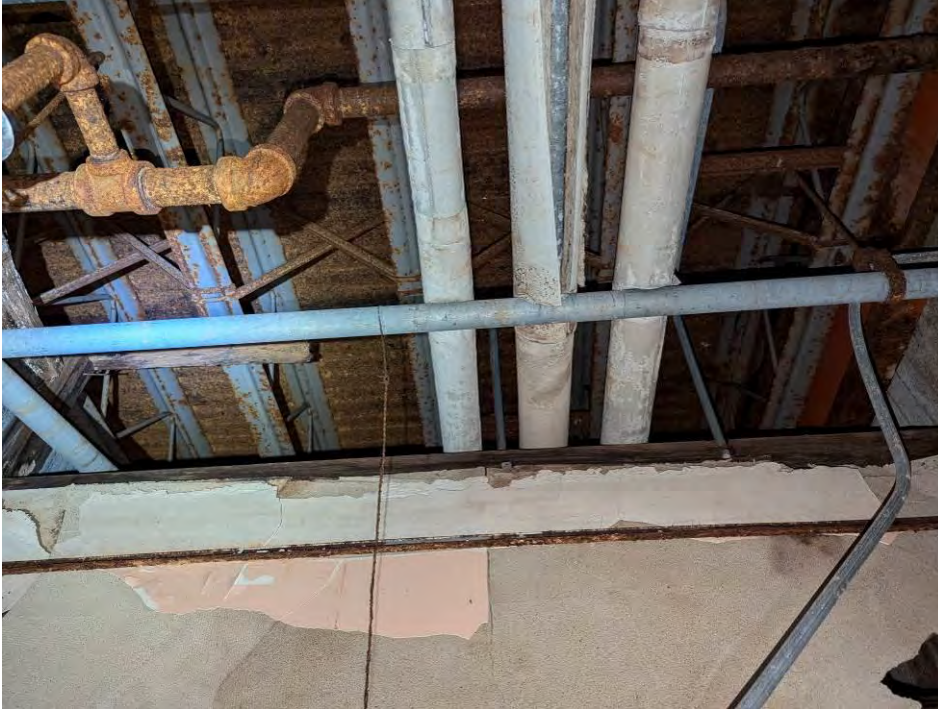
DATE: September 23, 2024  
LOCATION: 801-811 Broadway Street in Gary, Indiana  
SUBJECT: View of damaged TSI pipe wrap  
PHOTOGRAPHER: Ryan M. Orzechowicz (Heartland)  
PHOTO: 35

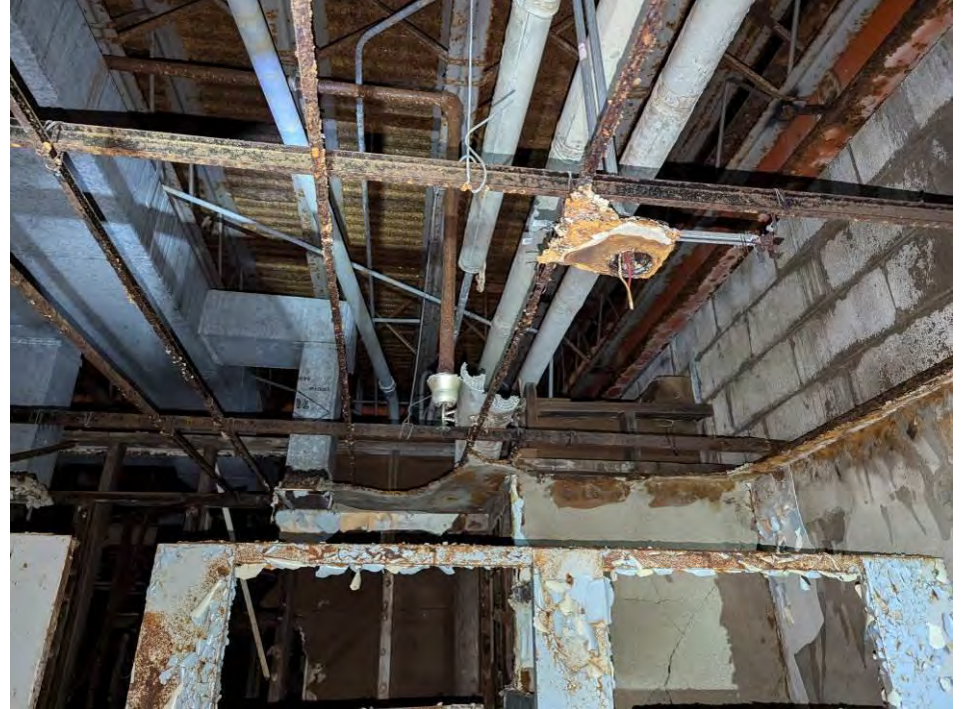
DATE: September 23, 2024  
LOCATION: 801-811 Broadway Street in Gary, Indiana  
SUBJECT: View of damaged TSI pipe wrap  
PHOTOGRAPHER: Ryan M. Orzechowicz (Heartland)  
PHOTO: 36

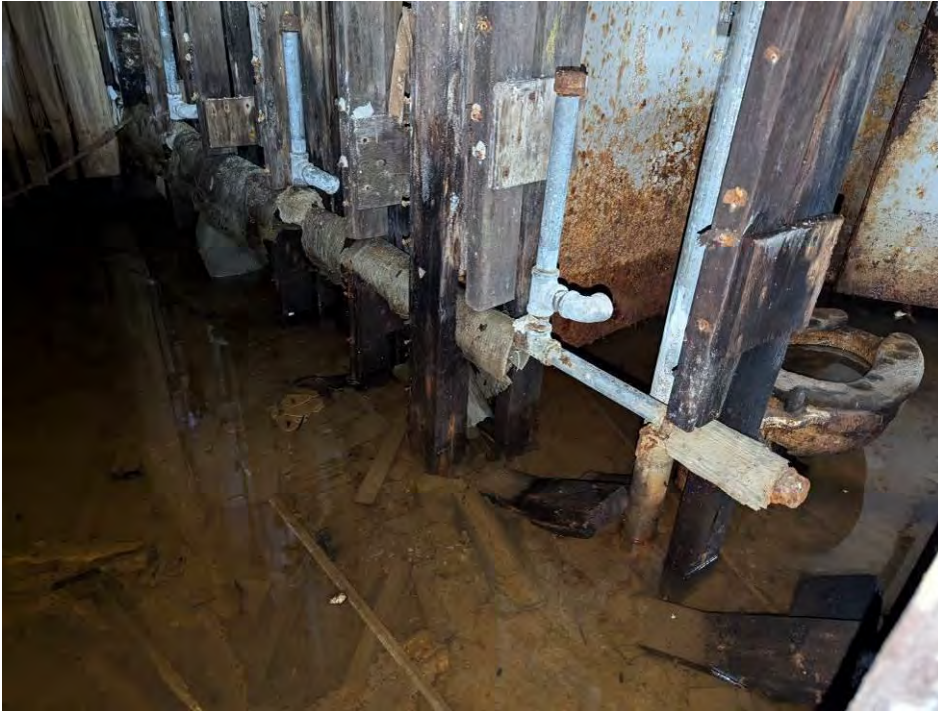
DATE: September 23, 2024  
LOCATION: 801-811 Broadway Street in Gary, Indiana  
SUBJECT: View of damaged TSI pipe wrap  
PHOTOGRAPHER: Ryan M. Orzechowicz (Heartland)  
PHOTO: 37

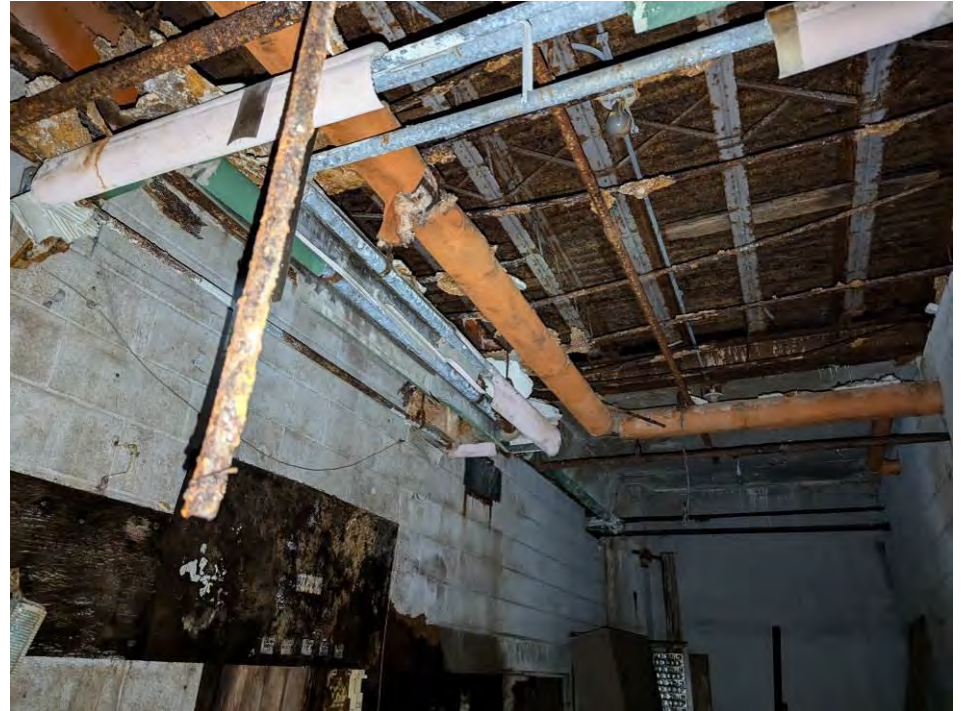
DATE: September 23, 2024  
LOCATION: 801-811 Broadway Street in Gary, Indiana  
SUBJECT: View of damaged TSI pipe wrap  
PHOTOGRAPHER: Ryan M. Orzechowicz (Heartland)  
PHOTO: 38

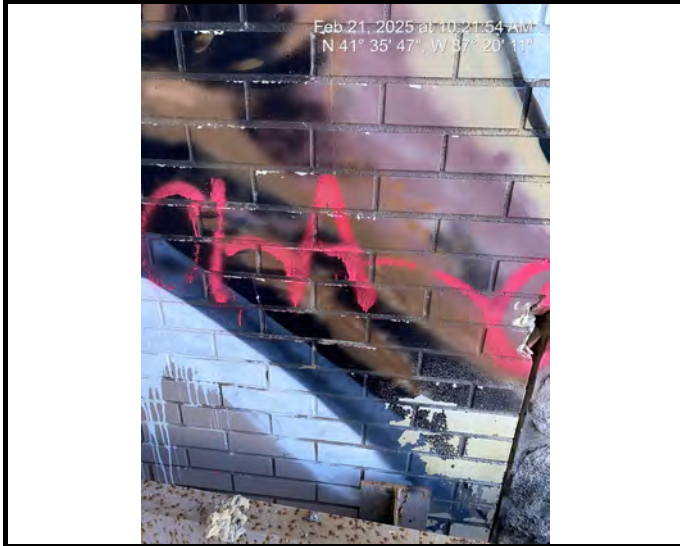
Sample # 1 Brick Mortar - Exterior glazed brick with mortar

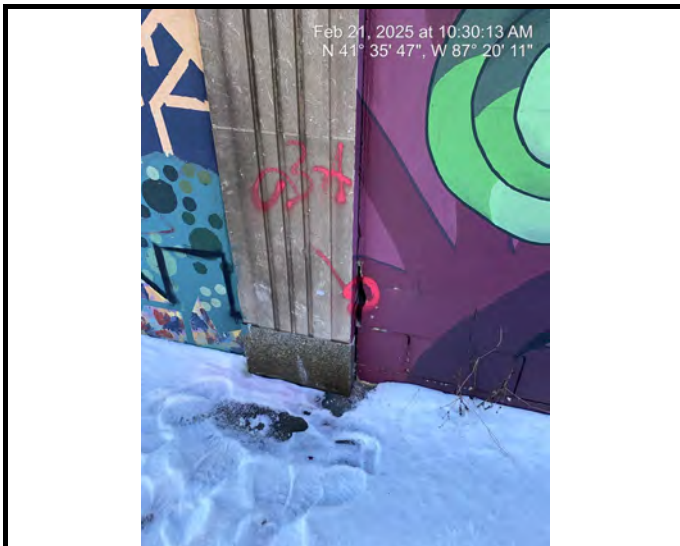
Sample # 3 Block Mortar - Exterior cinder block & mortar
