Indiana Classified Forest & Wildlands Forestry Best Management Practices Monitoring Results 1996-2020

1996 through 2020

Indiana Classified Forest and Wildlands BMP Report

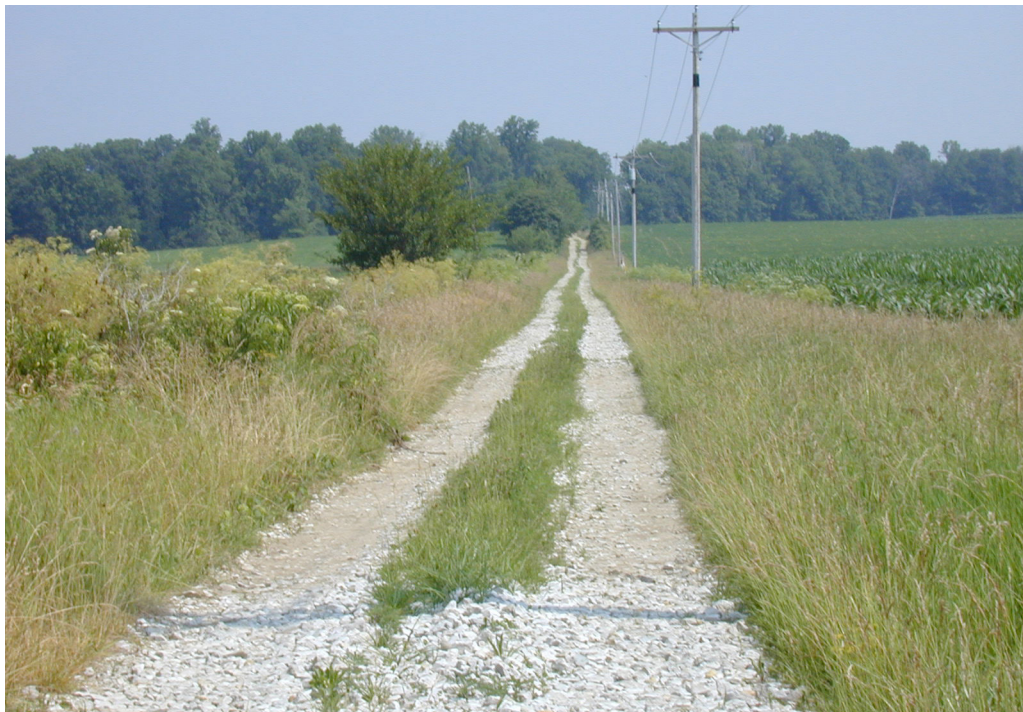
Stable graveled access road.

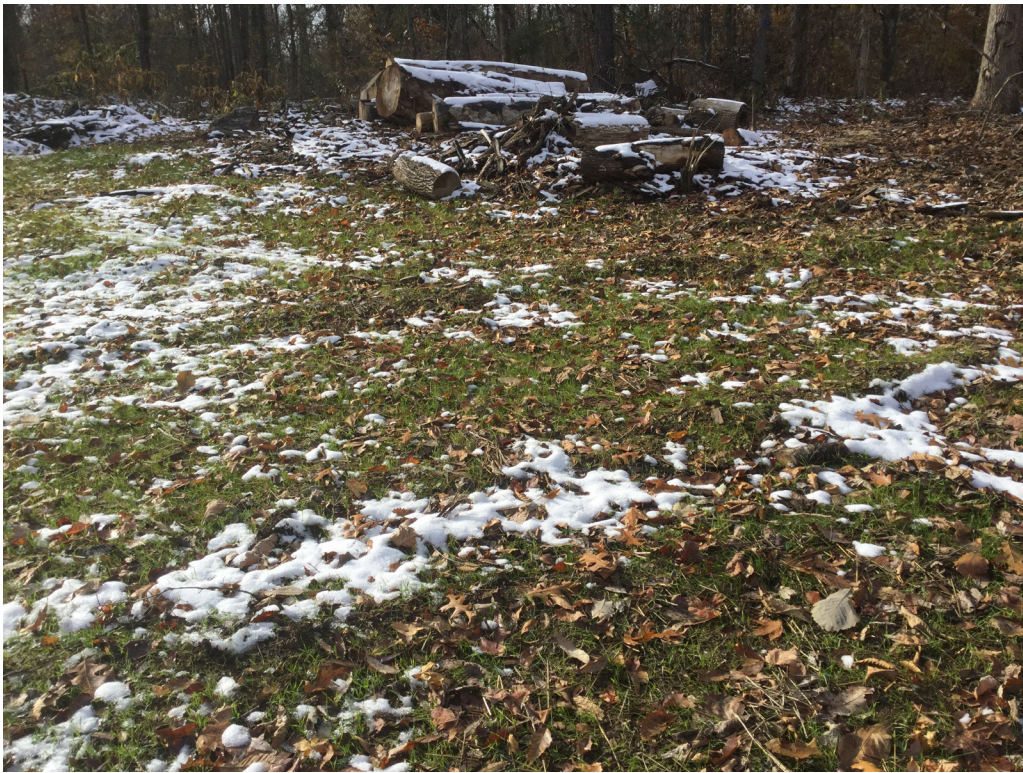
Log landing was properly closed out, smoothed and seeded in the fall. The resulting grass has protected the landing during the winter.

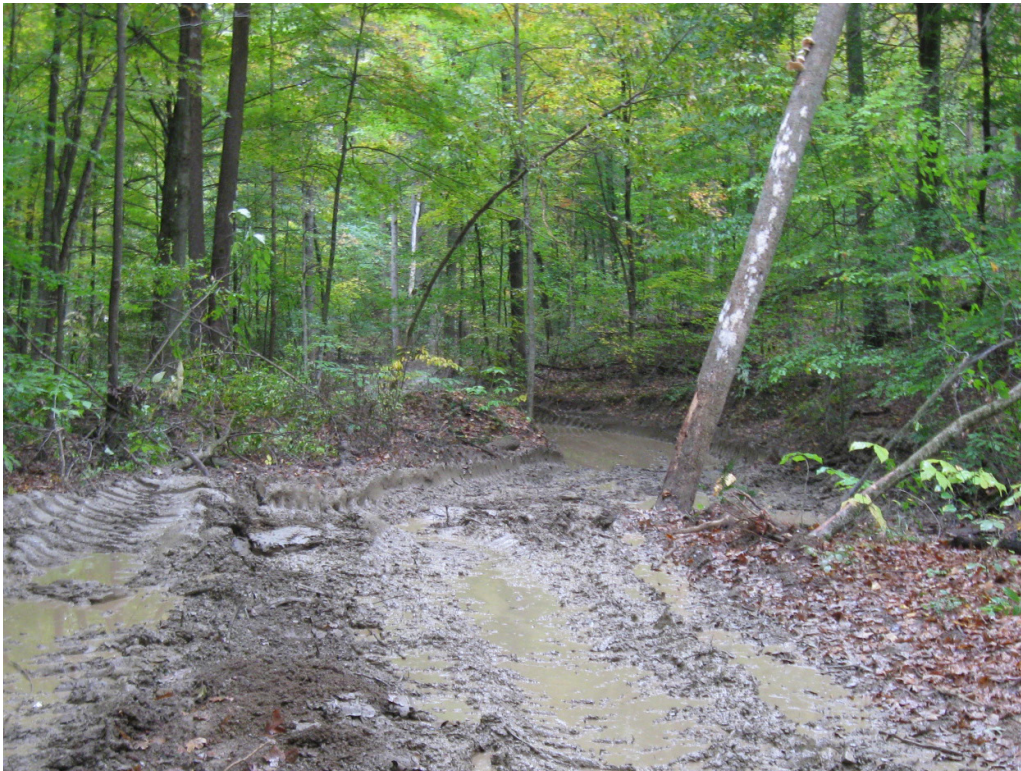
Harvesting during wet conditions can create deep rutting.

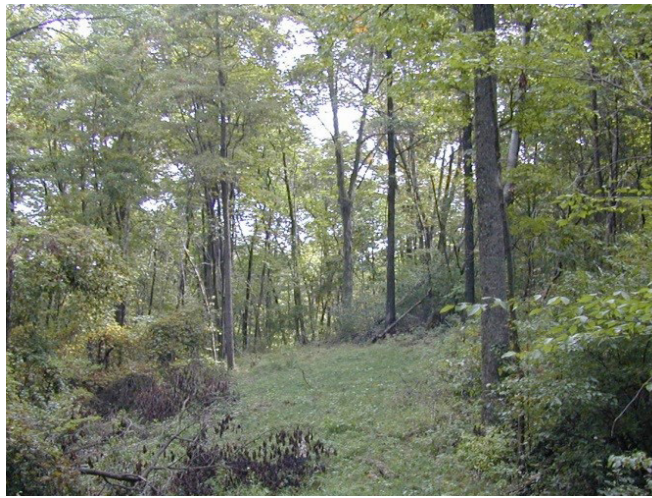
The combination of great revegetation and the construction of this trail on the contour has allowed the water to run off of the trail and keep it stable.

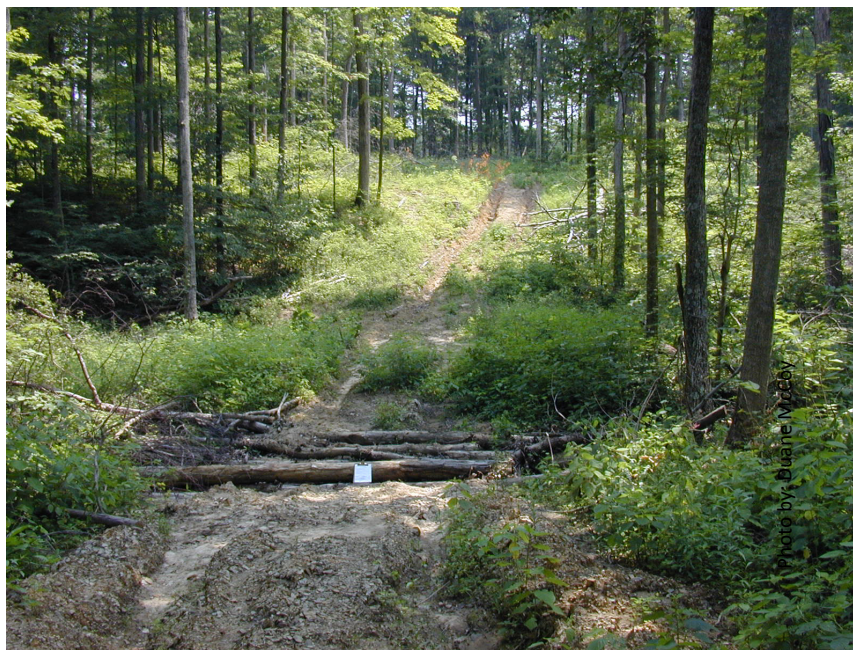
There are multiple issues on this skid trail and stream crossing. Logs used as corduroy to cross stream were not removed after the harvest was closed out, and there are no diversions on the skid trail coming down the hill. Lack of diversions and rutting are ensuring that all runoff is being funneled right into the stream.

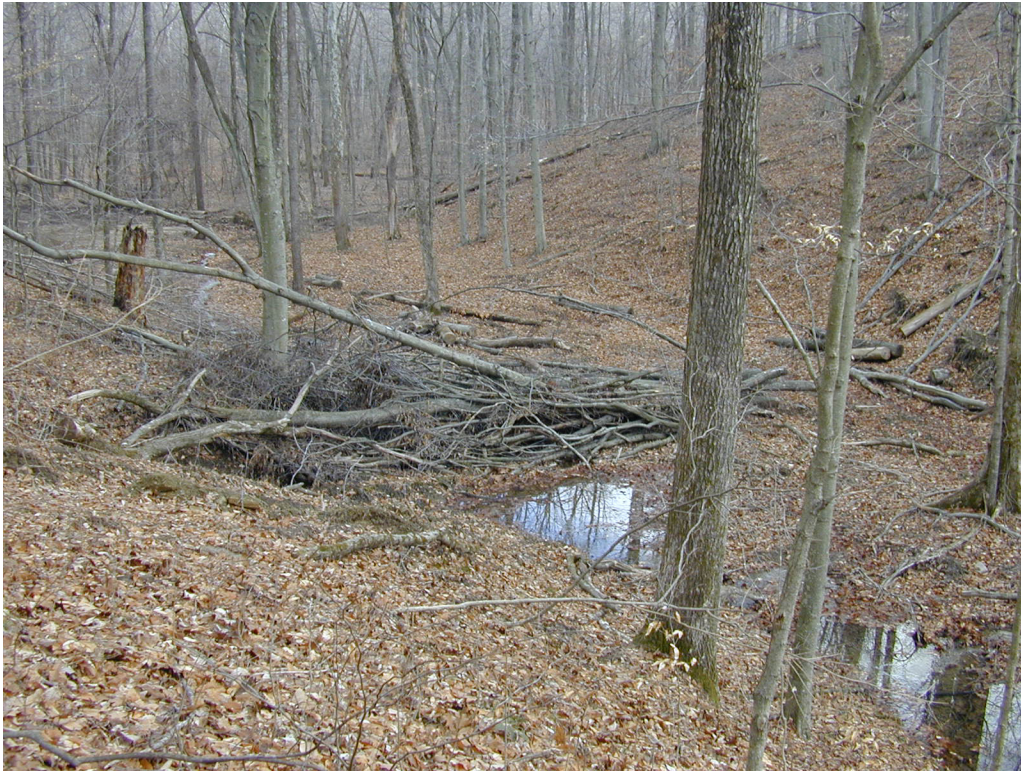
Harvest debris left in a stream, causing additional debris build up and blockage of flow.

Obstructing debris logging in streams (Z2) has a score of 61.2% application and 62.9% effectiveness. For RMZs “free of roads and landings” (Z7) with a 61.8% implementation rate, effectiveness was 80.2%. Water was not commonly diverted before entering RMZ (Z8), with application of 59.7% and effectiveness of 68.9%. When water was diverted, it was not always diverted onto stable areas of the forest floor (Z9); this process had 69.0% application and 73.9% effectiveness. Ephemeral channels were not always free of excavated materials (Z11) with a 71.6% application rate and 72.4% effectiveness rate.

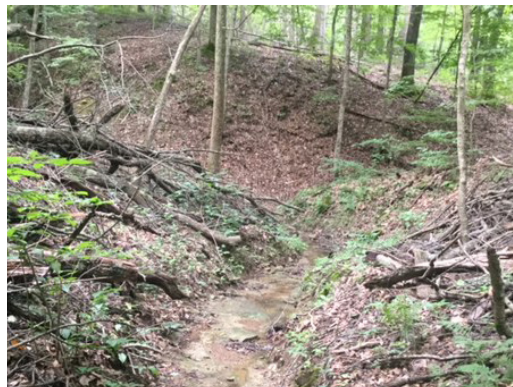
Great marking and removal of harvest debris from small streambed.

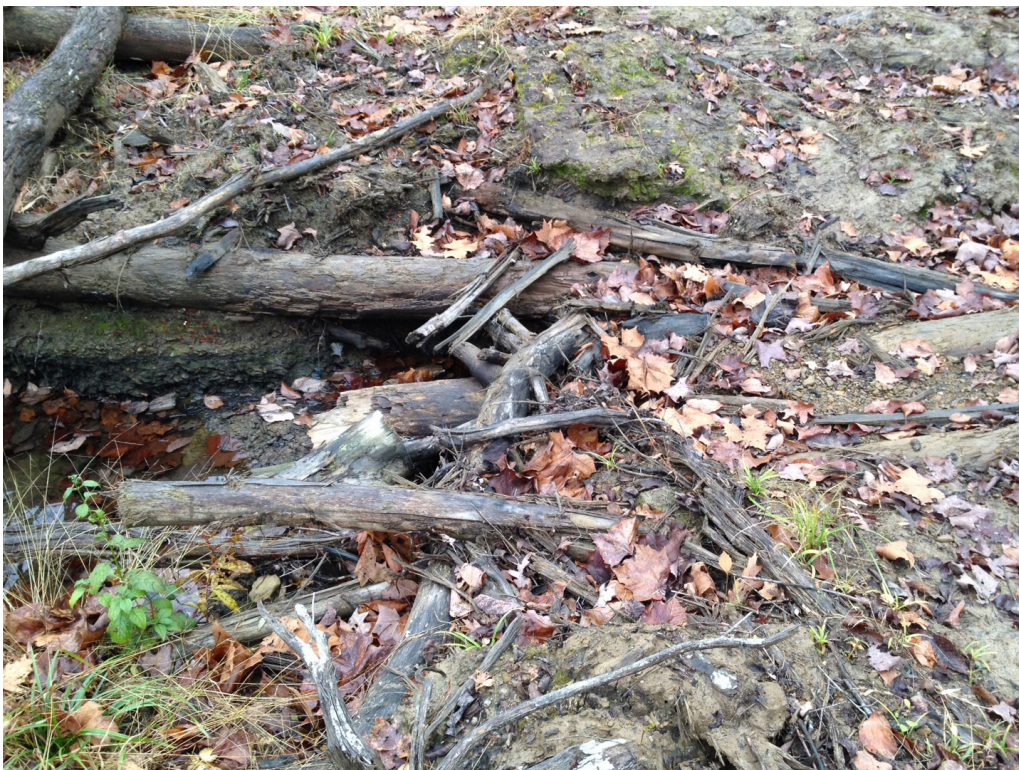
Logging debris in a stream can obstruct stream flow, leading to stream bank erosion. This occurs 19% more on private lands compared to state forest lands.

- Concentrate training, education, and implementation on areas where problems are most common, such as skid trails, RMZs and stream crossings.
- Continue to emphasize the importance of diverting water before it concentrates on roads, landings, and skid trails, and enters streams and RMZs. These types of BMPs were particularly challenging on private lands; therefore, continuing education for private-lands managers, owners and contractors is of distinct importance.
- The difference in removal of temporary structures from a stream crossing after a harvest (generally corduroy logs) is 19% lower for Classified Forest harvests than for harvests on State Forest sites. Importance of removal of these obstructions to stream flow needs to continue to be emphasized to landowners and loggers.
