VERA CRUZ BRIDGE FRACTURE CRITICAL REPORT
(Des. 2200460)

Bridge No. Vera Cruz Bridge over Wabash River (Str. 316-90-6418)

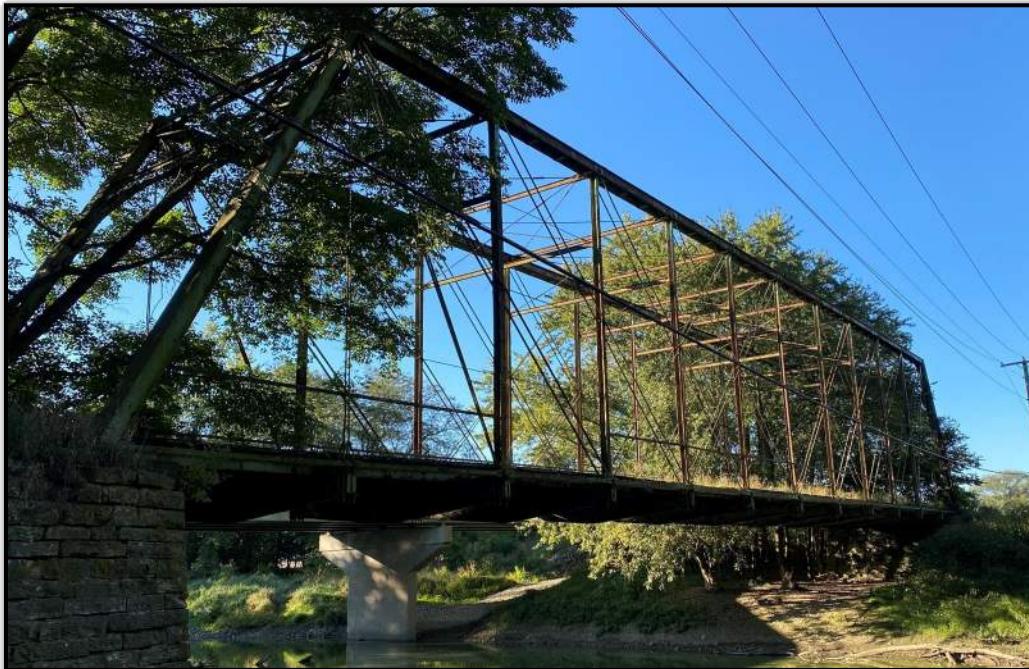
Prepared By:
HWC Engineering
135 N. Pennsylvania Street, Suite 2800
Indianapolis, IN 46204
Telephone: (317) 347-3663
www.hwcengineering.com

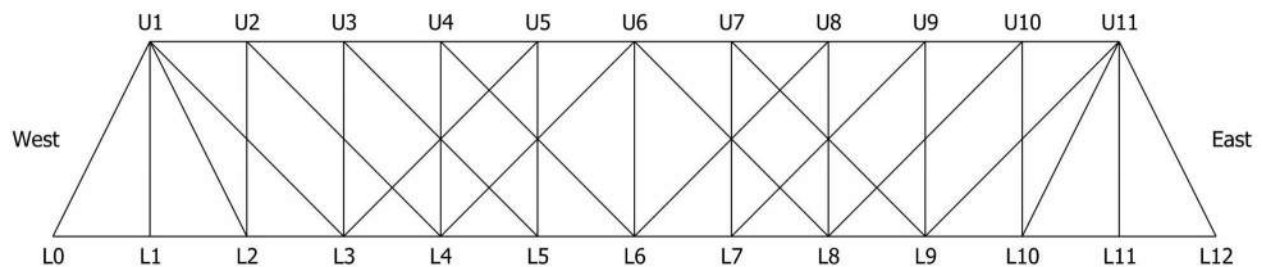
B. Bridge Cleaning Requirements

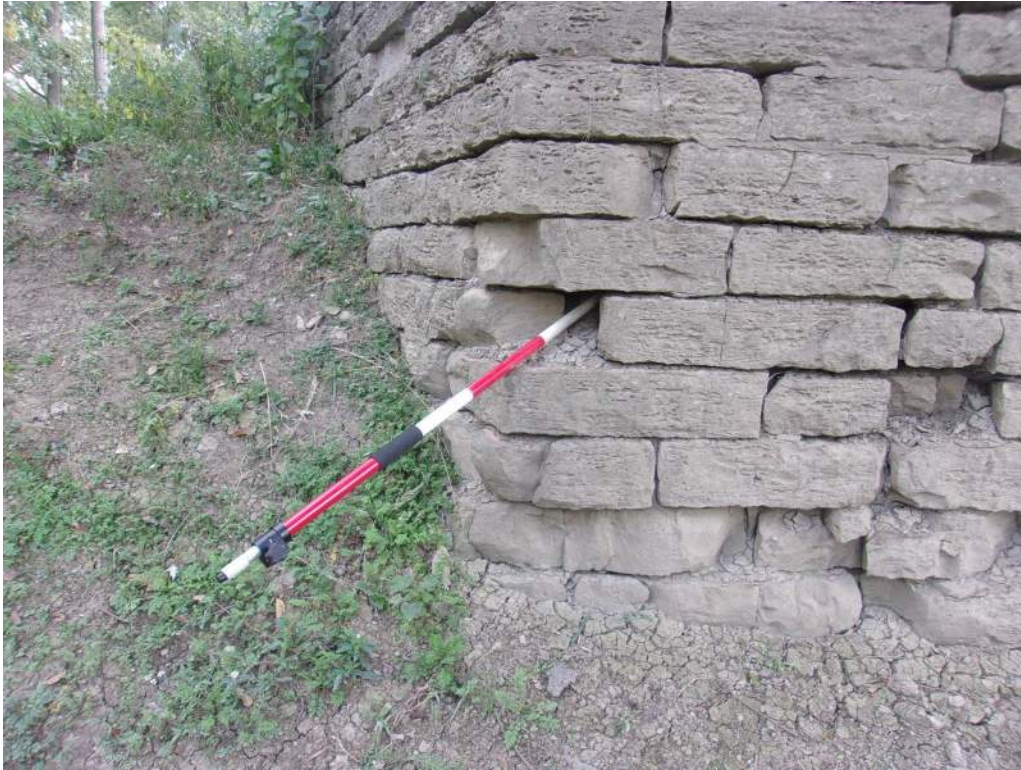
Photo 1: Missing Masonry Block; Section Loss on East Abutment, North Corner

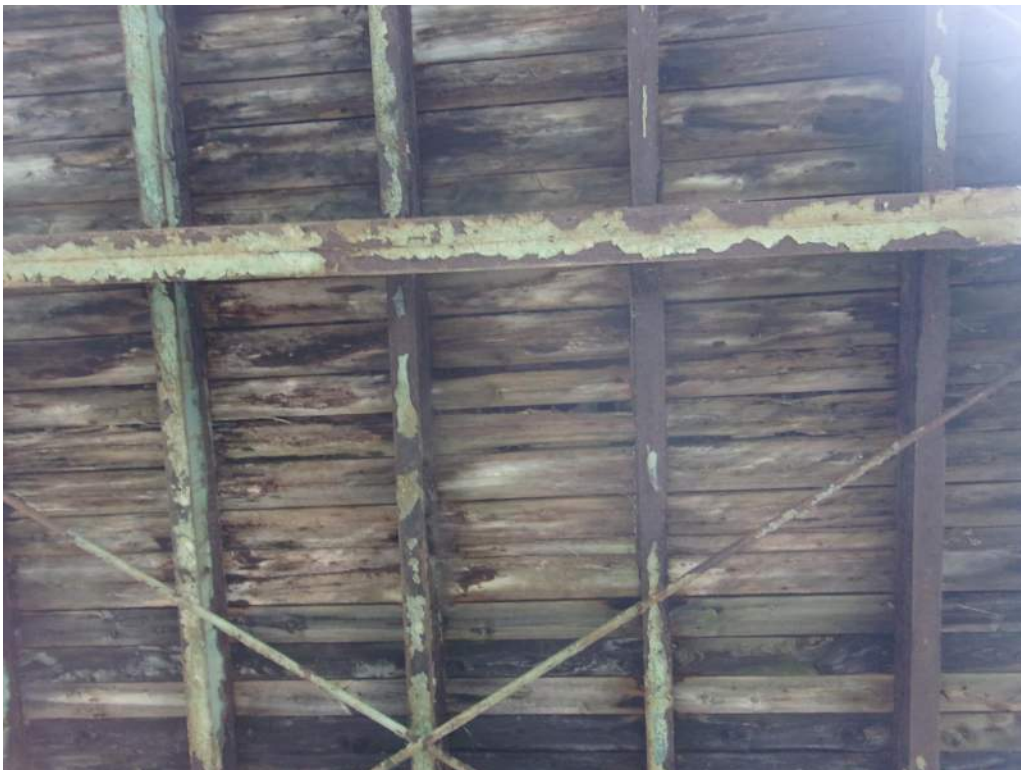
Photo 2: Timber Section Loss on underside of decking

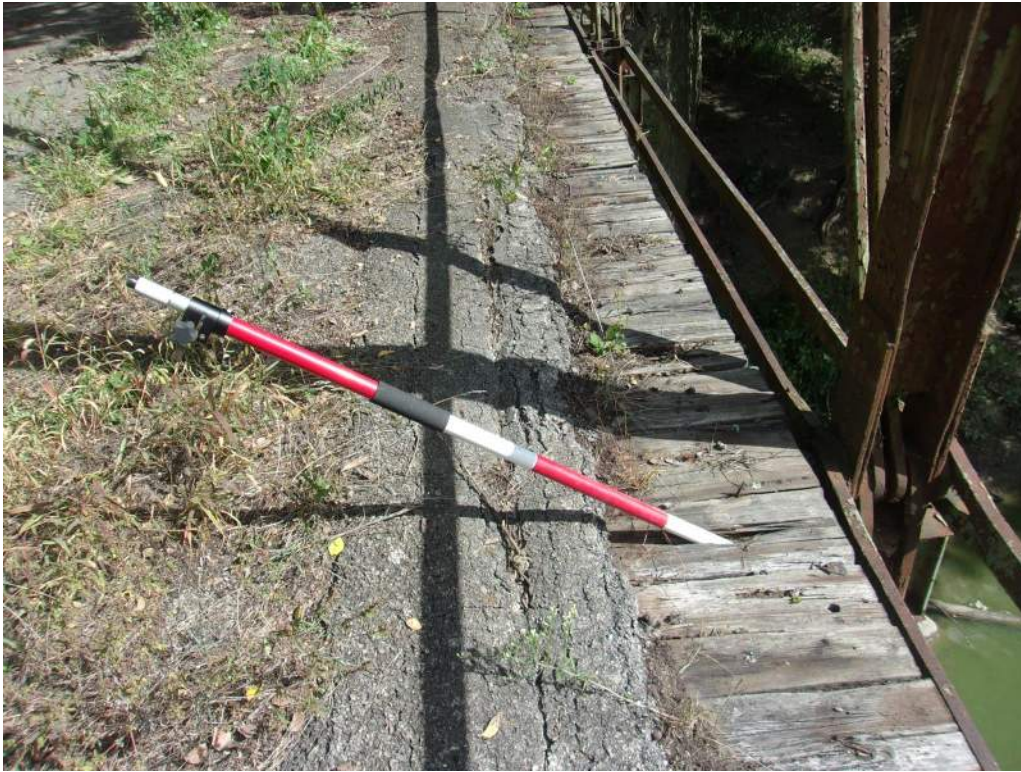
Photo 5: Damage in timber decking

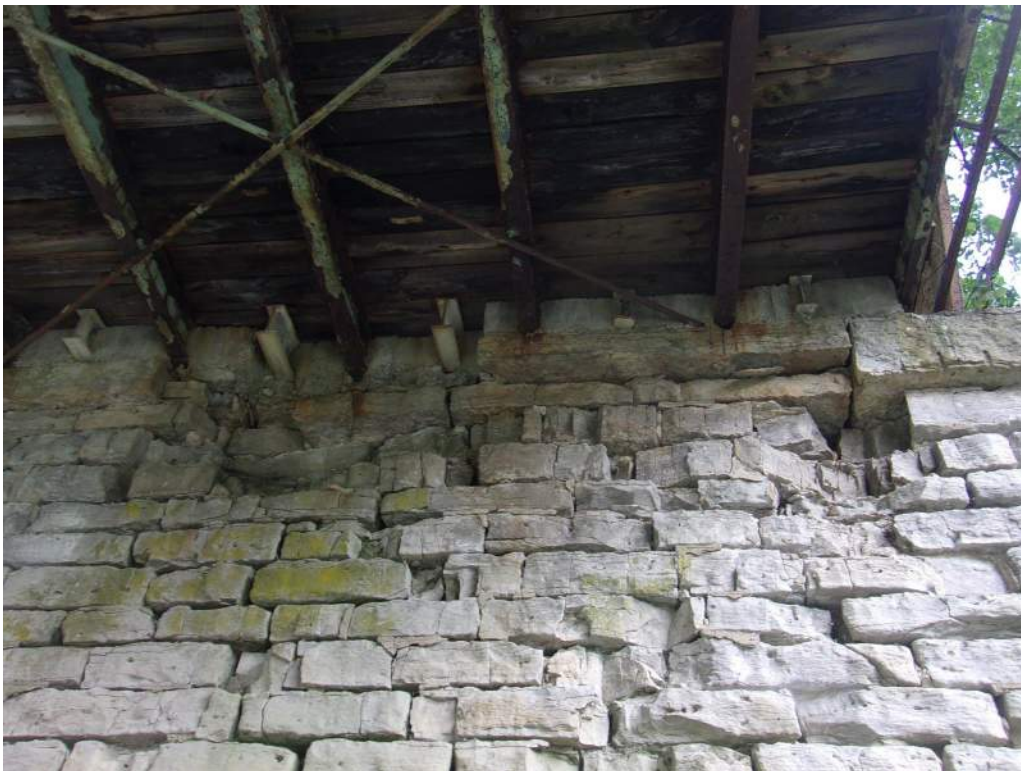
Photo 6: Section Loss of Masonry Blocks at East Abutment

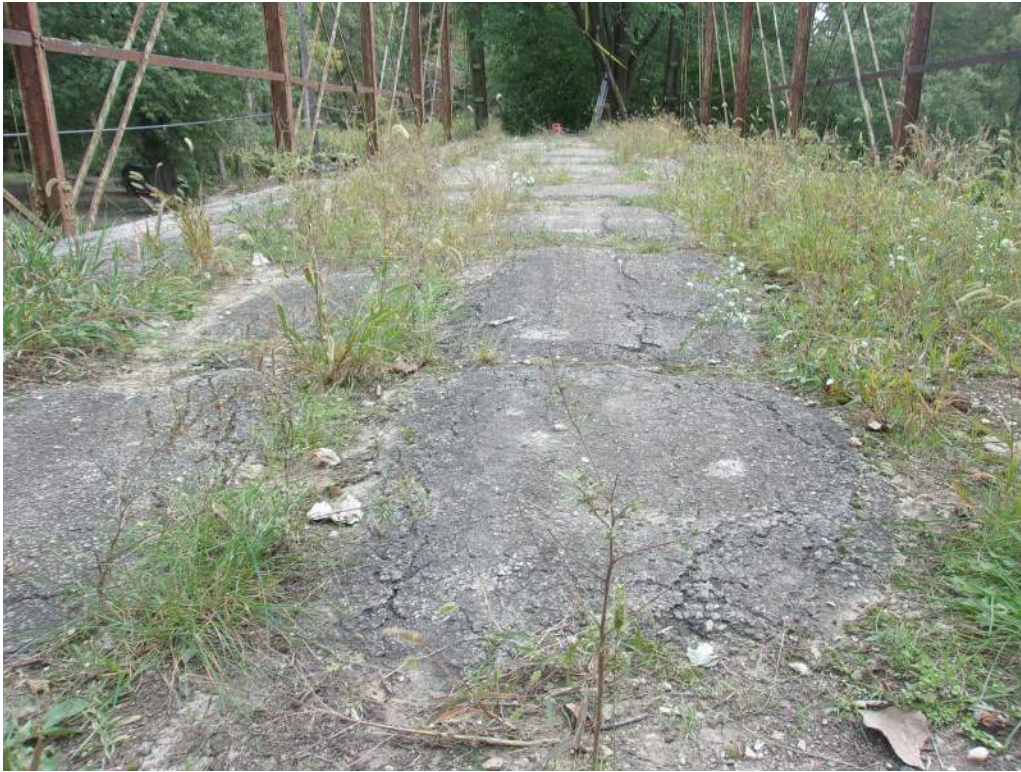
Photo 7: Typical Asphalt Wearing Surface

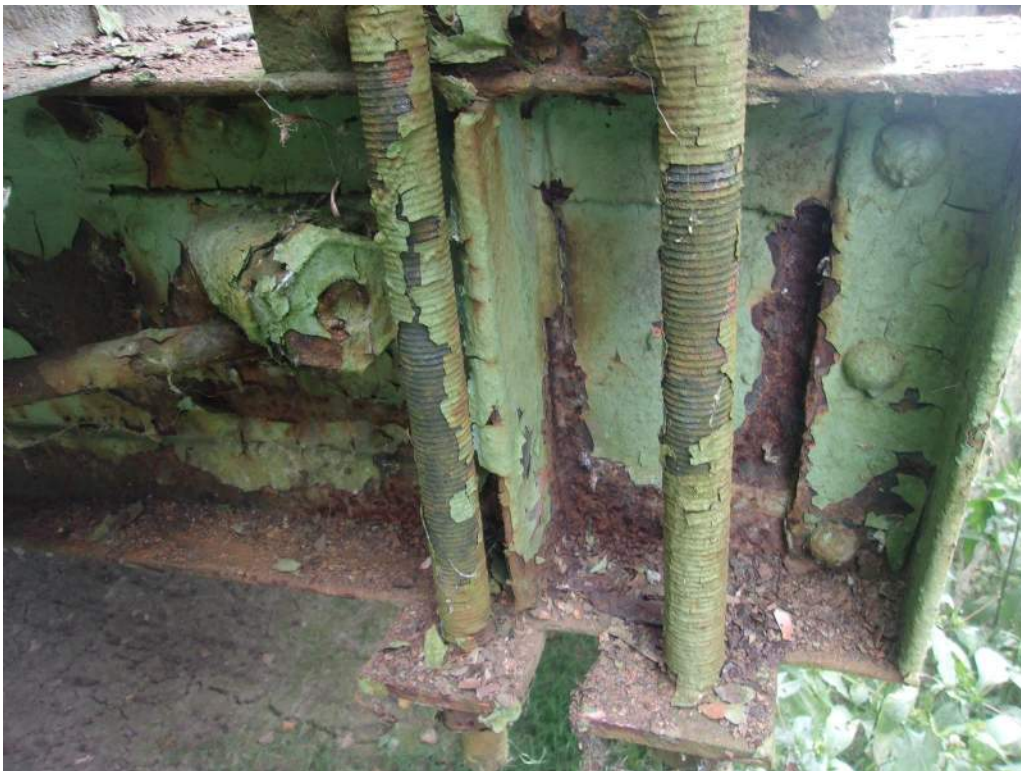
Photo 8: Section Loss on Floor Beam at L1, North Truss

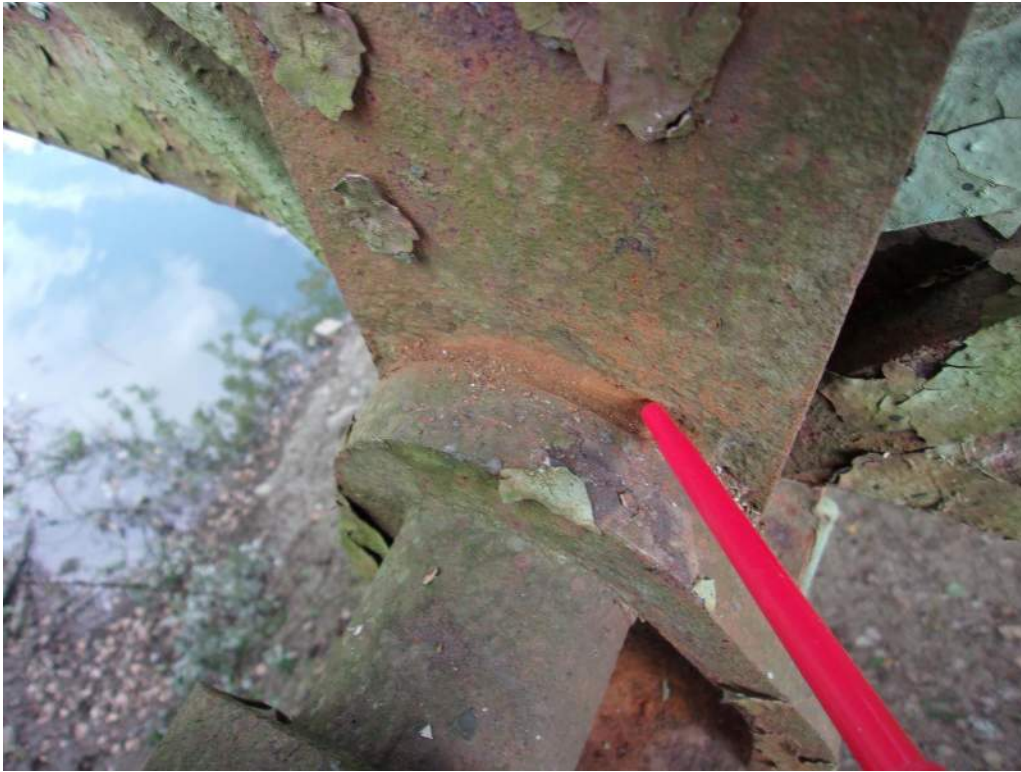
Photo 9: Pack Rust and Section Loss on L3-U3 at Threaded Rod at L3, South Truss

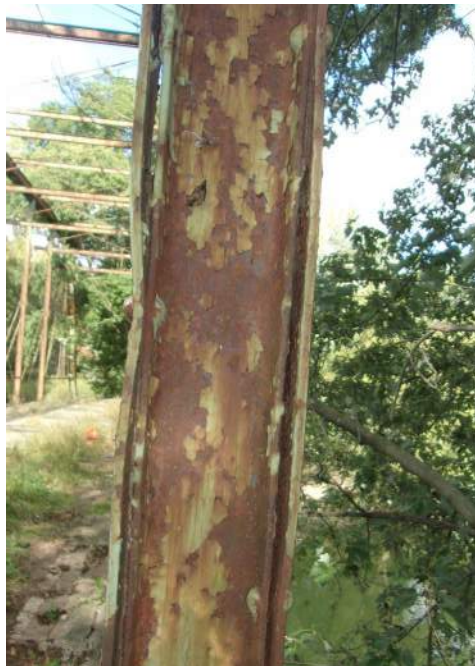
Photo 10: Broken rivets and Out-of-Plane Distortion of outer plate at L3-U3, South Truss

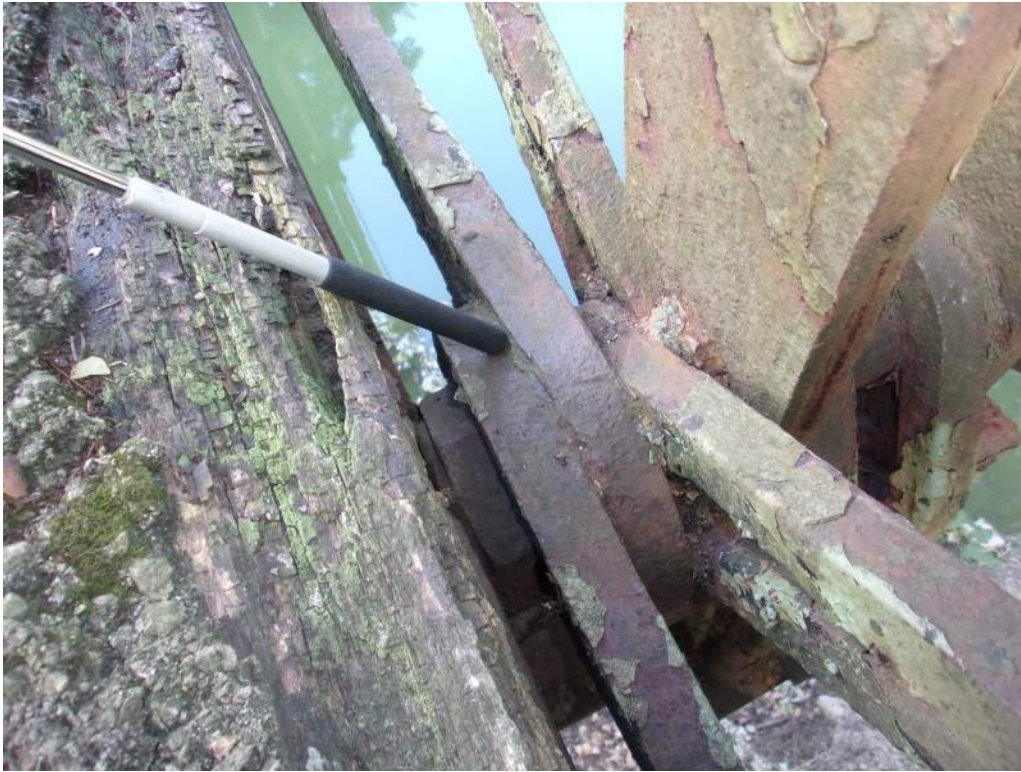
Photo 11: Typical Pack Rust and Rusting of Eyebars at Lower Connections, South Truss

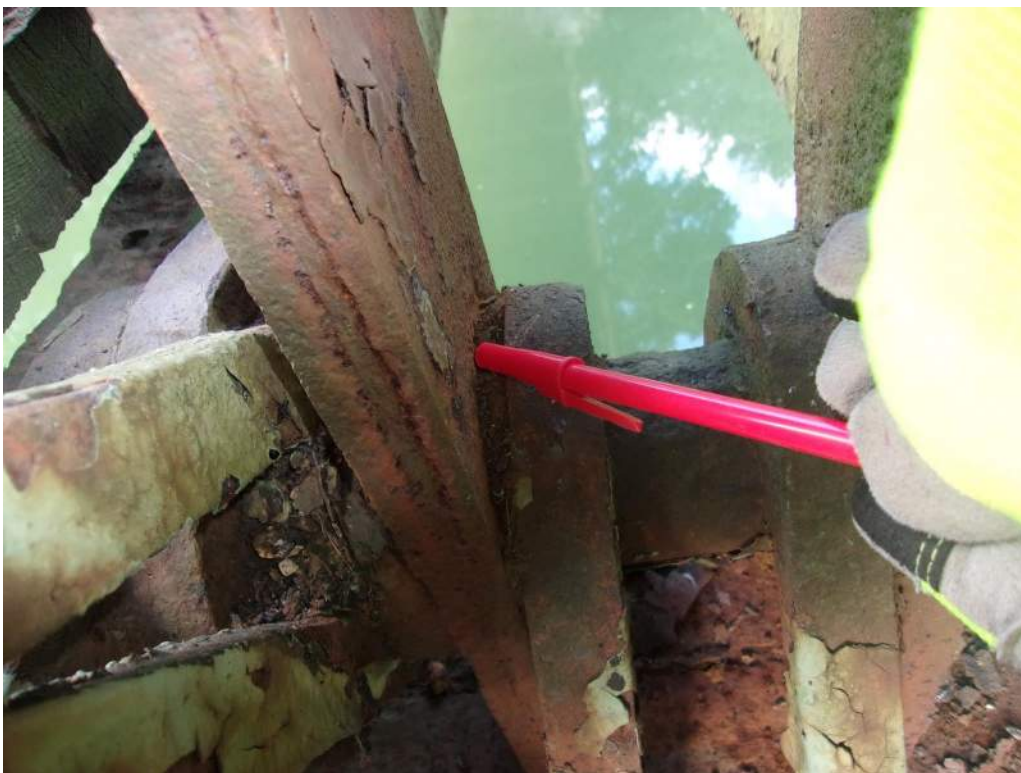
Photo 12: Pack Rust and Section Loss on Interior Plate of L4-U4, South Truss

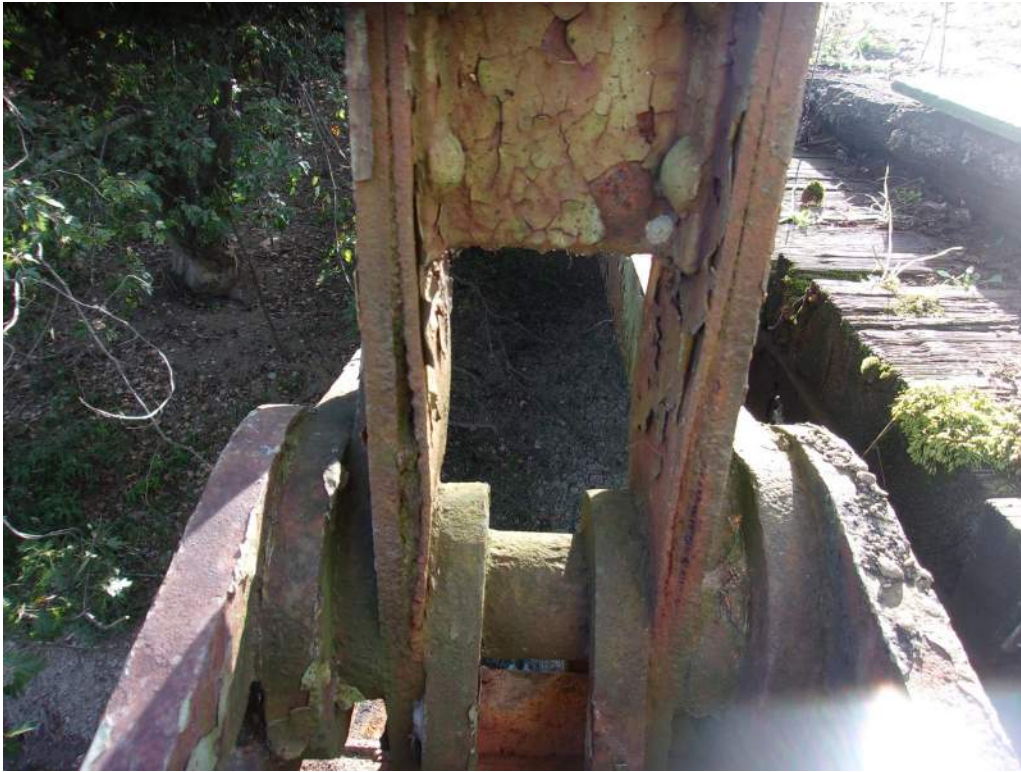
Photo 13: Out-of-Plane Distortion and Pack Rust at L5-U5 at L5, South Truss

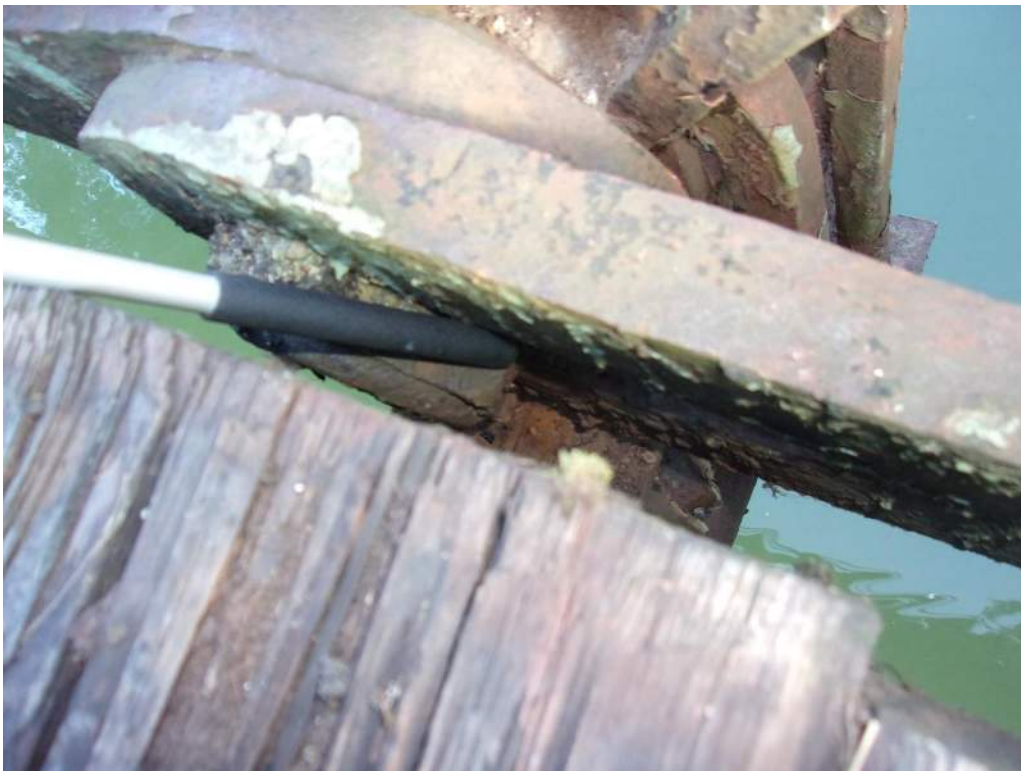
Photo 14: Section Loss on Interior nut and Pin at L6, South Truss

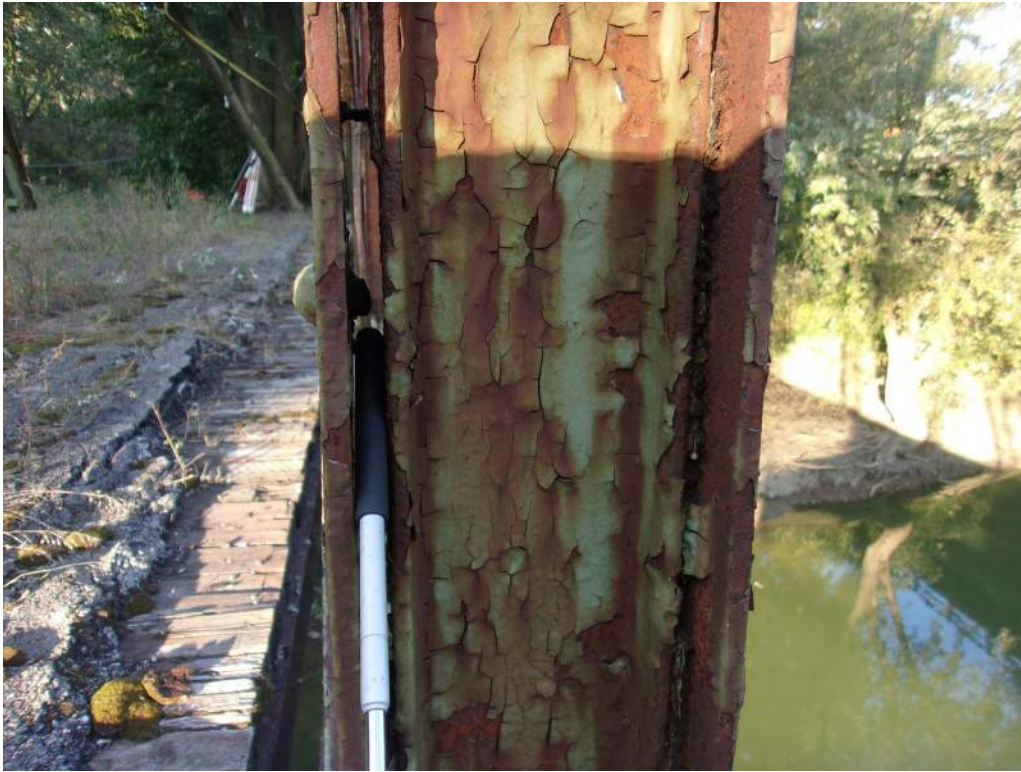
Photo 15: Broken Rivets at Pack Rust at L8-U8 at L8, South Truss

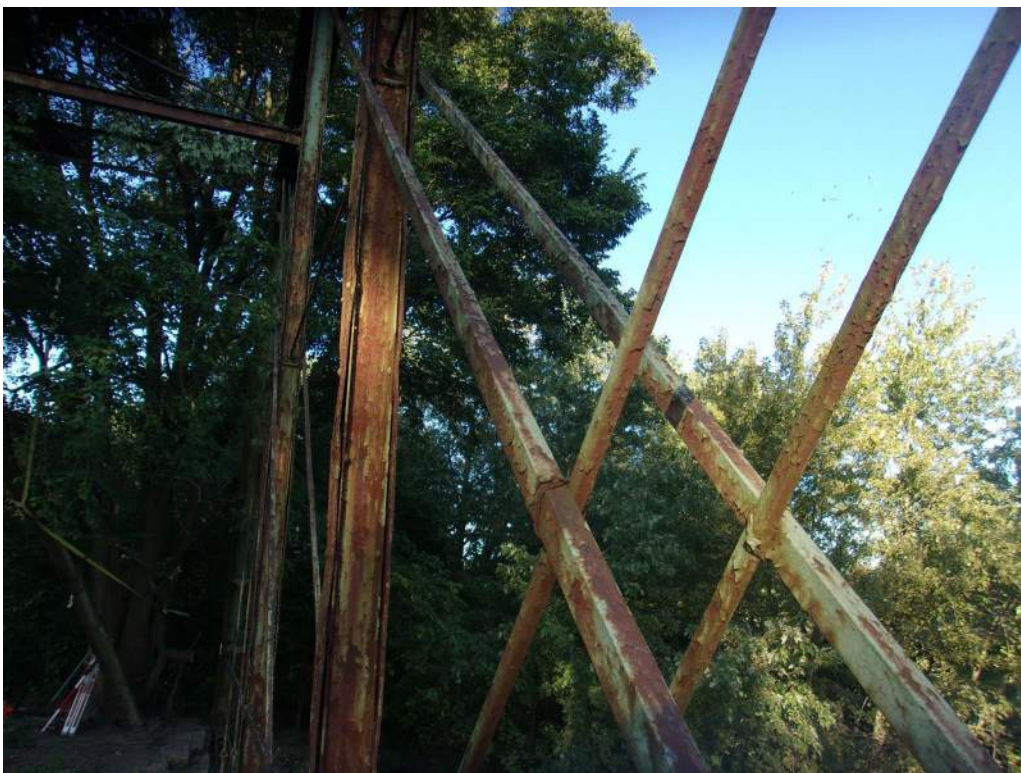
Photo 16: Typical Peeling Paint on Diagonals, South Truss

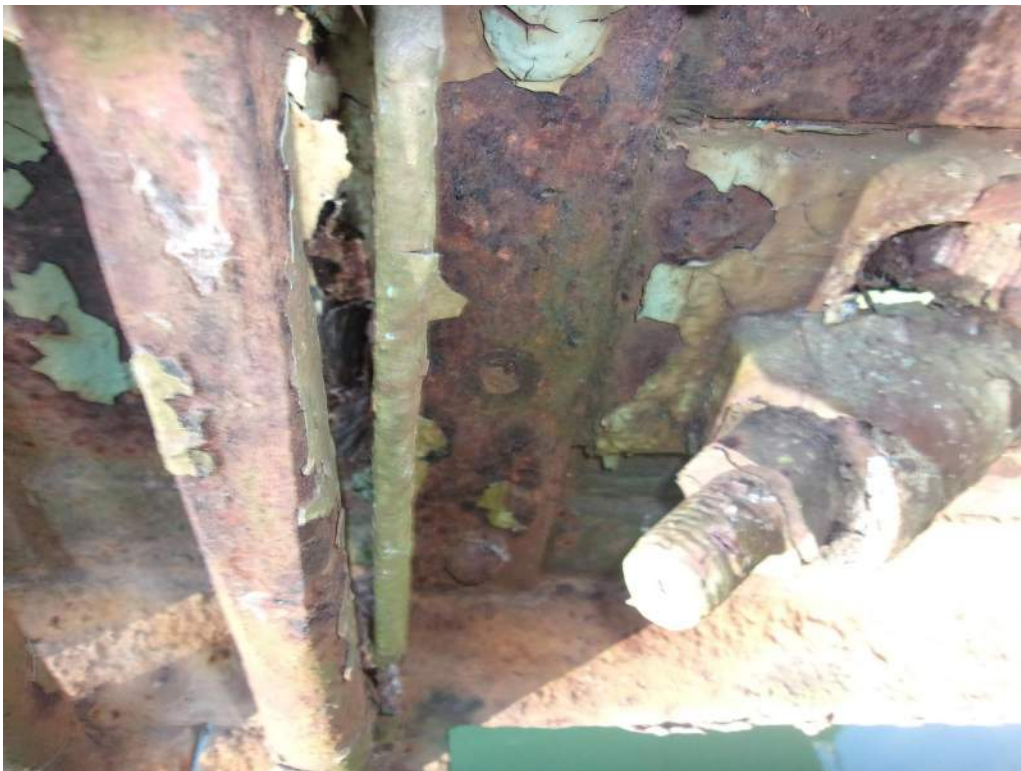
Photo 18: Missing Rivets on Floor Beam web at L9, South Truss

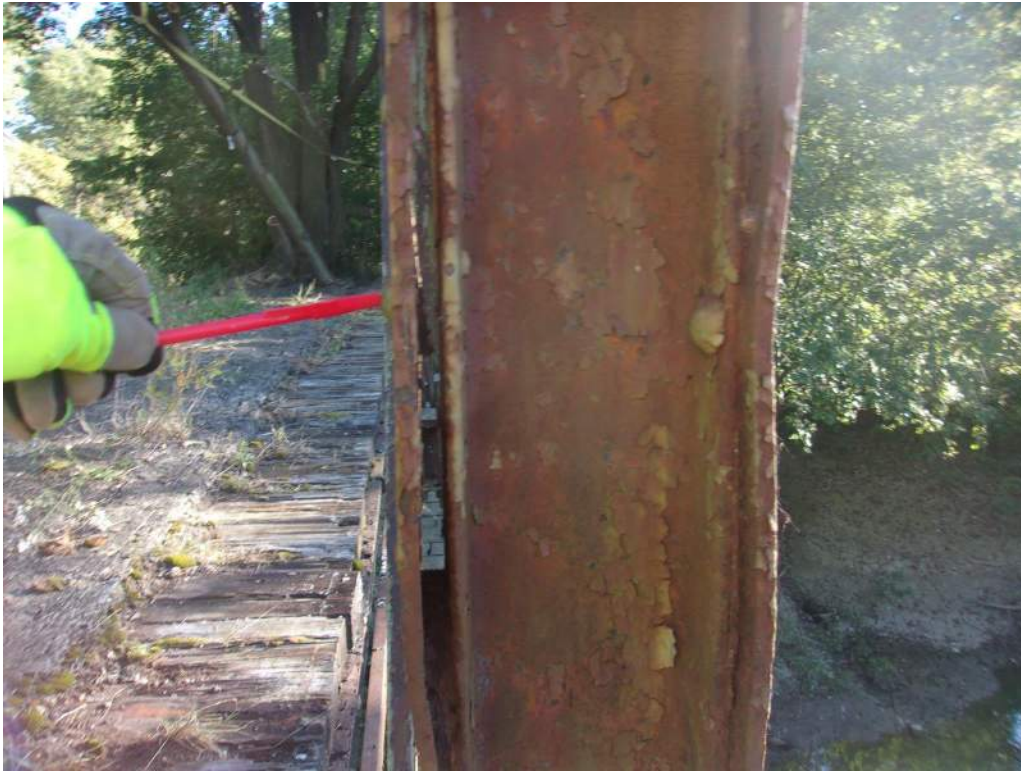
Photo 19: Out-of-Plane Distortion of Outer Plate and Broken Rivet at L9-U9, South Truss

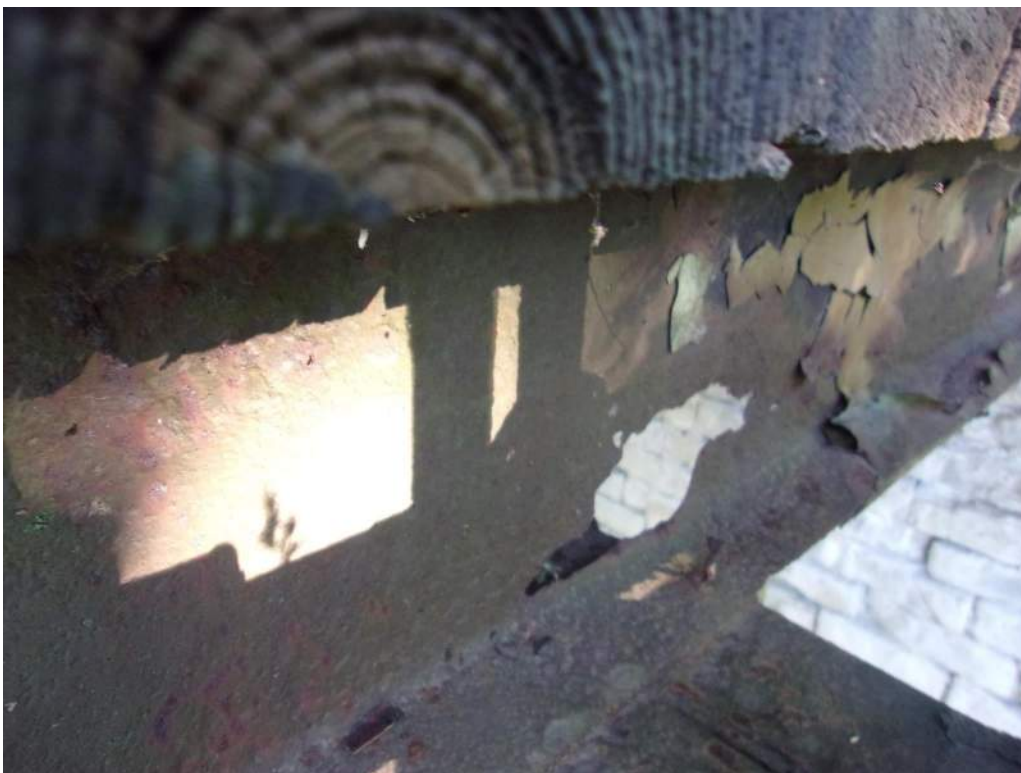
Photo 20: Hole in Stringer 1 near L11, South Truss

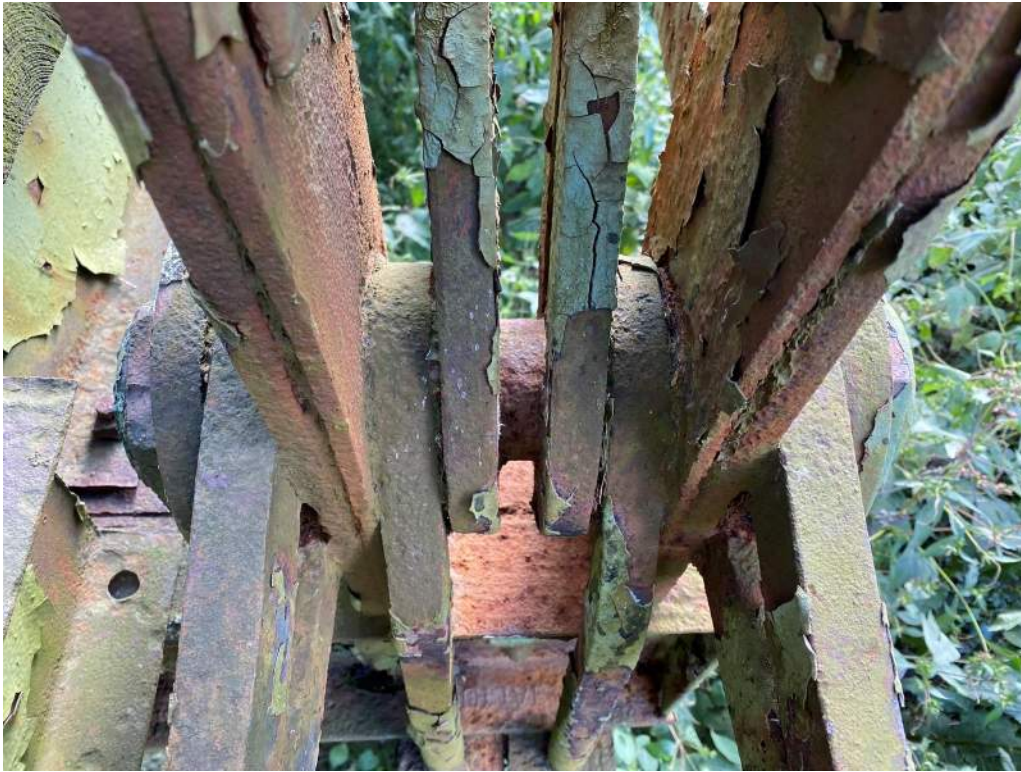
Photo 23: Surface Rust and Pitting with Section Loss on L2 Pin, North Truss

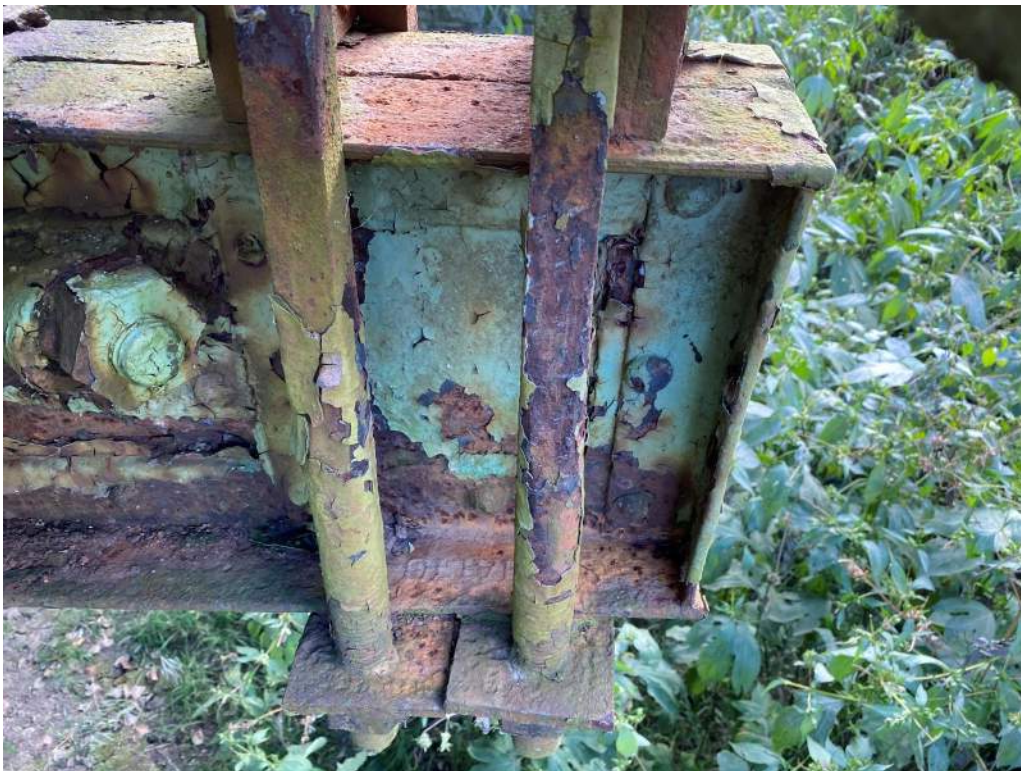
Photo 24: Heavy Pitting and Section Loss on Web and Bottom Flange on Floorbeam of L2, North Truss

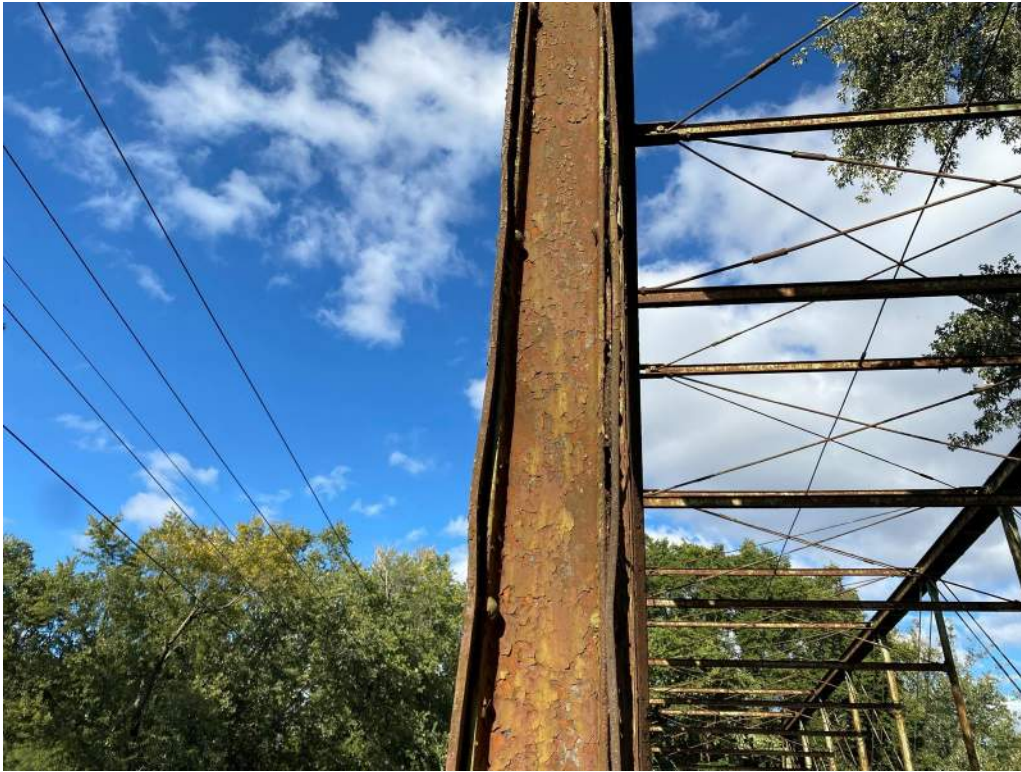
Photo 25: Out-of-Plane Distortion of Outer Plates due to Pack Rust at L2-U2, North Truss

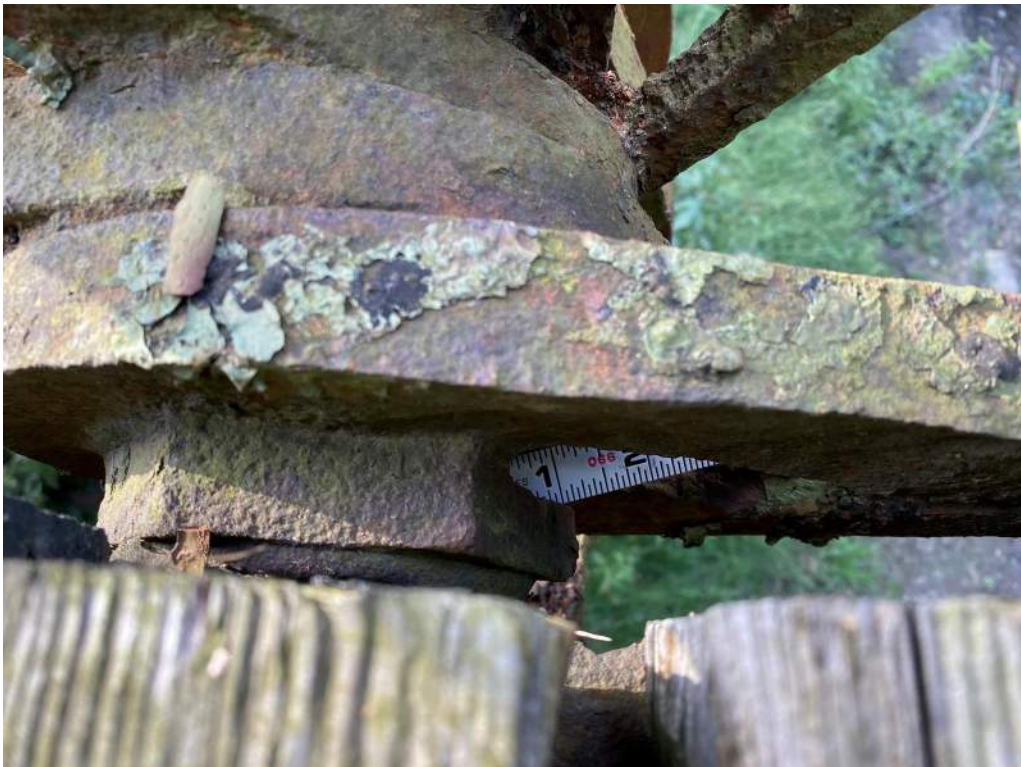
Photo 26: Section Loss on Pin and Interior nut of L3, North Truss

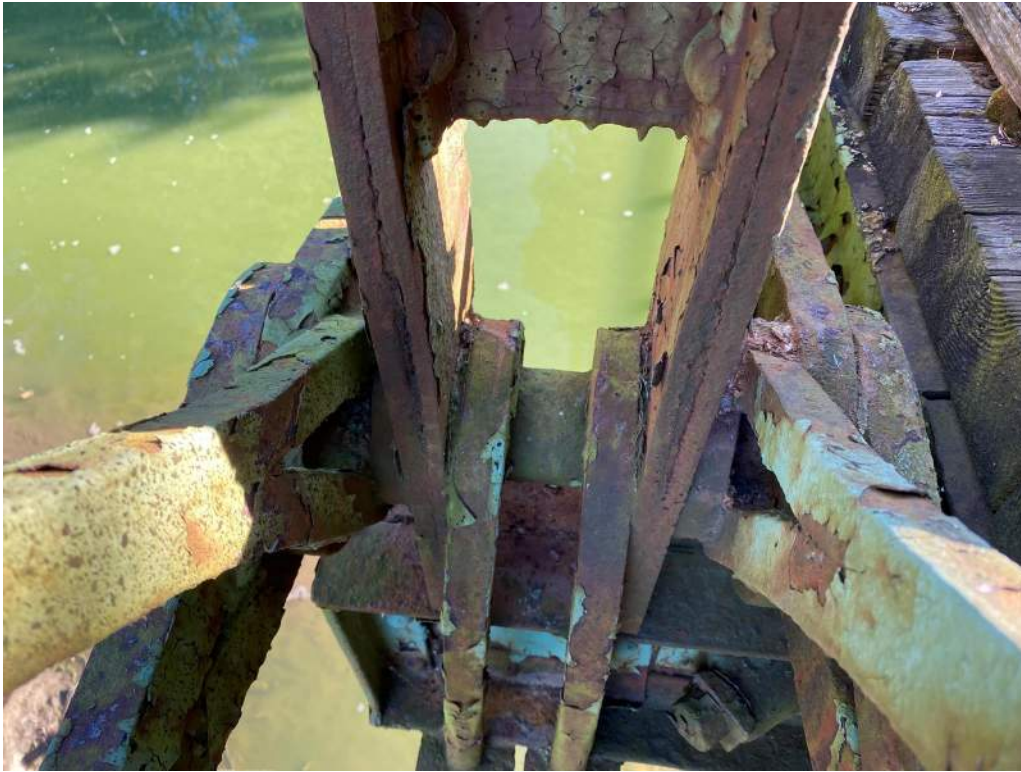
Photo 27: Pack Rust Between Plates and Heavy Rust at L4, North Truss

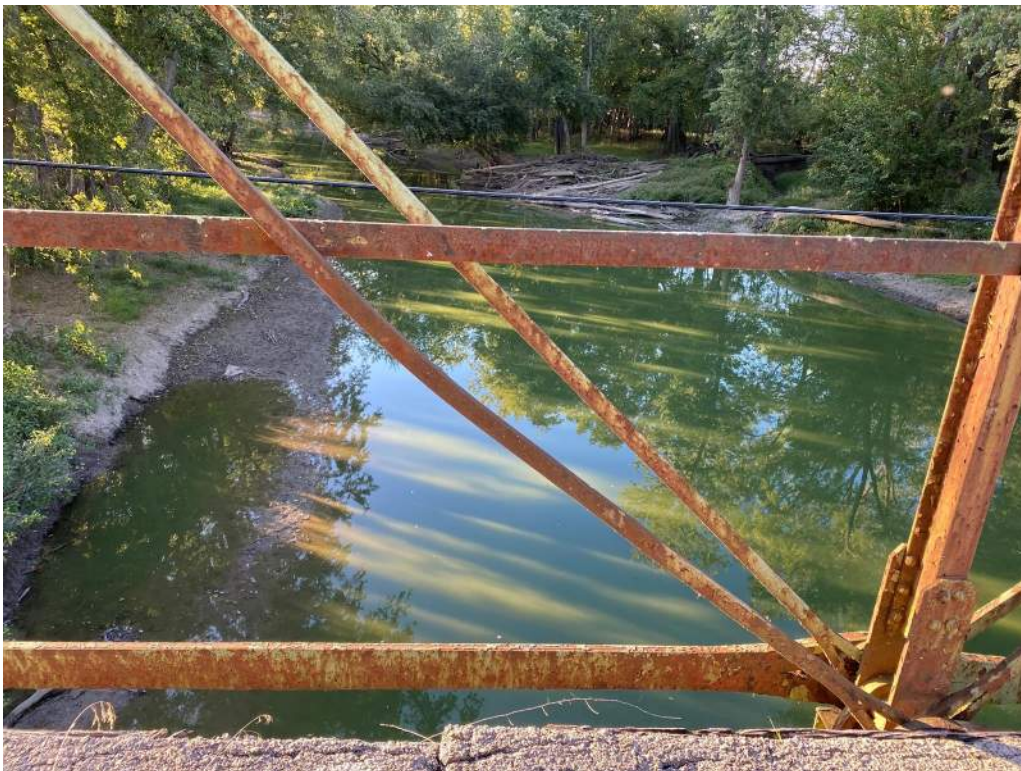
Photo 28: Out-of-Plane Distortion of U4-L6 near L6, North Truss

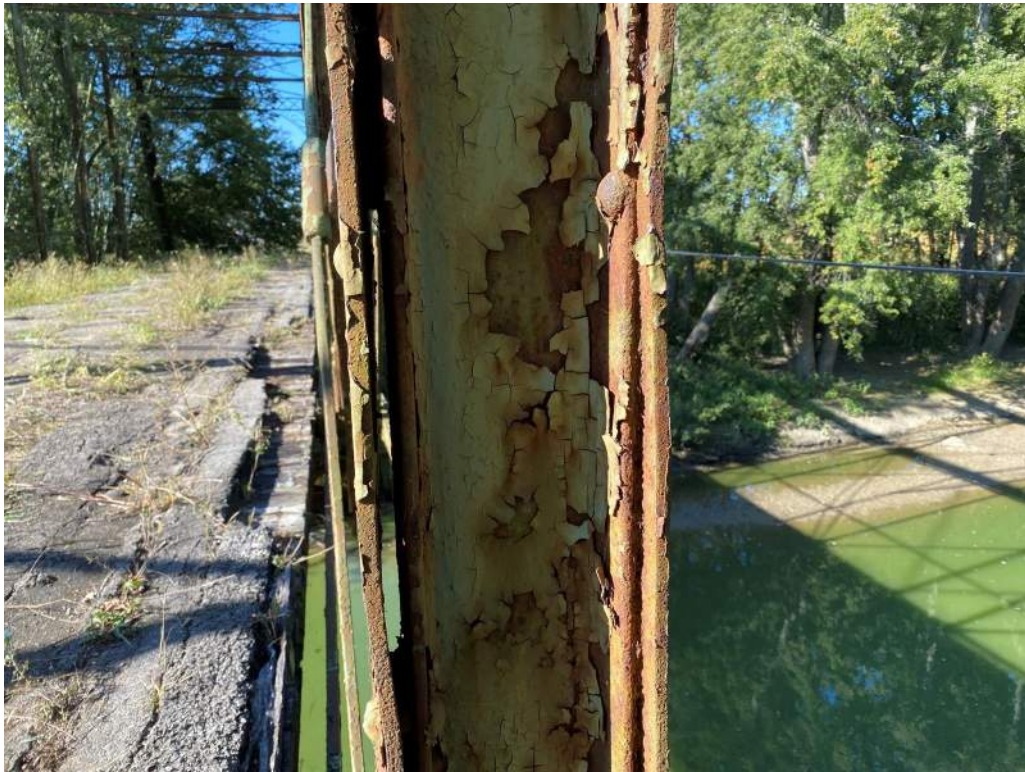
Photo 29: Out-of-Plane Distortion of Outer Plates between rivets with Broken Rivets at L9-U9, North Truss

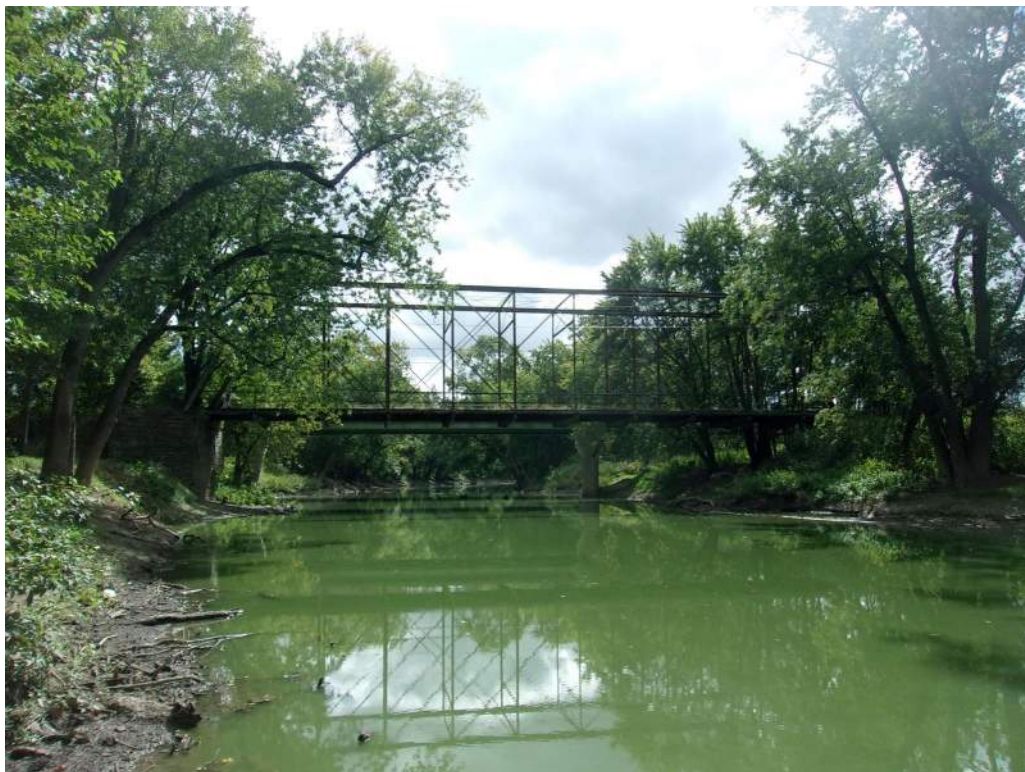
Photo 30: Bridge Elevation Looking South

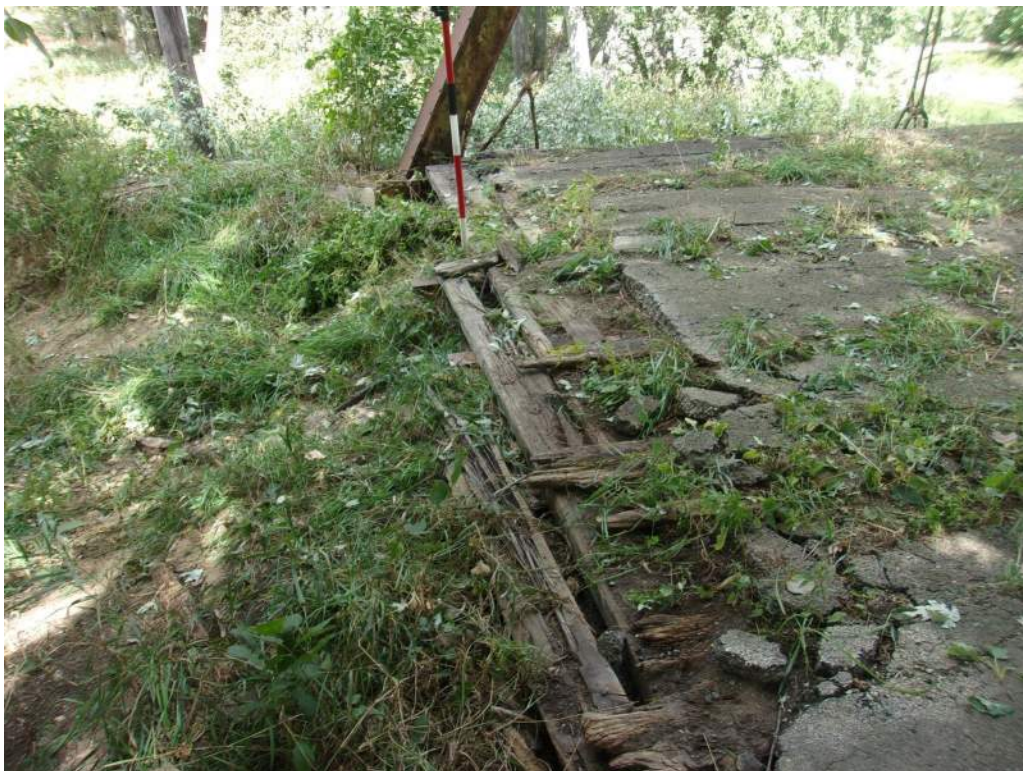
Photo 34: Deterioration on West end of Deck

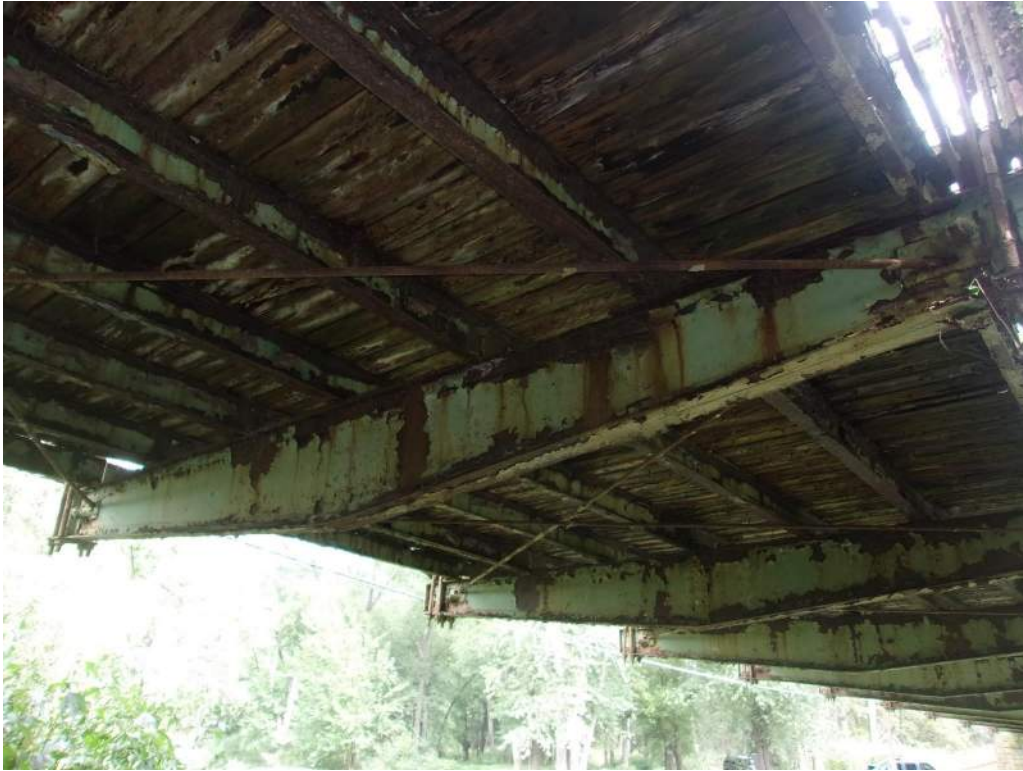
Photo 35: Typical Floorbeam Condition

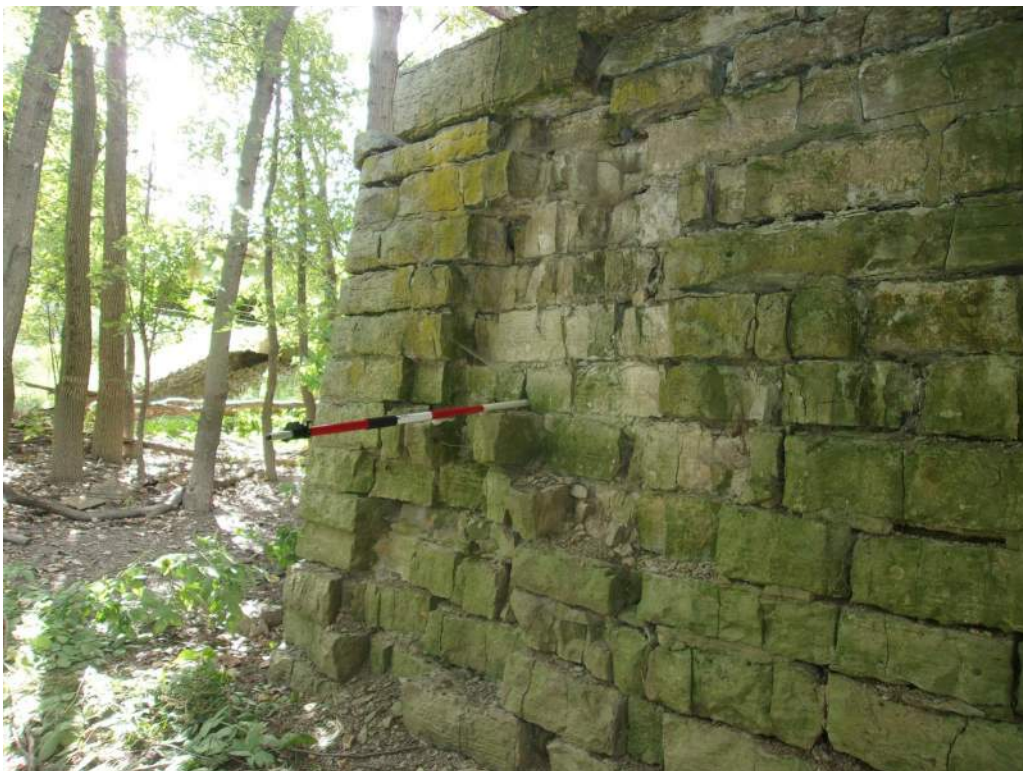
Photo 36: Masonry Block Section Loss on West Abutment
