VERA CRUZ BRIDGE FRACTURE CRITICAL REPORT
(Des. 2200460)

Bridge No. Vera Cruz Bridge over Wabash River (Str. 316-90-6418)

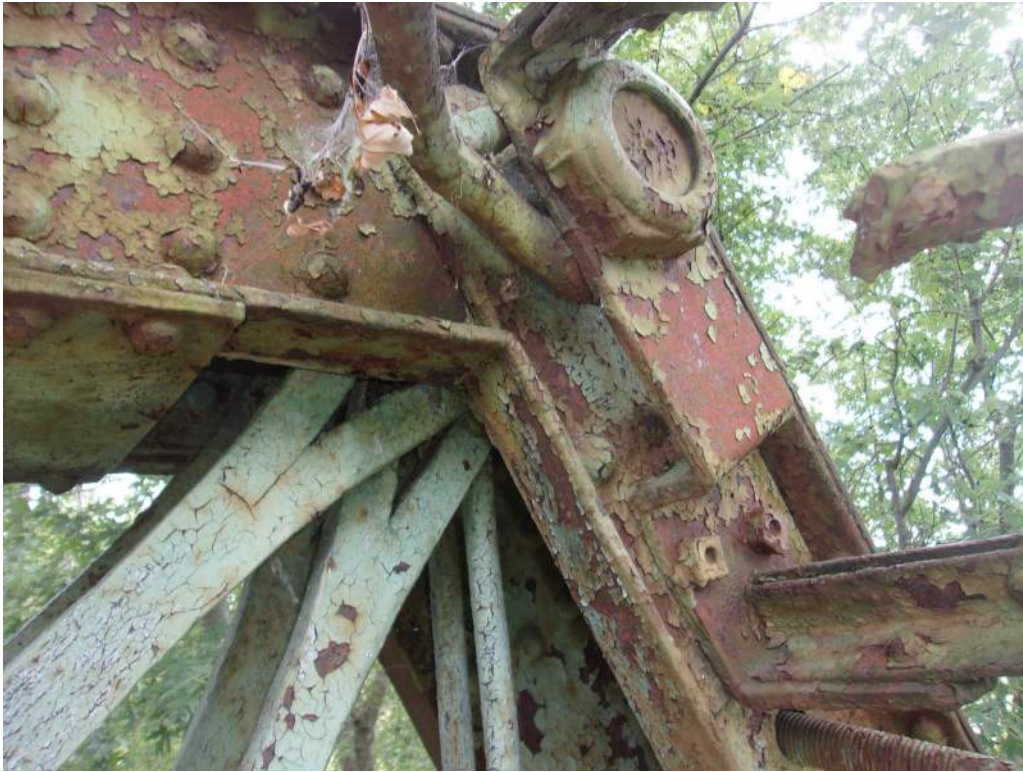
Photo 37: Typical Outside Condition on Upper Chord

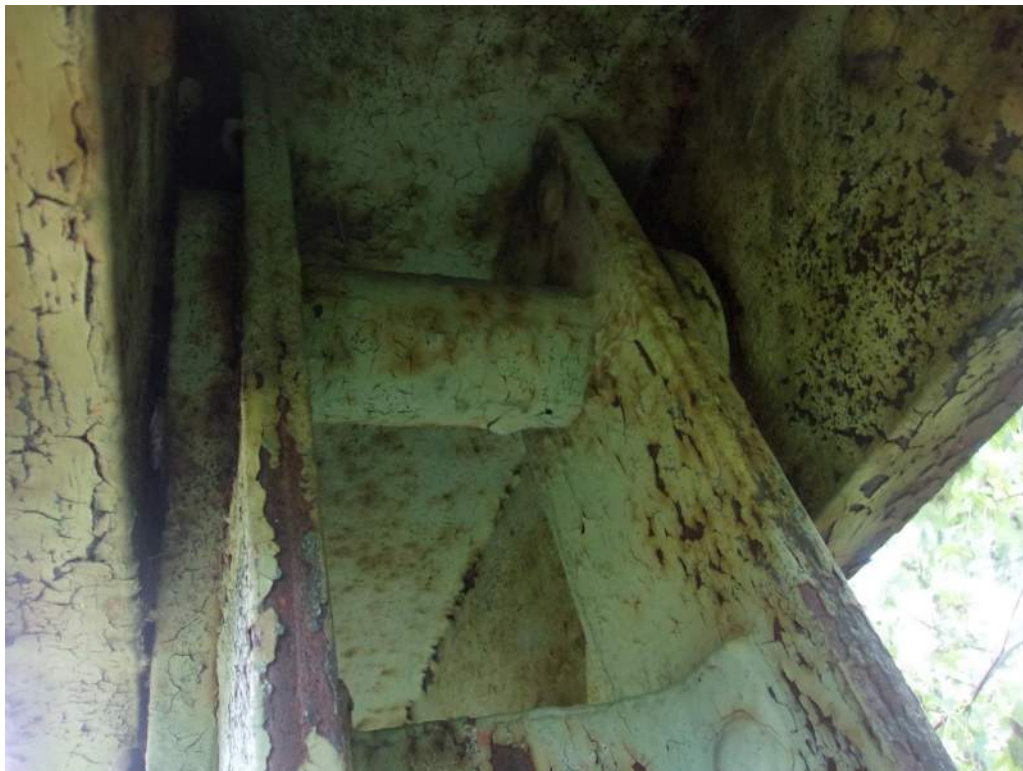
Photo 38: Typical Inside Condition on Upper Connections
