Re: Inspection Summary/ Enforcement Referral ArcelorMittal Burns Harbor LLC NPDES Permit No. IN0000175 Burns Harbor, Porter County

NPDES Industrial Facility Inspection Report INDIANA DEPARTMENT OF ENVIRONMENTAL MANAGEMENT

Inspection Photographs

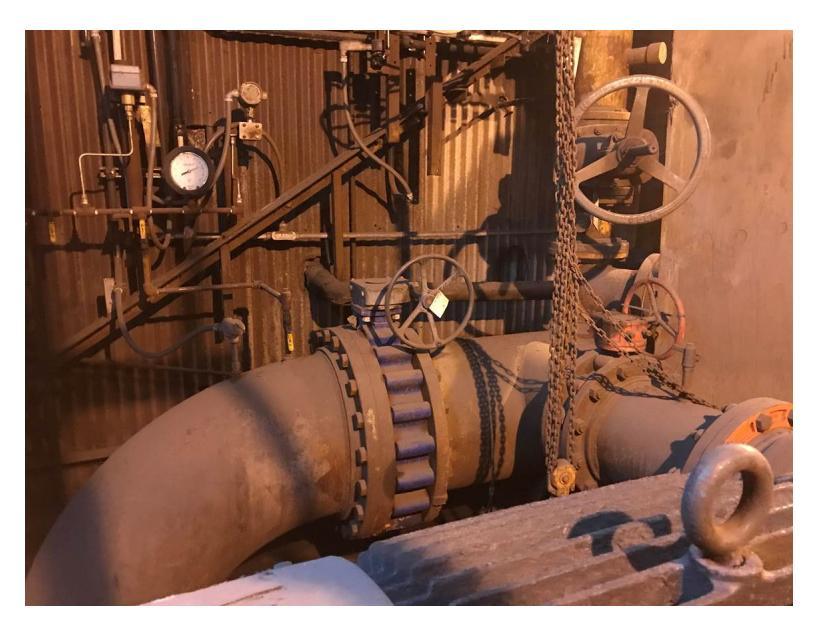
The Blast Furnace D block and bleed valve system had an incident that resulted in the self-reported release of an estimated 15,000 gallons of blast furnace recycle system (BFRS) water through Outfall 002 on June 15, 2020. This incident was cited in the report for the inspection conducted on August 12, 2020 for a violation of 327 IAC 5-2-2, which prohibits the point source discharge of pollutants to waters of the state except in conformity with a valid NPDES permit obtained prior to the discharge. Following the root cause analysis, on-site staff stated that the BFRS water made contact with the non-contact cooling water, which discharges to Outfall 002, after two valves were turned in an incorrect order. The BFRS system water is kept at a pressure of approximately 80 psi and the non-contact cooling water provides a cross-connection and a risk of discharge of BFRS system water to the non-contact cooling water system. ArcelorMittal Burns Harbor personnel attributed the discharge to operator error and stated further training had been implemented to operations staff.

Facility:			
ArcelorMittal Burns Harbor LLC			
Photographer: Nicholas Ream			
Date: 10/26/2020 Time: 11:15 AM			
Others Present:			
Joan Rogers, Bob Lugar, Morgan Swanson, Joyce Casillas, Cary Mathias, Patrick Gorman, Robert Maciel			
Location/Description:			
South view of a portion of the block and bleed valve system in the D Furnace Pump House.			
Also Present: Blake Crisman

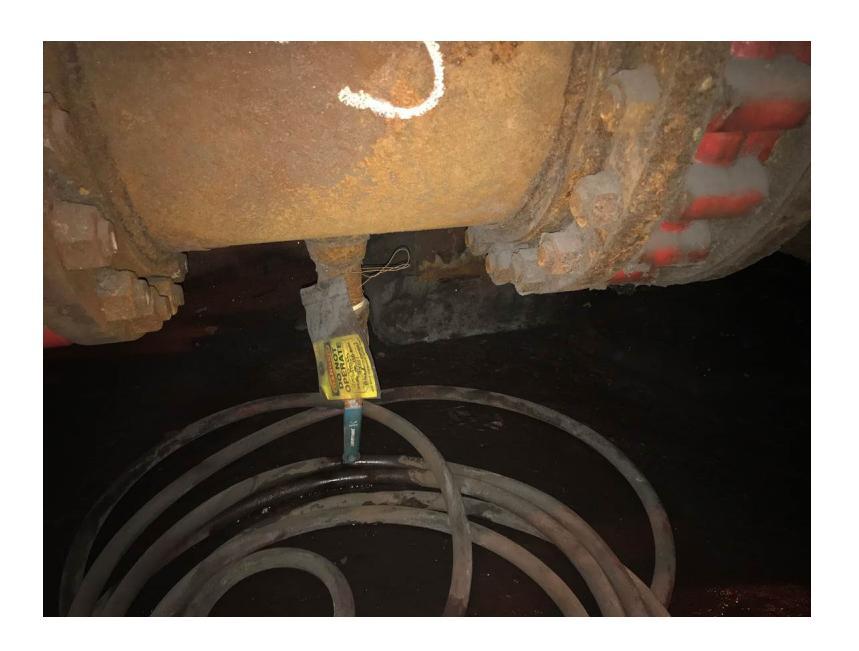
Facility:
ArcelorMittal Burns Harbor LLC
Photographer:
Nicholas Ream
Date: 10/26/2020 Time: 11:15 AM
Others Present:
Joan Rogers, Bob Lugar, Morgan Swanson, Joyce Casillas, Cary Mathias, Patrick Gorman, Robert Maciel
Location/Description: West view of the bleed portion of the block and bleed system in the D Furnace Pump house,
Also Present: Blake Crisman

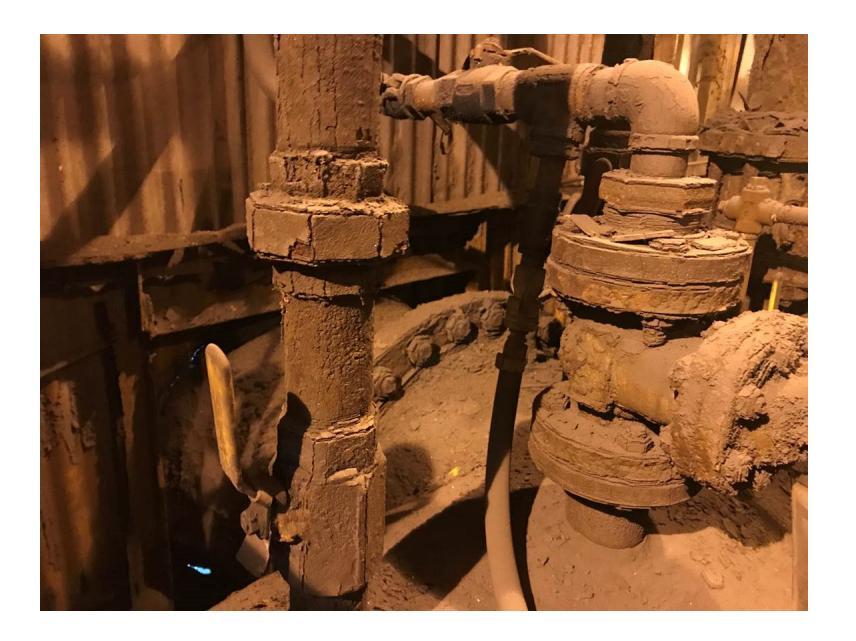
Facility: ArcelorMittal Burns Harbor LLC Photographer: Nicholas Ream Date: 10/26/2020 Time: 11:15 AM Others Present: Joan Rogers, Bob Lugar, Morgan Swanson, Joyce Casillas, Cary Mathias, Patrick Gorman, Robert Maciel Location/Description: Northwest view of a portion of the block and bleed system within the D Furnace Pump House. Also Present: Blake Crisman

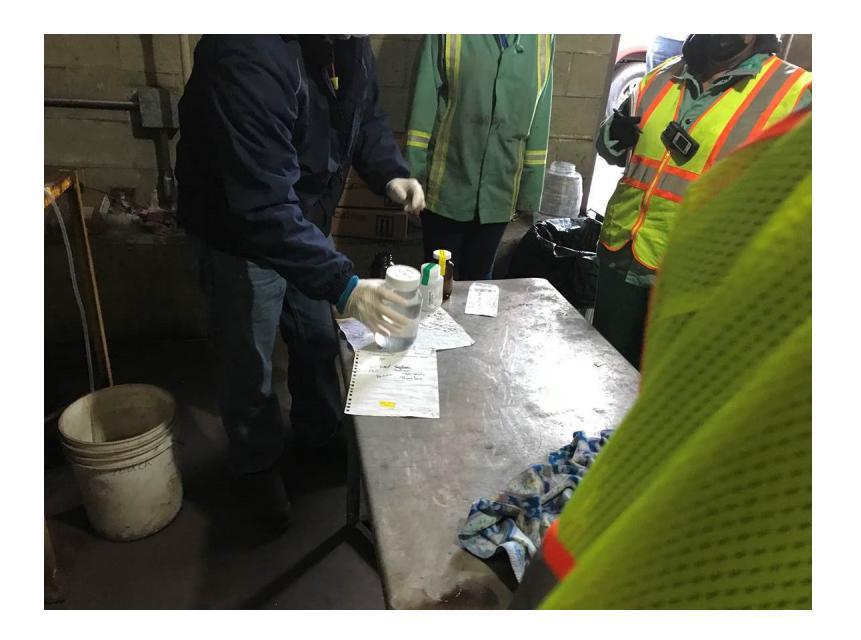
Facility:				
ArcelorMittal Burns Harbor LLC				
Photographer:				
Nicholas Ream				
Date: 10/26/2020 Time: 11:50 AM				
Others Present:				
Joan Rogers, Bob Lugar, Morgan Swanson, Joyce Casillas, Cary Mathias, Patrick Gorman, Robert Maciel				
Location/Description:				
North view of a demonstration of cyanide sampling at the Outfall 002 auto-sampler location.				
Also Present: Brandon Frye

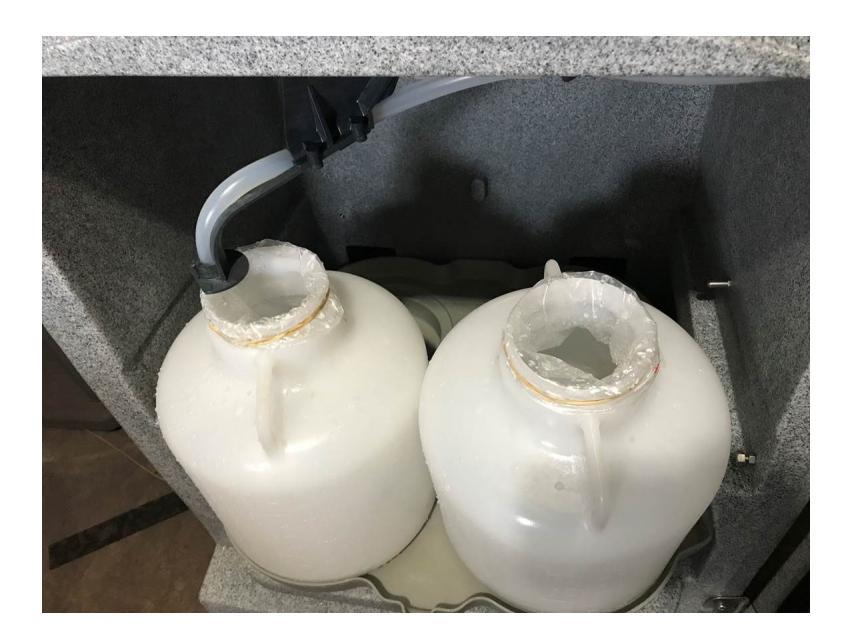
Self Monitoring was rated as unsatisfactory. A demonstration of the 24 hour compositing for Total Cyanide was observed. The grab was taken at Outfall 002 and compositing conducted within the on-site lab. The grab samples are stored within the auto-samplers located at the respective outfalls. The temperatures of the samples stored in the auto-samplers are presumed to be the same as the temperature readouts displayed on the auto-samplers rather than determined by thermometers in liquids stored within the auto-samplers. The auto-sampler temperature readouts are reflective of the air temperature within the auto-sampler and are subject to fluctuations, caused by such things as the auto-sampler door being briefly opened. Accordingly, these readouts are not necessarily reflective of the temperatures of the liquids stored within the auto-samplers. 40 CFR 136 requires that samples be held at or below six degrees Celsius, but above freezing, for several analytes. In order to accurately document the sample temperatures, a thermometer within a liquid, such as water, stored within the auto-samplers must be used.

Southern view of the new autosampler for Outfall 002. Cyanide samples are stored within until it is time to manually composite them within the lab. Temperature should be monitored via a thermometer in liquid and recorded daily when the sampler is in use. ArcelorMittal is currently utilizing the auto-sampler's built-in temperature gauge.

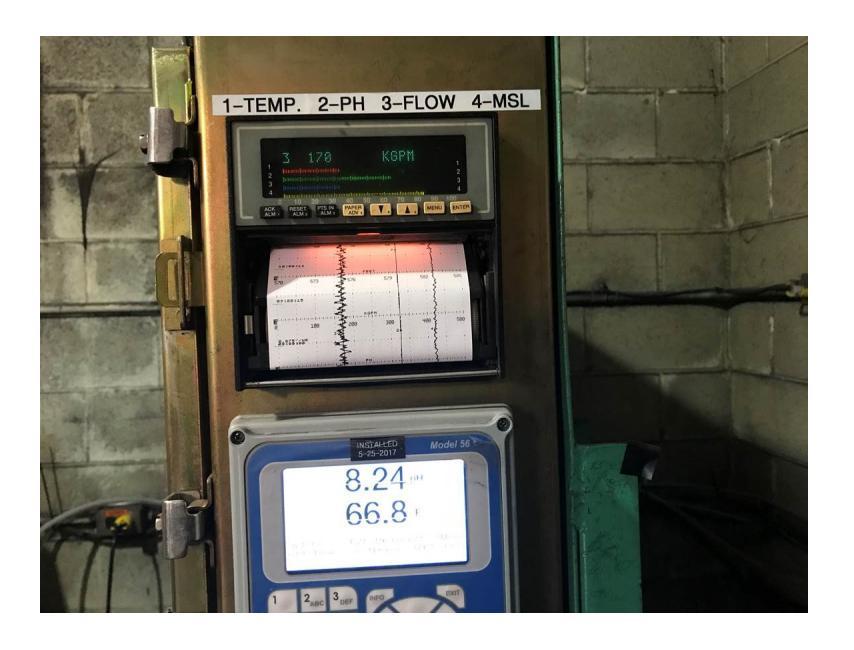
Facility:
ArcelorMittal Burns Harbor LLC
Photographer: Nicholas Ream
Date: 10/26/2020 Time: 11:50 AM
Others Present: Joan Rogers, Bob Lugar, Morgan Swanson, Joyce Casillas, Cary Mathias, Patrick Gorman, Robert Maciel
Location/Description: Southern view of the flow meter display for Outfall 002. Also Present: Brandon Frye

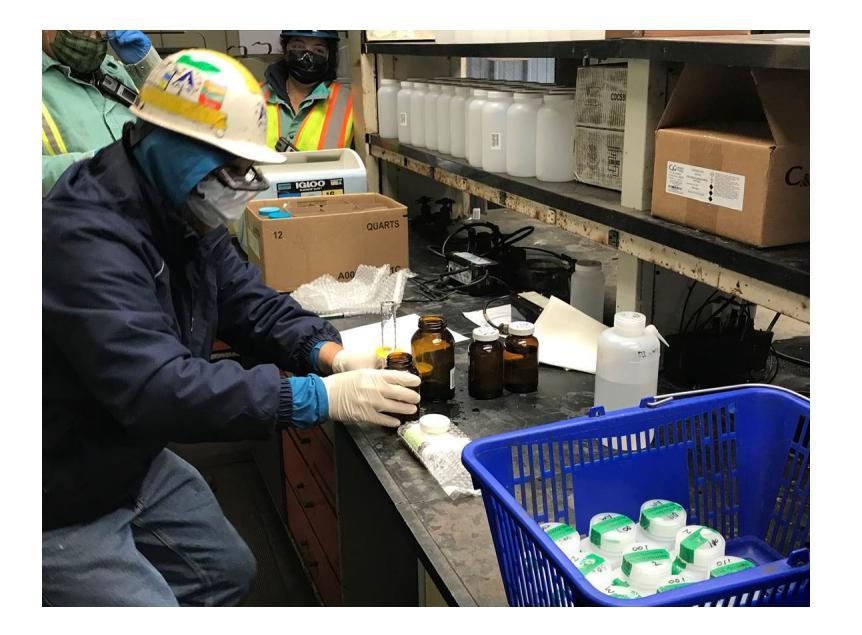
The cyanide composite example utilized three composite parts. The calculations indicated the need for volumes of sample in the tenths of a milliliter. The graduated cylinder used during the demonstration is not designed to measure to the tenths of a milliliter. Please ensure that sample volumes are precisely measured for compositing.

Facility: ArcelorMittal Burns Harbor LLC Photographer: Nicholas Ream Date: 10/26/2020 Time: 12:10 PM Others Present: Joan Rogers, Bob Lugar, Morgan Swanson, Joyce Casillas, Cary Mathias, Patrick Gorman, Robert Maciel Location/Description: Brandon Frye demonstrating manually compositing cyanide samples. Also Present: Brandon Frye

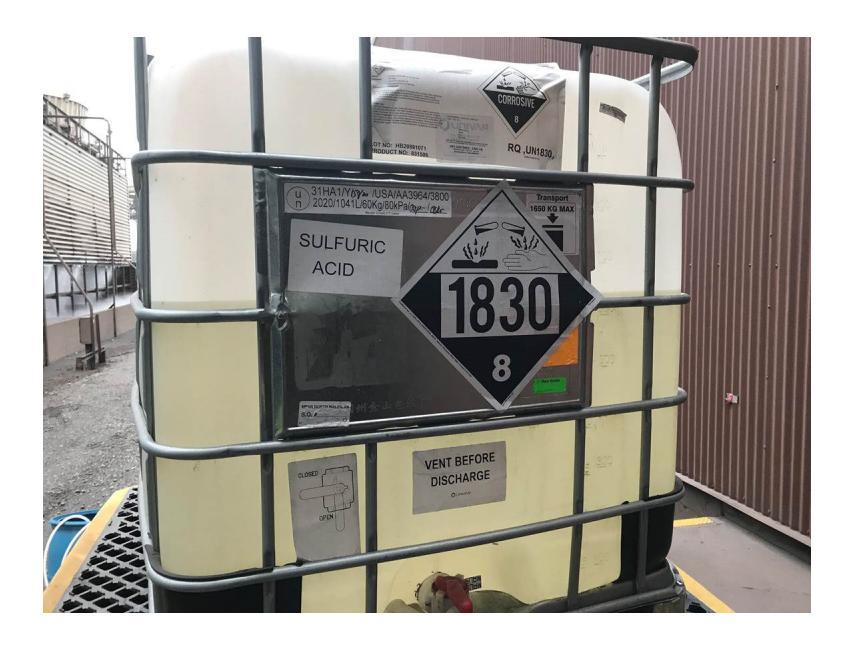
Facility:				
ArcelorMittal Burns Harbor LLC				
Photographer:				
Nicholas Ream				
Date: 10/26/2020 Time: 12:40 PM				
Others Present:				
Joan Rogers, Bob Lugar, Morgan Swanson, Joyce Casillas, Cary Mathias, Patrick Gorman, Robert Maciel				
Location/Description:				
Sulfuric Acide used in the production of Chlorine Dioxide.

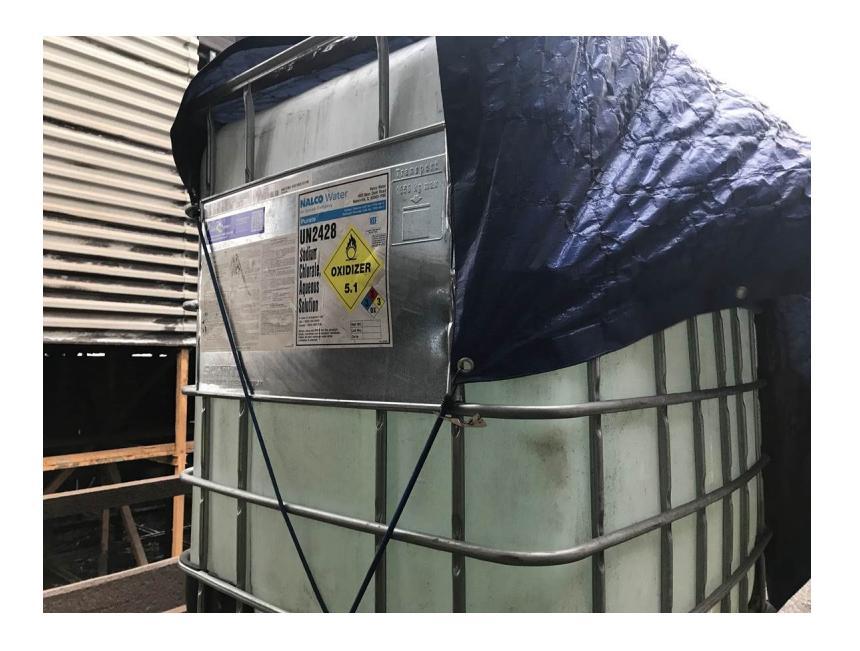
Photographer: Nicholas Ream Date: 10/26/2020 Time: 12:40 PM Others Present: Joan Rogers, Bob Lugar, Morgan Swanson, Joyce Casillas, Cary Mathias, Patrick Gorman, Robert Maciel Location/Description: Sodium Chlorate used in the production of Chlorine Dioxide.

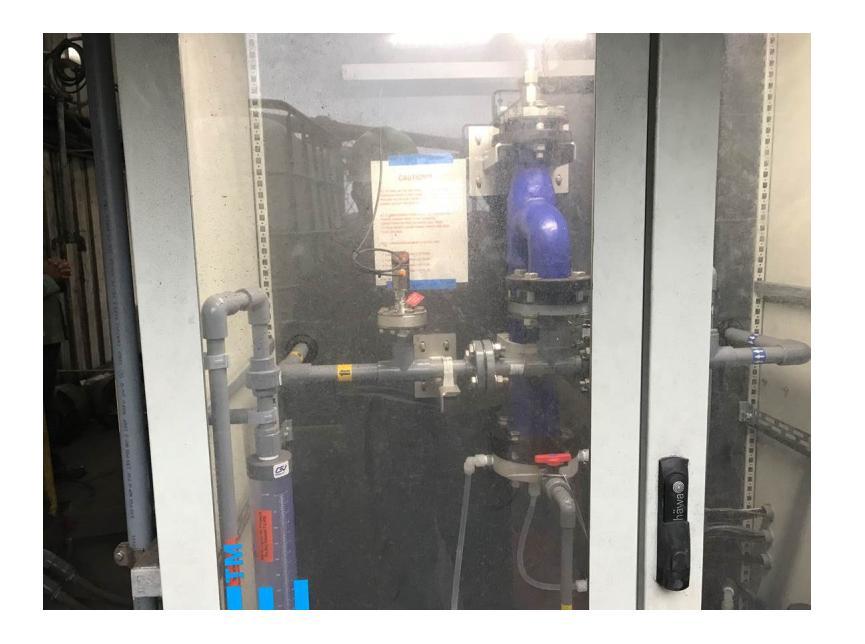
Facility: ArcelorMittal Burns Harbor LLC Photographer: Nicholas Ream Date: 10/26/2020 Time: 12:40 PM Others Present: Joan Rogers, Bob Lugar, Morgan Swanson, Joyce Casillas, Cary Mathias, Patrick Gorman, Robert Maciel Location/Description: East view of the Sodium Dioxide production area.

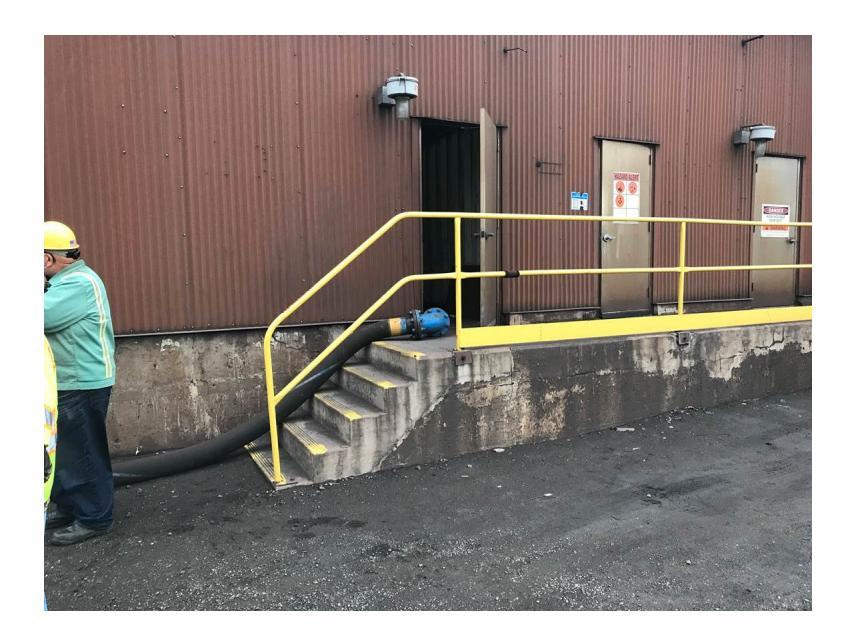
Facility:					
ArcelorMittal B	urns Harbor LLC				
Photographer:					
Nicholas Ream					
Date: 10/26/2020	Time: 12:50 PM				
Others Present:					
Joan Rogers, Bob Swanson, Joyce C Mathias, Patrick Go Maciel	Lugar, Morgan asillas, Cary orman, Robert				
Location/Description:					
West view of the line carrying					
blowdown of the BFRS water to the					
stripping tower.

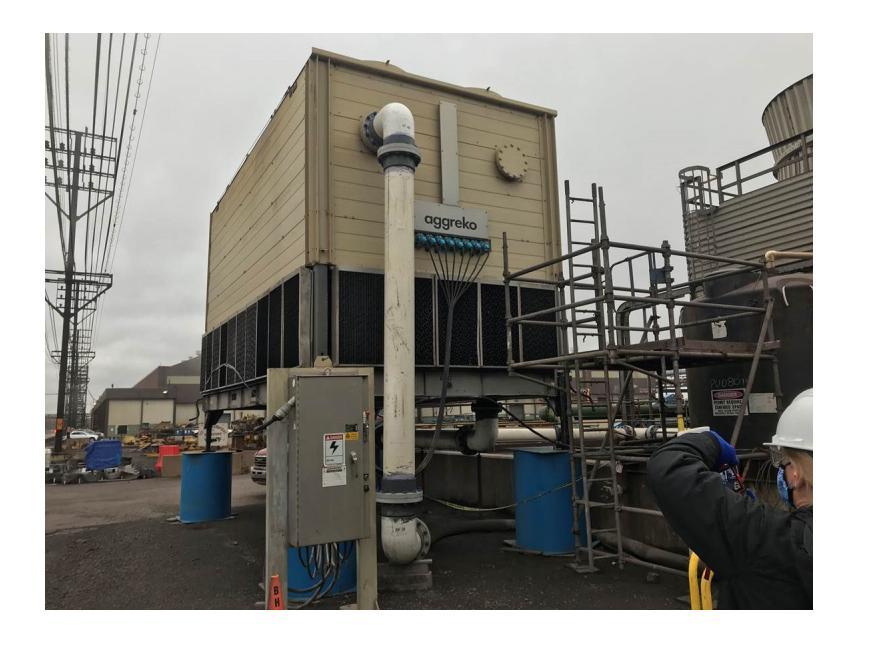
The Permit category was rated as unsatisfactory. A temporary stripping tower has been installed and sodium hydroxide is being used for pH adjustment to test for treatment for ammonia within the blast furnace recycle water system (as described in the Operation category below). Notice of this planned change to the facility was not provided to IDEM as required, in violation of Part II.C.1 and Part I.A.1[2] of the Permit.

South view of the stripping tower. pH is adjusted to 10+ standard units with Sodium Hydroxide for ammonia removal. This is meant to be a test to improve overall ammonia treatment at the facility.

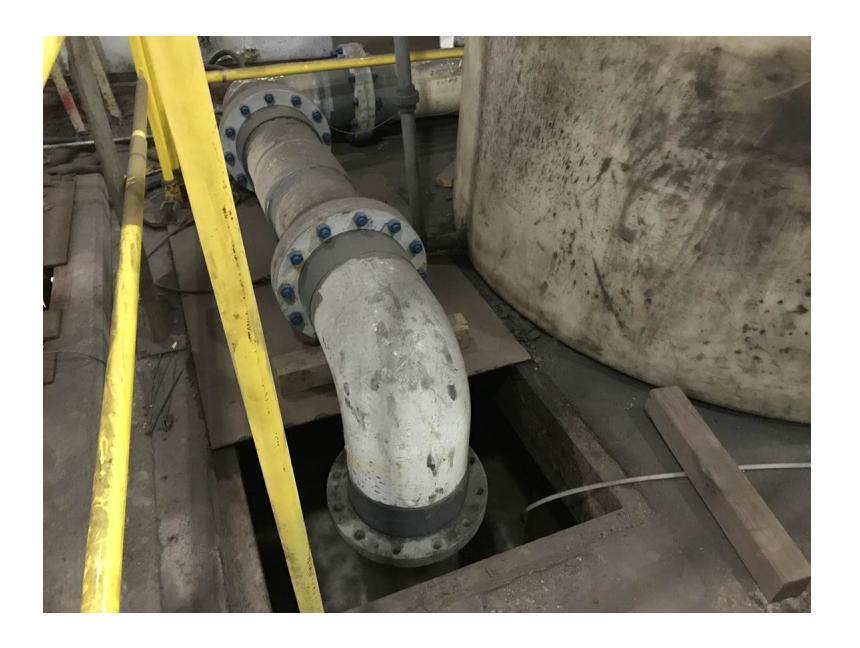
South view of the discharge from the stripping tower into Cell #6 where Chlorine Dioxide was added.

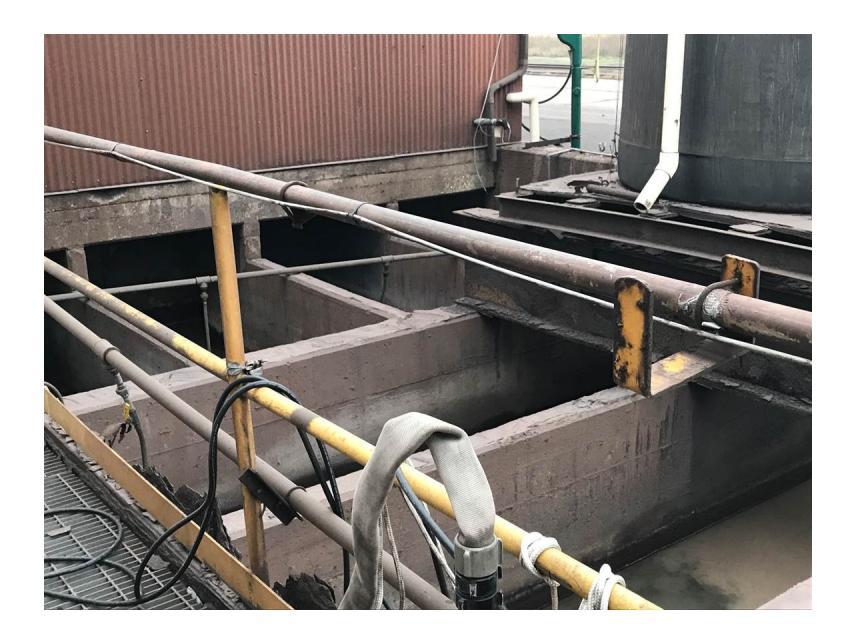
Facility:	
ArcelorMittal Bui	rns Harbor LLC
Photographer:	
Nicholas Ream	
Date: 10/26/2020	Time: 12:45 PM
Others Present: Joan Rogers, Bob Lu Swanson, Joyce Cas Mathias, Patrick Gorr Maciel	gar, Morgan illas, Cary nan, Robert
Location/Description: Northwest view of Ce (background) and Ce	II #5 II #4 (foreground).

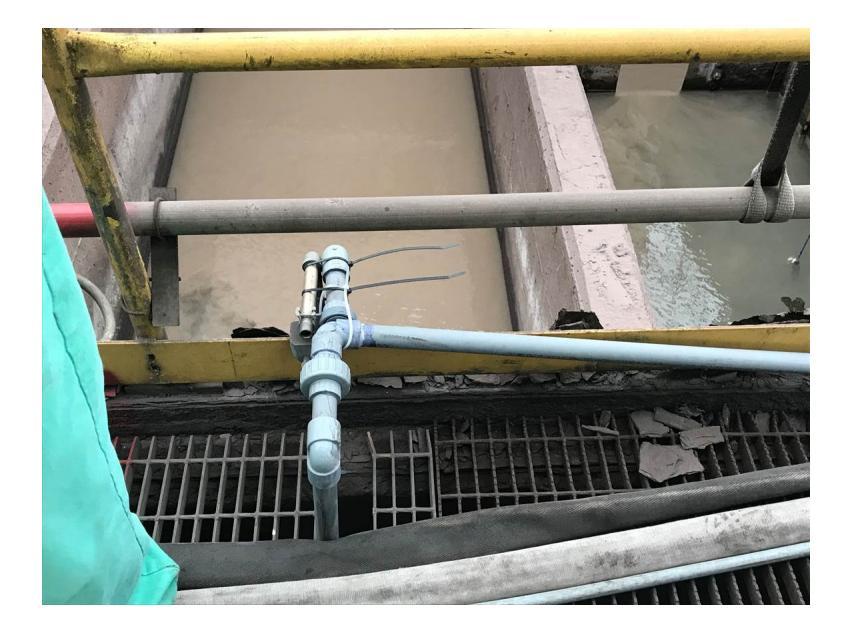
Nicholas Ream Date: 10/26/2020 Time: 12:45 PM Others Present: Joan Rogers, Bob Lugar, Morgan Swanson, Joyce Casillas, Cary Mathias, Patrick Gorman, Robert Maciel Location/Description: East view of the location where Chlorine Dioxide can be added to Cell #4.

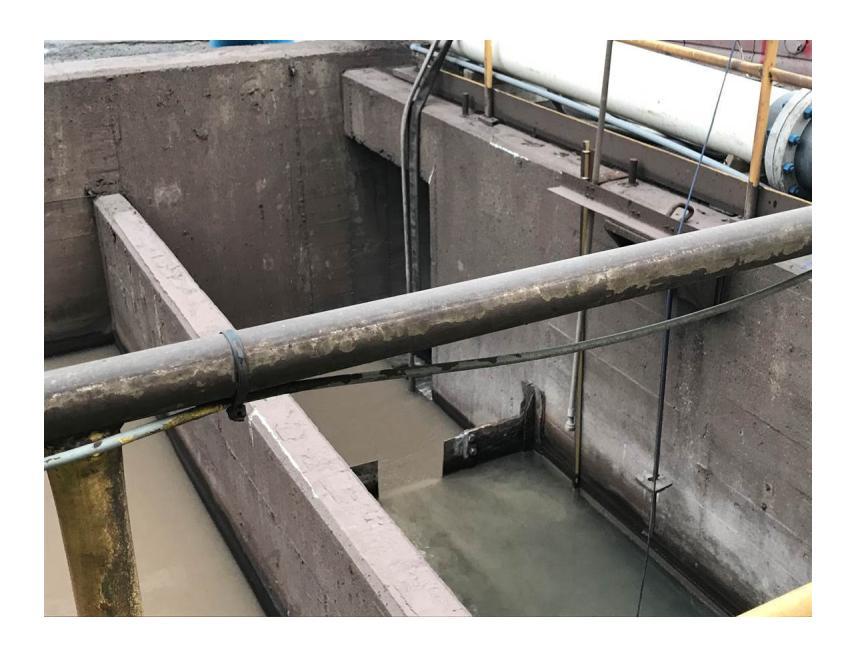
Southeast view of the discharge from Cell #4 to the DIW line. This discharge can also be dosed with Chlorine Dioxide.
