3.4.5 Himebaugh Drain – Fawn River Sub-watershed Land Use

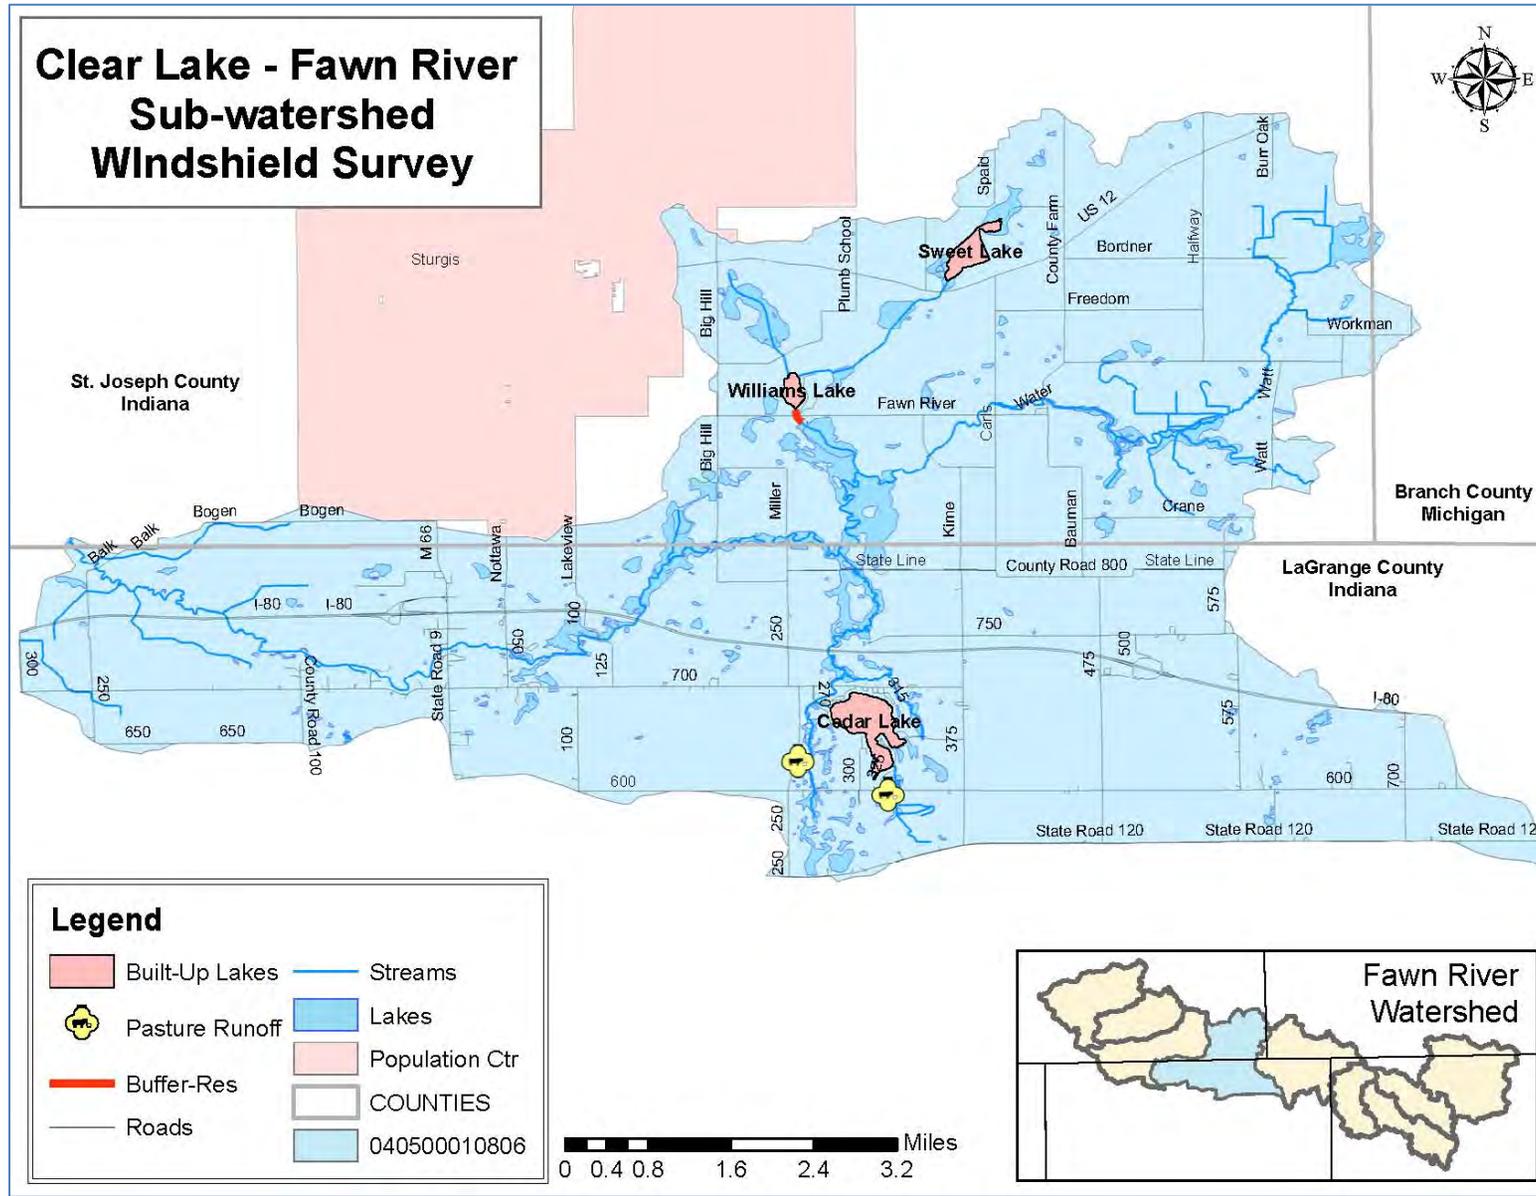
Figure 3.42: Windshield Survey Observations in the Clear Lake Sub-watershed

The windshield survey conducted as part of this project in May, 2014 revealed some common concerns scattered throughout the Clear Lake sub-watershed including agriculture land that lacks a riparian buffer along open water, sea walls constructed along the lakes in the watershed, and lush green lawns adjacent to open water, indicating fertilizer use in areas that lack adequate riparian and shoreline buffers. However, there were three locations where more specific issues were observed. There was one site where there was zero riparian buffer present adjacent to a residential property, and slight erosion of the streambank was observed at the site as well. The total length of the streambank needing a riparian buffer in the (verified through a desktop survey) is 743 linear feet. Two sites were identified as possibly having pasture runoff. One site on CR 250 has livestock in a pasture that frequently floods allowing for animal waste to wash into the adjacent stream during the floodwater recession back into the stream banks. The other location is on CR 600 near Duff Lake where cattle are in pasture directly adjacent to tributaries to Duff Lake. It appears the livestock are fenced out of the stream, however there is a high potential that animal waste will run directly into the stream due to the pasture’s proximity to the stream and the lack of riparian buffer. Table 3.4.16 lists the observations made during the survey, and the approximate length of the problem. Figure 3.42 shows the location of each of the issues discovered during the windshield survey, as well as the populated lakes where seawalls and excessive fertilizer application may be used.

Windshield Survey Observation	Potential Contaminant	Number or Length
Pasture Runoff	<i>E. coli</i> , Sediment and Nutrients	2
Lack of Riparian Buffer - Res	Sediment and Nutrients	743 linear ft

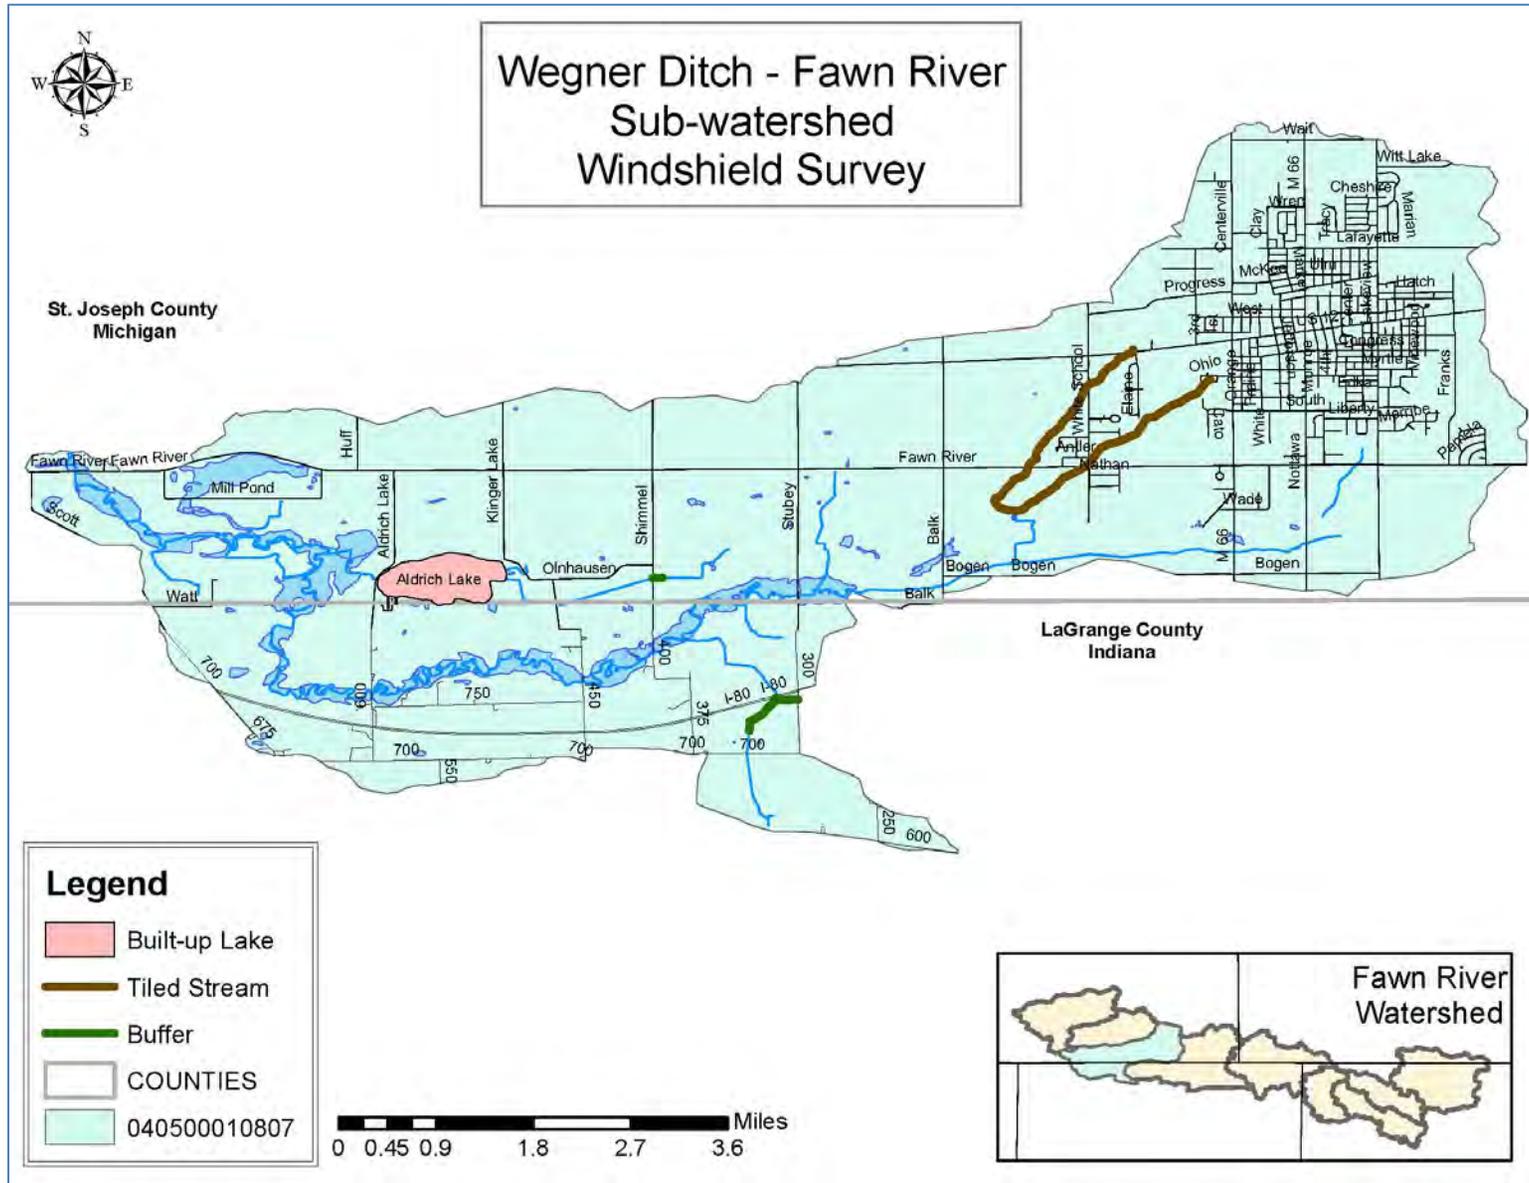
Figure 3.48: Windshield Survey Observations in the Wegner Ditch Sub-watershed

The windshield survey conducted as part of this project in May, 2014 revealed some common concerns scattered throughout the Wegner Ditch sub-watershed including agriculture land that lacks a riparian buffer along open water, sea walls constructed along the lakes in the watershed, and lush green lawns adjacent to open water, indicating fertilizer use in areas that lack adequate riparian and shoreline buffers. However, there were four locations where more specific issues were observed. There were three sites where there was zero riparian buffer present adjacent to agricultural land, and slight erosion of the streambank was observed at the sites as well. Two of the streams that lacked a buffer were also directly adjacent to I-80 so erosion may be more intense at those streams due to the runoff from the highway. The total length of the slightly eroded streambank needing a riparian buffer in the (verified through a desktop survey) is 3,177 linear feet. There were also two natural streams which run through the same agriculture field that have been tilled and no longer function as a natural stream. The tilled streams would benefit from daylighting as they are connected to a tributary of the Fawn River. The total length of the two streams that have been tilled is 10,977 linear feet. Table 3.4.21 lists the observations made during the survey, and the approximate length of the problem. Figure 3.48 shows the location of each of the issues discovered during the windshield survey, as well as the populated lake (Aldrich Lake) where seawalls and excessive fertilizer application may be used.

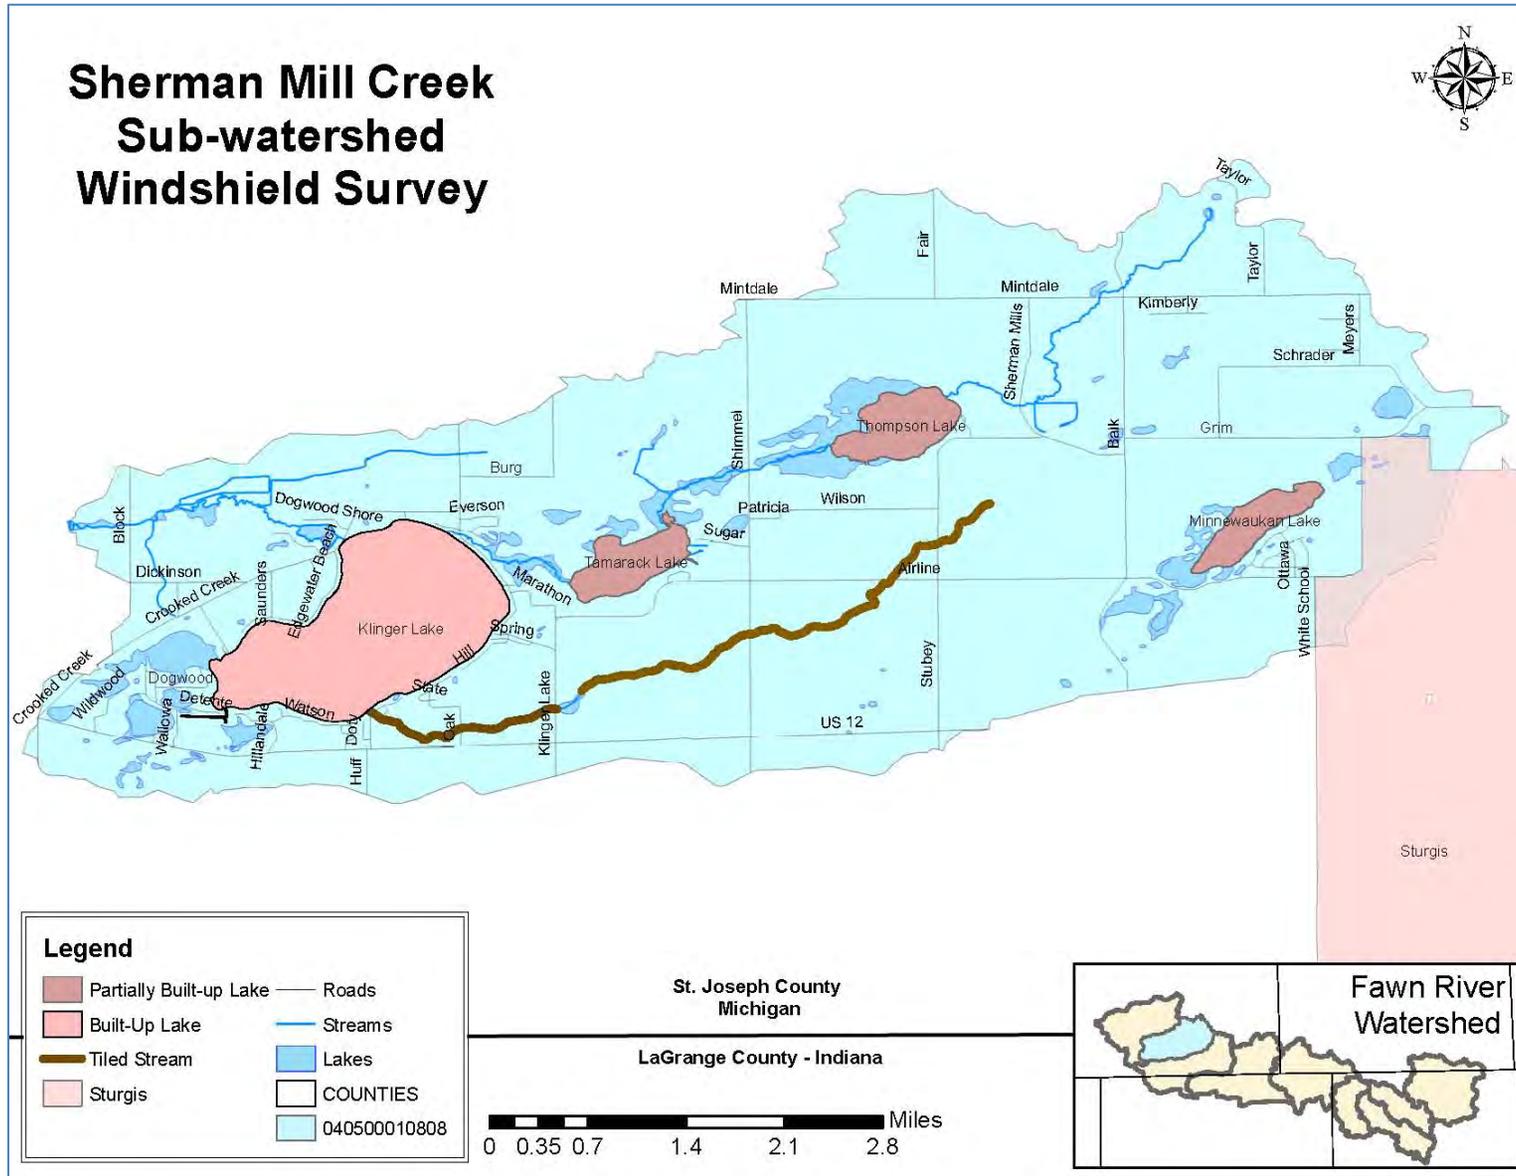
Figure 3.54: Windshield Survey Observations in the Sherman Mill Creek Sub-watershed

The windshield survey conducted as part of this project in May, 2014 revealed that Sherman Mill Creek has few problems associated with inadequate riparian buffers, though it could benefit from cover crops and increased conservation tillage usage. A small and sparsely populated area of Sturgis is located in Sherman Mill Creek sub-watershed, though Klinger Lake is completely developed, and three smaller lakes are partially developed, indicating that future development may be a possibility. Lush green lawns on lake residences were observed during the windshield survey, indicating fertilizer use in areas that lack adequate riparian and shoreline buffers. There was one natural stream, a tributary to Klinger Lake, that has been tiled and no longer functions as a natural stream. The tiled stream would benefit from daylighting. The total length of the stream that has been tiled is approximately 21,637 linear feet. Figure 3.54 shows the location of each of the issues discovered during the windshield survey, as well as the populated lakes in the sub-watershed where seawalls and excessive fertilizer application may be used.

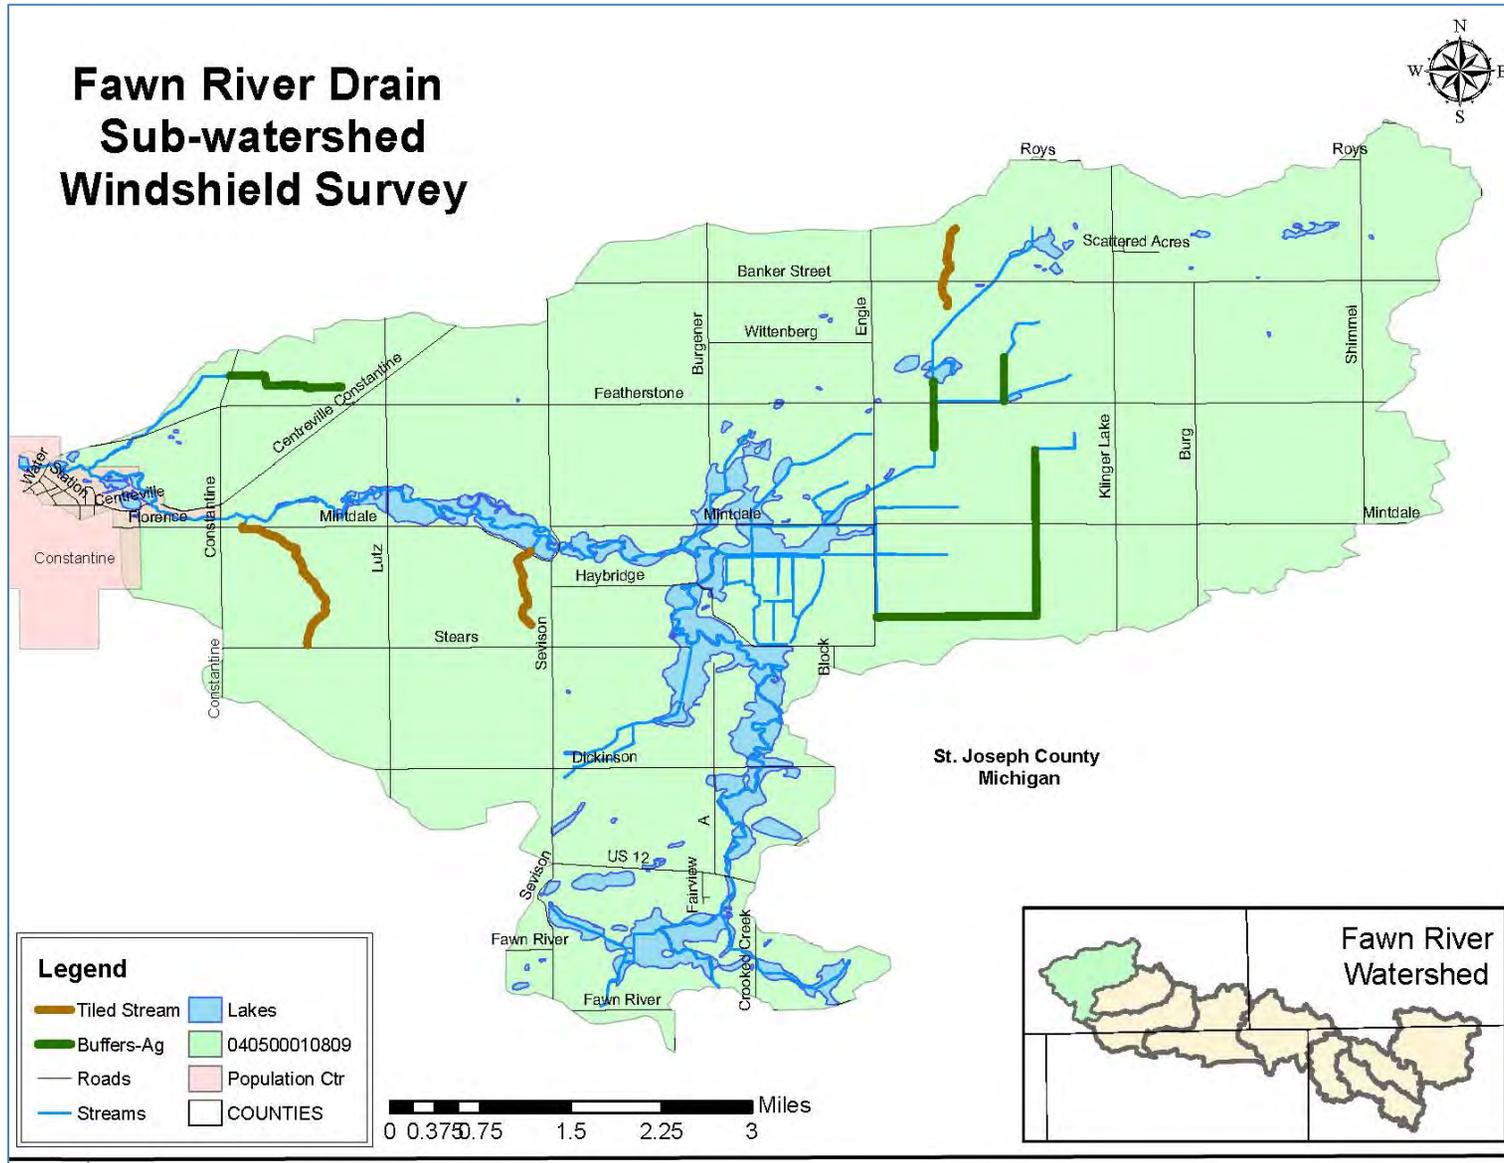
Figure 3.60: Windshield Survey Observations in the Fawn River Drain Sub-watershed

The windshield survey conducted as part of this project in May, 2014 revealed that the Fawn River Drain has more areas than other sub-watershed where agriculture fields have an inadequate riparian buffer resulting in streambank erosion. Observations made during the windshield survey, and verified through a desk top survey, reveal that approximately 10,086 linear feet of open water is in need of a larger riparian buffer to protect water quality. The Fawn River Drain also has several natural streams that have been tiled and converted to farm land, approximately 14,182 linear feet. The Village of Constantine is partially located in the Fawn River Drain. Constantine is at the confluence of the Fawn River and the St. Joseph River; therefore, it is important to manage polluted stormwater in Constantine. Unlike the other sub-watersheds, there are not any populated lakes located in the Fawn River Drain. It was also noted during the windshield survey, that the Fawn River Drain has far more channelized ditches and streams than any of the other sub-watersheds within the Fawn River watershed. Table 3.4.30 shows the observations made during the windshield survey, and the approximate length of the problem (verified through a desktop survey of aerial photography). Figure 3.60 shows the location of each of the issues discovered during the windshield survey.

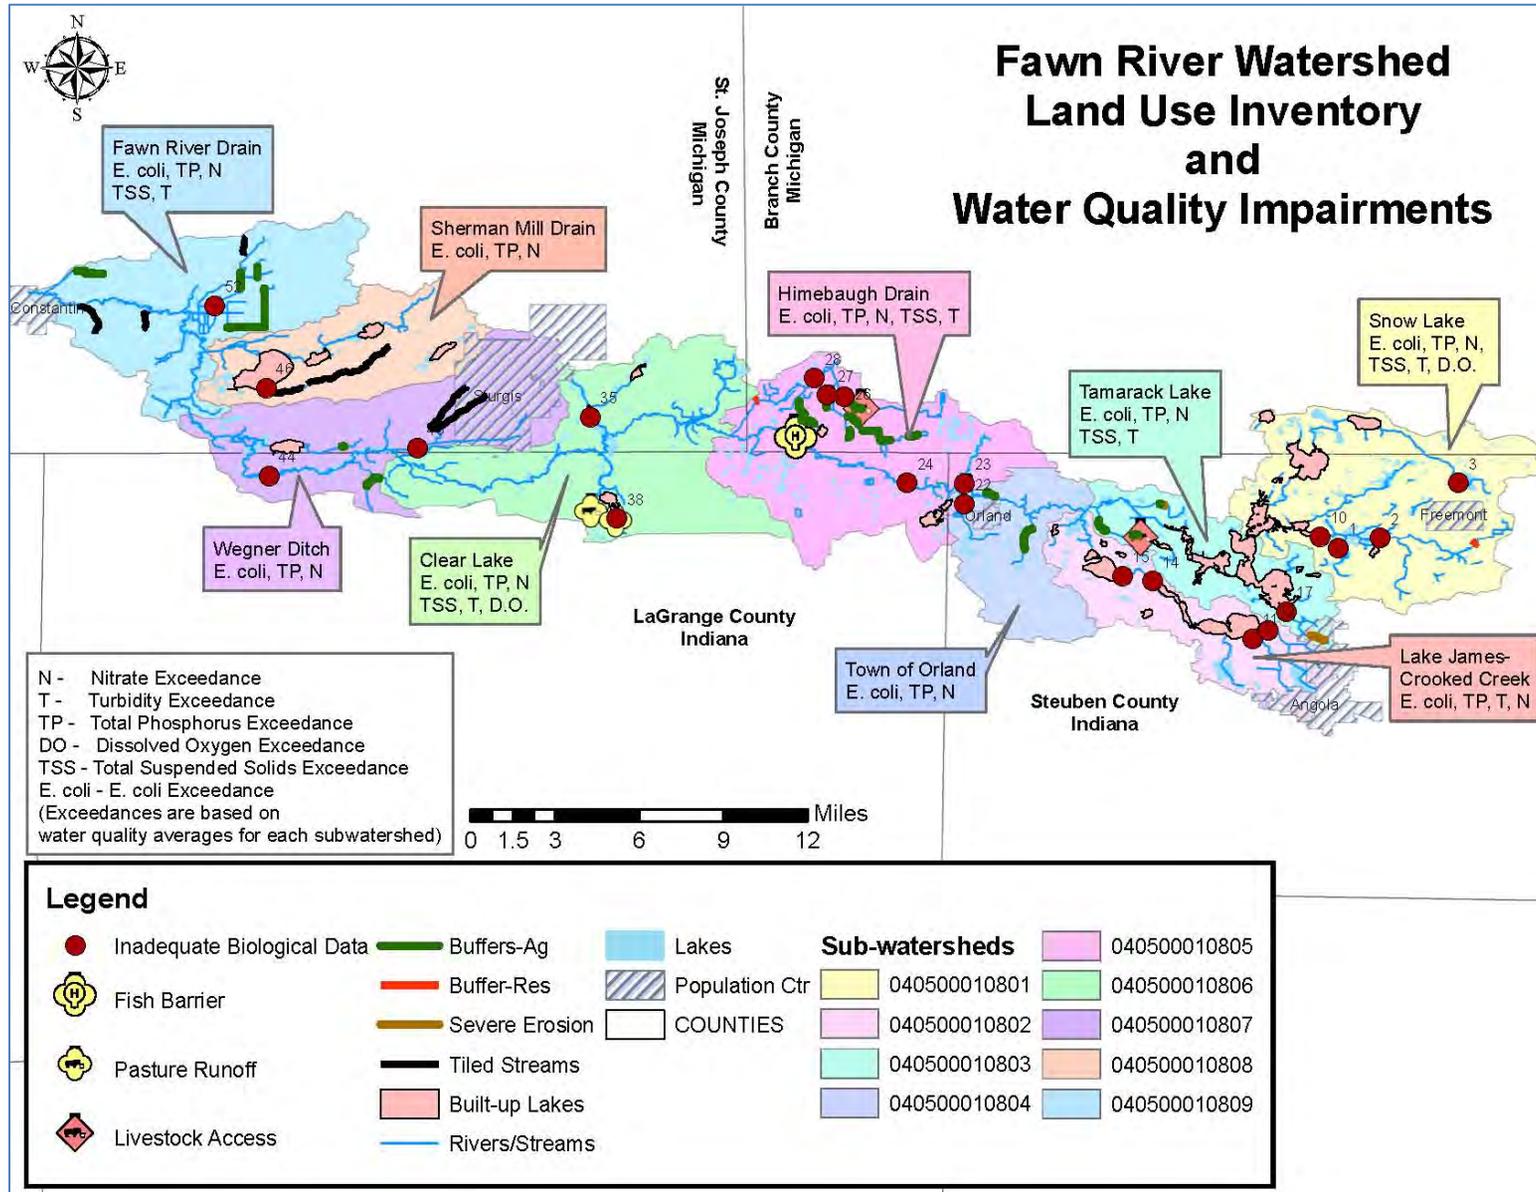
Figure 3.65: Land Use and Water Quality Summary of the Fawn River Watershed

To better understand the water quality problems in the Fawn River Watershed and what influences may be contributing to those problems, a map was developed outlining the water quality issues in each sub-watershed, as well as showing the results of the land use inventory, specifically those sites that were identified during the windshield survey, where inadequate macroinvertebrate and/or habitat data was found as well as other points of interest that may be contributing to the degradation of water quality (Figure 3.65). As can be seen in the map below, *E. coli*, Nitrates, and Phosphorus levels were elevated in every sub-watershed and TSS and turbidity were elevated slightly in scattered sub-watersheds. It can also be seen in Figure 3.65 that biological data was poor at sample sites downstream of populated areas, as well as at sites located on streams or ditches that have been modified, or where livestock issues were noted during the windshield survey.

The windshield survey revealed several possible contributors to the degradation of water quality in the Fawn River watershed including mowed residential lawns that have little to no riparian and/or shoreline buffer. Often times, stormwater runoff from urban areas can carry bacteria from pet waste and excess fertilizer and pesticides, as well as road salt, oil and grease and other pollutants. These urban issues transcend to the lake communities as well. However, lake residents can exacerbate the problems by installing hard surface seawalls which can increase erosion, as well as not provide the vegetation necessary to decrease the velocity of storm flow carrying nutrients, bacteria and other pollutants, prior to it discharging into the lake. Some more direct sources of pollution identified during the windshield and desktop survey are; two sites where livestock have direct access to open water and two sites with pasture runoff,

49,027 linear feet of riparian buffer needed where slight erosion is beginning to occur as well, 4,465 feet of streambank with severe erosion, 56,210.26 feet of stream that has been tiled and would benefit from being daylighted, a culvert under a bridge providing a barrier for fish migration, nearly 15,373 acres of wetland lost since pre-settlement times, and extensive irrigation use, especially in St. Joseph County. Each of these sites and observations made during the windshield survey provide a direct means for pollution to enter surface water and can be remediated with the implementation of BMPs.
