Critical Findings

Joseph D. Clark, PE, NBIS Director
Bailey H. Spear, EI, Design Engineer

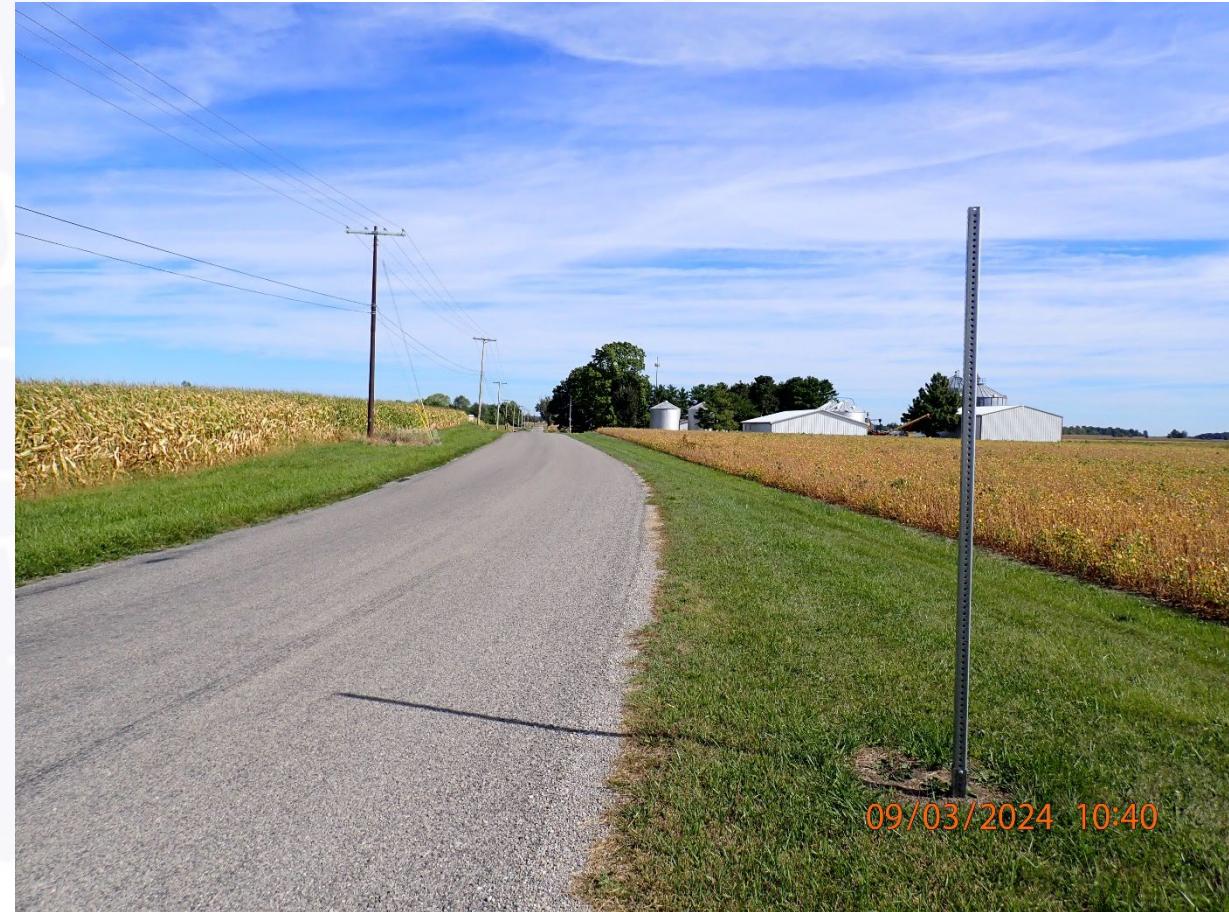
- Yes! Safety, Severe (30d)
- The missing weight limit sign is a regulatory sign and considered a critical finding. However, the missing W16-3aP distance plaque is not a regulatory sign and is not considered a critical finding. However, it should still be reported as a maintenance item.

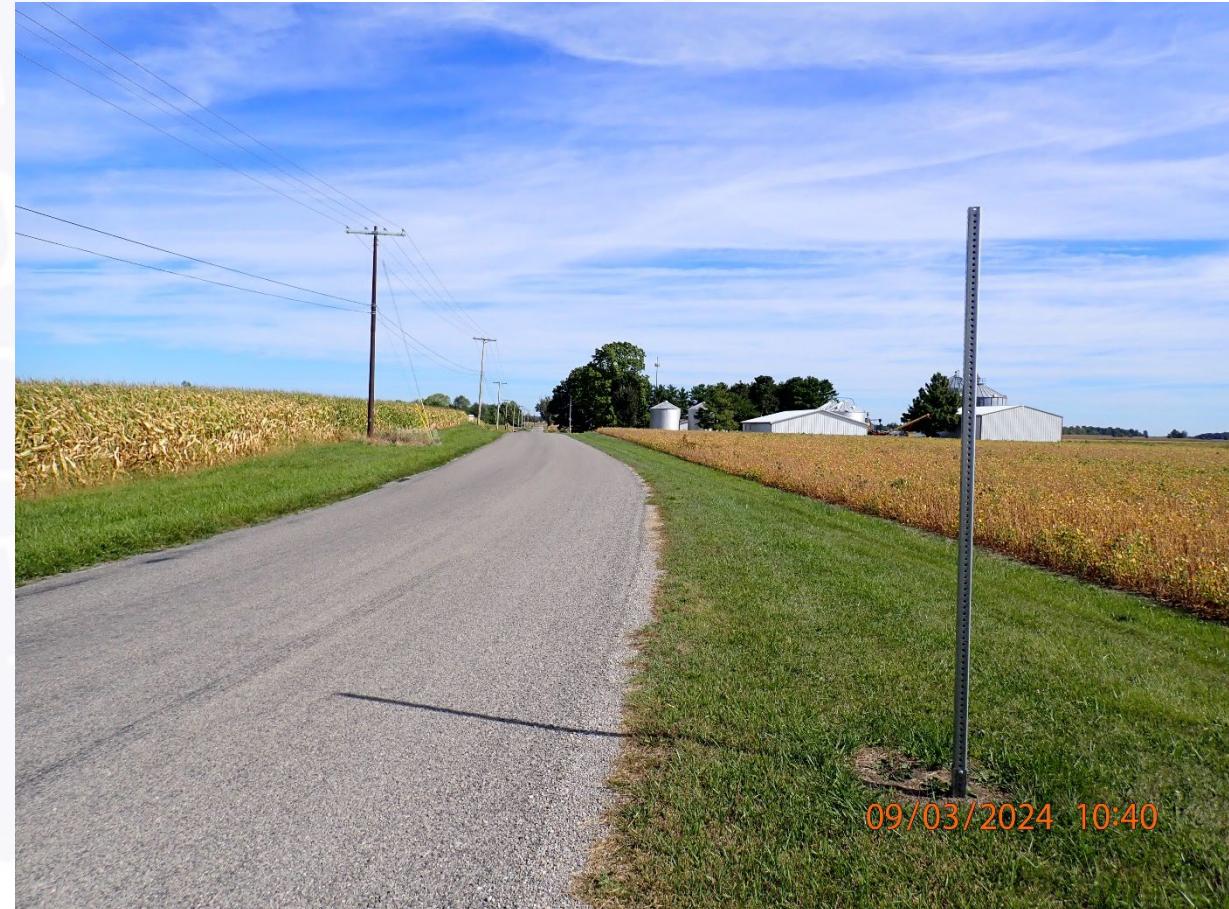
- A bridge is required to be posted Narrow Bridge. The sign is in place at the east approach, but it is missing at the west approach.

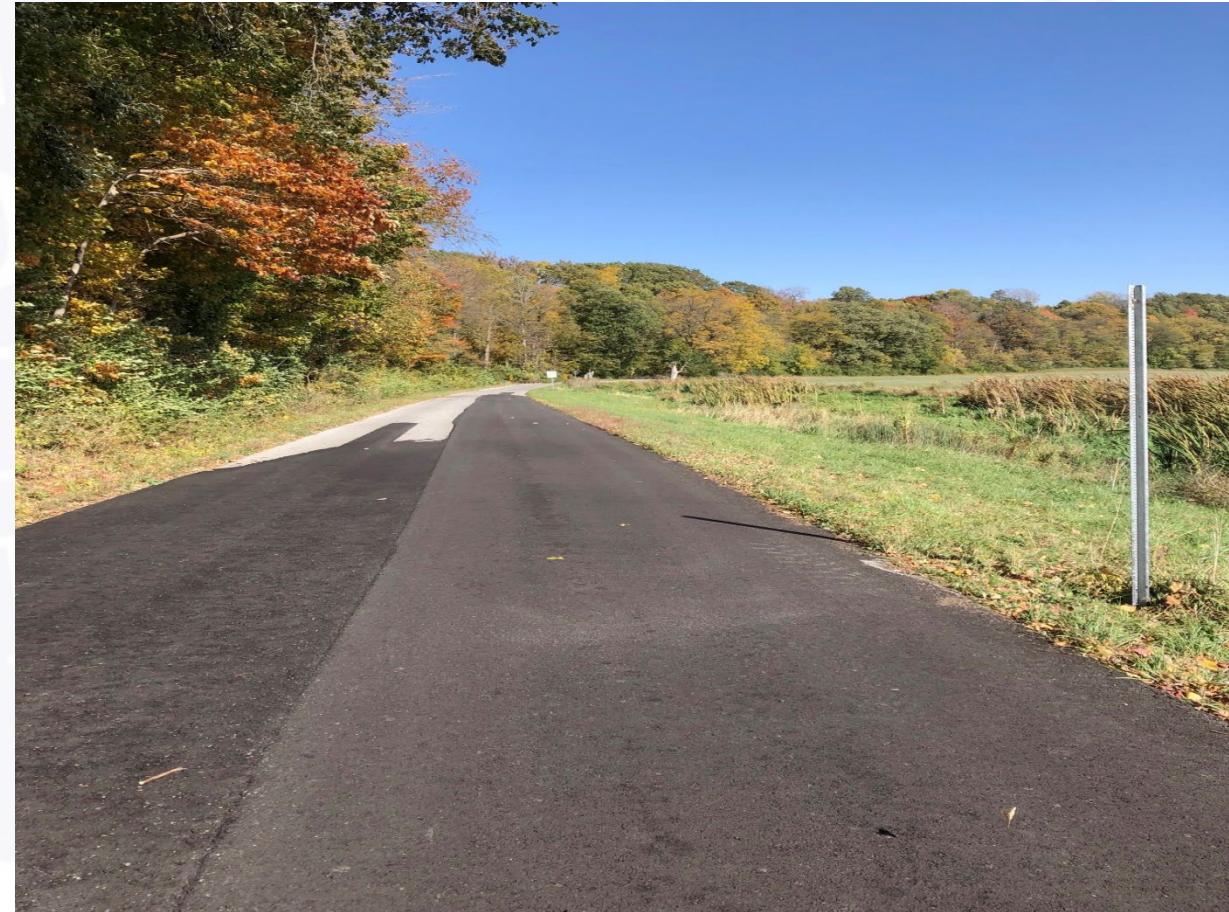
- No!
- Narrow Bridge signs are considered warning signs and not regulatory. Therefore, they are not considered critical findings.

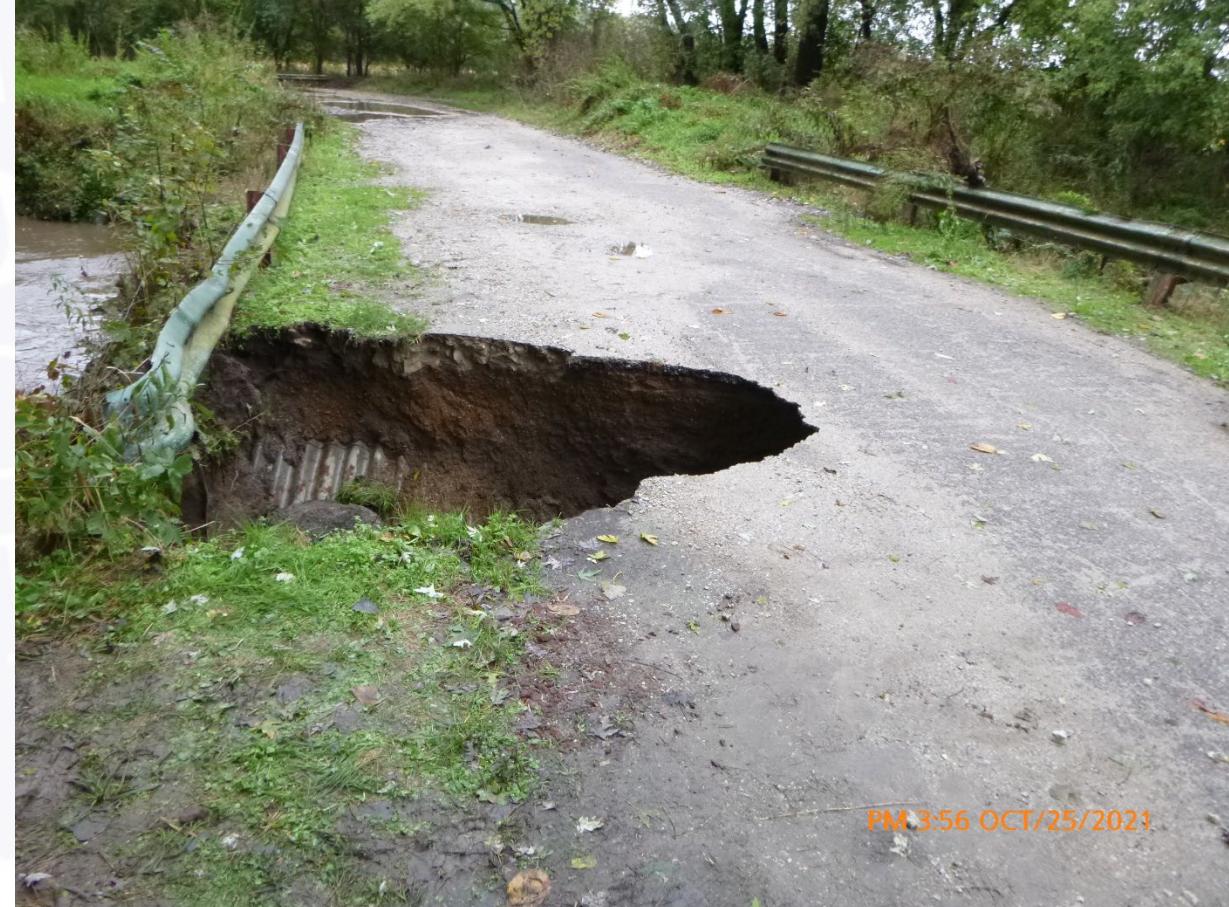
- Yes! Safety, Urgent (3d)
- The roadway is washed out, creating a safety hazard for the motor vehicles. Even though the other half of the roadway is intact, it is still dangerous for vehicles to cross. There is a high potential the remaining roadway will be washed out. The traffic volume information is irrelevant.
- Be careful when approaching this type of defect, as there may not be backfill under the asphalt and it could collapse. Ensure you don't become the Critical Finding!

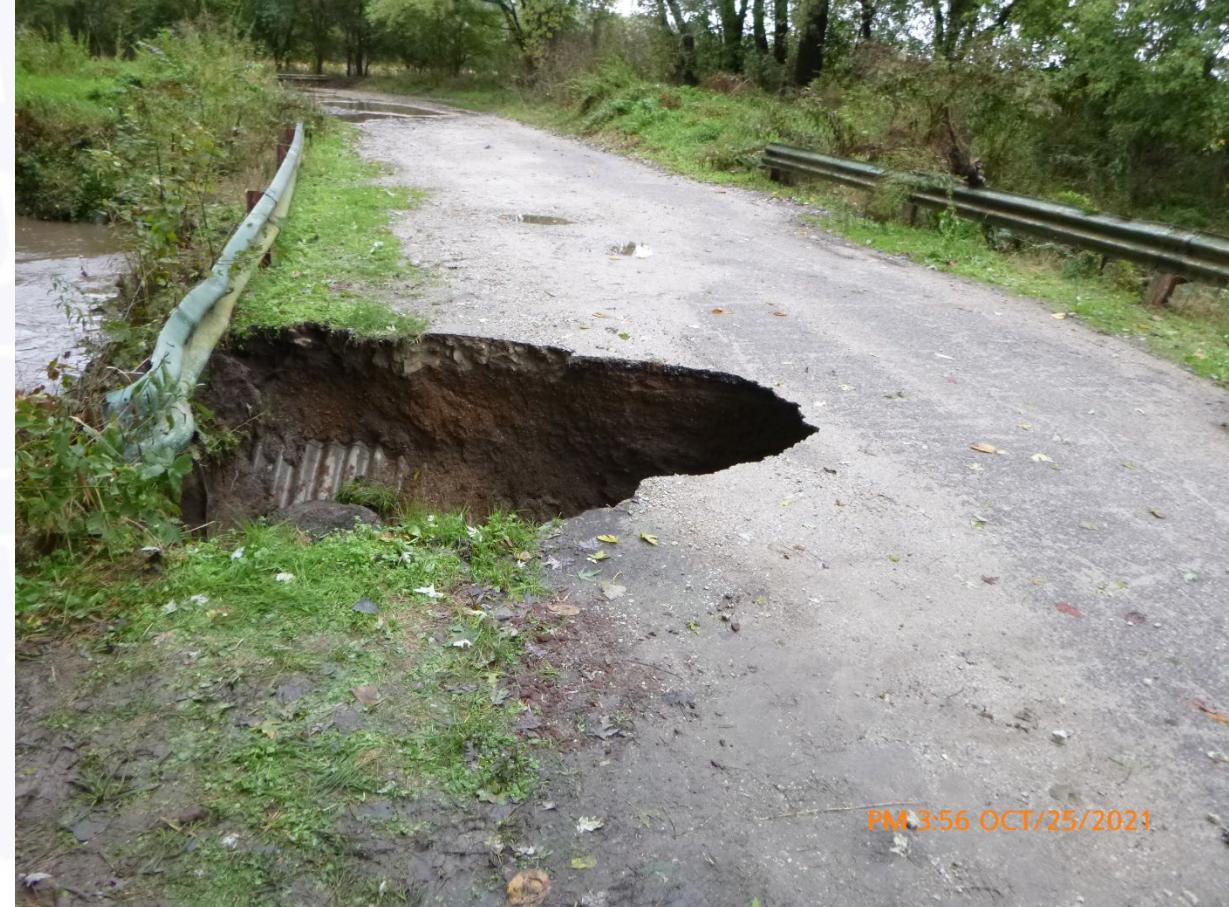
- A bridge was discovered to have a 48" long x 30" wide void through the deck at the northeast corner. Other "soft" areas of deck were noted in the northwest and southeast corners. The rest of the area was determined to be in good condition.

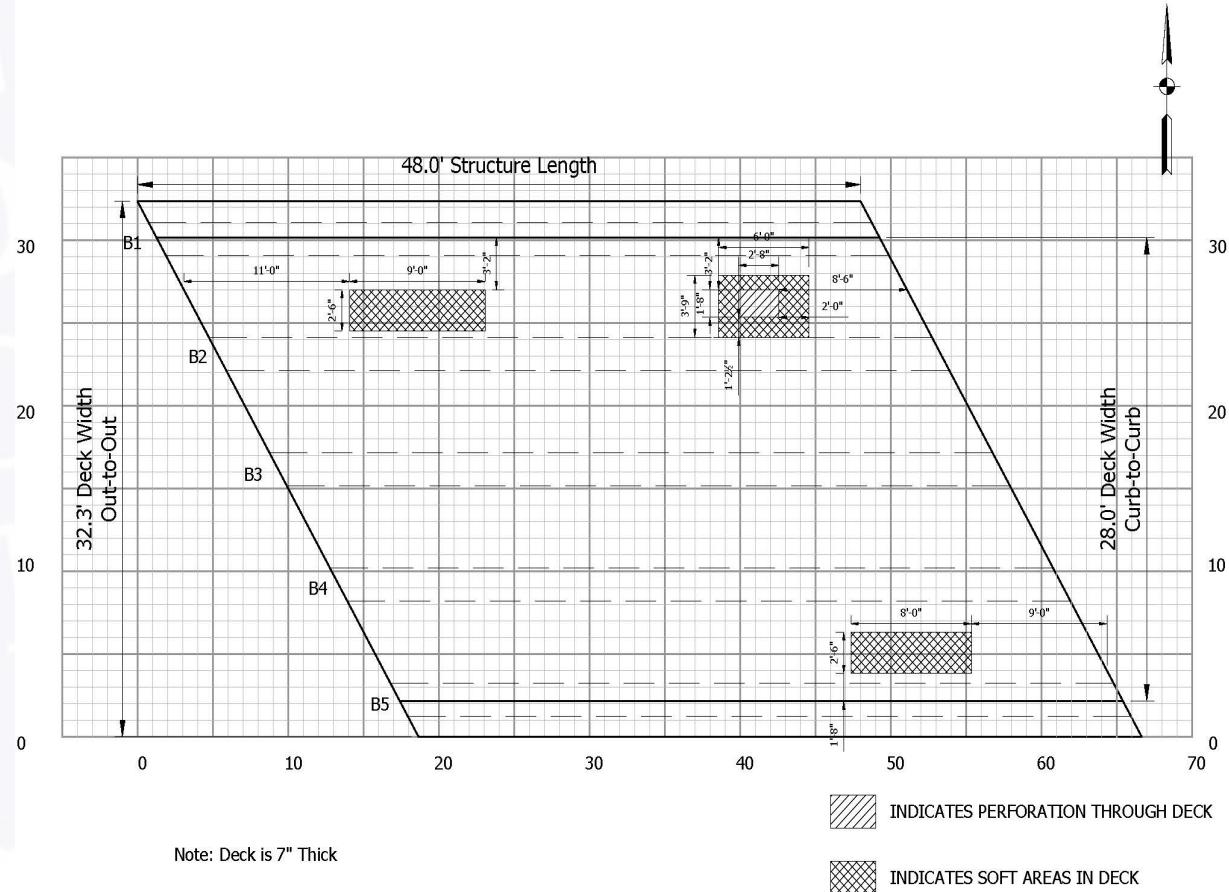
- Yes! Structural, Urgent (3d)
- Holes and “soft” areas in the deck are considered a structural issue. Therefore, the bridge should be partially closed and restrict traffic away from the affected areas.

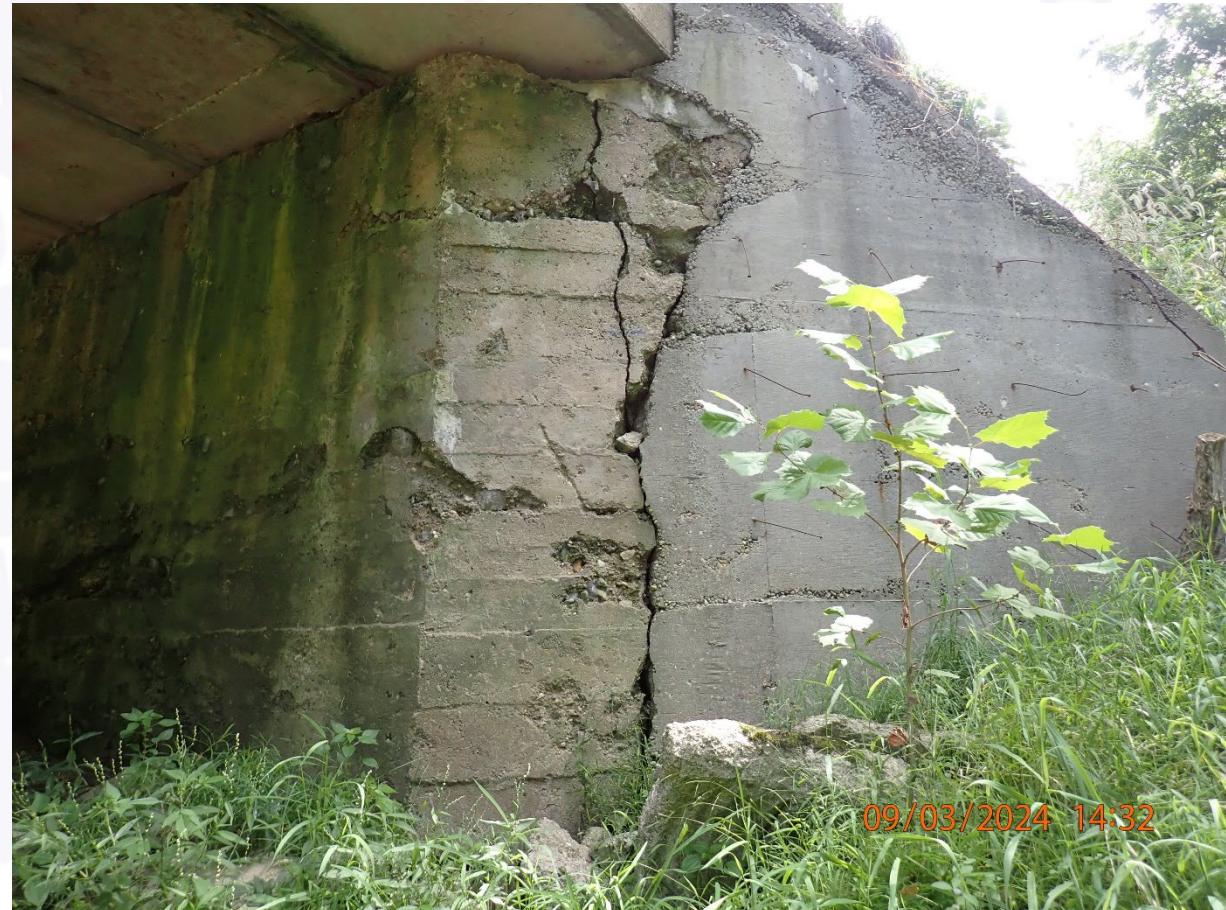
- No!
- The crack and spalls haven't changed since the last inspection. As there is no settling or loss of bearing, a critical finding is not warranted. However, this should be monitored closely.

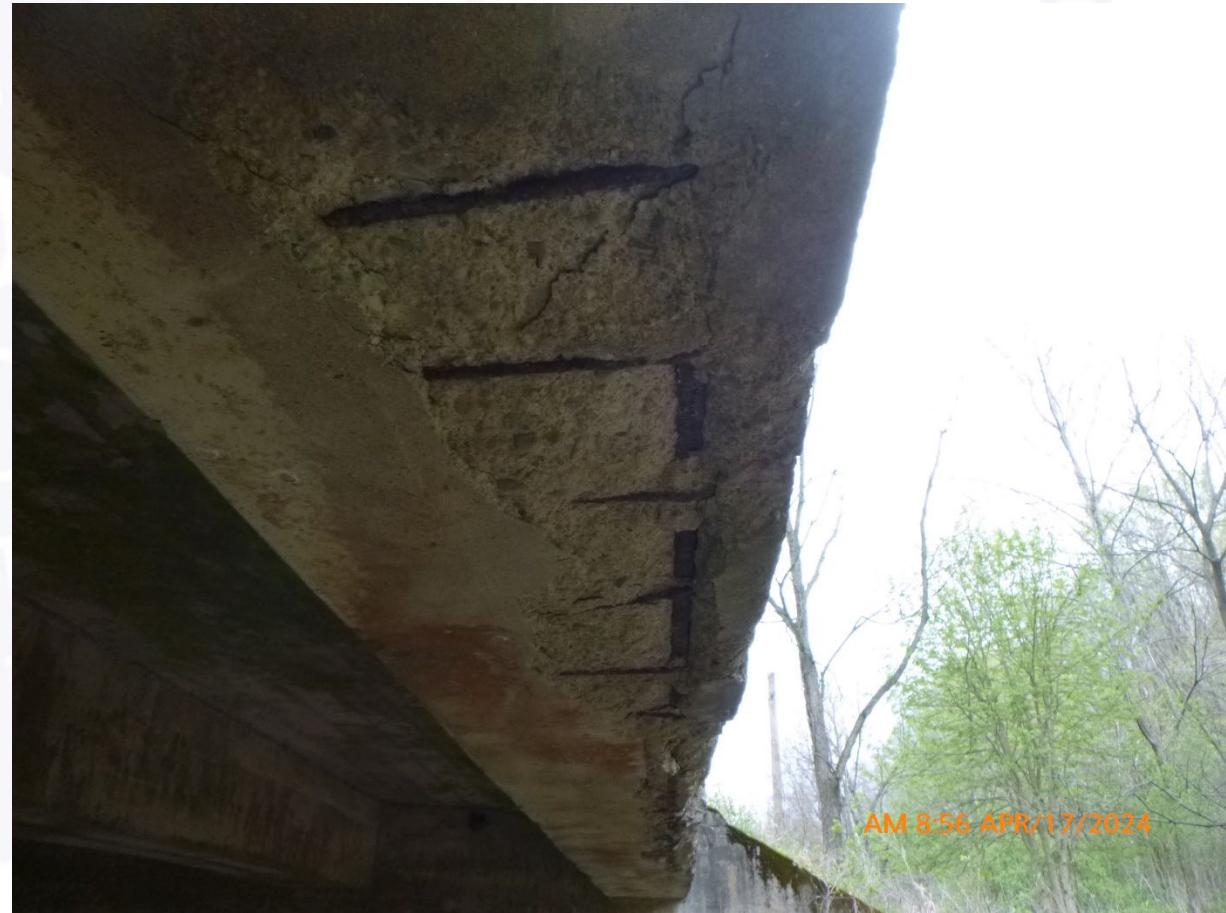
- No!
- The spalls haven't changed since the last inspection and account for only 10% of the area. This is not enough to warrant a critical finding. The bridge has been load rated and is posted correctly; if no weight limit signs were in place, and all rating factors were above 1.0, then a critical finding may be warranted.

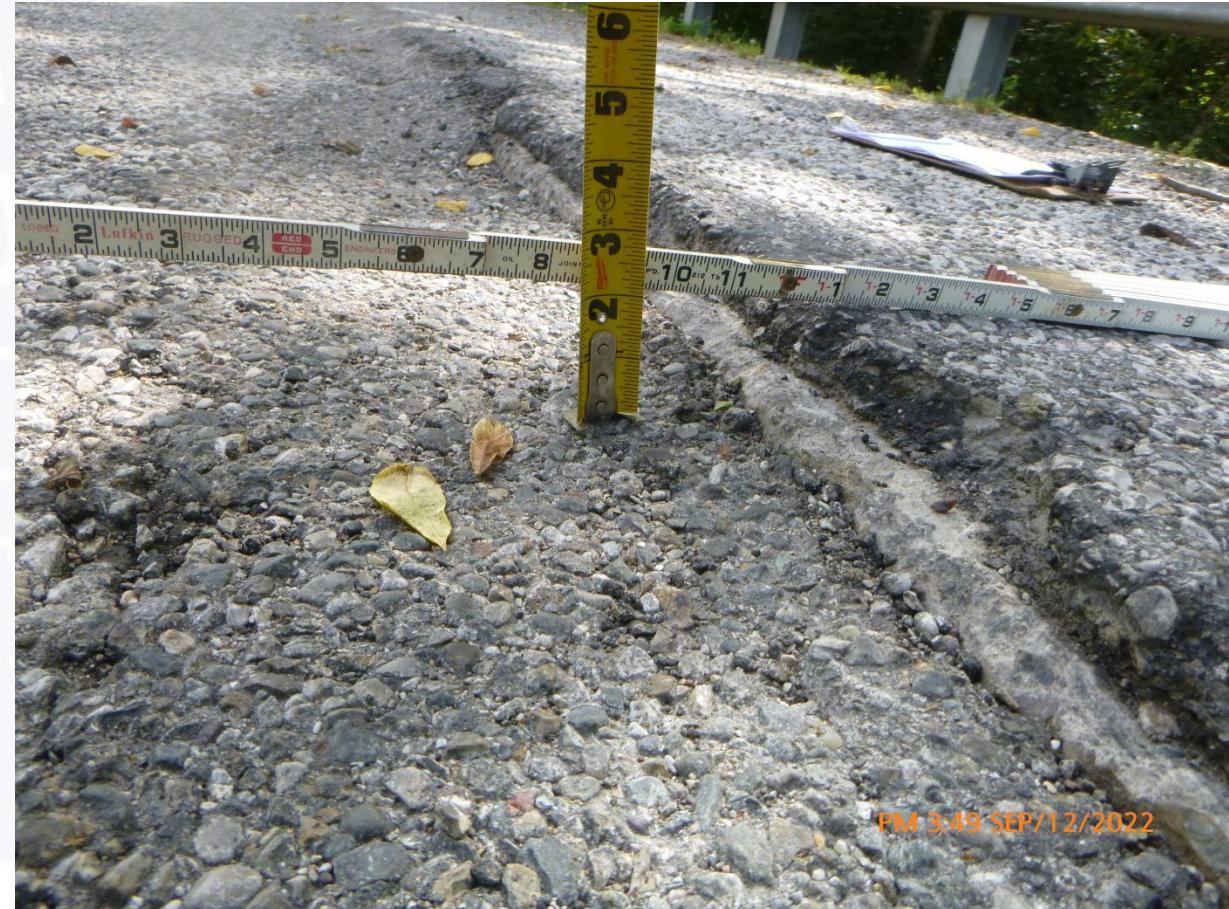
- Yes! Structural (Urgent, 3d)
- The beam has permanently deflected, indicating it is acting independently from the rest of the beams, and is overstressed. Bridge should be closed (or partial lane closure) until repairs can be made.

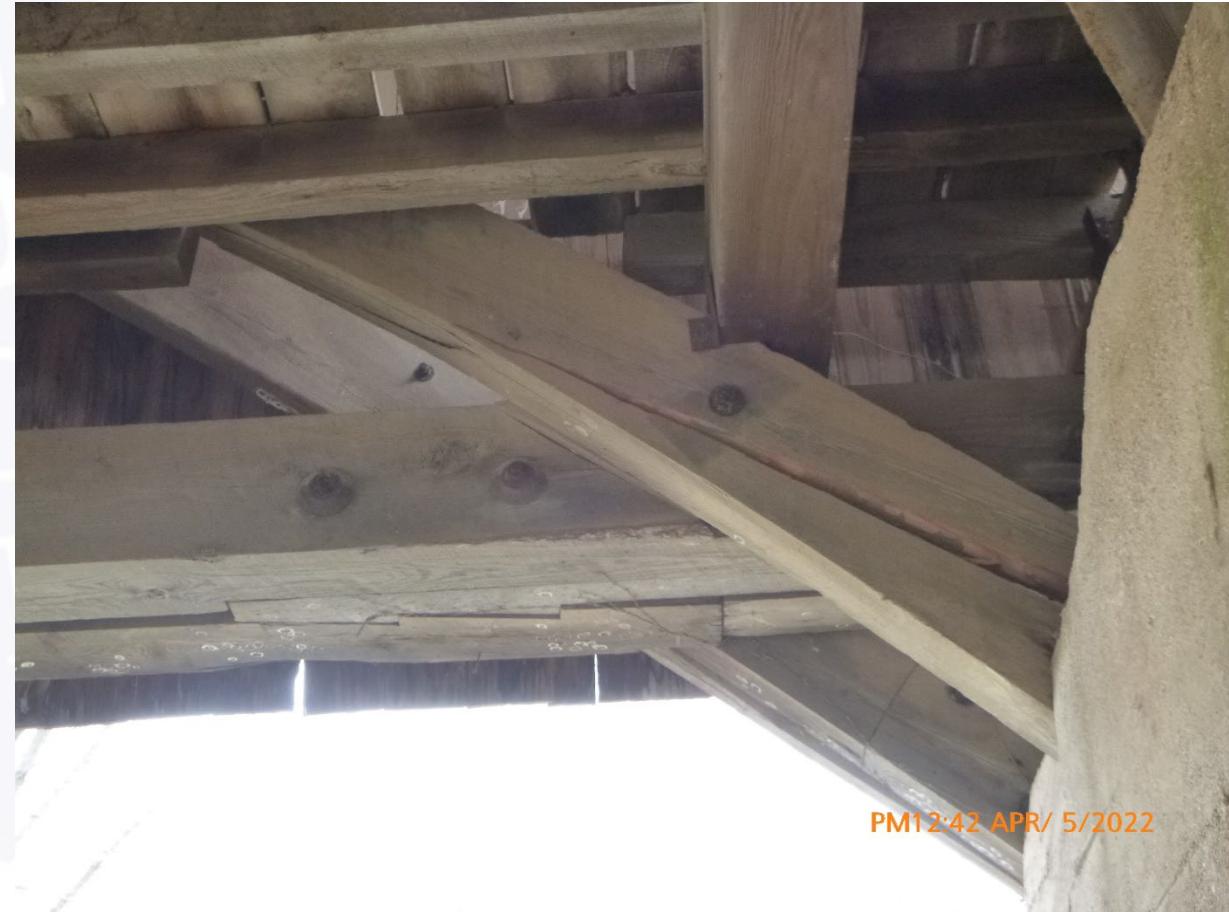
- Yes! Structural, Urgent (3d)
- Even though in most cases the floor beams control the load rating, this is a primary member that is ineffective and is causing additional stress on the other members. Until a new load rating is performed and shows that there is no reduction in load, a critical finding should be filed and the bridge closed.

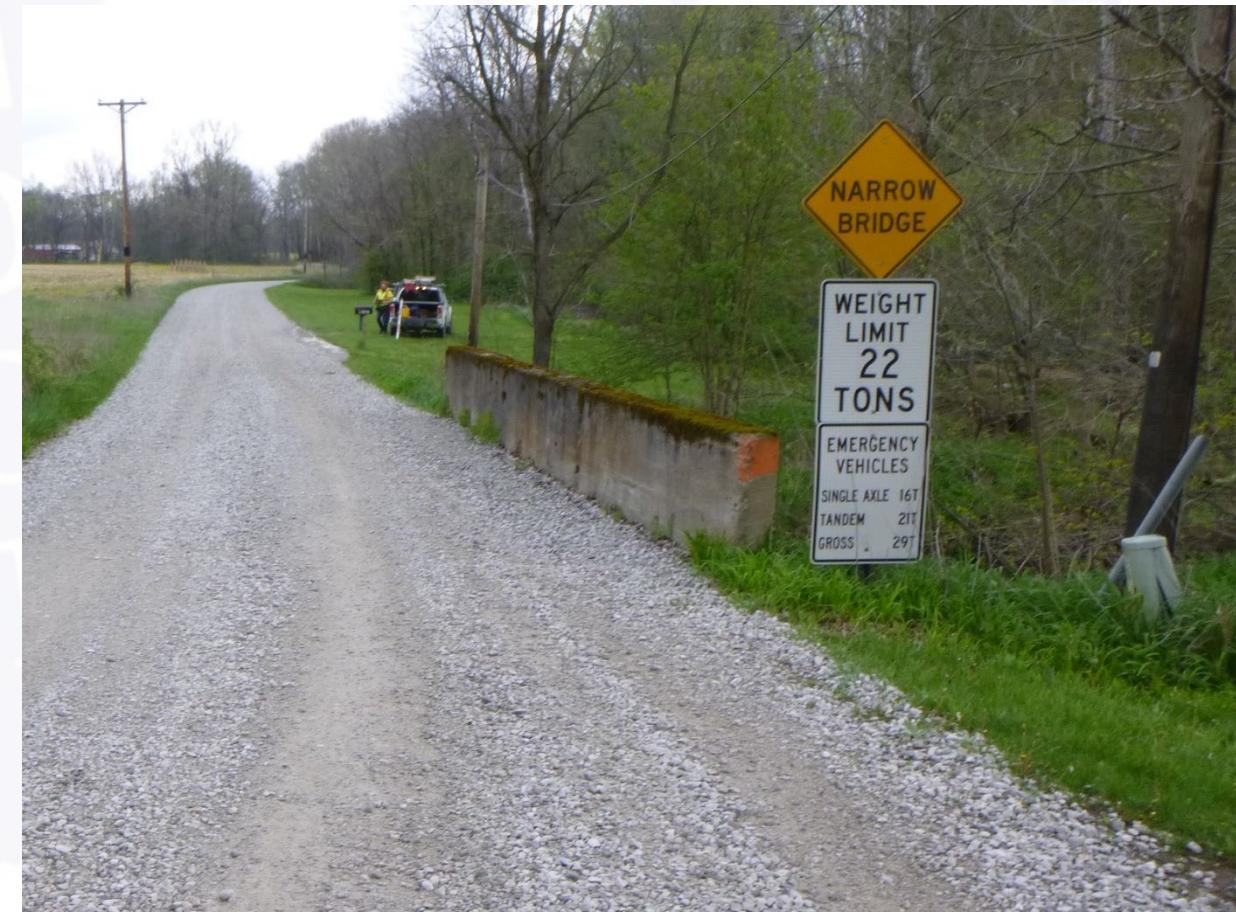
- Yes! Safety, Severe (30d)
- From INDOT Standard Drawing E 802-SNPL-02:
 - Minimum 5 ft. to bottom of single sign
 - Minimum 4 ft. to bottom of secondary sign

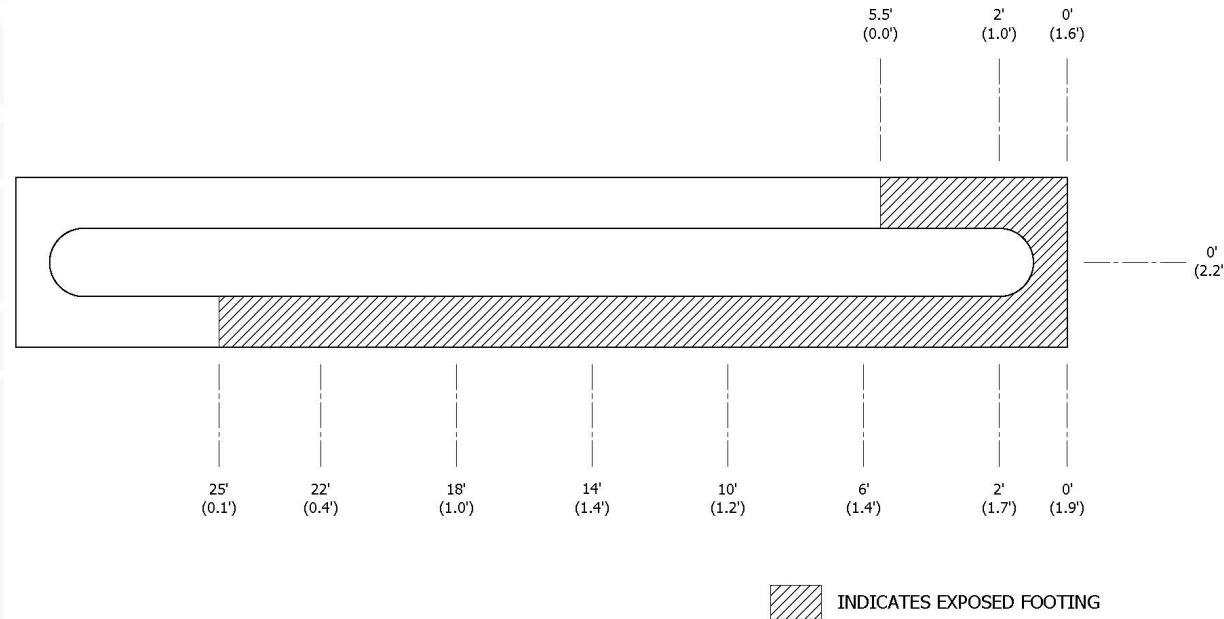
PIER 4 | SCOUR PROFILE AGAINST SUBSTRUCTURE

- A bridge has scour around one of its piers. A sketch was made showing that the top of the footing was exposed for approximately half its area. The upstream end was exposed up to 2.2'. There is no undermining. There was no sketch from the previous inspection, and it only noted that the footing was exposed 1.0' at the upstream end. The plans indicate that the footing is 2.5' deep and is on pilings 20' deep and on good soil.

- No!
- Although the scour is increasing and the footing is almost undermined, the pier is on 20' deep piling and on good soil. Following Form 6B in the BIM (Scour Assessment), item 113 (scour rating) would be a 5. This bridge is not scour critical, and since the pier is determined to be stable with the structural integrity not affected, no critical finding is necessary. However, continued monitoring is important!
