**WATERS REPORT
INDIANA DEPARTMENT OF TRANSPORTATION (INDOT)
STATE ROUTE 234 IN MONTGOMERY COUNTY, INDIANA
SMALL STRUCTURE REPLACEMENT
DES. NO.: 1800155
ASSET ID #: CV 234-054-46.50**

**SUBJECT: SR 234 Small Structure Replacement
DES No. 1800155, Montgomery County, Indiana**

Asset Name: CV 234-054-46.50
Facility Carried: SR 234

Culvert Inspection Report

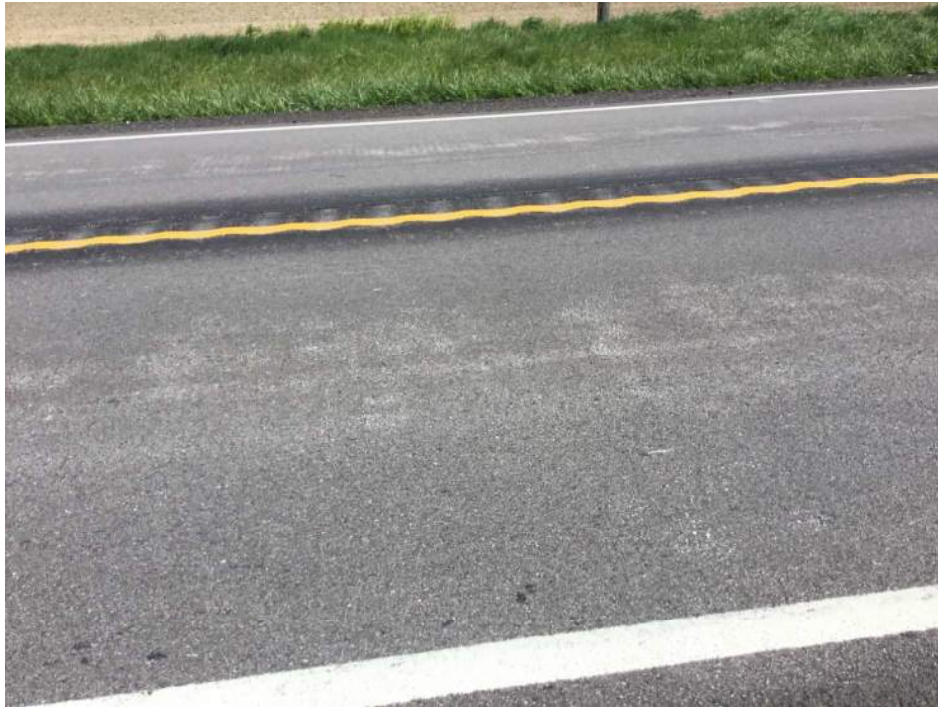
PHOTO 3 Condition
Description Pavement condition above culvert

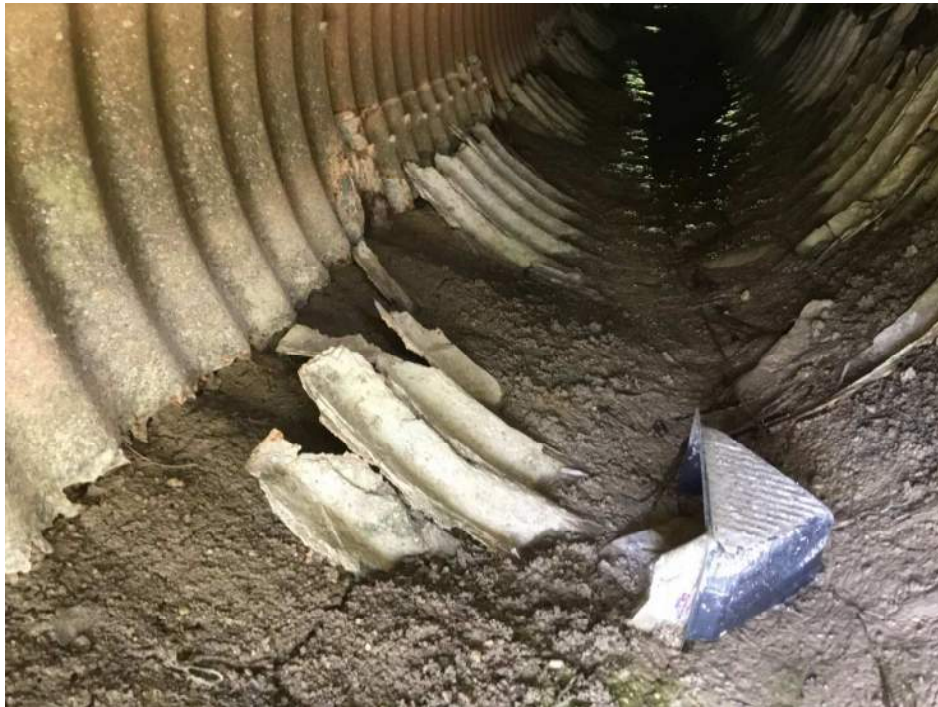
PHOTO 6 Condition
Description Looking South through middle pipe showing no bottom

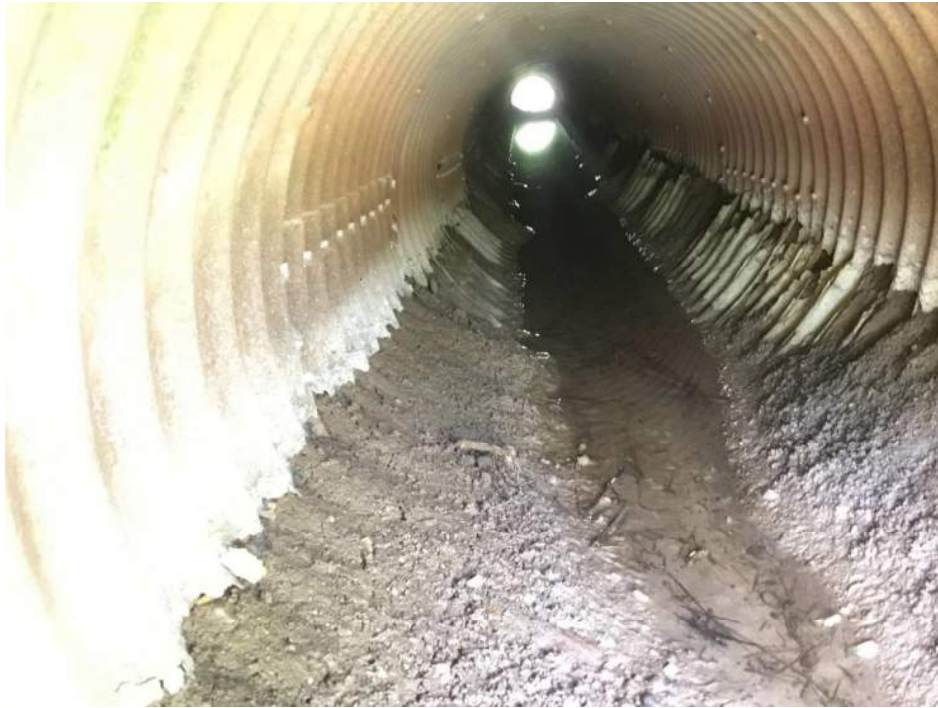
PHOTO 7 Condition
Description Looking south through west pipe

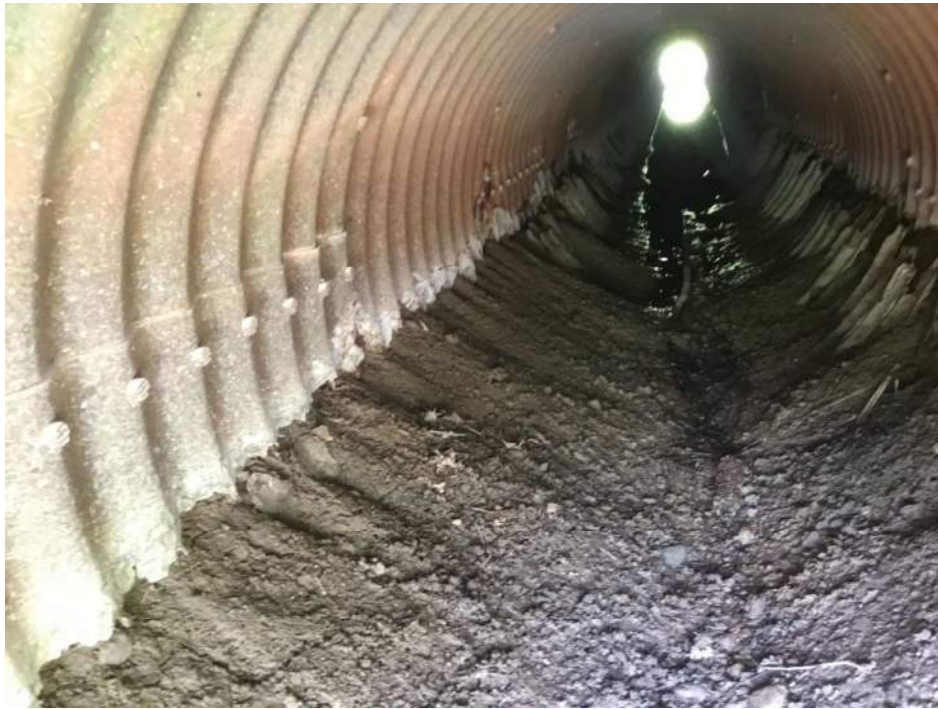
PHOTO 8 Condition
Description Looking South through East pipe

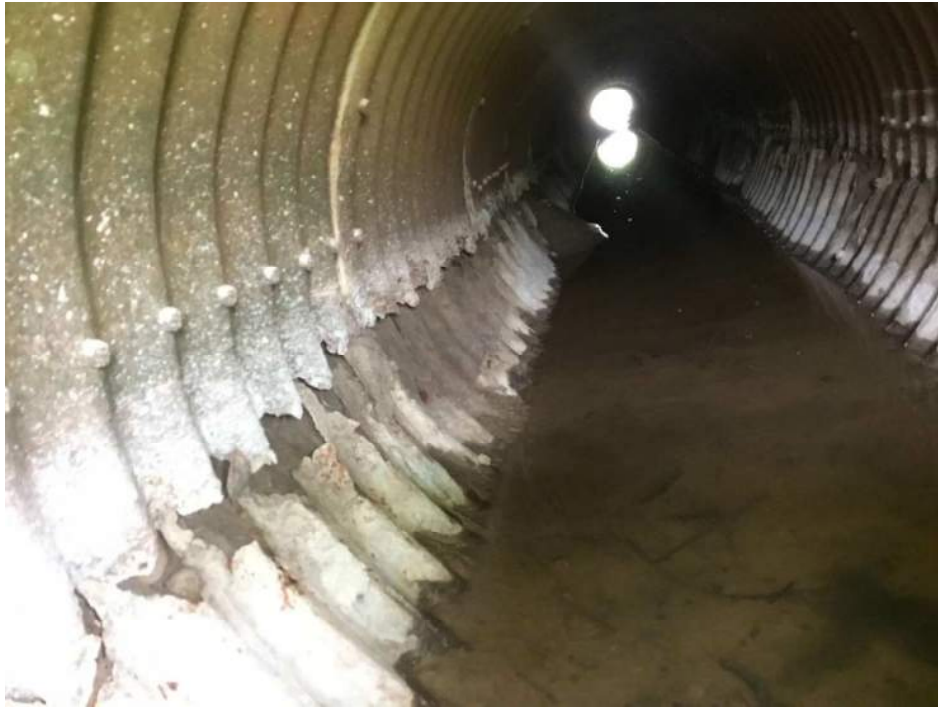
(62) Culvert Rating Comments: *There is severe rusting throughout the structure. The head walls have severe spalling with exposed rebar at both ends of the structure. All three pipes have rust holes along the water line. All pipes are still maintaining their shape. No obvious changes since last inspection.*

PHOTO 9 Condition
Description Looking North through middle pipe showing rusted through areas

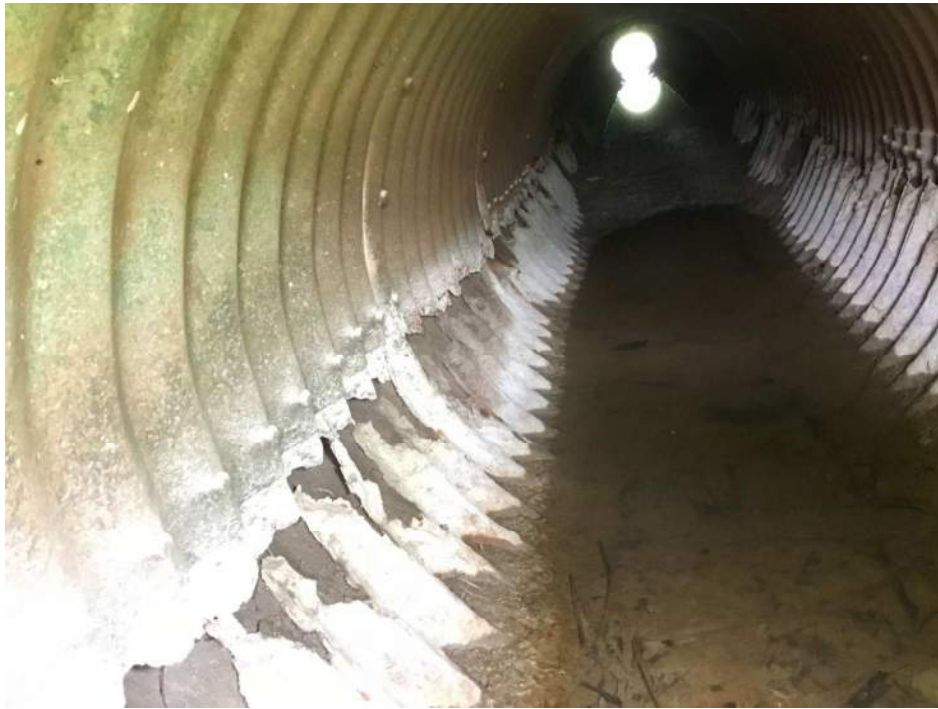
PHOTO 10 Condition
Description Looking North through West pipe

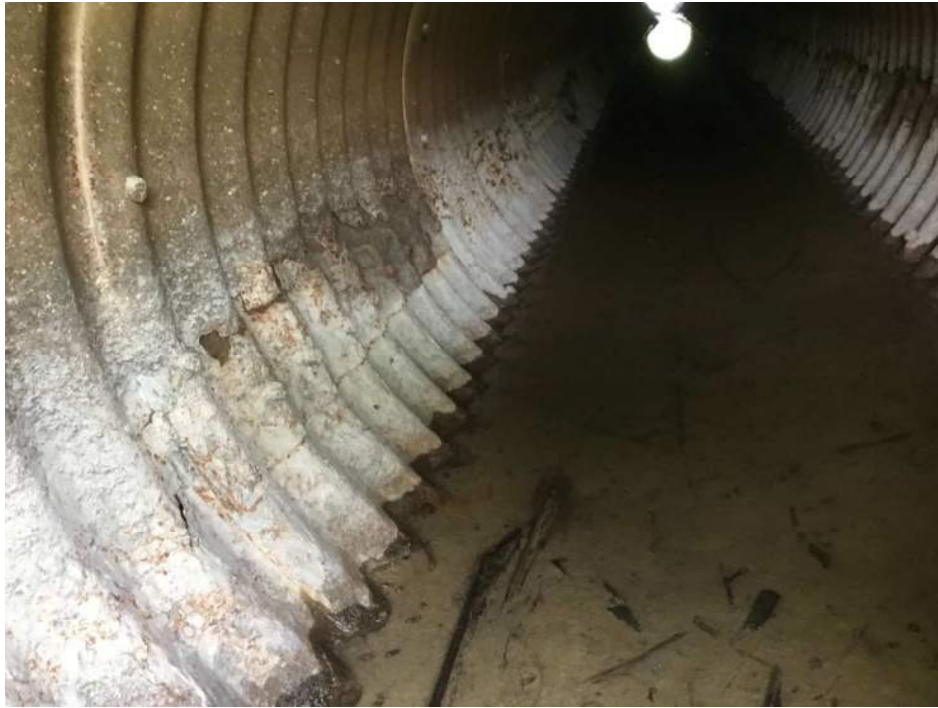
PHOTO 11 Condition
Description Looking North through East pipe
