Bridge Inspection Report

Inspector: Stephen F. Hurst
Inspection Date: 04/14/2021

Asset Name: I65-024-04229
Facility Carried: BNBI
I-65 NB

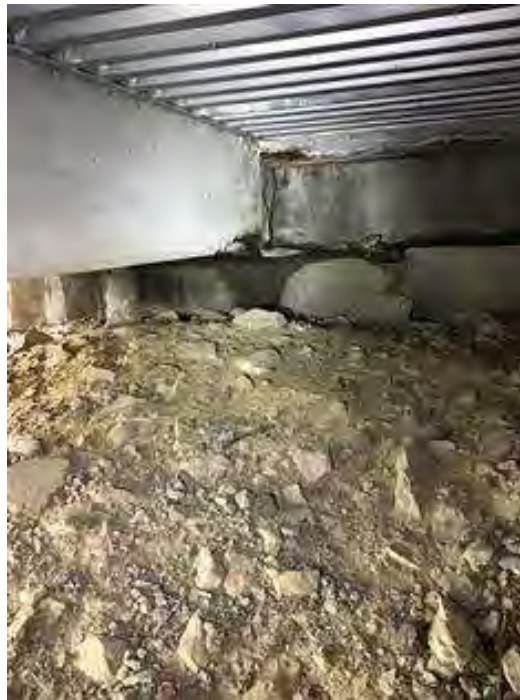
PHOTO 8 Condition, Other
Description Span A Beam 6. 3'x6"x6".

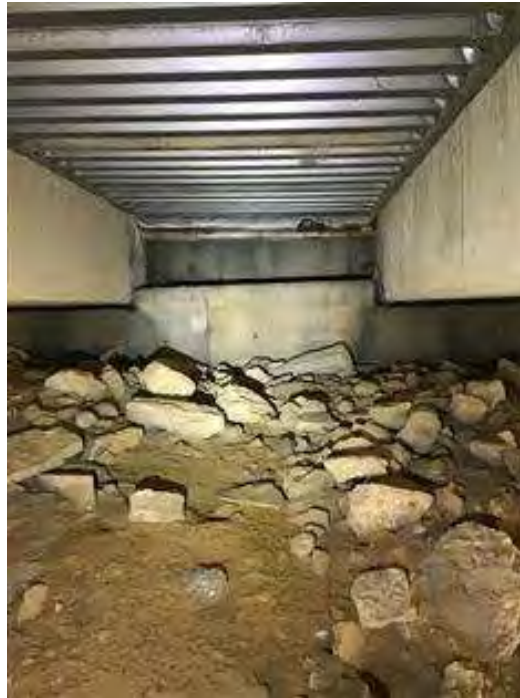
PHOTO 11 Condition, Other
Description Span C Beam 3 and Beam 4.

Span A at Abutment 1 (south): Cracking on both sides Beam 4. 4" spall on west side Beam 5.
 Span C at Abutment 4 (north): Spall 2' long on east side Beam 1. Cracking on both sides Beam 2. Cracking on west side Beam 6.
 General: Staining at the ends of the beams due to the leaking joints. A few curtain walls have minor cracks and delamination.

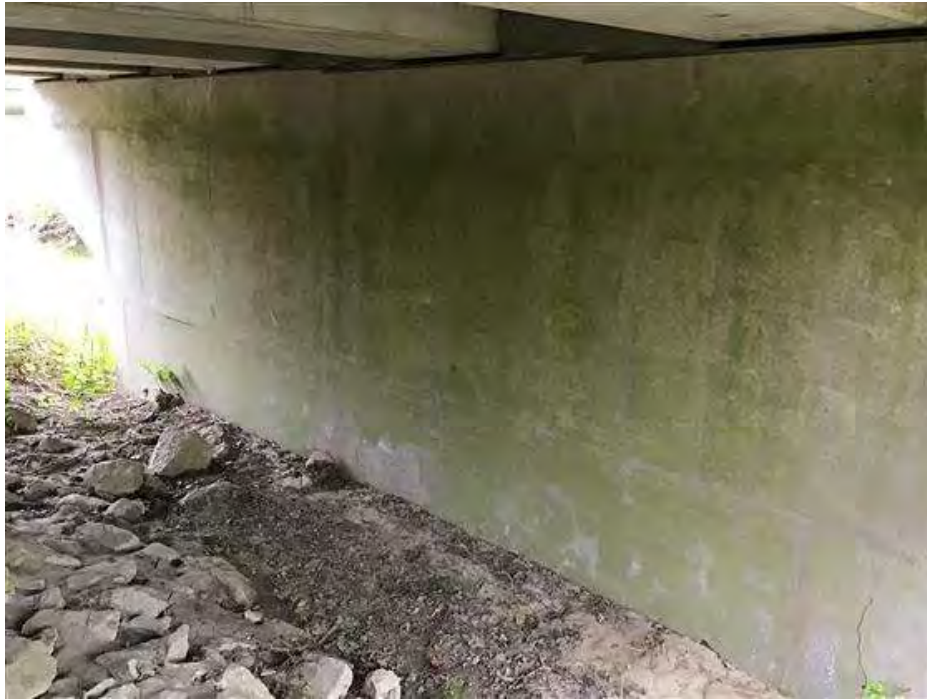
PHOTO 13 Condition
Description Pier 2 south side.

General: Minor cracks in both abutment back walls and bent caps.
 Pier 2: Minor spalling with exposed rebar on the north side.
 Pier 3: Minor spalling with exposed rebar on both sides.

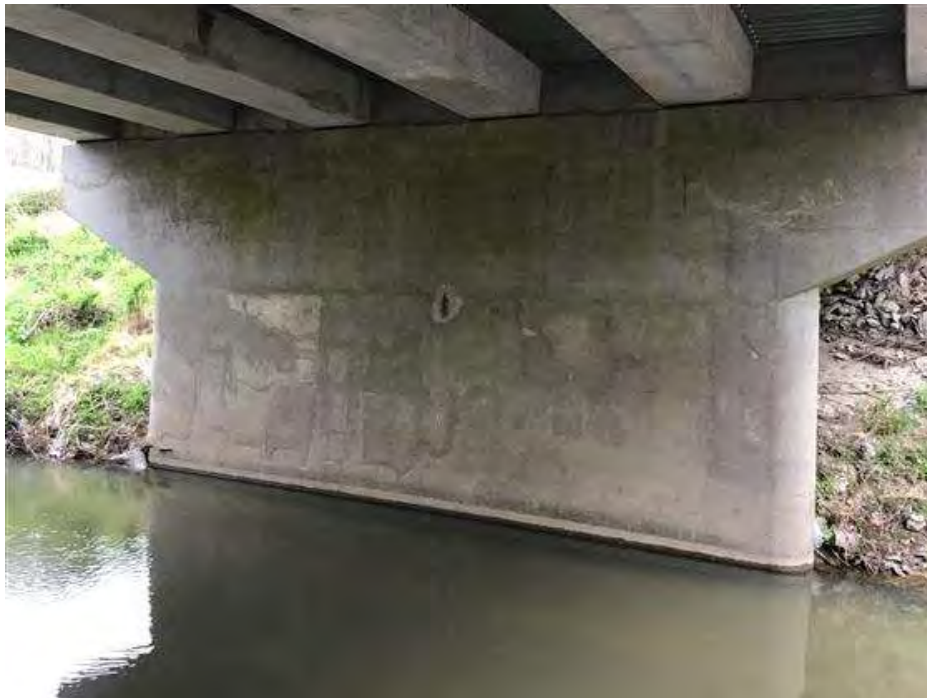
PHOTO 14 Condition
Description Pier 3 south side.

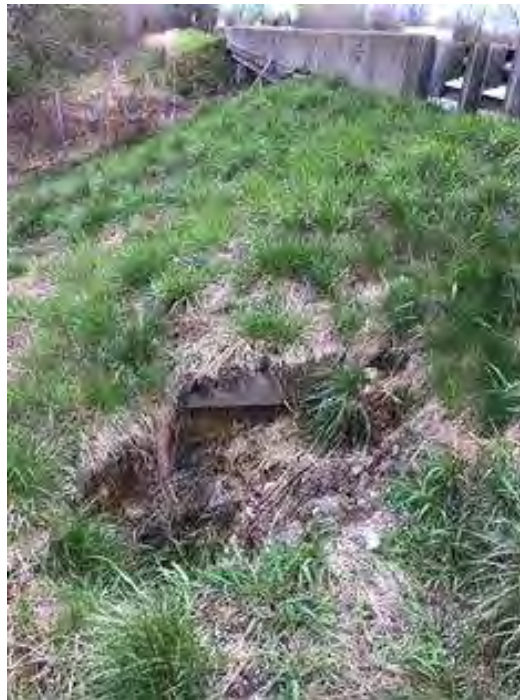
PHOTO 18 Condition, Other, Maintenance - Bridge
Description Sinkhole on northeast shoulder just past north approach.

Deficiency Description:
There is a sinkhole on the east shoulder at the north end of the north approach slab.

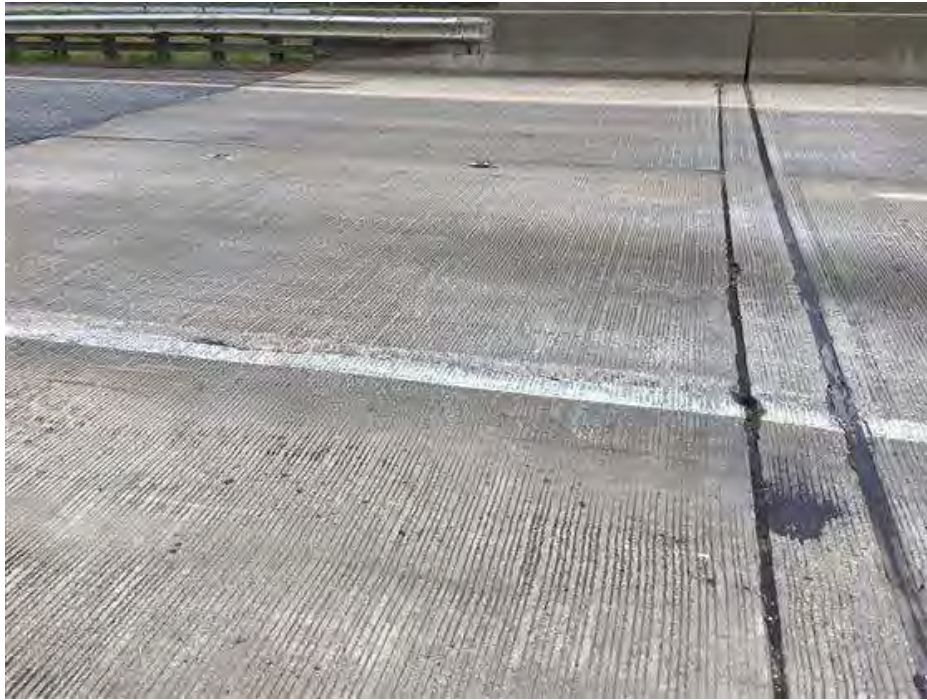
PHOTO 5 Condition
Description North joint and approach slab.

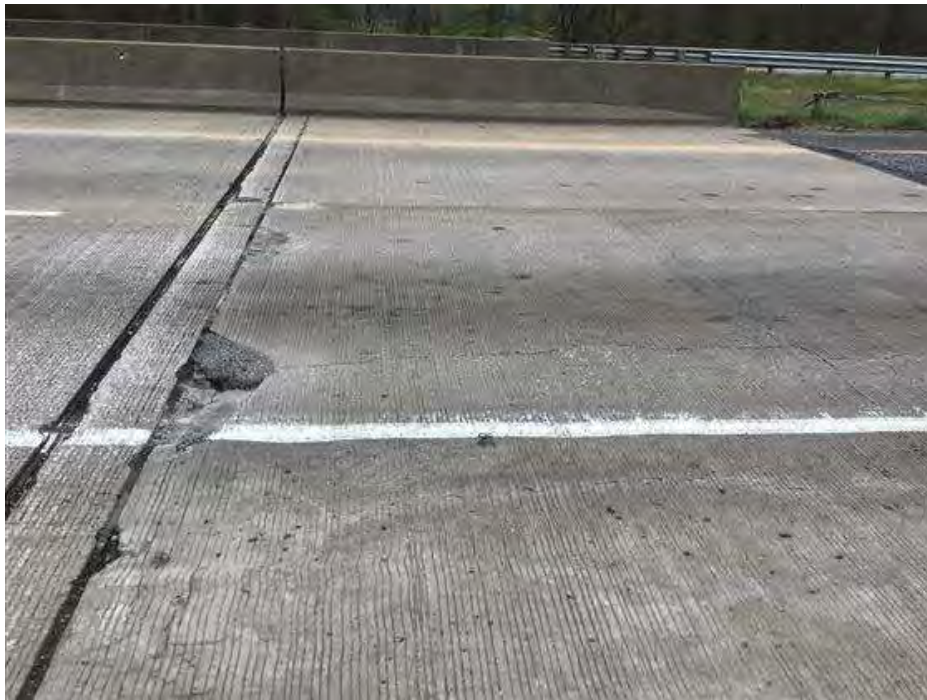
PHOTO 6 Condition
Description South joint and approach slab.

Longitudinal and transverse cracking in south slab. Spall in south slab at joint.

Deficiency Description:
Pothole in south slab. 1'x1'

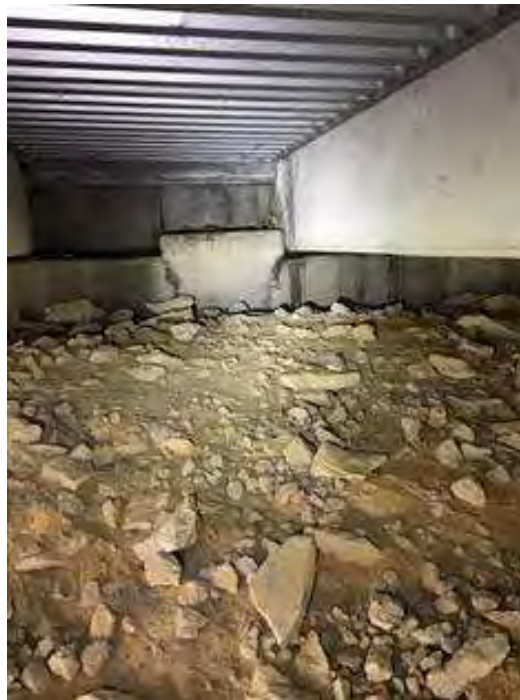
PHOTO 8 Condition
Description Span A Beam 4.

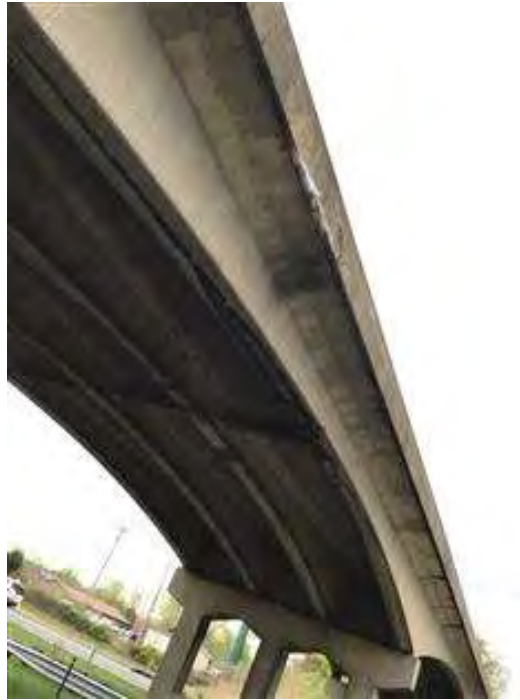
Span B: Beam 1 has multiple spots with small spalls and delamination on the north side. Beam 4 has a small spall in bottom flange. South vertical side of south coping/curb has cracking and delamination.

PHOTO 9 Condition
Description Span B south coping and beam.

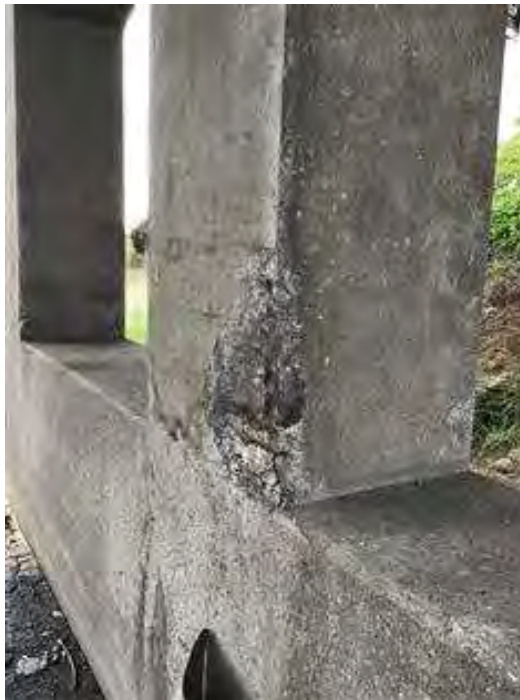
Abutment 1: Minor cracks in backwall.
 Pier 2: There is spalling on all 3 columns with the worst on column 3.
 Pier 4: There is spalling on column 2.
 Abutment 4: Minor cracks in backwall.

PHOTO 16 Condition, Other
Description Pier 4 column 2.

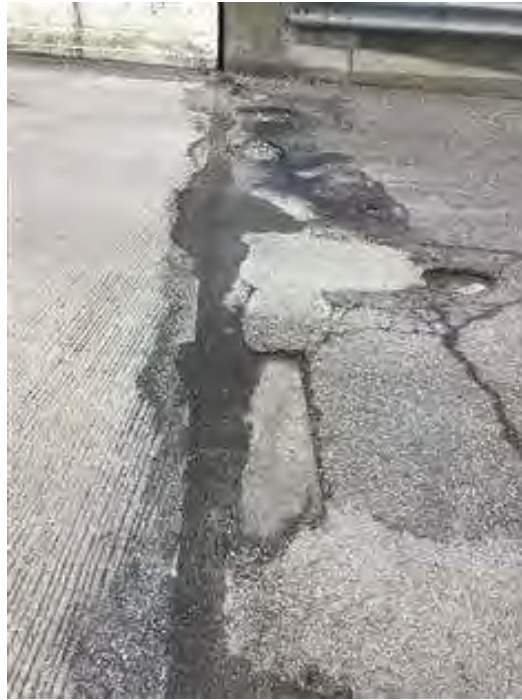
PHOTO 1 Condition
Description West Joint facing South

Spalls with damage to joint material. West joint is mostly patched over with bituminous material.

Date Reported: 04/21/2021
Priority: Green - 3
Work Code: Joint Repair

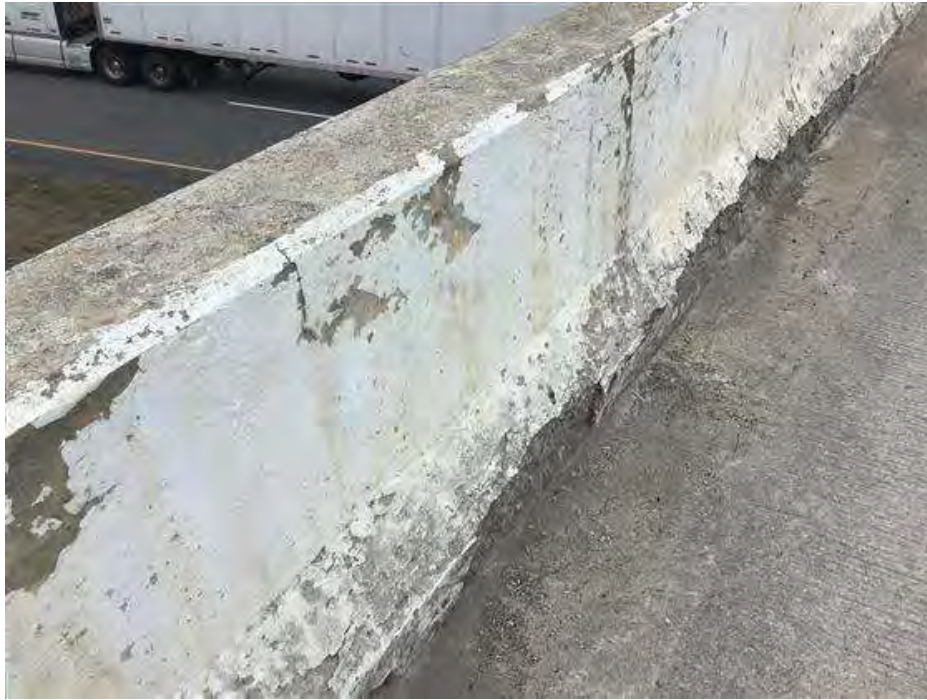
Superstructure is in satisfactory condition with some minor cracking and spalling in the girders. There is some cracking and spalling with exposed rebar on the interior bents. There is spalling at the joints with bituminous patches and some collision damage to the base of the north barrier wall in two locations.

PHOTO 3 Condition
Description Damage to North Barrier Rail Mid Span

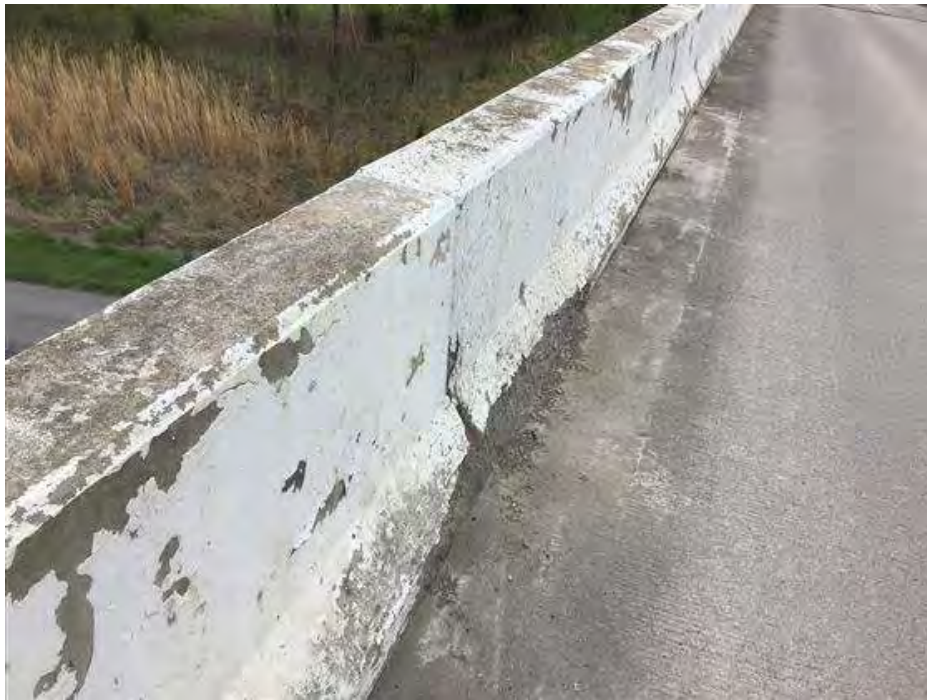
PHOTO 4 Condition
Description Damage to North Barrier Rail over Span C facing East

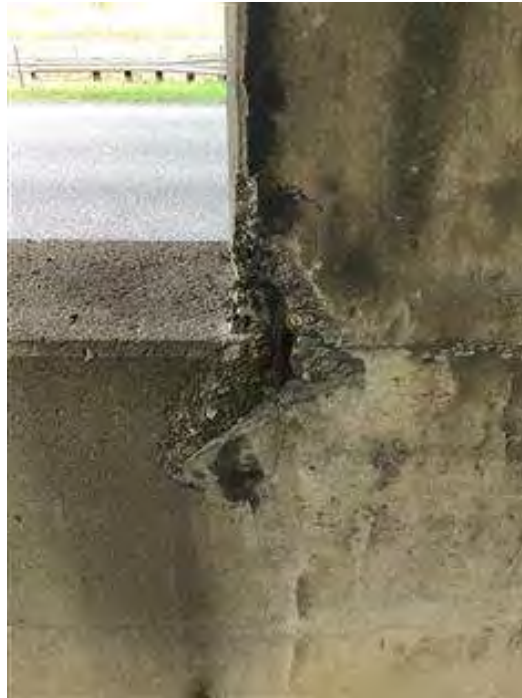
Pier 2: Small spall in column 1. 2' vertical spall with exposed rebar in column 2. 2' vertical crack in column 3.

PHOTO 11 Condition
Description Spall West Side Bent #2 Center Column

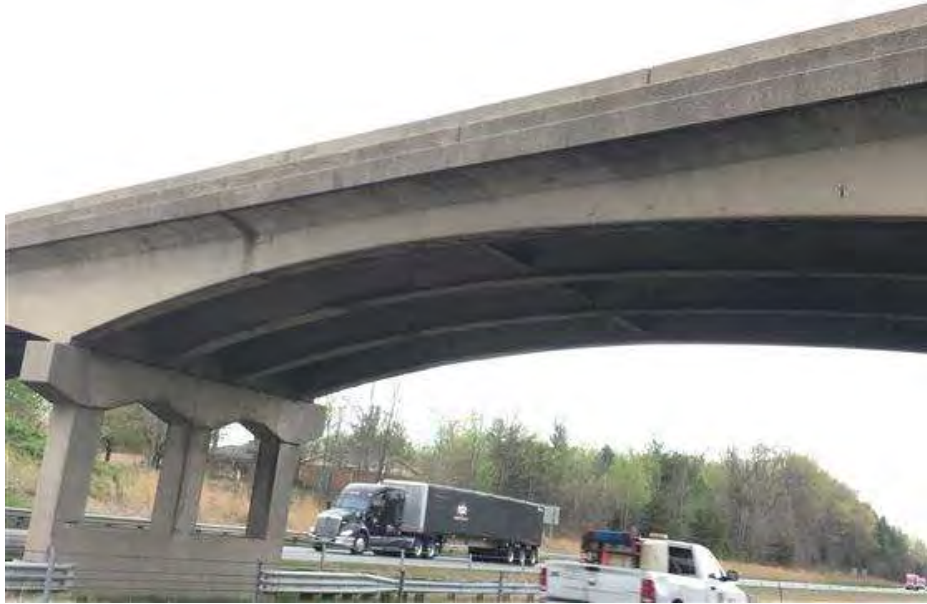
(59) SUPERSTRUCTURE: 6 - Satisfactory Condition (minor deterioration)
 Comments:
 General: Light vertical cracks in girders at about five feet from piers on each side of piers. Pack rust on bearing plates. There is some minor cracking and spalls in Beam 1 in Span C over the median and west shoulder.

PHOTO 17 Condition
Description Minor Spalls and Cracks in Beam #1 Span C

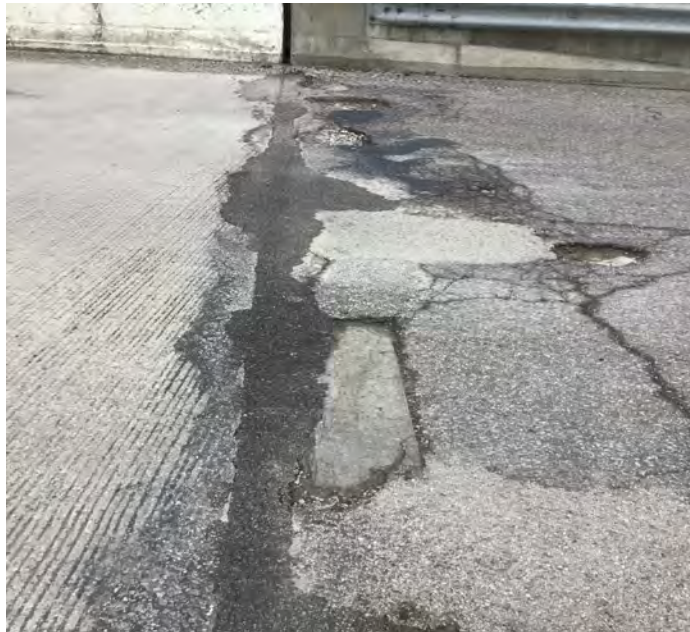
PHOTO 1 Description West Joint facing South
