# Appendix E

Red Flag and Hazardous Material

Des. No. 1900330

Re: RED FLAG INVESTIGATION  
DES #1900330, State Project  
Small Structure Replacement  
SR 246, 7.39 Miles West of SR 46  
Owen County, Indiana

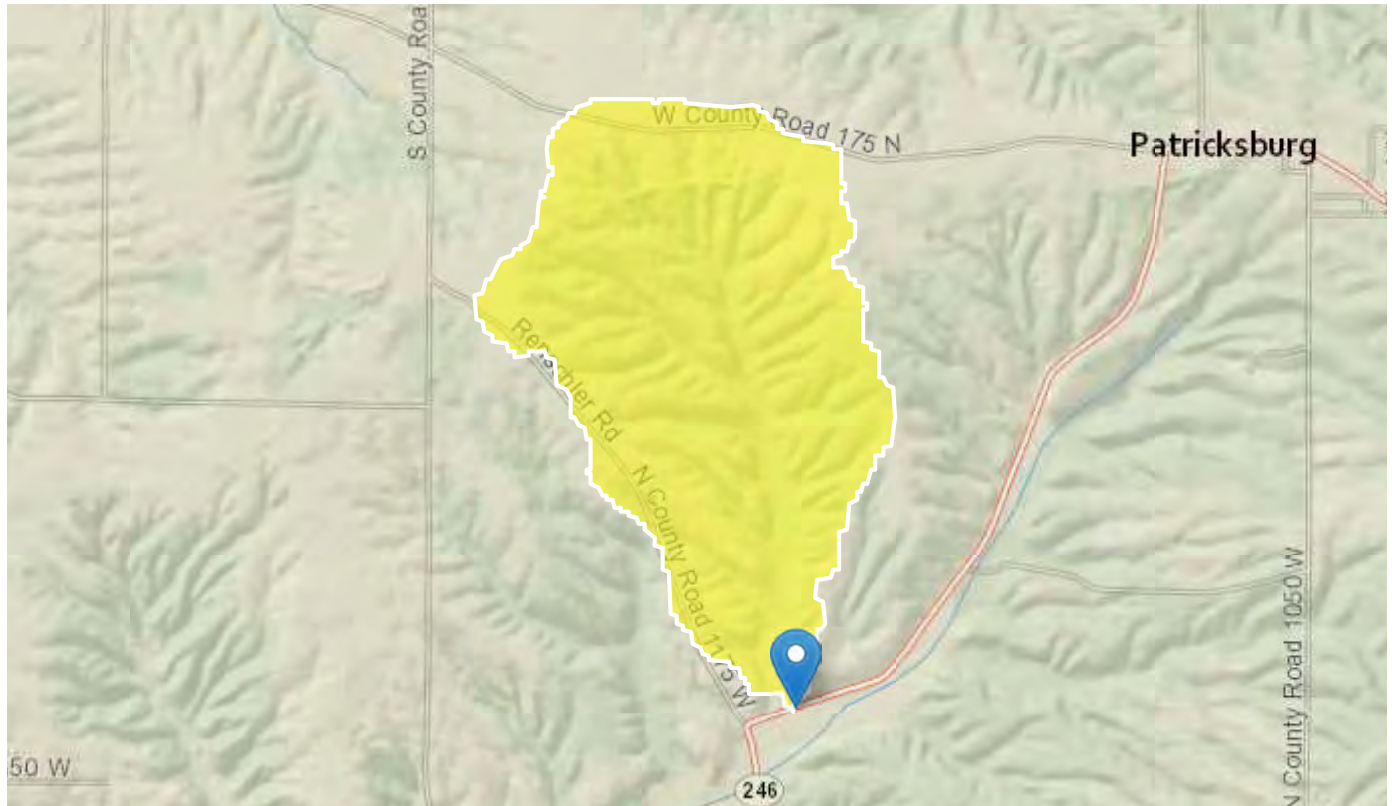
## Basin Characteristics

Parameter Code	Parameter Description	Value	Unit
DRNAREA	Area that drains to a point on a stream	0.802	square miles
K2INDNR	Average hydraulic conductivity (ft/d) for the full depth of unconsolidated deposits from InDNR well database.	15	ft per day
QSSPERMTHK	Index of the permeability of surficial Quaternary sediments computed as in SIR 2014-5177	25	dimensionless
LOWREG	Low Flow Region Number	1730	dimensionless
T2INDNR	Average transmissivity (ft <sup>2</sup> /d) for the full depth of unconsolidated deposits from InDNR well database.	2181	square feet per day

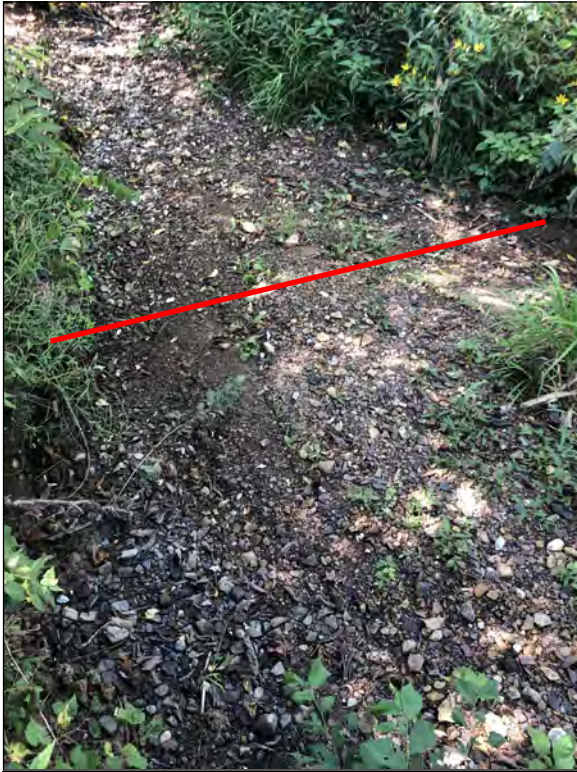
Picture 1—UNT to Lick Creek downstream and OHWM measurement, southeast view; 9 SEP 2021.

OHWM: 41.179412; -86.890904

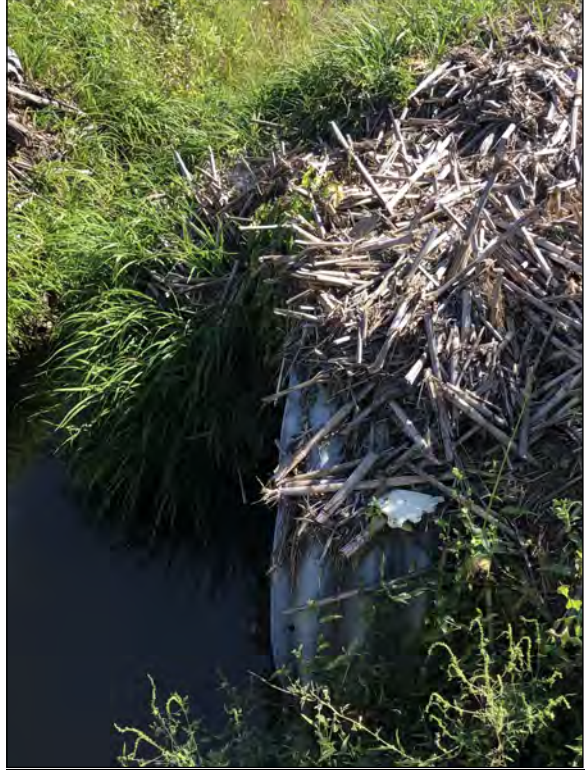
**Picture 8—UNT to Lick Creek project structure northeast view; 9 SEP 2021. Note extensive drift deposits (corn stalks) from flooding.**

UNT to Lick Creek exhibited a well-defined bed and bank. All banks of UNT to Lick Creek were steep. Drift deposits are found throughout the north end of the project area including above the project structure and along the roadside, consisting of corn stalks from flooding prior in the year. No other signs of wetland hydrology were noted outside the OHWM. SR 246 and the deficient drainage of the project structures appear to act as a dam during rapid precipitation events, however water does not appear to be retained for long enough to support hydrophytic vegetation in most areas. Creekside vegetation was dominated by facultative upland plants such as *Solidago canadensis*, *Schedonorus arundinaceus*, *Asclepias syriaca*, *Celastrus orbiculatus*, *Rubus allegheniensis*, and *Rhus glabra*. Soil in the area of UNT to Lick Creek is Steff Silt Loam which is designated as nonhydric. A combination of wetland hydrology and dominant hydrophytic vegetation did not occur beyond the OHWM of UNT to Lick Creek and therefore these wetland characteristics are considered a feature of UNT to Lick Creek and not a separate feature. UNT to Lick Creek is listed as a stream/river in the USGS National Hydrography Dataset. It is likely that UNT to Lick Creek is a Water of the U.S. due to its apparent connectivity with the White River.

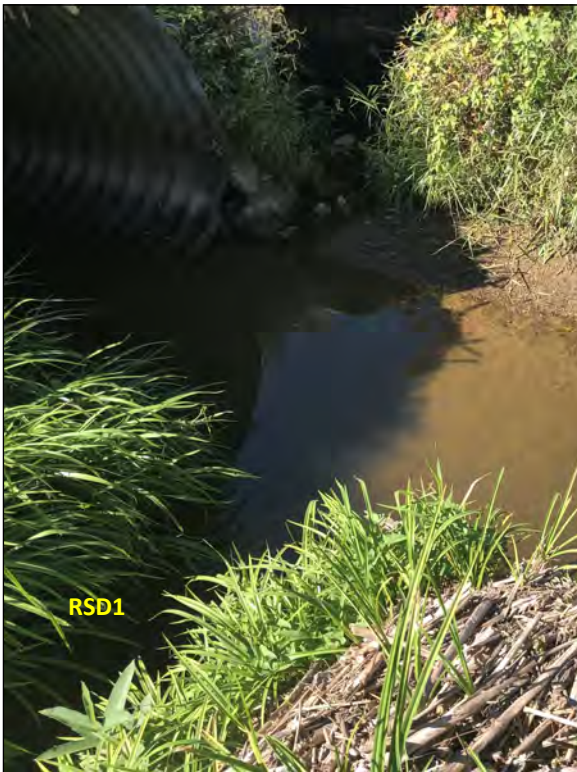
Picture 11—UNT to Lick Creek at RSD1; southwest view; 9 SEP 2021.

A ditch encounters UNT to Lick Creek approximately 5 feet north of the project structure. This ditch is referred to as RSD1 in this report. Within the project area, RSD1 drains the surrounding roadside and agricultural area. During the site inspection, stagnant water was present for approximately 5 feet east of UNT to Lick Creek, then was replaced with a bed with increasing vegetation as the ditch goes farther from the tributary. Vegetation within the ditch was dominated by facultative upland plants such as *Schedonorus arundinaceus*, with smaller but dominant amounts of *Solidago canadensis* and *Melilotus* sp. There were small clusters of the wetland obligates *Typha* sp. and *Juncus* sp. in places, but not in dominant coverage. The area which held water appeared to be an erosion feature which holds backwater. Notably, during site inspection, UNT to Lick Creek was holding standing water which was not draining through the project structure and this standing water was continuous with the first 5 feet of RSD1. Vegetation above the bank was dominated almost exclusively by the facultative upland *Schedonorus arundinaceus*. No OHWM was noted, because upland vegetation was dominant above and below the bank. Vegetation does not support wetland status. Therefore, RSD1 is believed to be a nonjurisdictional feature within the investigative area.

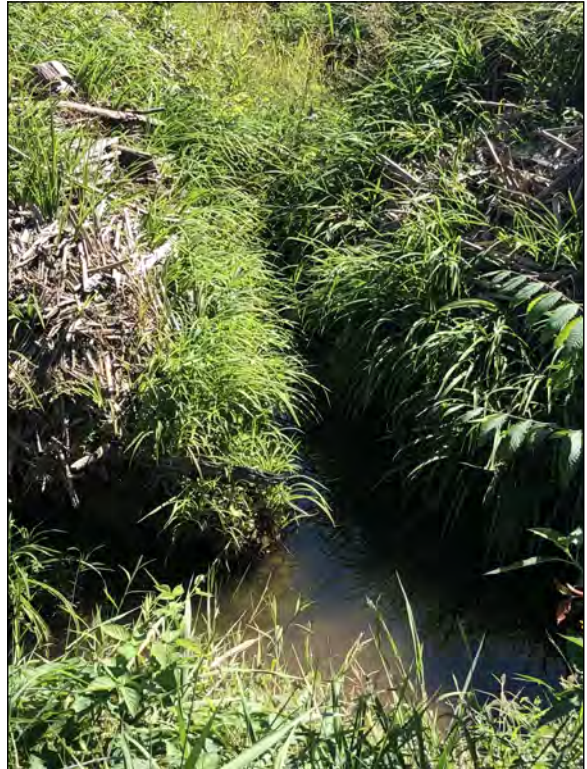
Picture 14—RSD<sub>1</sub> backwater feature at UNT to Lick Creek; northeast view; 9 SEP 2021.

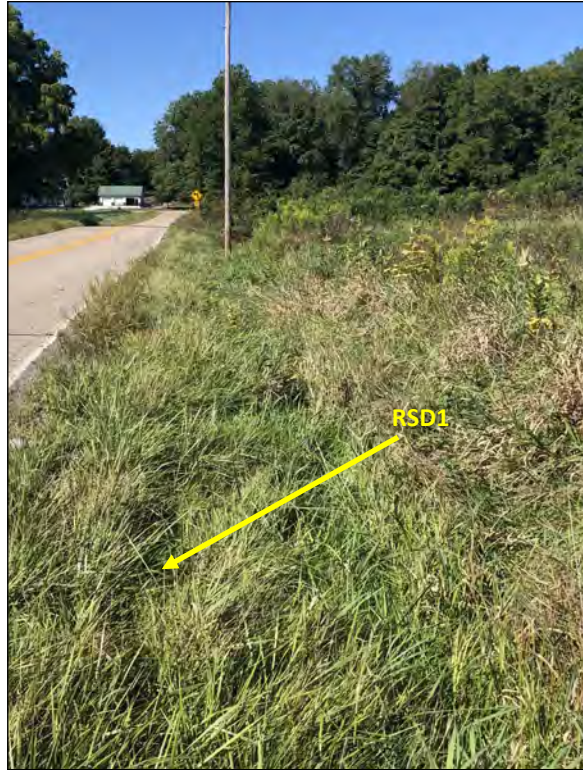
Picture 18—Northeast quadrant and RSD1—  
surrounding vegetation somewhat obscures the  
ditch ; southwest view; 9 SEP 2021.

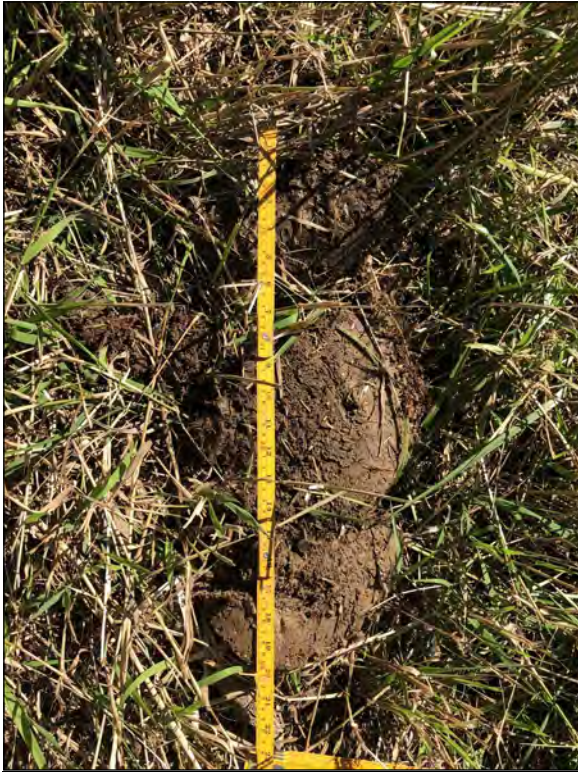
**Picture 25—Wetland 1 data point 1A soil sample; 9 SEP 2021.**

Depth (inches)	Matrix		Redox Features				Texture	Remarks
	Color (moist)	%	Color (moist)	%	Type <sup>1</sup>	Loc <sup>2</sup>		
0-9	10YR 4/2	87	10YR 5/1	10	D	M	Sandy	
			5YR 4/6	3	C	M		Prominent redox concentrations
9-20	10YR 4/2	70	10YR 5/1	20	D	M	Sandy	
			5YR 4/6	10	C	M		Prominent redox concentrations

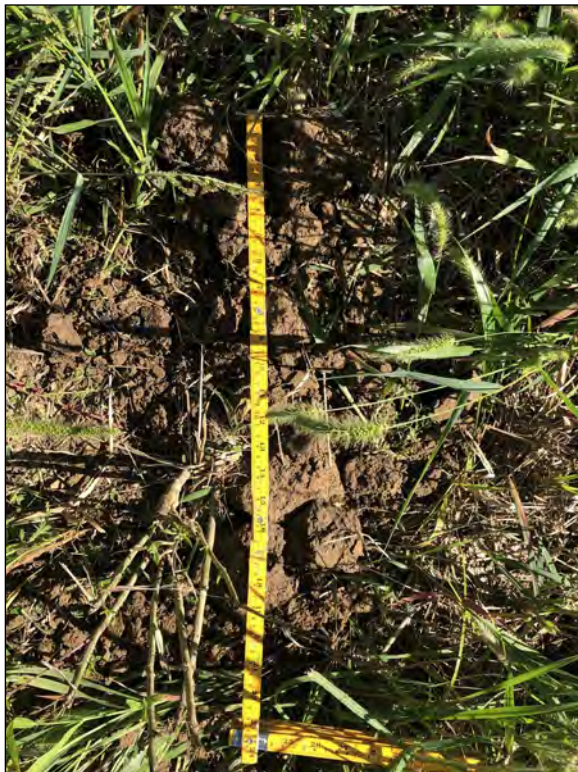
**Picture 27—Upland data point 1B soil sample; 9 SEP 2021.**

Depth (inches)	Matrix		Redox Features				Texture	Remarks
	Color (moist)	%	Color (moist)	%	Type <sup>1</sup>	Loc <sup>2</sup>		
0-20	10YR 4/4	100					Sandy

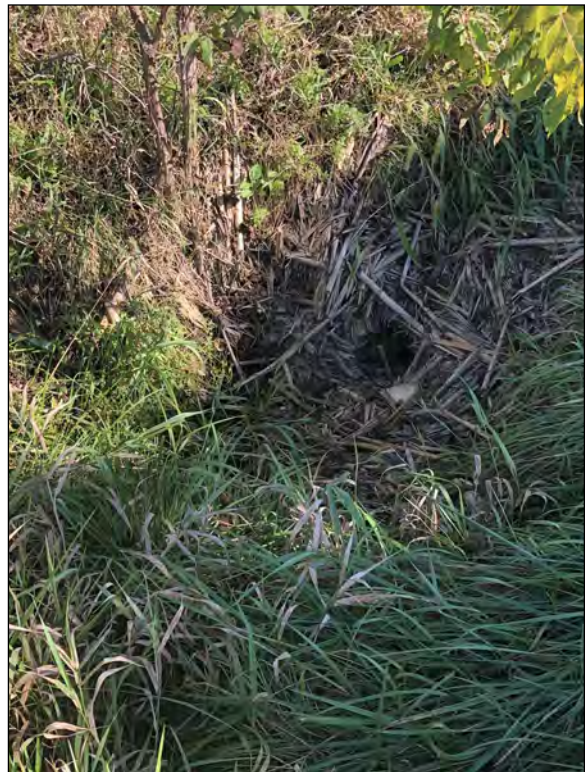
**Picture 28—Northwest quadrant edge of Wetland 2 and pipe under overgrown farm entrance; north view; 9 SEP 2021.**

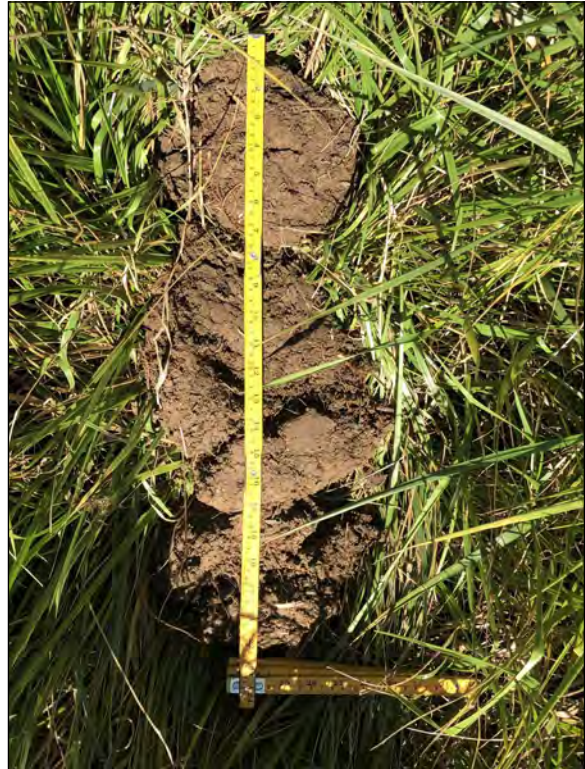
Picture 34—Wetland 2 data point 2A soil sample; 9 SEP 2021.

Profile Description: (Describe to the depth needed to document the indicator or confirm the absence of indicators.)								
Depth (inches)	Matrix		Redox Features				Texture	Remarks
	Color (moist)	%	Color (moist)	%	Type <sup>1</sup>	Loc <sup>2</sup>		
0-8	10YR 4/2	87	10YR 5/1	10	D	M	Sandy	
			5YR 4/6	3	C	M		Prominent redox concentrations
8-22	10YR 4/2	70	10YR 5/1	20	D	M	Sandy	
			5YR 4/6	10	C	M		Prominent redox concentrations

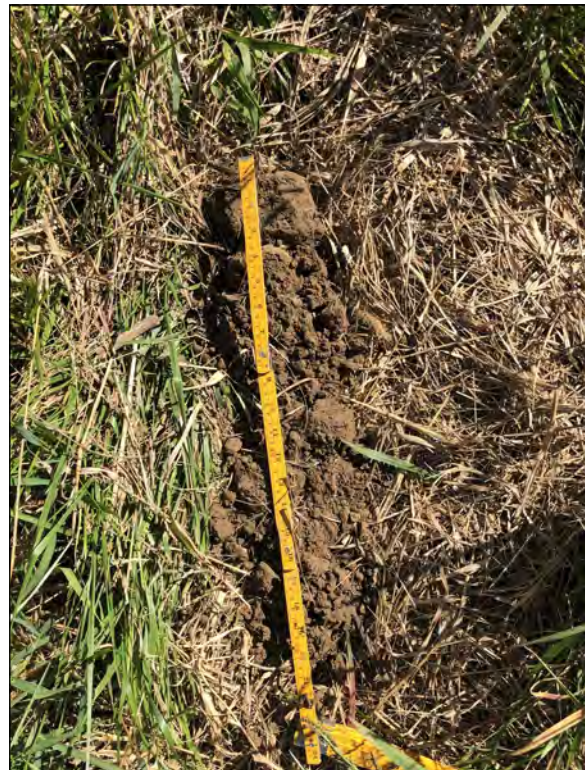
Picture 36—Upland data point 2B soil sample; 9 SEP 2021.

Profile Description: (Describe to the depth needed to document the indicator or confirm the absence of indicators.)								
Depth (inches)	Matrix		Redox Features				Texture	Remarks
	Color (moist)	%	Color (moist)	%	Type <sup>1</sup>	Loc <sup>2</sup>		
0-21	10YR 4/4	100					Sandy

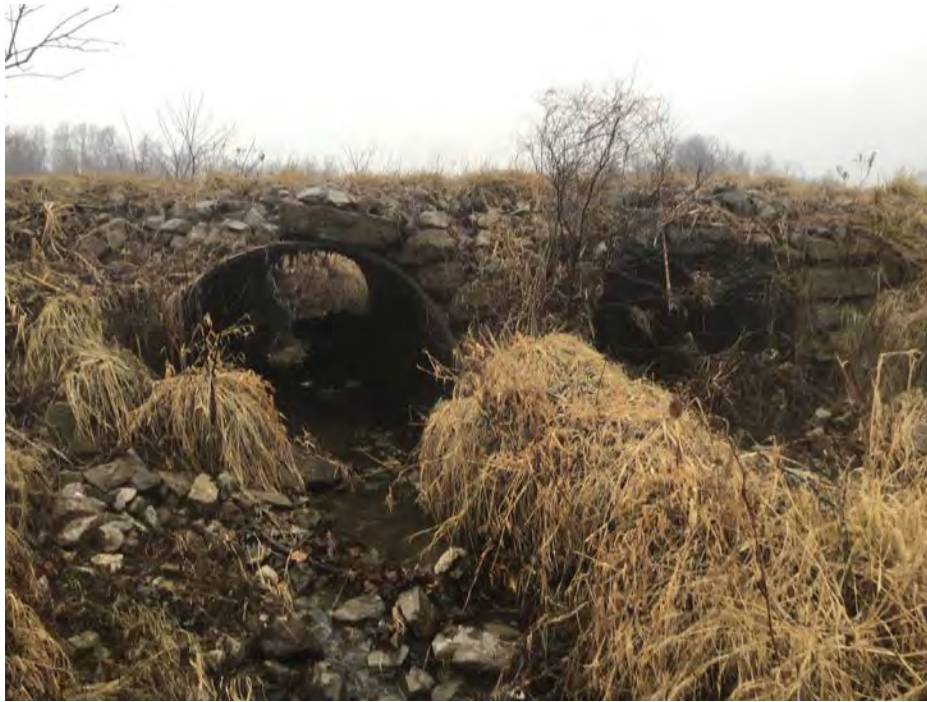
PHOTO 1

Description South Profile

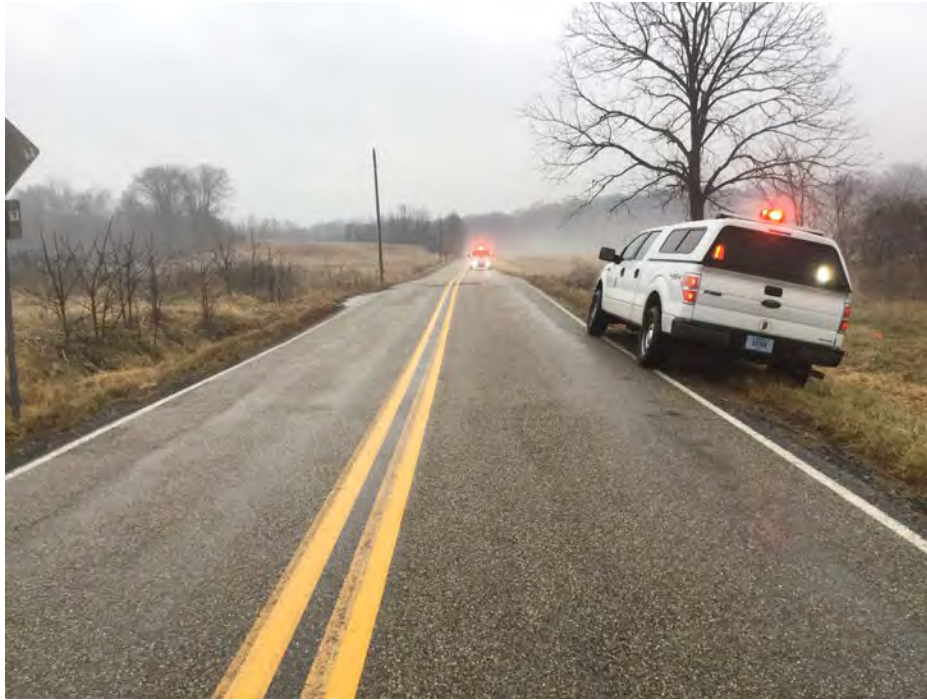
PHOTO 3

Description Eastbound Alignment

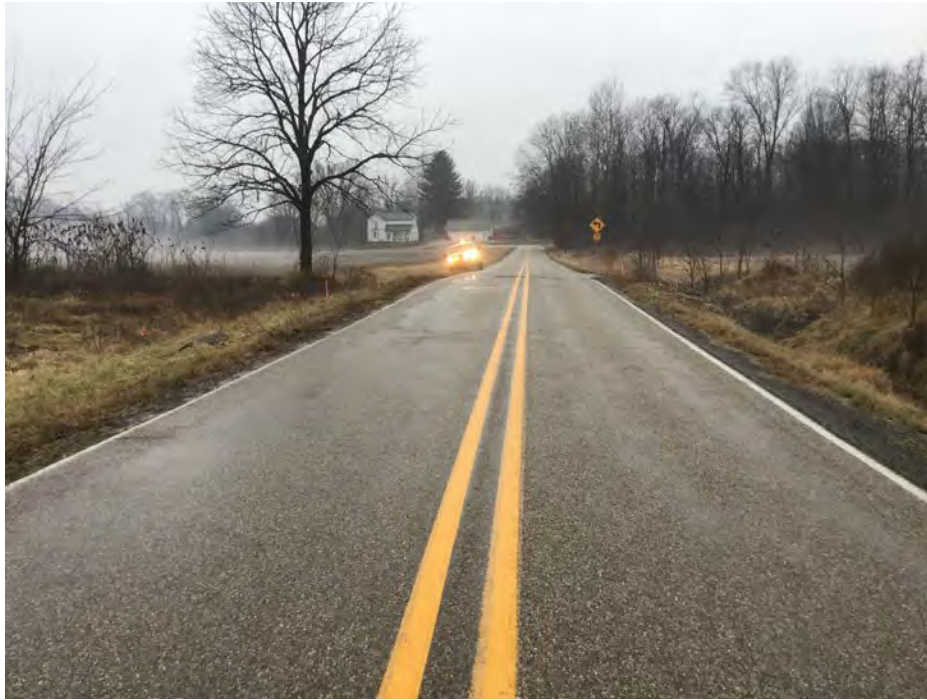
PHOTO 5

Description Westbound Alignment

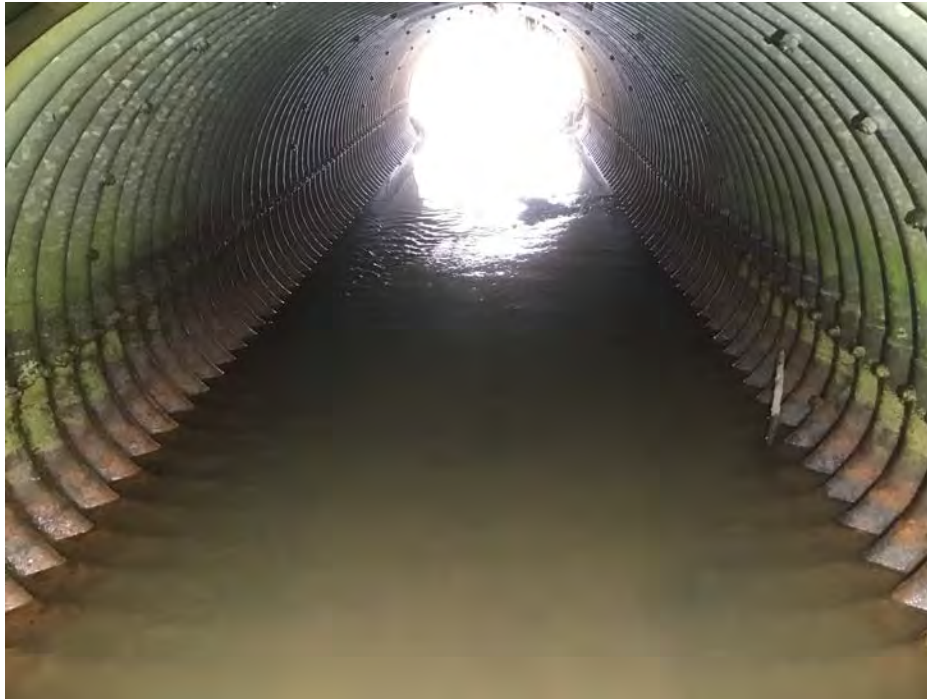
PHOTO 7

Description View through the east pipe from the south end
