FHWA-Indiana Environmental Document
CATEGORICAL EXCLUSION / ENVIRONMENTAL ASSESSMENT FORM
GENERAL PROJECT INFORMATION

Road No./County:	State Route (SR) 8 / Noble County
Designation Number(s):	2002234
Project Description/Termini:	Small Structure Project located on SR 8 approximately 4.22 Miles East of SR 9

SR 8 Small Structure Project
Indiana Department of Transportation
Des. No.: 2002234

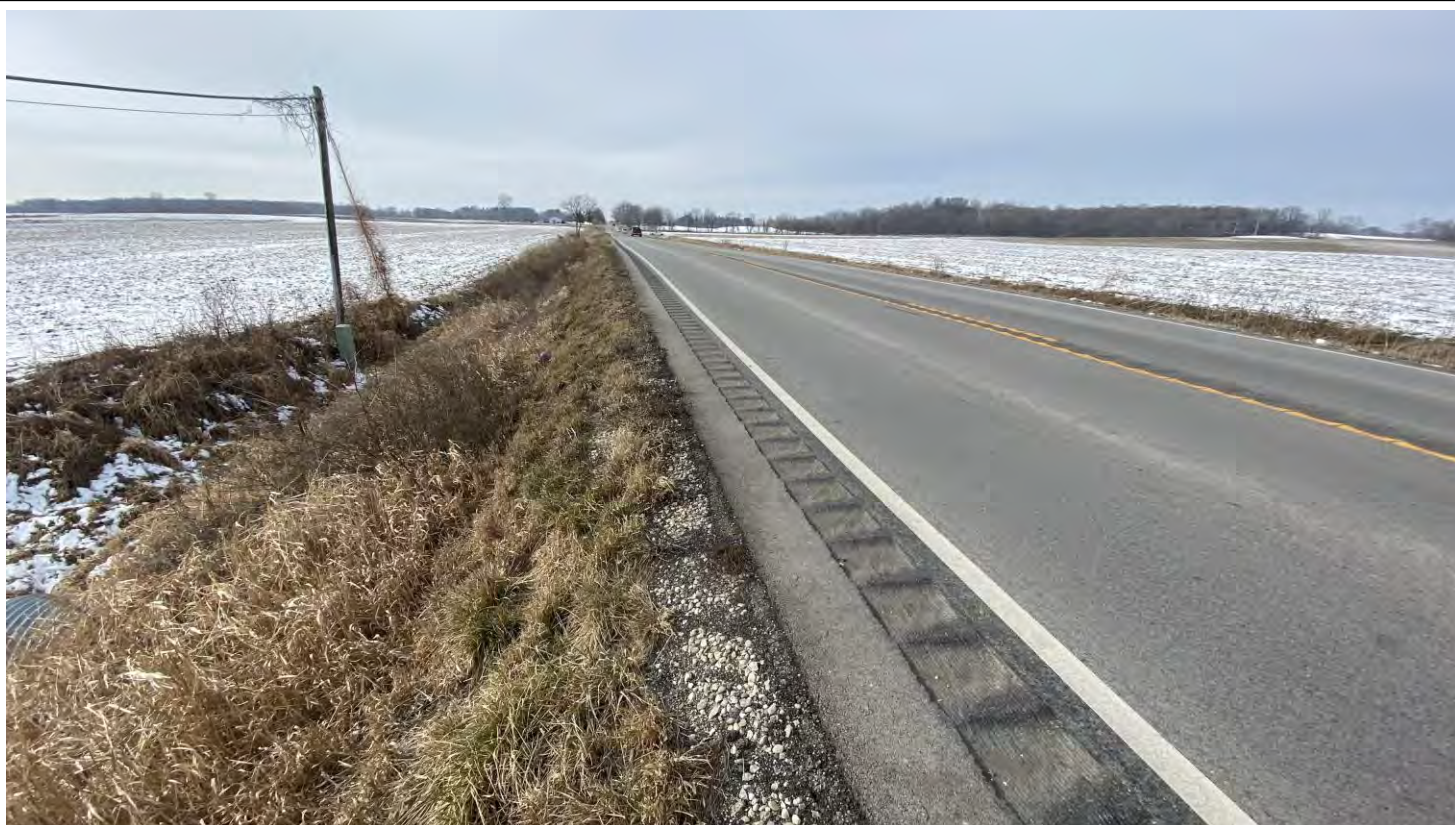
Photo 1 – View westerly along SR 8 from small structure CV 008-057-47.08

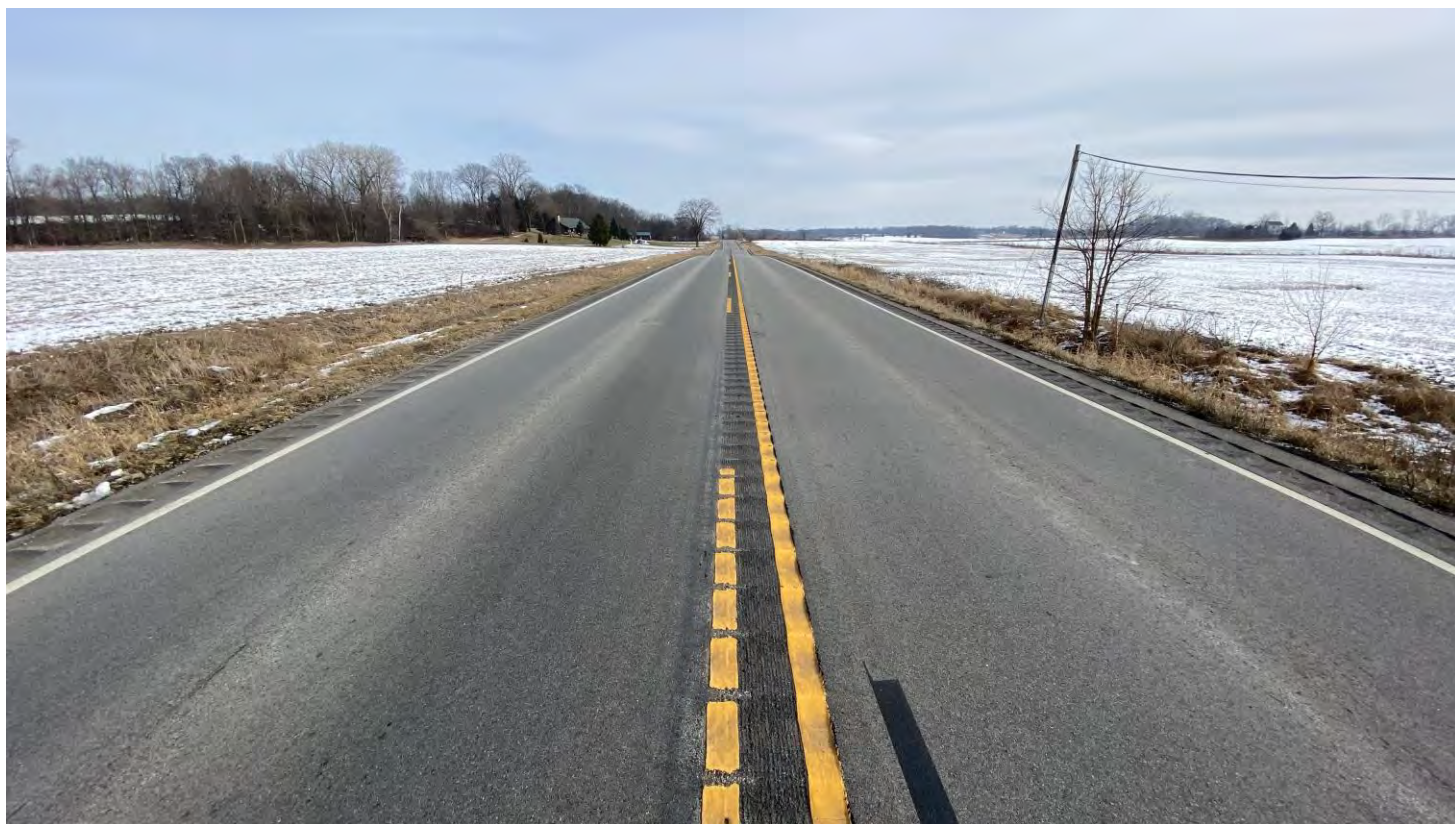
Photo 2 – View easterly along SR 8 from small structure CV 008-057-47.08

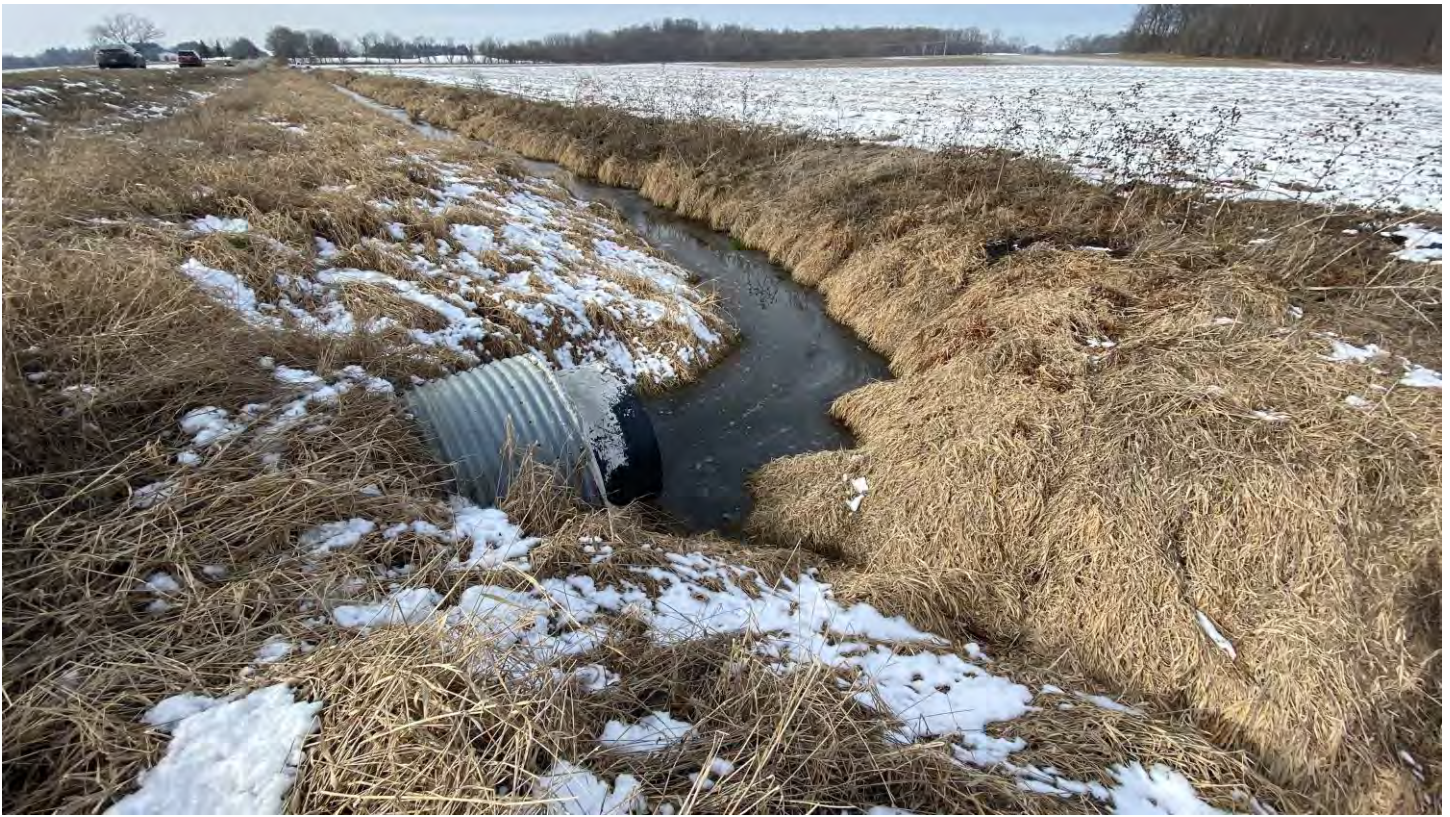
Photo 3 – View westerly, north end of small structure CV 008-057-47.08

The existing structure is a 5-foot diameter CMP that was lined in 2019 with a 3.6-foot diameter HDPE liner due to the deteriorating condition of the existing pipe. The structure has about 5 feet of cover and a length of 73 feet. The existing structure does not meet roadway serviceability requirements, as hydraulic analyses have shown that the roadway would be overtopped by a 100-year flood event (Appendix I, page 4).

The existing structure (CV 008-057-47.08) is a 5-foot diameter CMP that was lined in 2019 with a 3.6-foot diameter HDPE liner due to the deteriorating condition of the existing pipe. The structure has about 5 feet of cover and a length of 73 feet. The existing structure will be removed and replaced. The existing structure was constructed in 1989 and is not historic.

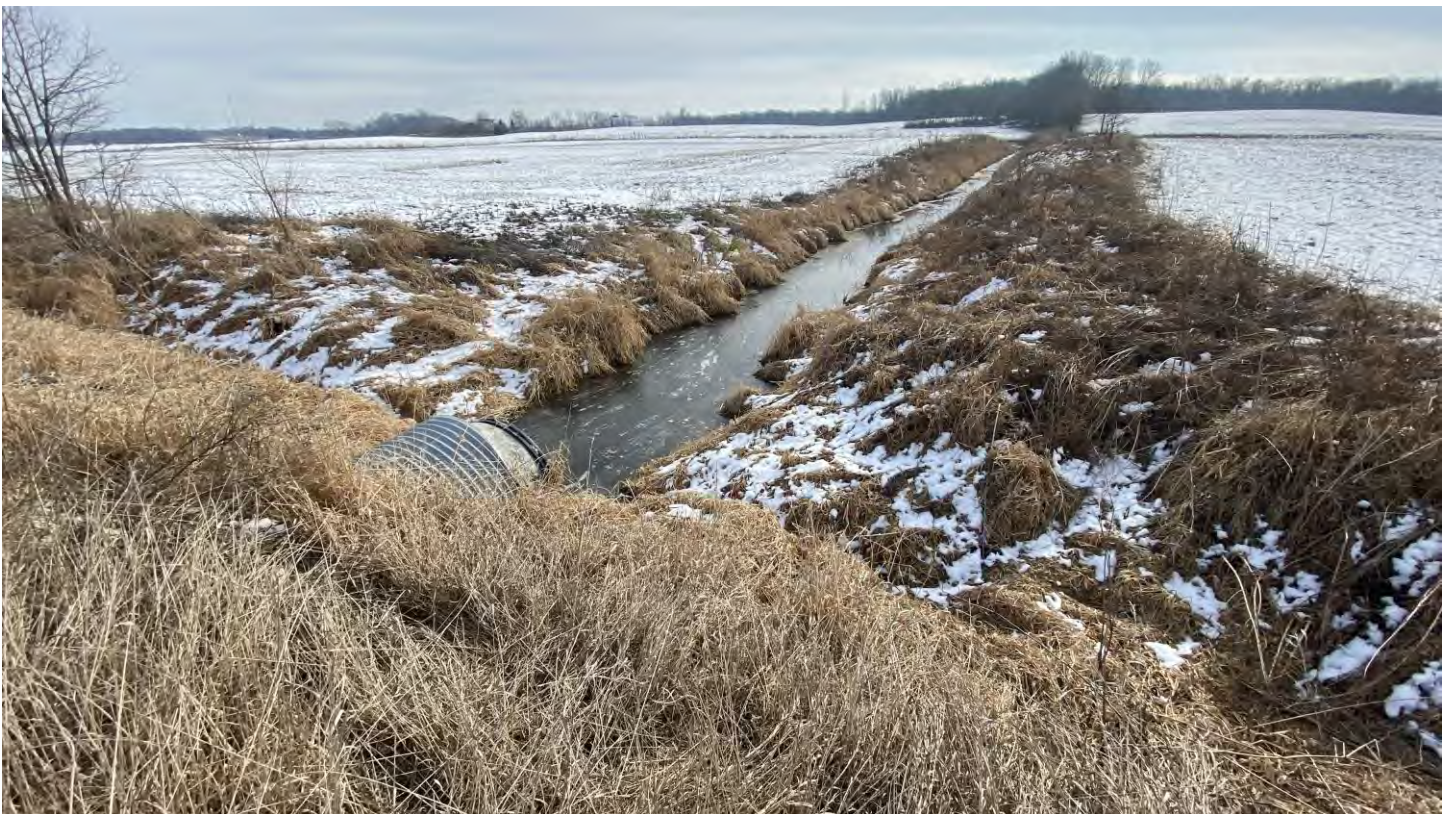
Photo 4 – View southeasterly, south end of small structure CV 008-057-47.08

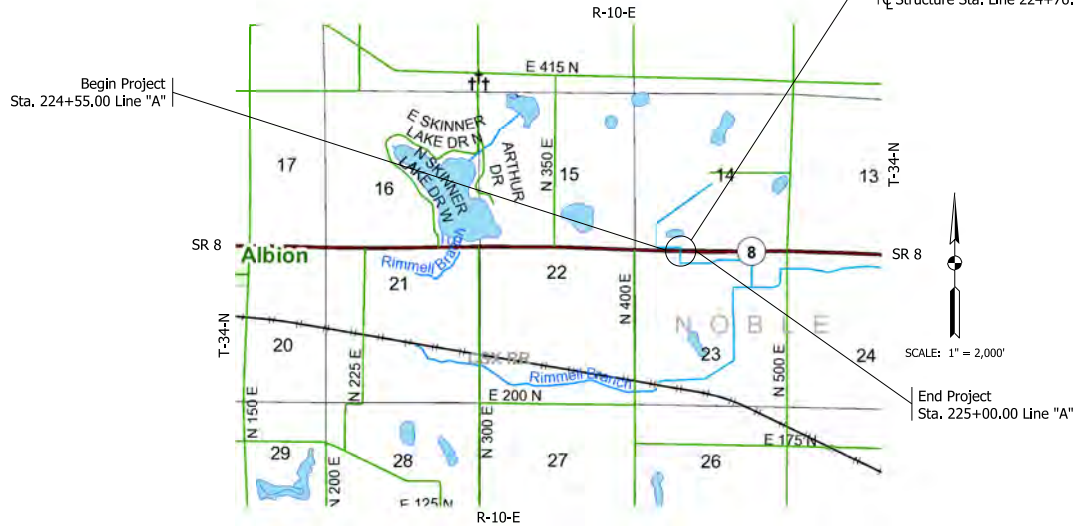
Structure, Reinforced Concrete Box Section
10' x 8' Span Over UNT of Rummel Branch
W/ Waterproofing Membrane &
2' Tall Cutoff Walls at Inlet and Outlet
Skew: 04°00'00" Lt.
Ç Structure Sta. Line 224+76.00 "A"

Begin Project
Sta. 224+55.00 Line "A"

The replacement structure is a reinforced concrete box (RCB) structure with a clear span of 10 feet and an 8-foot rise with a 6-inch sump (7.5 feet rise above the flowline). The out-to-out length of the proposed culvert will be approximately 98 feet.

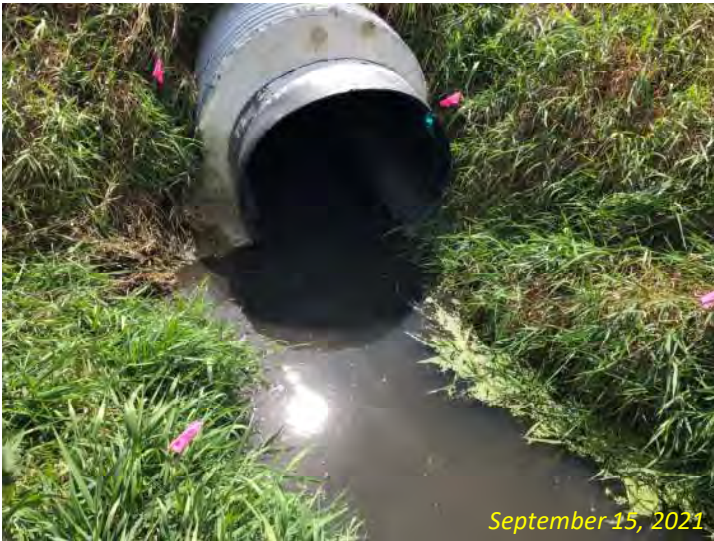
Photo 3: View south (downstream) along UNT to Rimmel Branch on the north side of SR 8. Structure CV 008-057-47.08 is also shown.

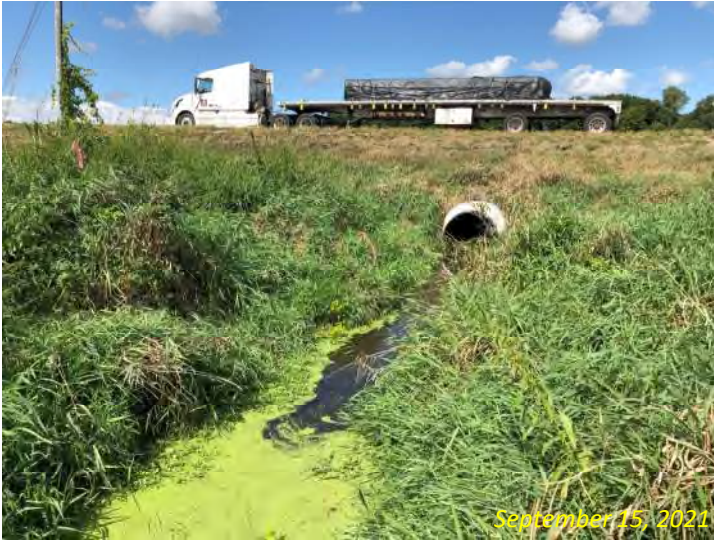
Photo 5: View north (upstream) along UNT to Rimmel Branch on the south side of SR 8. Structure CV 008-057-47.08 is also shown.

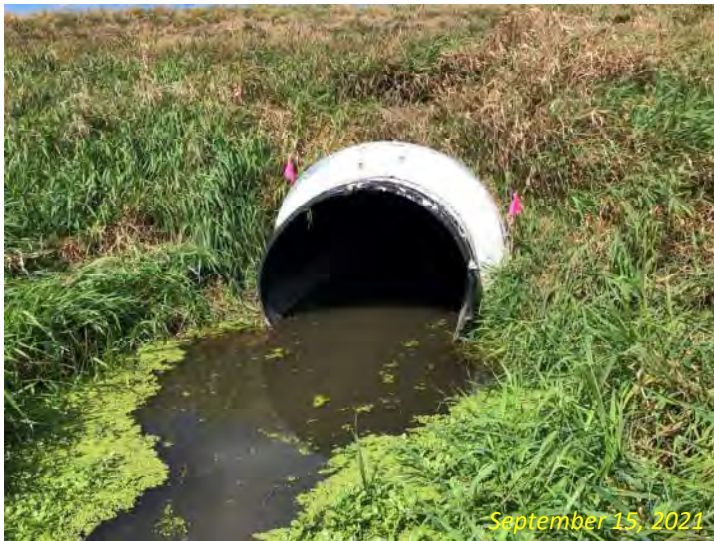
Photo 7: View north (upstream) along UNT to Rimmel Branch on the south side of SR 8. Structure CV 008-057-47.08 is also shown.

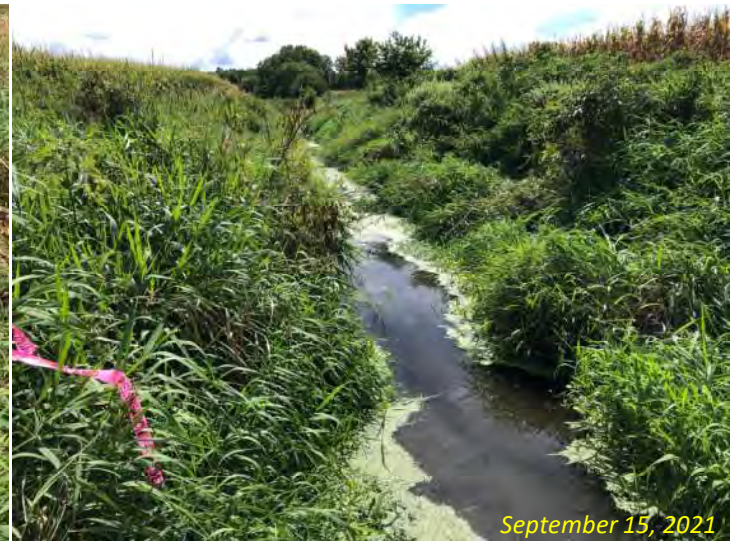
Photo 8: View south (downstream) along UNT to Rimmel Branch on the south side of SR 8. The typical OHWM width was measured here (Latitude 41.395324° and Longitude -85.342830°).

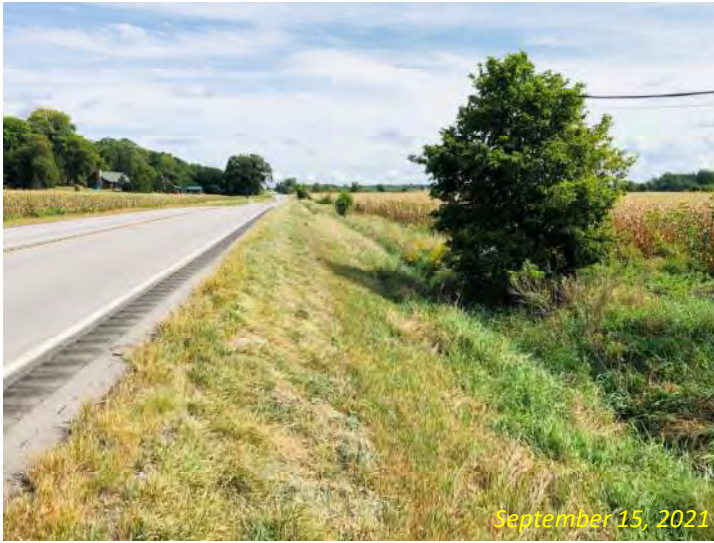
Photo 9: View east from the small structure along the south side of SR 8. Wetland B is also shown.

Wetland B is located in a ditch along the south side of SR 8 and to the east of UNT to Rimmel Branch. Wetland B is dominated by reed canarygrass (*Phalaris arundinacea*), a wetland plant. This plant community meets the hydrophytic plant criteria. The plant community type is emergent wetland. The quality of Wetland B is considered poor since it is dominated by reed canarygrass, an invasive species. Wetland hydrology and hydric soils were noted to be present. This area therefore meets the three jurisdictional wetland criteria. The size of Wetland B within the study limits is approximately 0.044 acre. Wetland B extends beyond the east study limits. The boundary of Wetland B was determined by observing the change in plant community and corresponding change in topography. Wetland B is considered a jurisdictional Water of the U.S. because it abuts UNT to Rimmel Branch.

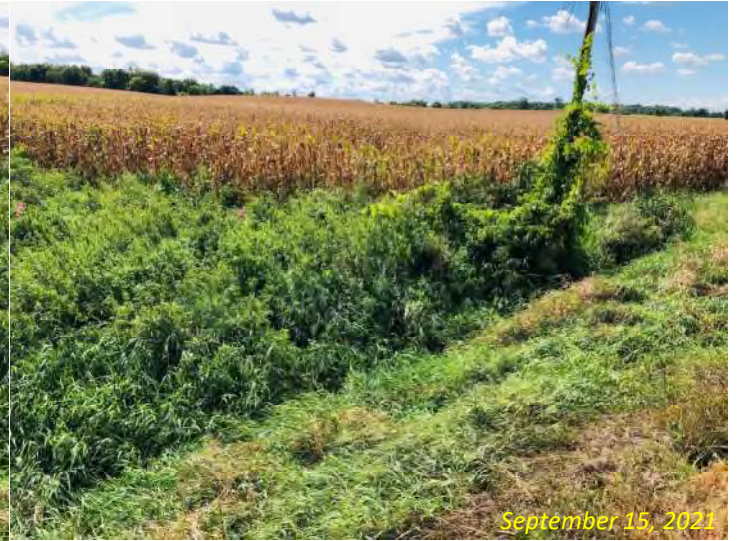
Photo 12: View southwest from the small structure. Wetland A is also shown.

Wetland A is located in a ditch along the south side of SR 8 and to the west of UNT to Rimmel Branch. Wetland A is dominated by wetland plants consisting of elderberry (*Sambucus nigra*), reed canarygrass (*Phalaris arundinacea*) and stinging nettle (*Urtica dioica*). The plant community type is emergent wetland; however, it does include scattered elderberry shrubs. The quality of Wetland A is considered poor since it is dominated by reed canarygrass, an invasive species. Wetland hydrology and hydric soils were noted to be present. This area therefore meets the three jurisdictional wetland criteria. The size of Wetland A within the study limits is approximately 0.075 acre. Wetland A extends beyond both the west and south study limits. The boundary of Wetland A was determined by observing the change in plant community and corresponding change in topography. Wetland A is considered a jurisdictional Water of the U.S. because it abuts UNT to Rimmel Branch.

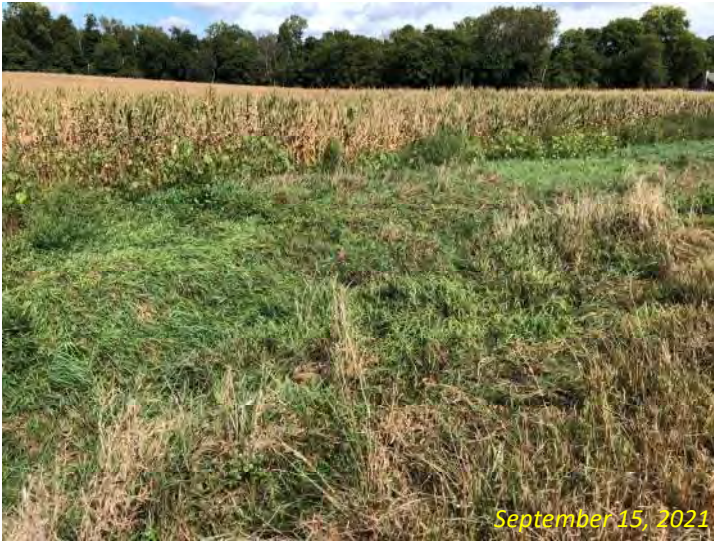
Photo 17: View northeast from the small structure. Wetland C is also shown.

Wetland C is located in a ditch along the north side of SR 8 and to the east of UNT to Rimmel Branch. Wetland C dominated by reed canarygrass (*Phalaris arundinacea*), a wetland plant. This plant community meets the hydrophytic plant criteria. The plant community type is emergent wetland. The quality of Wetland C is considered poor since it is dominated by reed canarygrass, an invasive species. Wetland hydrology and hydric soils were noted to be present. This area therefore meets the three jurisdictional wetland criteria. The size of Wetland C within the study limits is approximately 0.043 acre. Wetland C extends beyond the east study limits. The boundary of Wetland C was determined by observing the change in plant community and corresponding change in topography. Wetland C is considered a jurisdictional Water of the U.S. because it abuts UNT to Rimmel Branch.

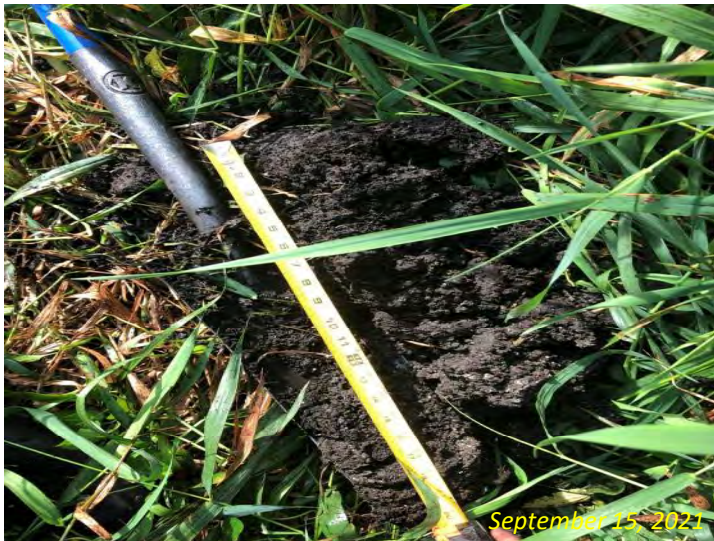
Photo 35: View of SP-A1 soil profile, within Wetland A

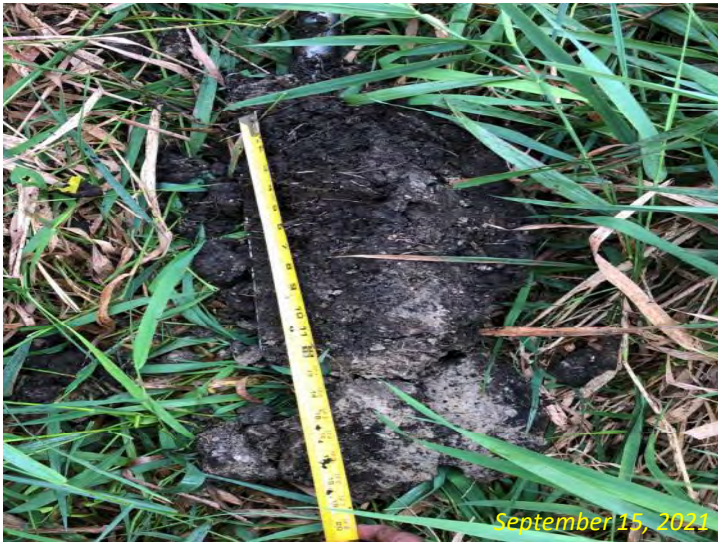
Photo 45: View of SP-B1 soil profile, within Wetland B

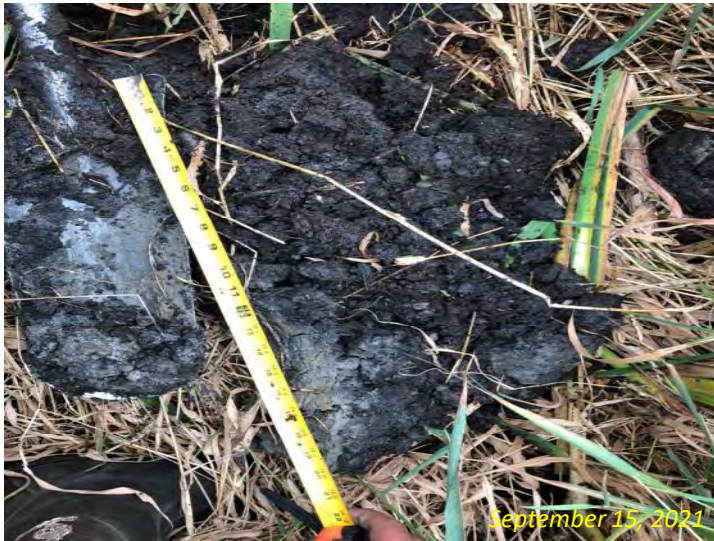
Photo 55: View of SP-C1 soil profile, within Wetland C
