1996-2018 Indiana Forestry Best Management Practices Audit Report

Monitoring Results for State Forest Properties

**Indiana Forestry Best Management Practices
Monitoring Results for State Forest Properties
1996-2018**

By: Jennifer Sobecki & Duane McCoy

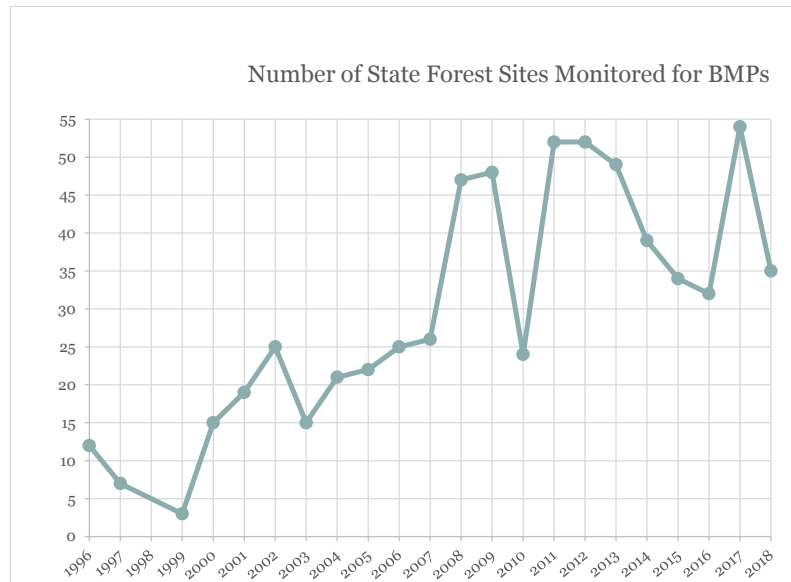
Figure 2. Total number of State Forest sites monitored each year since the BMP program began 22 years ago.

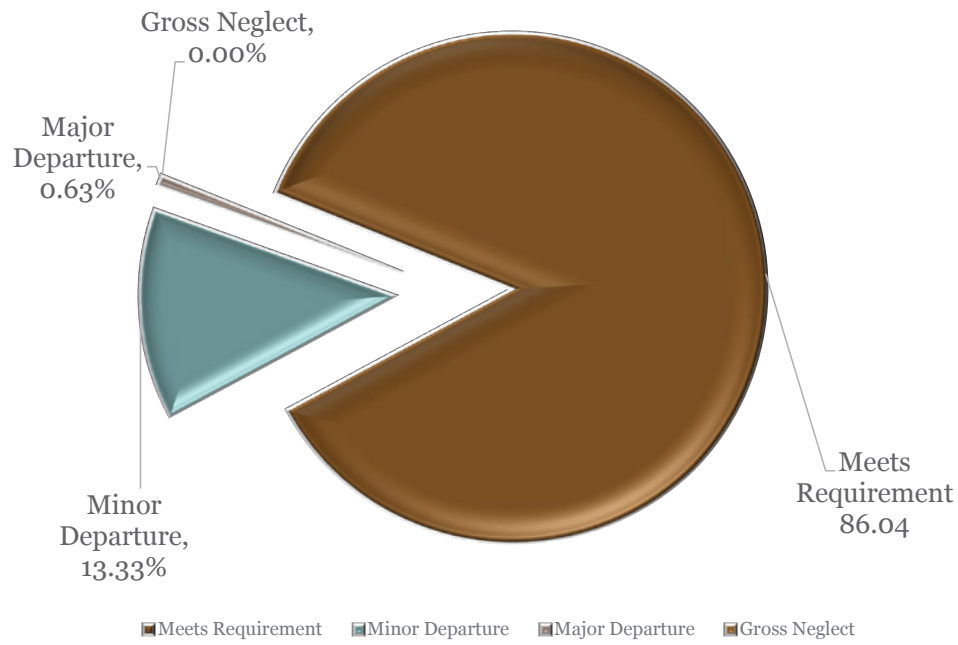
Figure 3. BMP application for 656 State Forest sites monitored from 1996--2018.

The application and effectiveness rates for BMPs used to protect sites after timber harvests are excellent for the 656 sites monitored since 1996. The overall application rate is 86.04%, and the overall effectiveness rate is 92.02%.

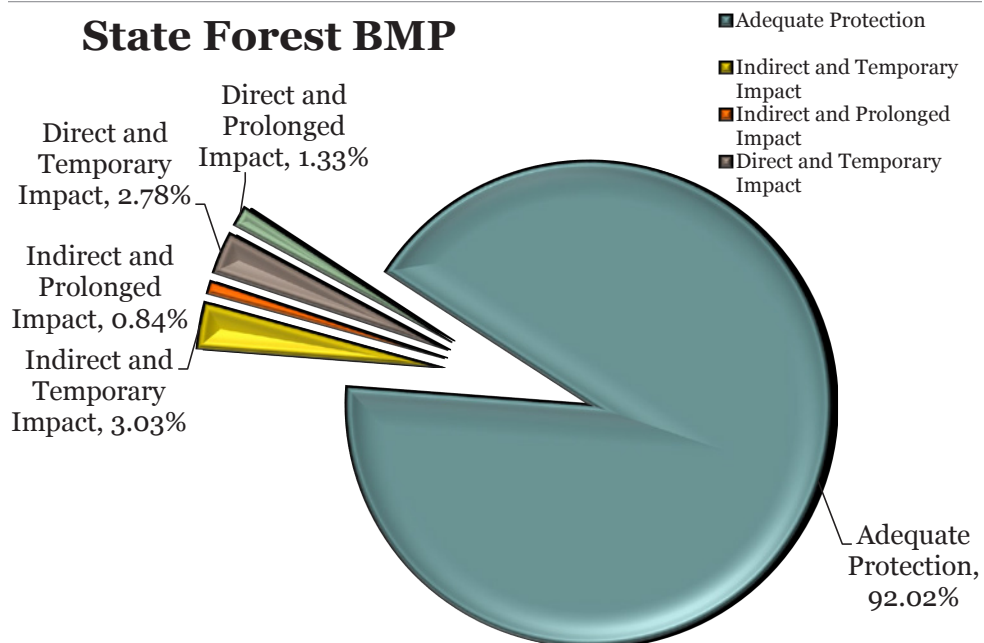
Figure 4. BMP effectiveness for 656 State Forest sites monitored from 1996-2018.

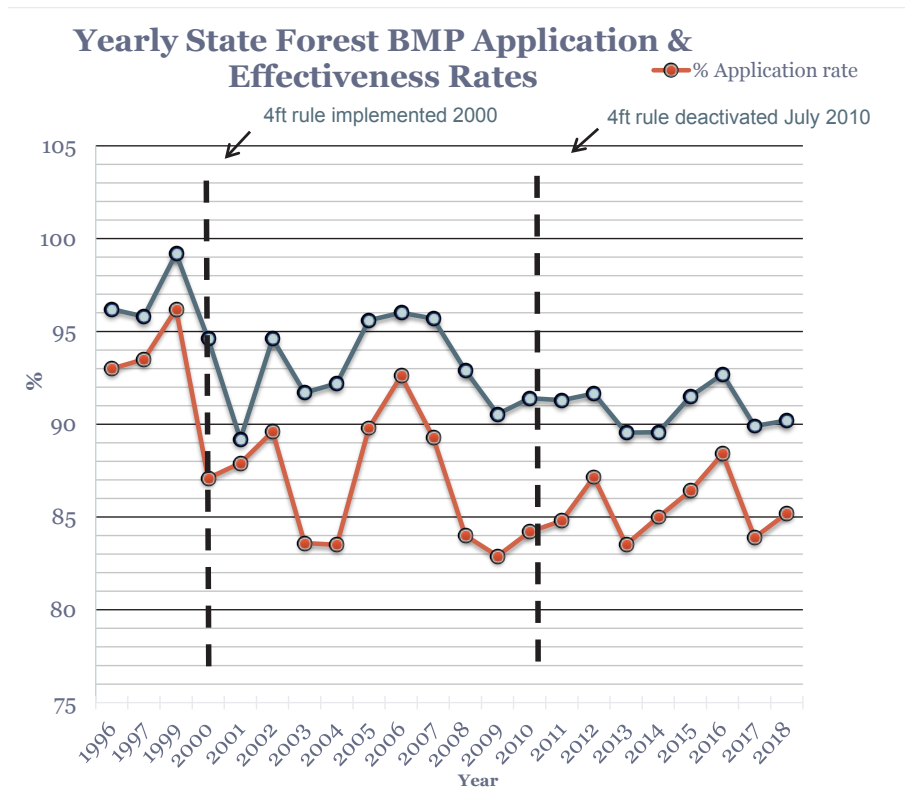
Figure 5: Yearly trends of BMP application and effectiveness on Indiana State Forests for 22 years of monitoring. These percentages are calculated for each year’s data separately, not combined with the running totals from previous years.

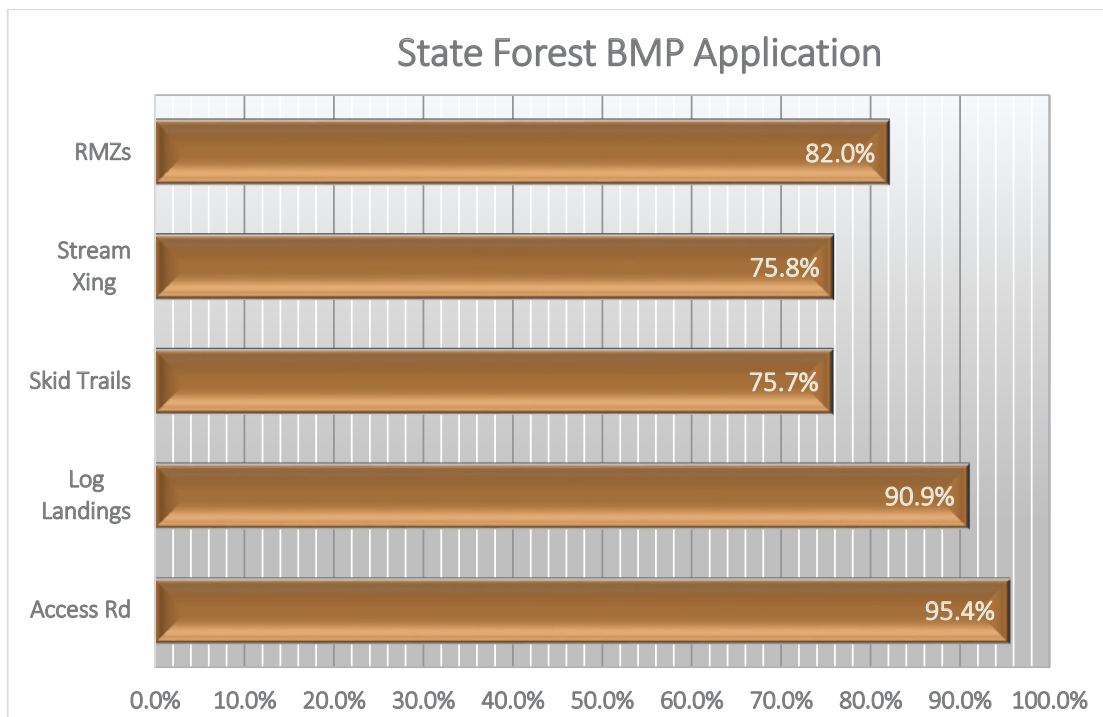
Figure 6. Overall BMP application for each of the five BMP categories.

The overall BMP application and effectiveness for the five categories, access roads, and log landings were the highest ranked, with access roads having a 95.4% application and 98.4% effectiveness rate. Log-landing application was 90.9% and effectiveness, 97.8%. The third-highest category was RMZs, with 82% application and 86.2% effectiveness rates. Skid trails had the lowest application rate of all categories, at 75.7% application. Effectiveness is good on skid trails, 88.1%, considering the low application rate. The BMP area with the most difficulty was stream crossings. Because of the direct impact crossings can have on water resources, BMP application and effectiveness are most critical in this area. Small problems in application on stream crossings can lead to lower effectiveness with more direct impacts to the streams, making this area the most critical and important BMP area. Wet conditions can also lead to large departures in effectiveness of stream crossings. The application of stream crossings across the 22 years of monitoring on State Forests is 75.8% and 77.6% effectiveness.

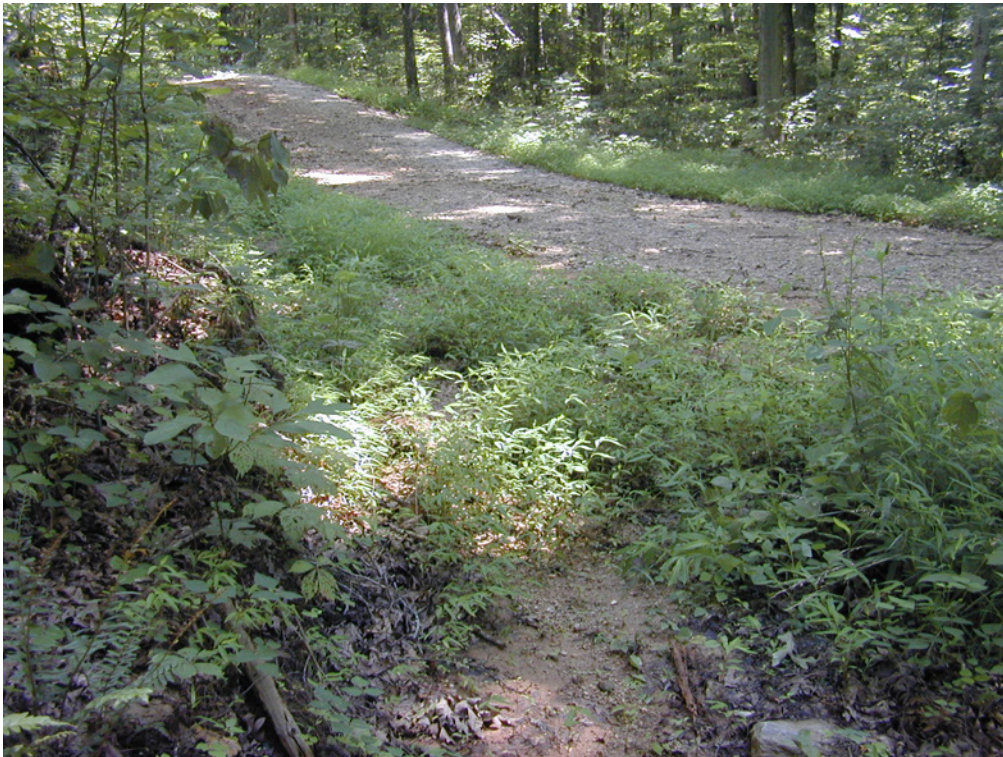
Effective cutout on a permanent access road. Photo by Duane McCoy, DNR

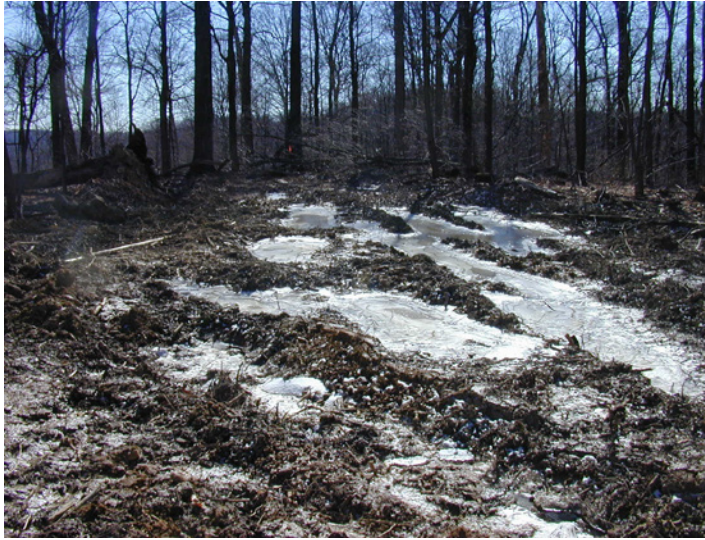
Log landing that was used during a wet period, causing rutting and the collection of runoff at the site.
Photo by Duane McCoy, DNR

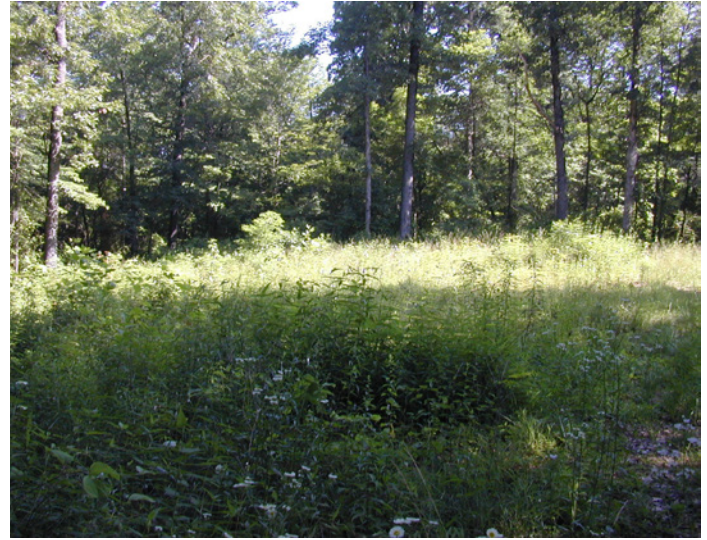
Seeded landing two years after closeout.
Photo by Duane McCoy, DNR

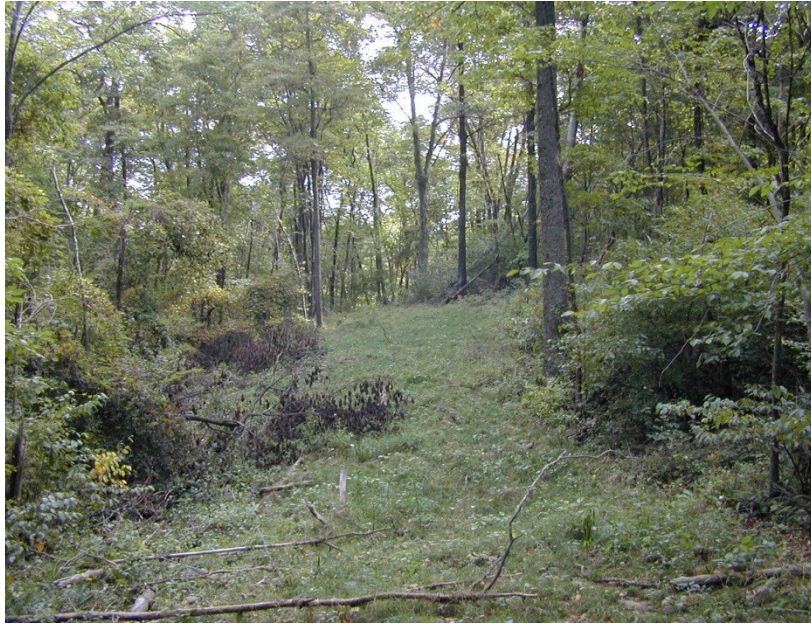
A steep skid trail that has well-established vegetative cover.
Photo by Duane McCoy, DNR

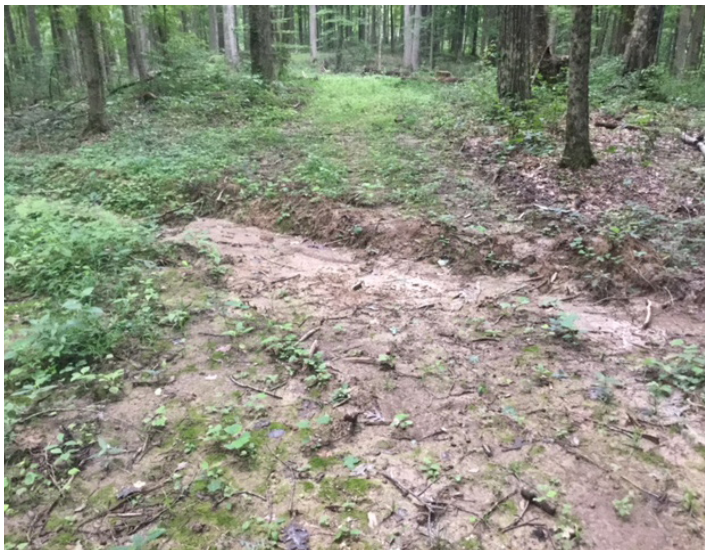
An effective water bar conveying runoff and sediment from a skid trail and diverting the flow onto the forest duff layer, where water will infiltrate the soil, the sediment will be filtered and the water will become groundwater. Photo by Jennifer Sobecki, DNR

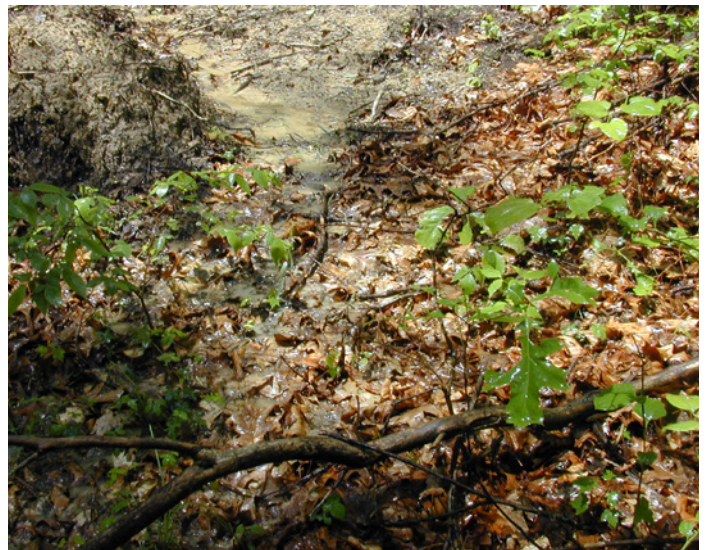
Water-bar outlet conveying runoff on to the stable forest floor.
Photo by Duane McCoy, DNR

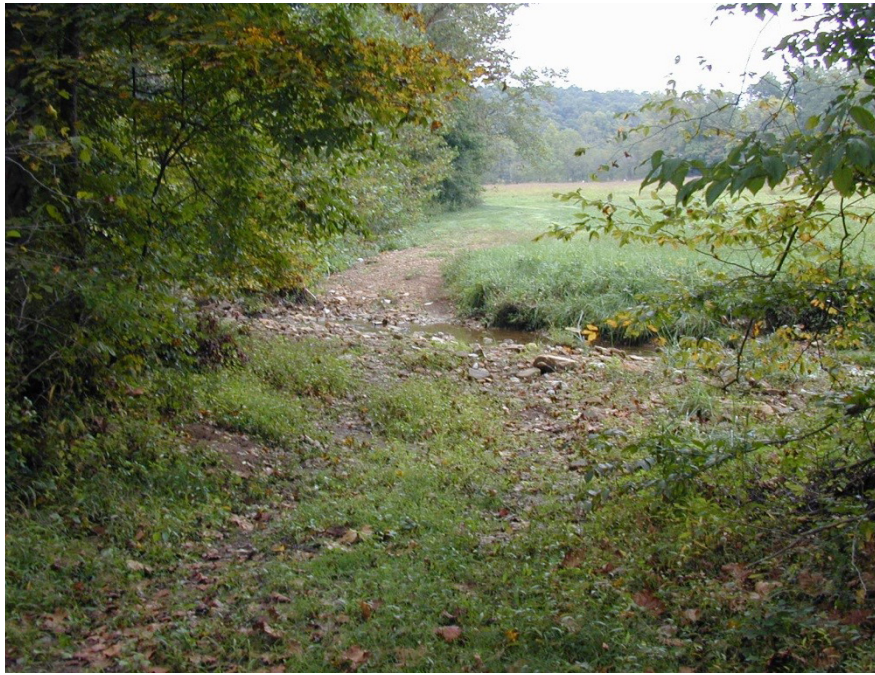
An access-road ford across a small stream with low and stable banks.
Photo by Duane McCoy, DNR.

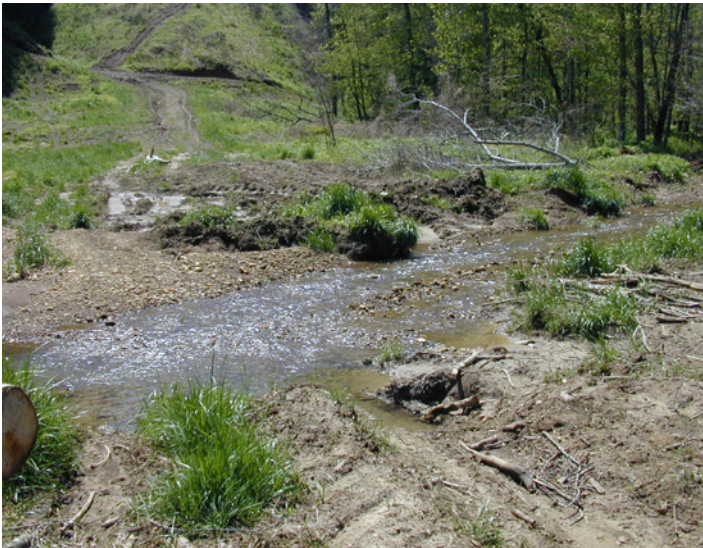
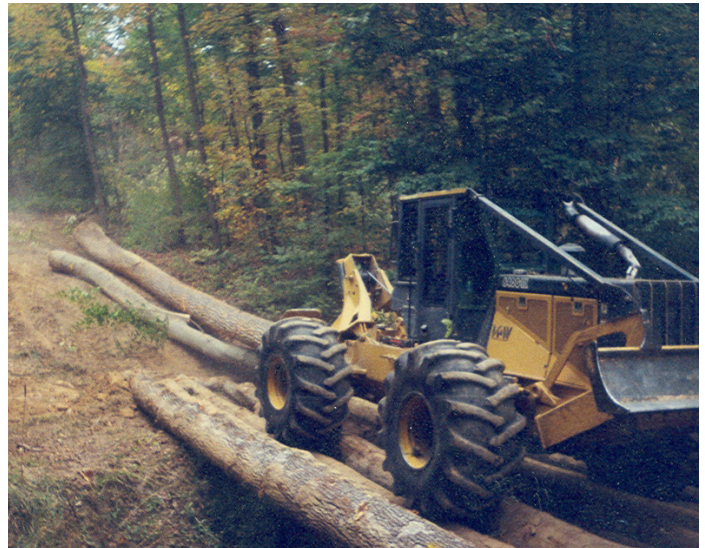
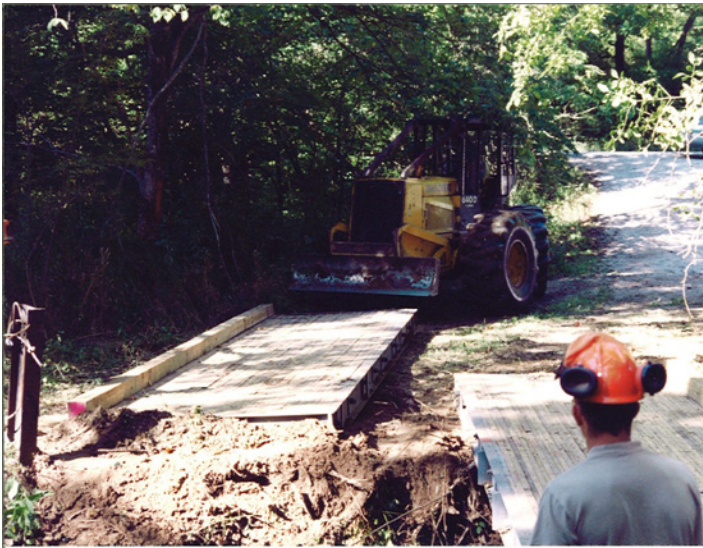
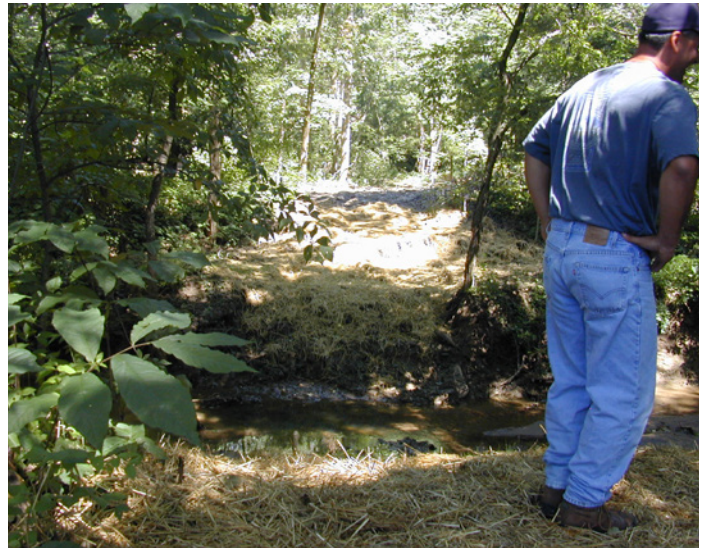
TOP LEFT: On a private site: No water diversions before stream crossing. No stream bank stabilization/revegetation. **TOP RIGHT:** A skidder crosses a log bridge. **BOTTOM LEFT:** Dozer installing bridge for stream crossing during a demonstration. **BOTTOM RIGHT:** A well closed-out stream crossing, with seed and straw applied to stabilize bare soil and promote revegetation. All Photos by Duane McCoy, DNR

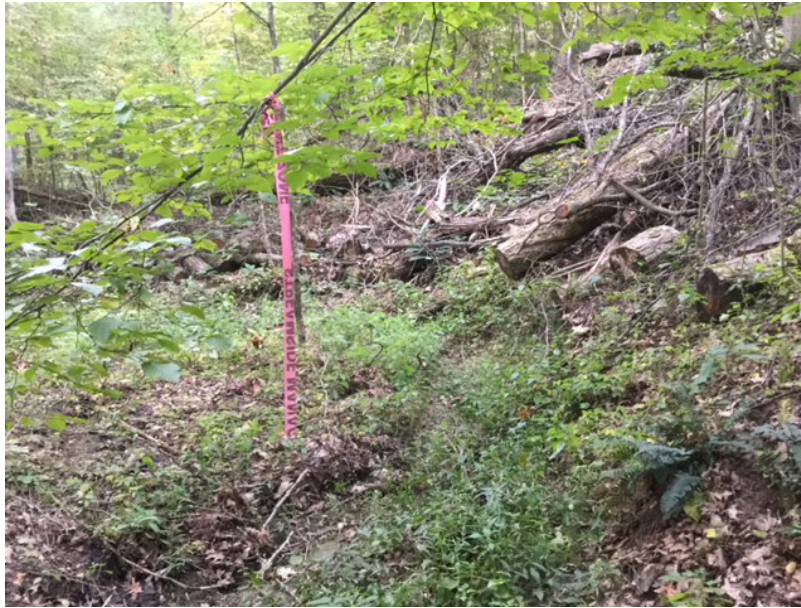
RMZ in Morgan-Monroe State Forest, marked by forester, debris removed from small intermittent stream. Photo by Jennifer Sobecki, DNR

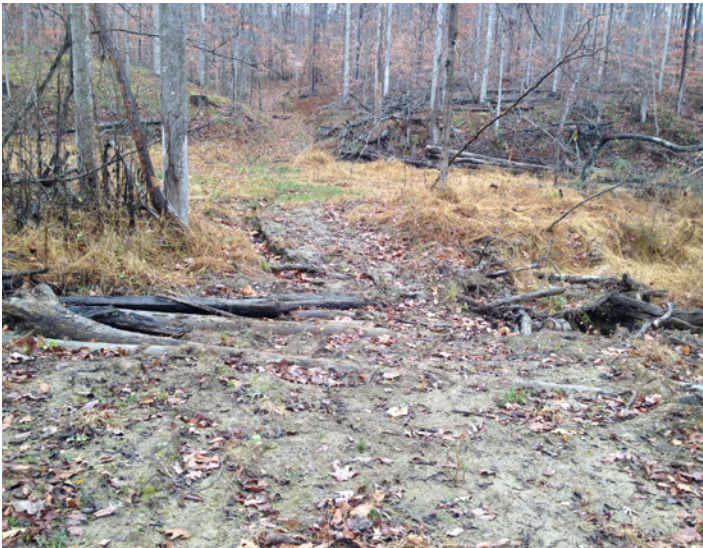
Corduroy logs and soil left in intermittent stream crossing on this private site caused obstruction of flow. Impacts from this kind of BMP departure can lead to sometimes extreme erosion and sedimentation. The stream will reroute itself to find ways around the obstruction. This results in destabilization of the stream banks and bed stream both upstream and downstream of the obstruction.
Photo by Jennifer Sobecki, DNR

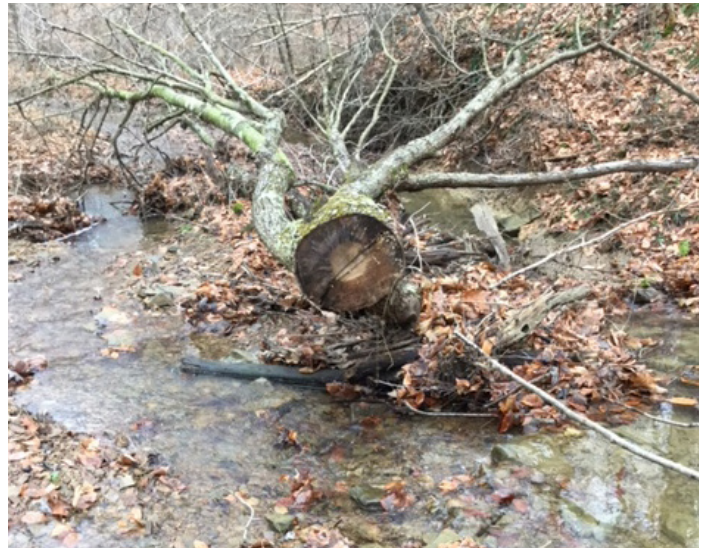
Logging debris in streams can obstruct stream flow, leading to the stream carving a new bank, which results in erosion and sediment going directly into the stream. Photo by Duane McCoy, DNR
