The Portersville Bridge

The Portersville Bridge Serving Dubois and Daviess Counties

The steel bridge was built by the Vincennes Bridge Company in 1912. The two spans crossed the White River at Portersville.

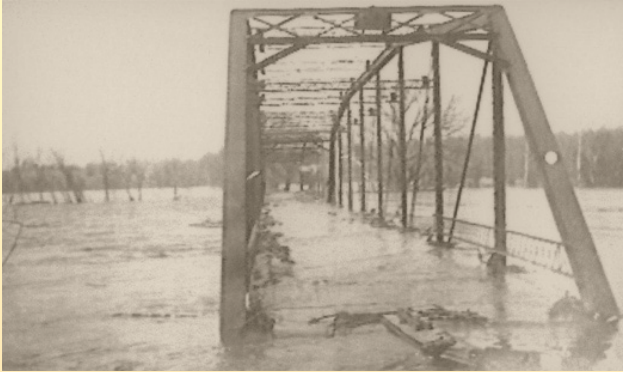
Shortly after the bridge was completed in 1912, a huge flood

on the White River submerged the bridge deck under a few feet of water. The railings and decking were removed to prevent heavy debris from becoming entangled on the bridge. After the waters receded, the bridge was raised three feet higher and opened in 1913.

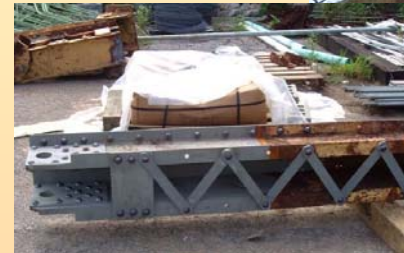
As the spans were taken apart, pieces were numbered for reassembly. Every piece was inspected, cleaned and painted.

Only 5% of the bridge trusses had to be replaced, largely due to rust. The decking and railings are new.
