Indiana Department of Environmental Management Office of Water Quality Wetlands Section

PUBLIC NOTICE

| 5. Project Description: | Remove the Thompson Mill Dam from the Big Blue River. The foundation of the dam failed in October 2023. The dam is owned by the Town of Edinburgh, which has given permission for ECI to access and remove the dam. Additional information may be found online at https://www.in.gov/idem/5474.htm | | |

Thompson Mill Dam Removal Permit Supplemental Information

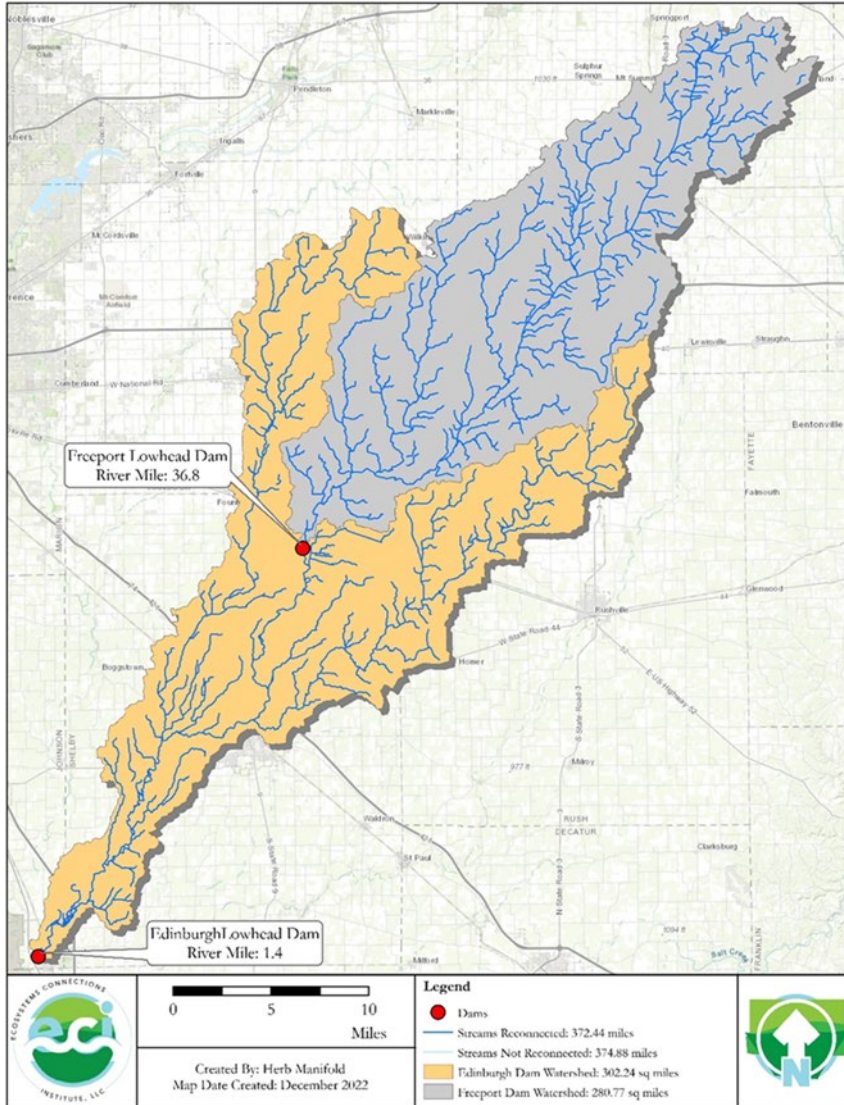
Figure 1. The Lower Big Blue River watershed, located in east central Indiana, has a watershed of 280 square miles. There are two 10-digit hydrologic unit code (HUC) sub-watersheds that make up the Lower Big Blue River. These include Little Blue River (0512020408) and Big Blue River (0512020409). The Lower Big Blue River Watershed originates near southern Henry County and flows southwest, where it joins Sugar Creek to form the Driftwood River about 1.5 miles downstream from Edinburgh. Approximately 342 stream miles will be reconnected with full removal of the Thompson Mill Dam.

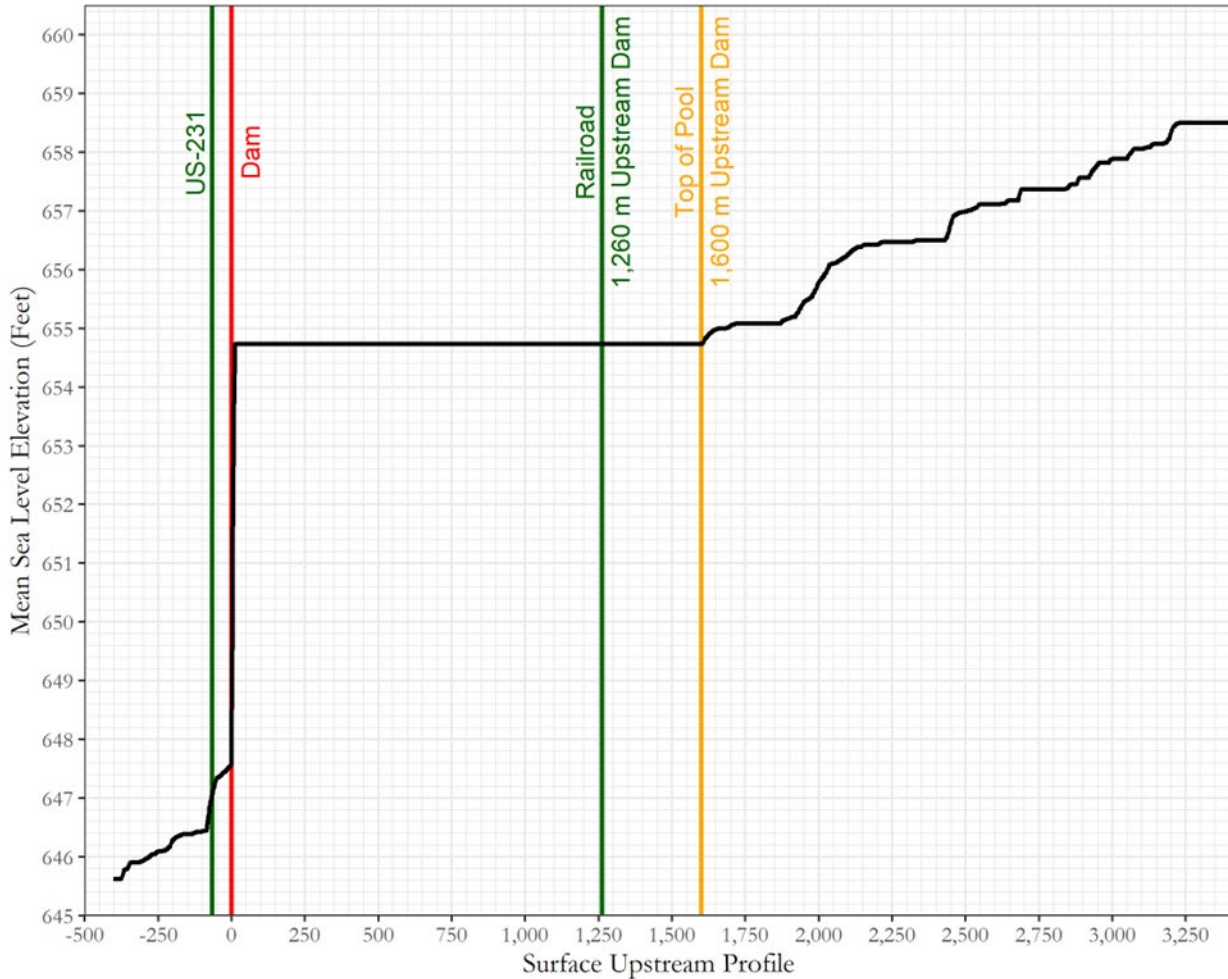
Figure 3. Water surface elevation longitudinal profile for Thompson Mill dam. The elevation data was collected in 2017 during the statewide LiDAR initiative. During the survey the dam was still fully functional. The dam breached in October 2023 and much of the existing pool was drained. The top of the original pool is 1,600 meters (5,248 feet) upstream of the dam.

The Surface profile was derived from the data collected during the 2017 statewide LiDAR initiative. LiDAR utilized during these surveys are unable to penetrate water and will only provide a water surface elevation. This surface elevation data combined with a stream centerline; we were able to plot where the extent the pool was during the 2017 survey. It is important to note that the dam breached in October 2023 and the current pool depth and length is currently much lower.

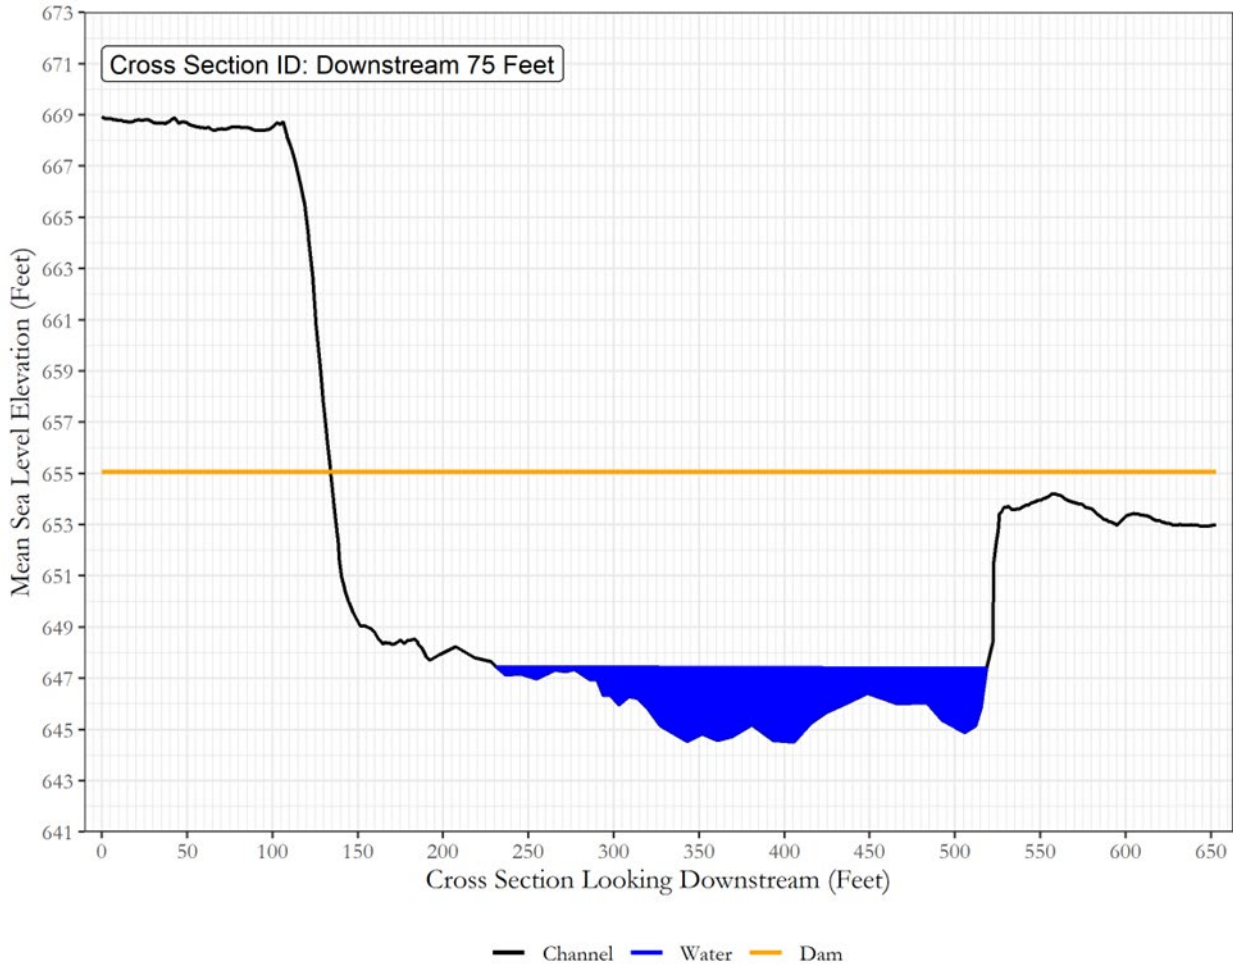
Figure 6. Cross Sectional collected 75 feet downstream of Thompson Mill dam. Downstream orientation with river left being on left side of the plot. In channel and water surface data was collected on 8 January 2024. Above channel data collected as part of the statewide LiDAR initiative in 2017. Orange line represents the top elevation of the Thompson Mill Dam.

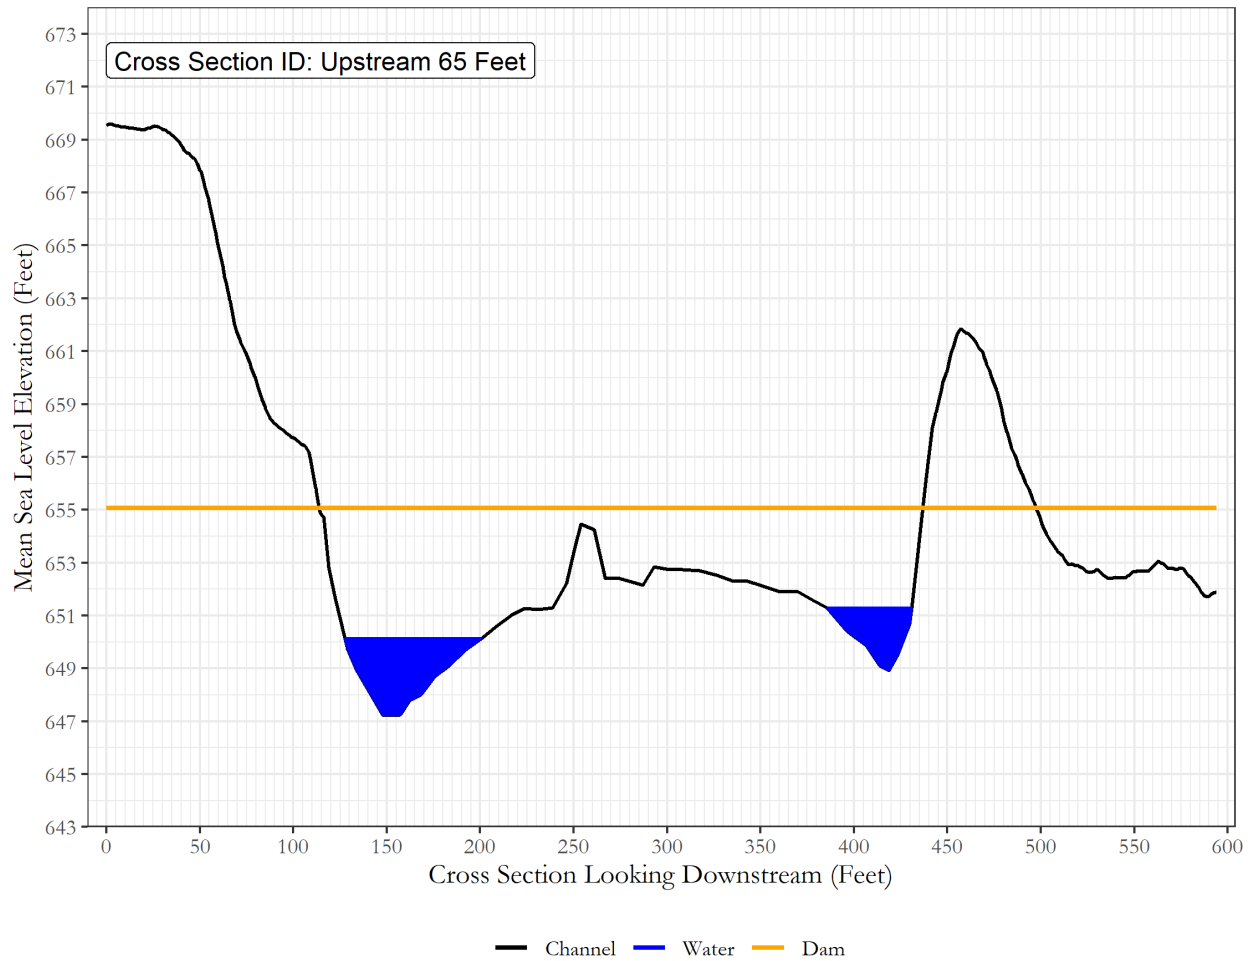
Figure 7. Cross Sectional collected 65 feet upstream of Thompson Mill dam. Downstream orientation with river left being on left side of the plot. In channel and water surface data was collected on 8 January 2024. Above channel data collected as part of the statewide LiDAR initiative in 2017. Orange line represents the top elevation of the Thompson Mill Dam.

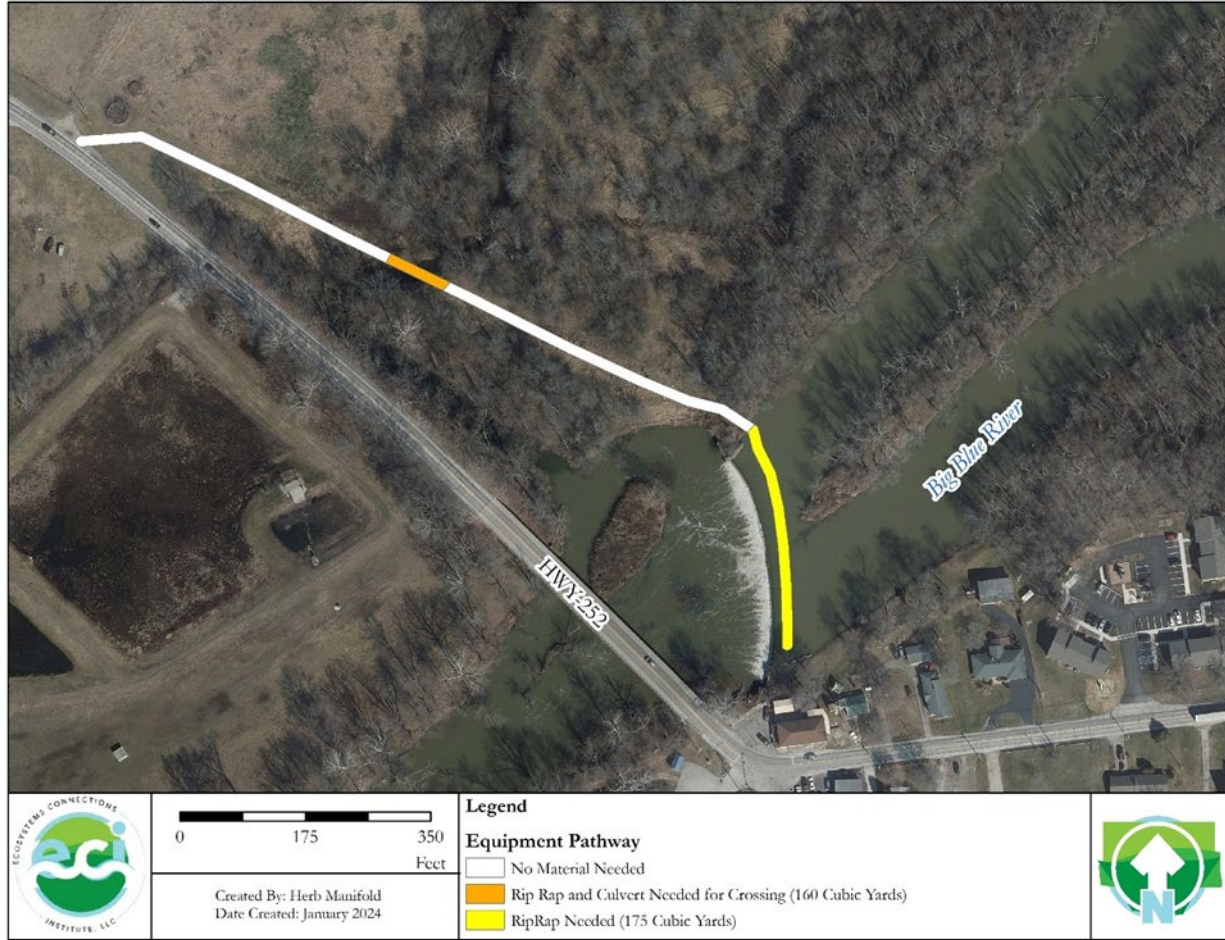
Figure 10. Equipment path needed to access Thompson Mill dam. This pathway is already clear large woody vegetation as it is under a decommissioned power line. White sections of the pathway will require no additional material for access. Orange sections will require a culvert and riprap to provide crossing over a small drainageway. Yellow sections of pathway will be used as a footing for the removal equipment, A maximum of 350 cubic yards of riprap will be utilized. All material will be removed when the project is complete.

The Thompson Mill dam is about 350 feet long, 10 feet tall, and 3 feet wide. The dam is made from limestone blocks approximately 5 feet by 3 feet by 3 feet. Removal of the dam will require a pathway approximately 950 feet long in an Edinburgh utility right of way from highway 252 to the dam. The right of way is under a set of decommissioned power lines from highway 252 to the dam. Most of this pathway will require no additional resources to build a pathway (white sections of pathway). One ephemeral draining crossing will be required to access the dam (orange pathway). This crossing is 3 feet deep and 90 feet long perpendicular to the stream. A culvert will be utilized to allow water movement in the ditch. Riprap will be utilized to create a pathway over the culvert to access the dam with a maximum of 160 cubic yards utilized. Riprap will also be needed upstream of the dam to provide a pathway for the equipment to remove the dam. A maximum of 175 cubic yards of riprap will be needed upstream of the dam. Sections of the dam on the right descending bank and on the left descending bank may remain and be preserved in accordance with SHPO MOA or to support the wingwalls. Otherwise, all sections of the dam will be removed and staged in Edinburgh for future use by the town of Edinburgh. All riprap and broken blocks and timbers from the foundation will be removed from the project site upon completion of the project. No staged water release is necessary due to the current breach in the dam.

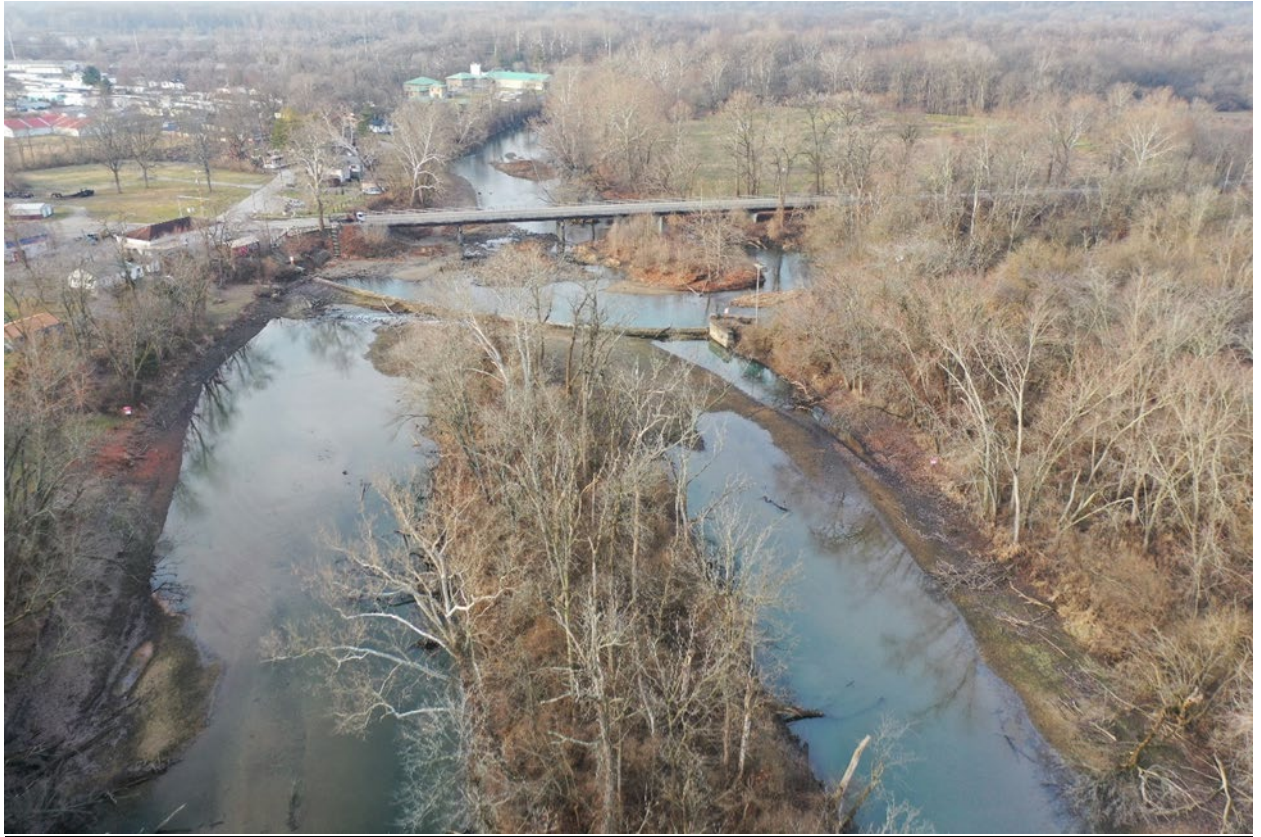
Figure 14. Drone picture from upstream of the dam looking downstream. Photo taken 8 January 2024. Thompson Mill dam, Edinburgh Indiana. Note the lower water level because as a result of the breach in the dam.

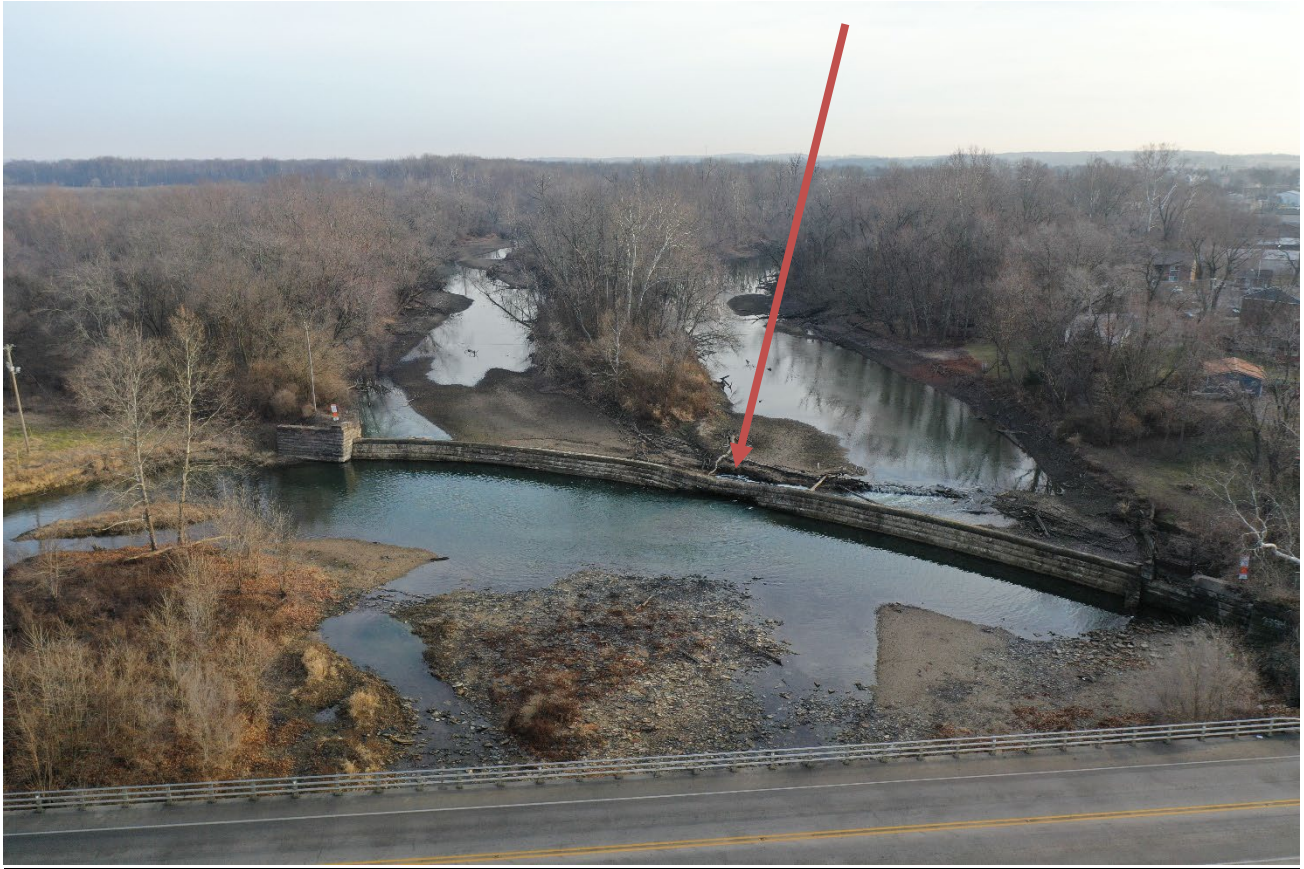
Location of foundation failure of the
Thompson Mill Dam.

Figure 15. Thompson Mill Dam looking upstream. Note breach in the middle part of the dam.

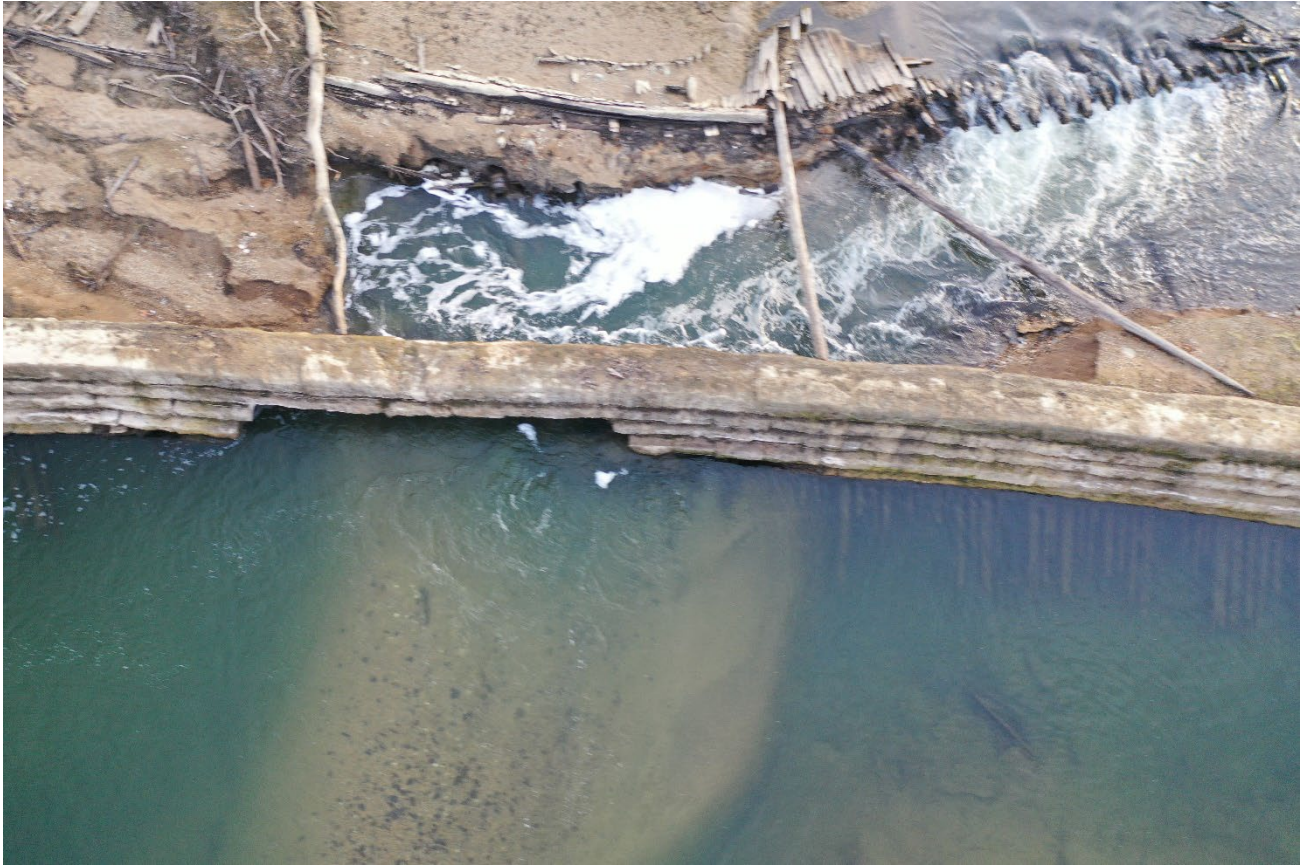
Figure 16. Breach in the Thompson Mill Dam and sediment plume. Note exposed logs on the right side of the image.
