Categorical Exclusion
Appendix F
Water Resources

SR 66 INTERSECTION IMPROVEMENT AT EPWORTH ROAD VANDERBURGH & WARRICK COUNTY, IN

*December 29, 2021
Waters of the U.S. Report
Prepared by: Peter Putzier*

**Des. No.: 1400195
Contract No.: R-39921**

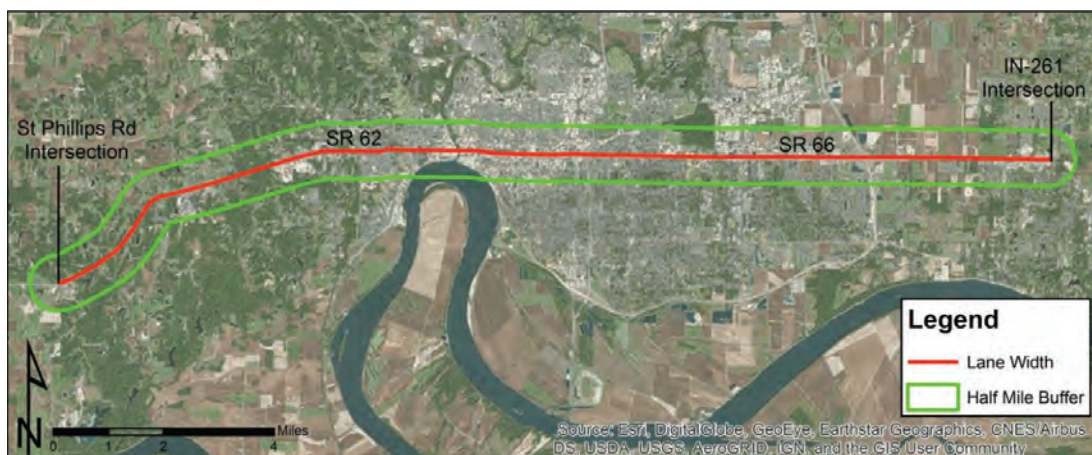
Figure A - Study Area

- Compiling an inventory of existing conditions
- Preparing a red flag summary, conducting traffic data counts
- Traffic forecasting (short-term 10-year forecasts as well as long-term, 20-year forecasts)
- Traffic simulation modeling
- Analyzing and proposing alternatives as well as cost estimates
- Conducting stakeholder involvement activities
- Producing a compilation of the findings

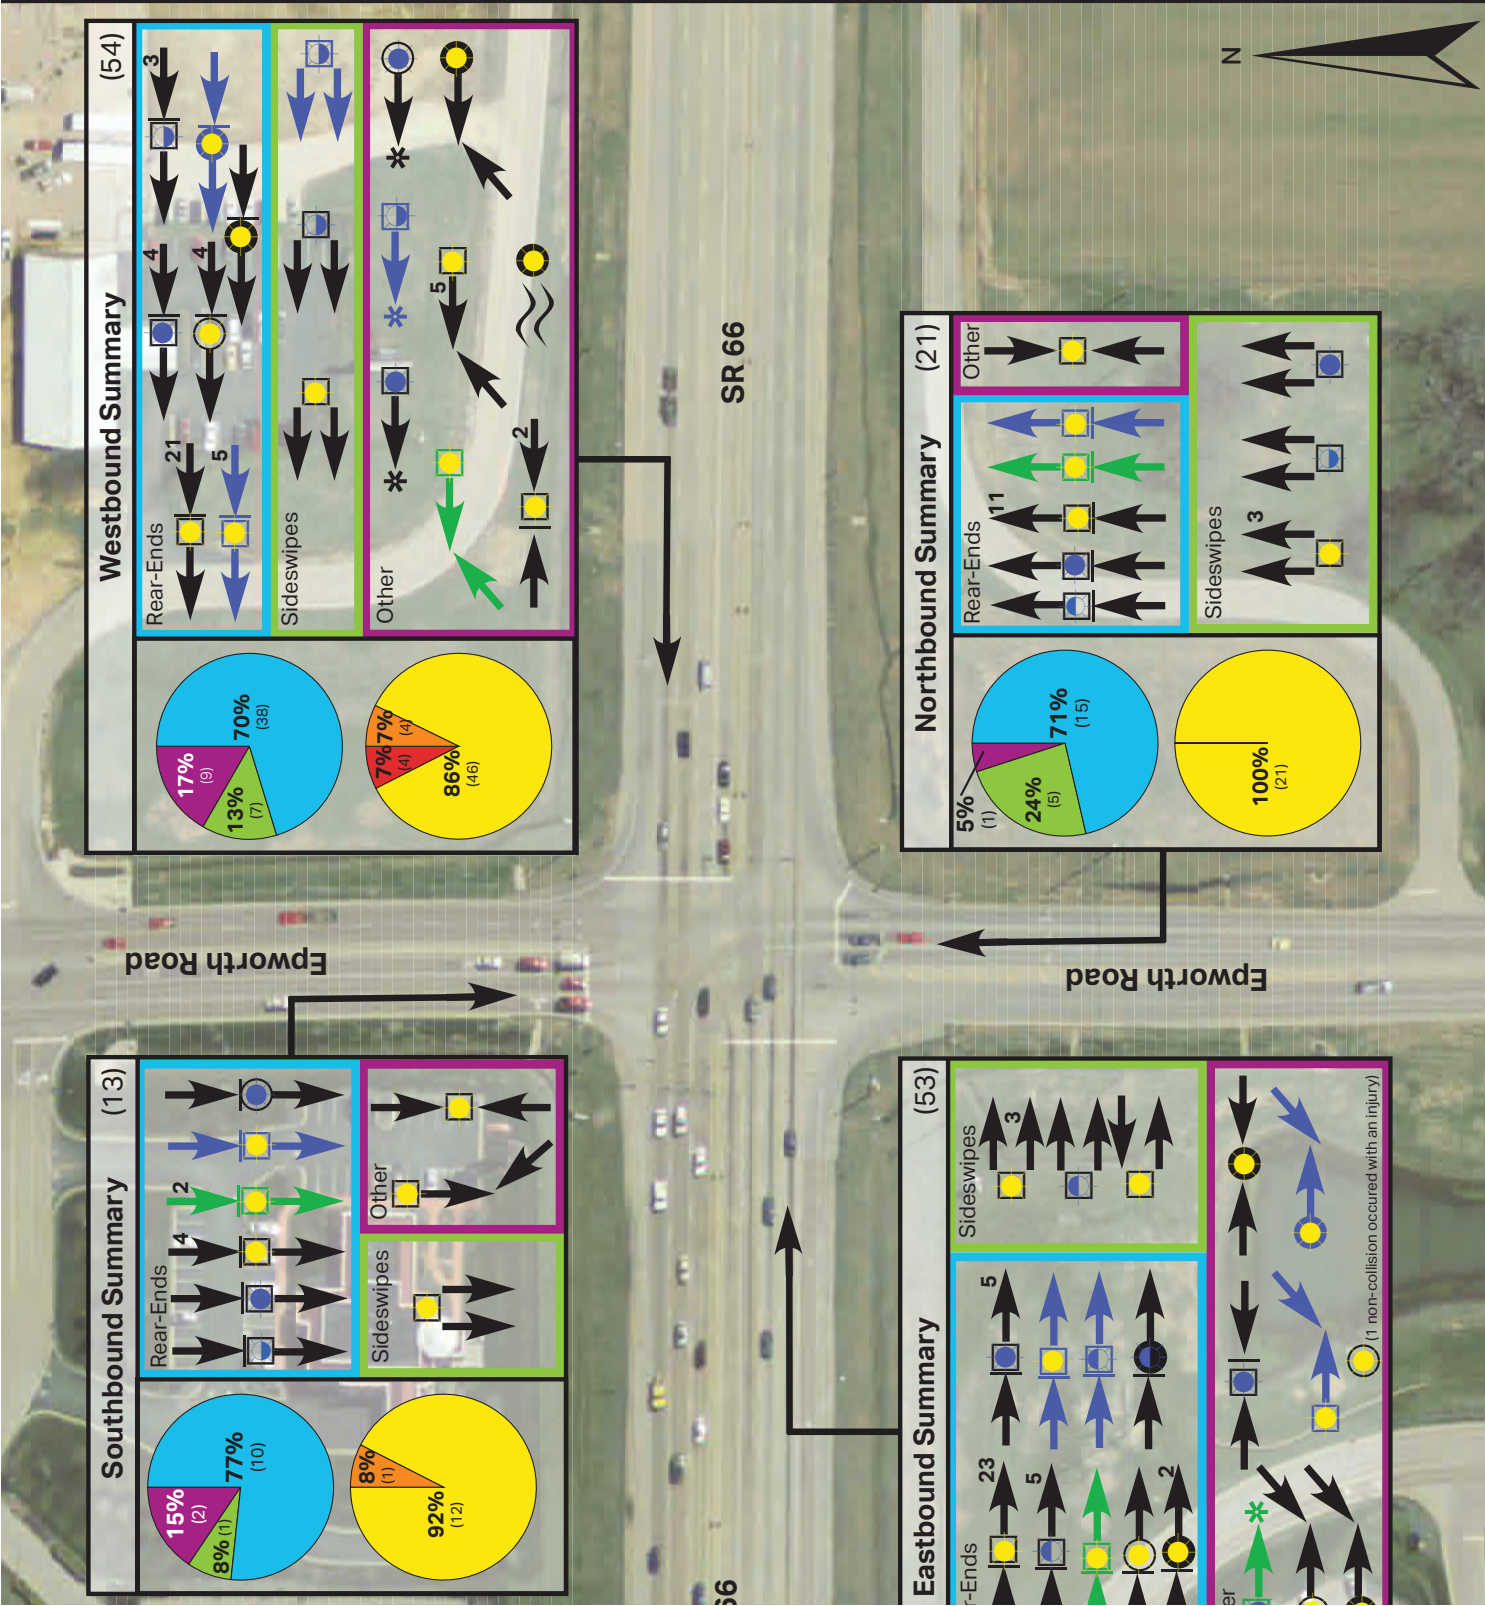
P	LOCATION SR 66 at Epworth Road	PRIORITY: High	
DESCRIPTION P - Construct Hybrid Displaced Left Turn / Boulevard Left Turn Intersection at Epworth Road		COST ESTIMATE PE: \$600,000 ROW: \$100,000 Utilities: \$0 Construction: \$2,300,000 Total: \$3,000,000	
<p>This section of SR 66 carries about 40,000 vehicles per day (VPD). Traffic is expected to grow about 1.0% per year. The purpose of the improvement is to reduce the number of crashes within the intersection. There were approximately 141 collisions at the intersection between 2014 and 2016. Approximately 76% of the crashes occurred along SR 66.</p> <p>There are no short-term recommendations.</p> <p>The long-term recommendation P) is to construct a hybrid displaced left turn / boulevard left turn intersection for the SR 66 approaches. Westbound left turn would use the DLT configuration. Eastbound left turns would use the boulevard left configuration. The proposed recommendation will improve the LOS and reduce crashes as it will limit the number of conflict points.</p>
