**SUBJECT: SR 250 Small Structure Replacement
DES No. 1801015 Jackson County, Indiana**

S.R. 250 OVER U.N.T. TO RIDER DITCH
SMALL STRUCTURE REPLACEMENT
JACKSON COUNTY

DESIGNATION #: 1801015
LEAD DESIGNATION #: 1800276

STRUCTURE FILE #: CV 250-036-09.30

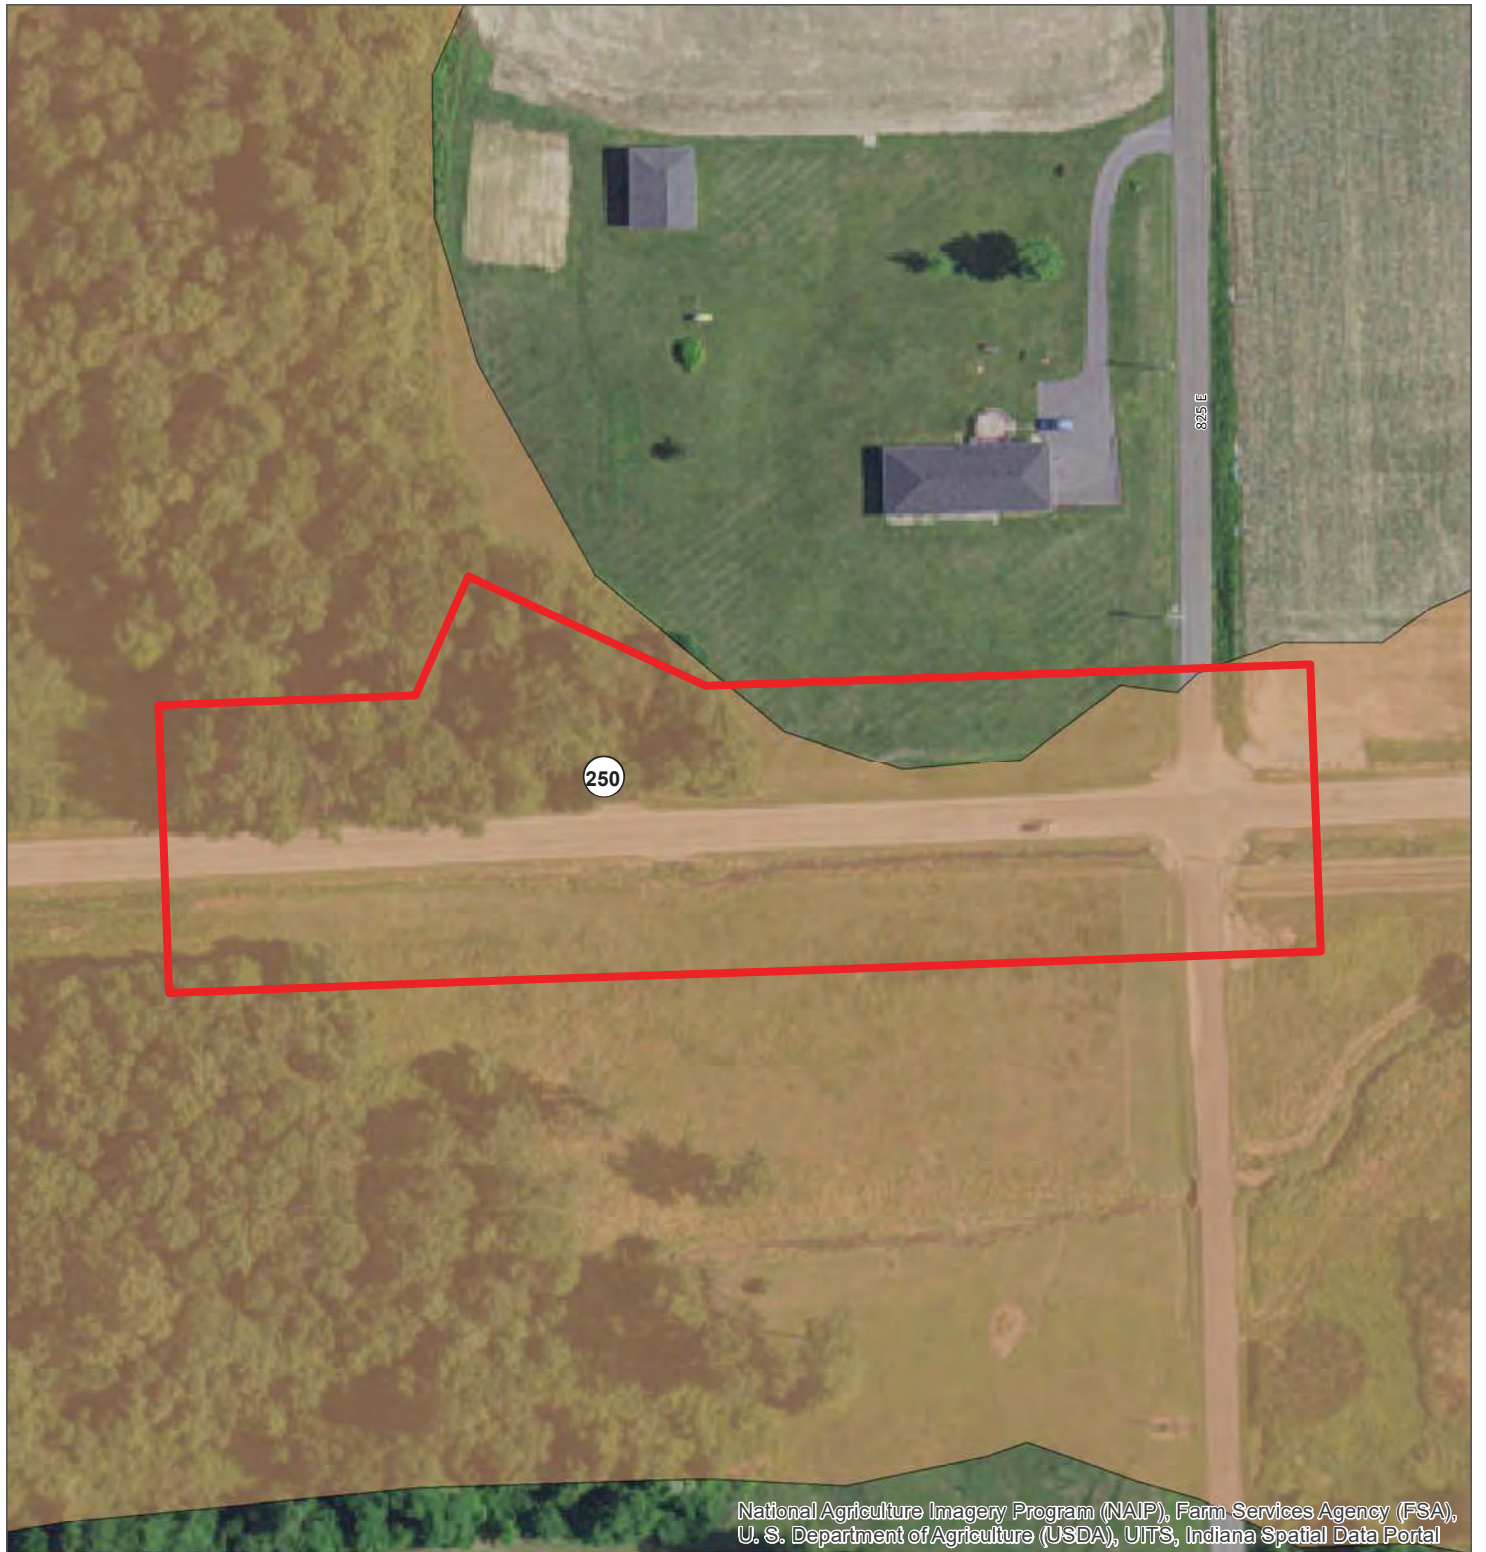
Figure 6: Floodplain Map
 Author: Hillary Shaffer
 Small Structure Project
 SR 250 over UNT to Rider Ditch
 Jackson County, Indiana
 Des. No. 1801015

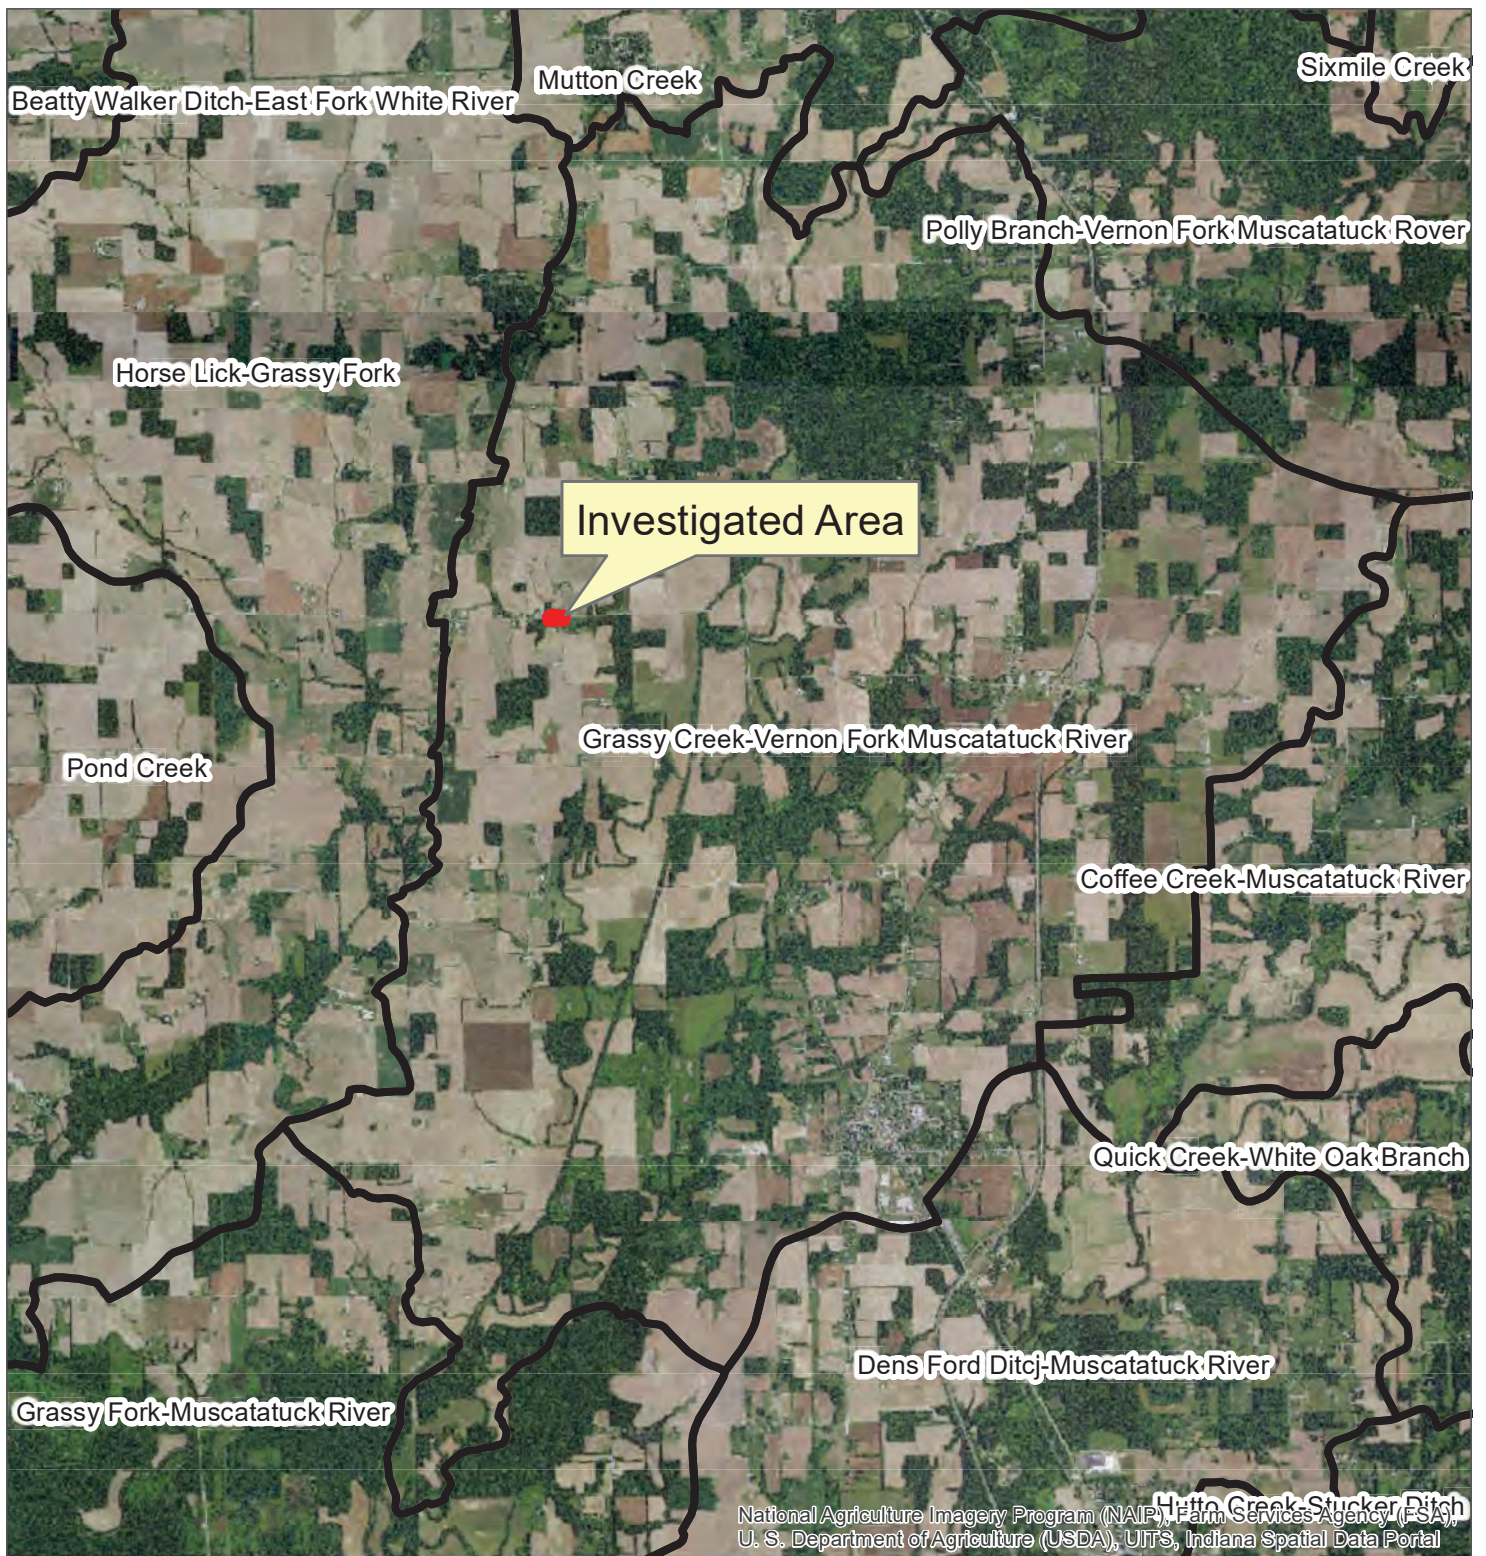
Figure 7: Watershed Map
 Author: Hillary Shaffer
 Small Structure Project
 SR 250 over UNT to Rider Ditch
 Jackson County, Indiana
 Des. No. 1801015

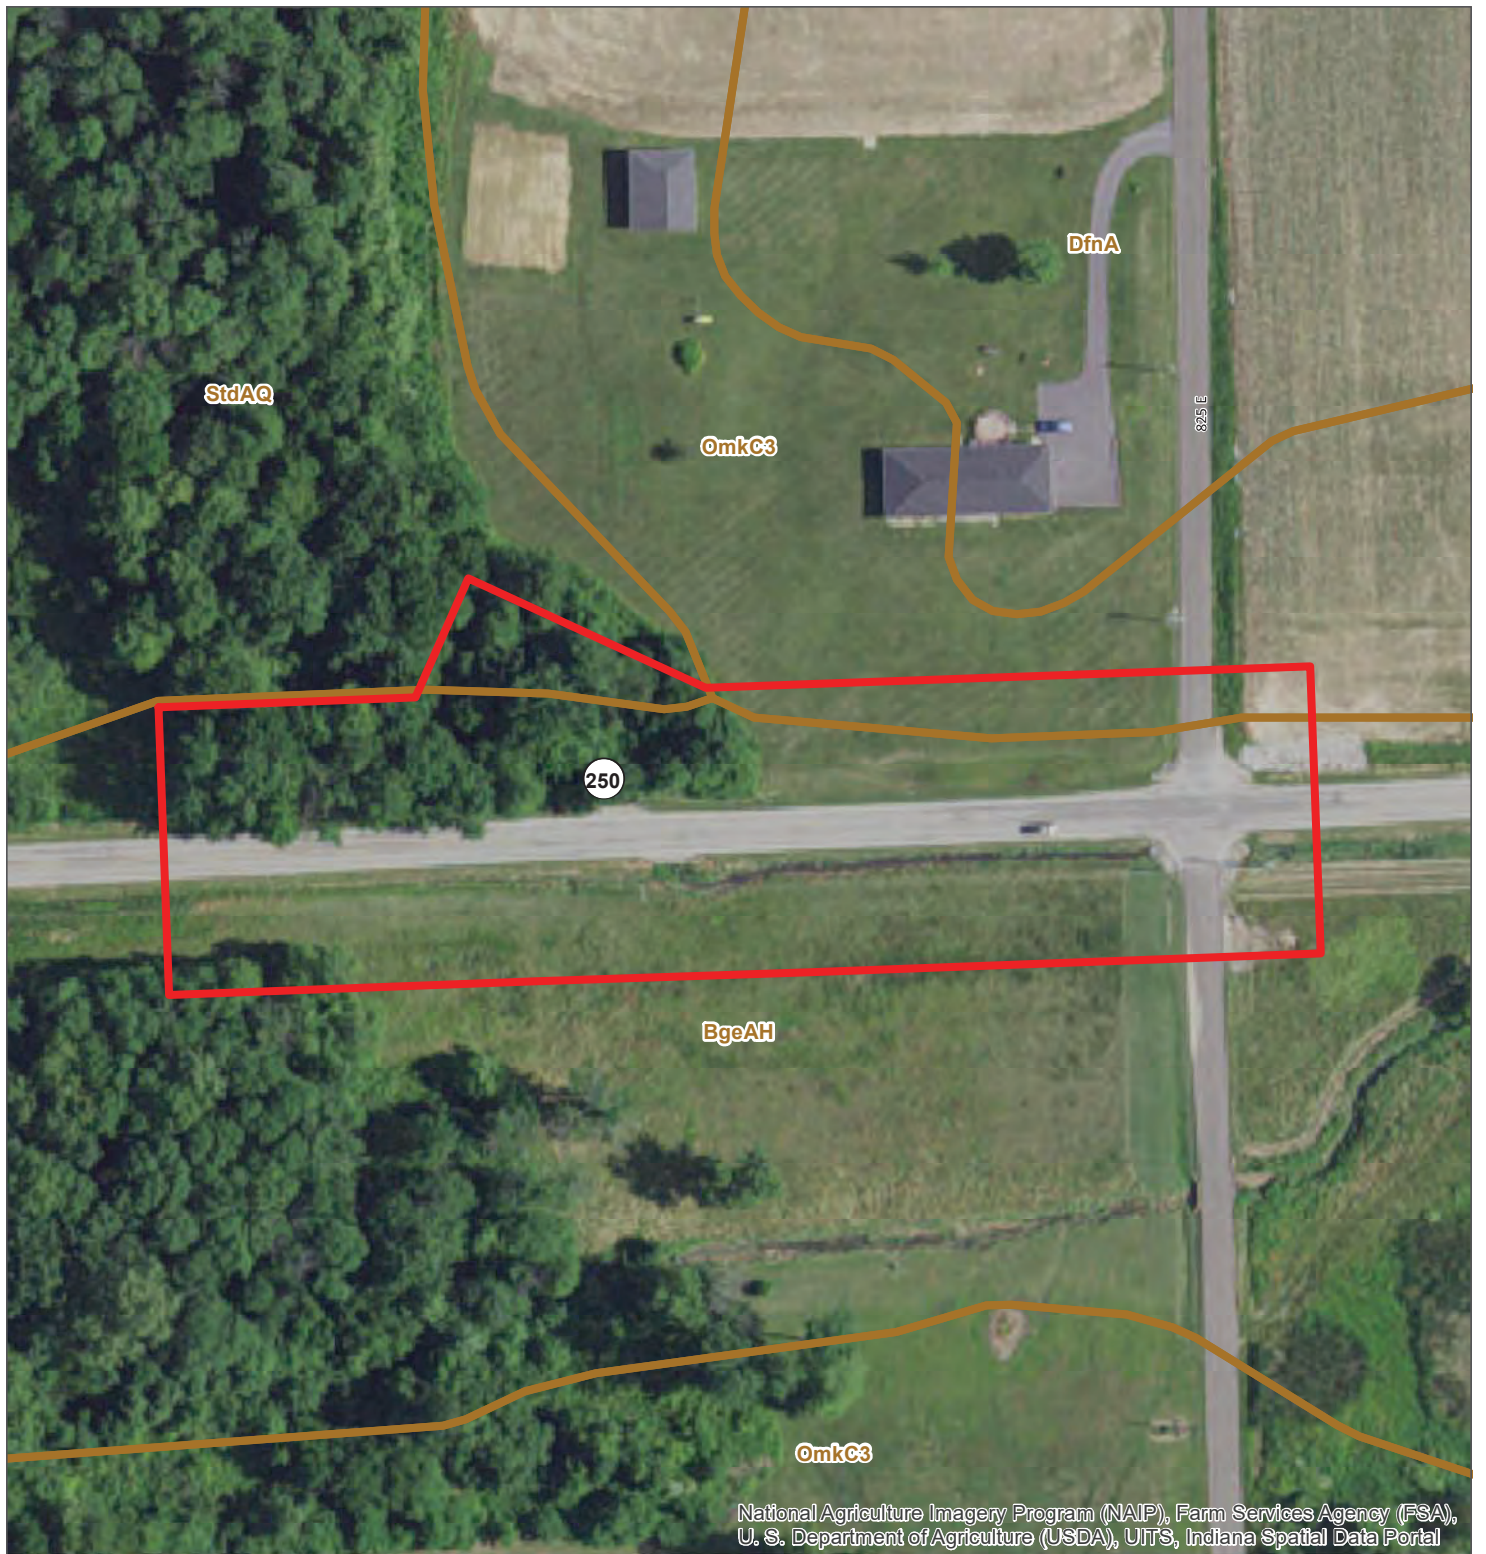
Figure 8: Soil Survey Map
 Author: Hillary Shaffer
 Small Structure Project
 SR 250 over UNT to Rider Ditch
 Jackson County, Indiana
 Des. No. 1801015

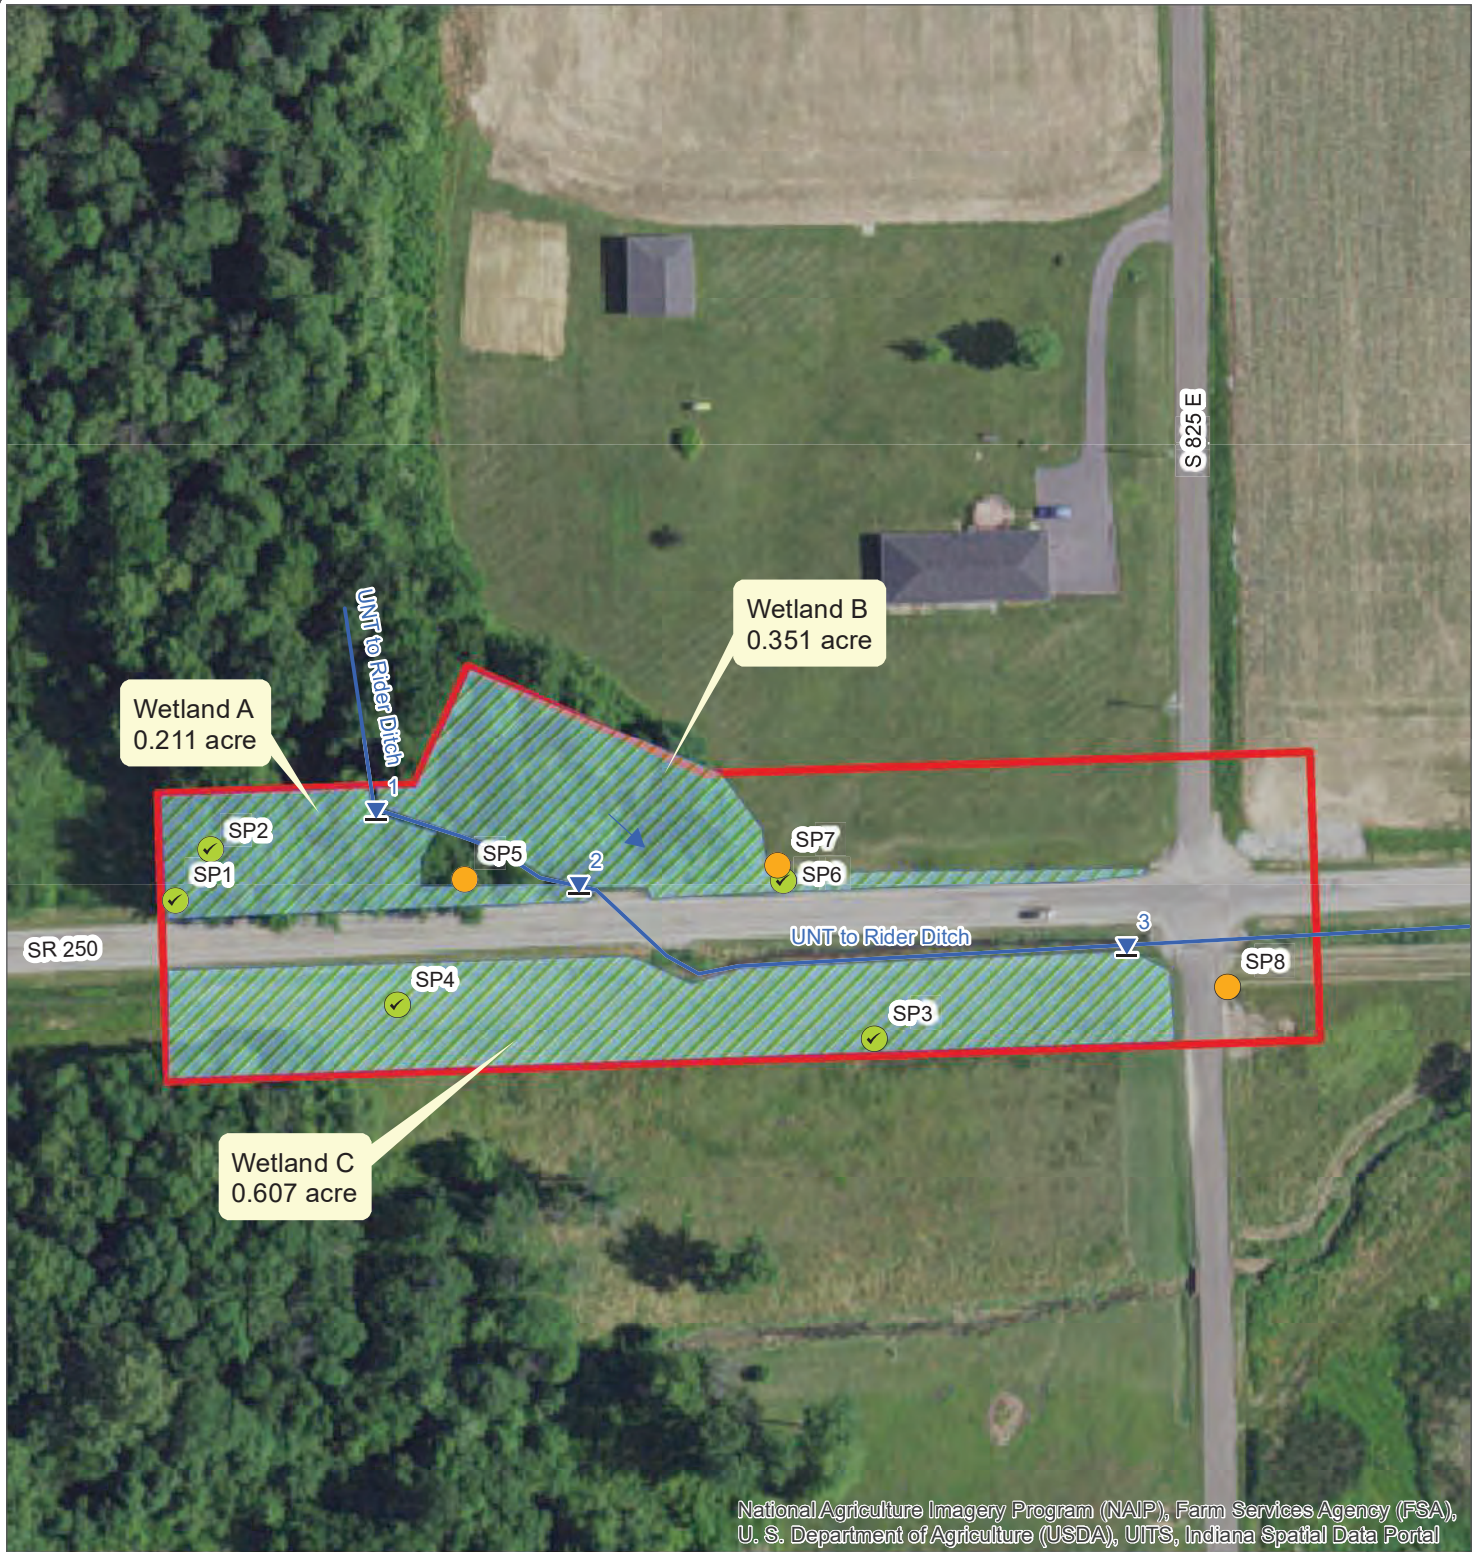
Figure 9: Water Resources Map
 Author: Hillary Shaffer
 Small Structure Project
 SR 250 over UNT to Rider Ditch
 Jackson County, Indiana
 Des. No. 1801015

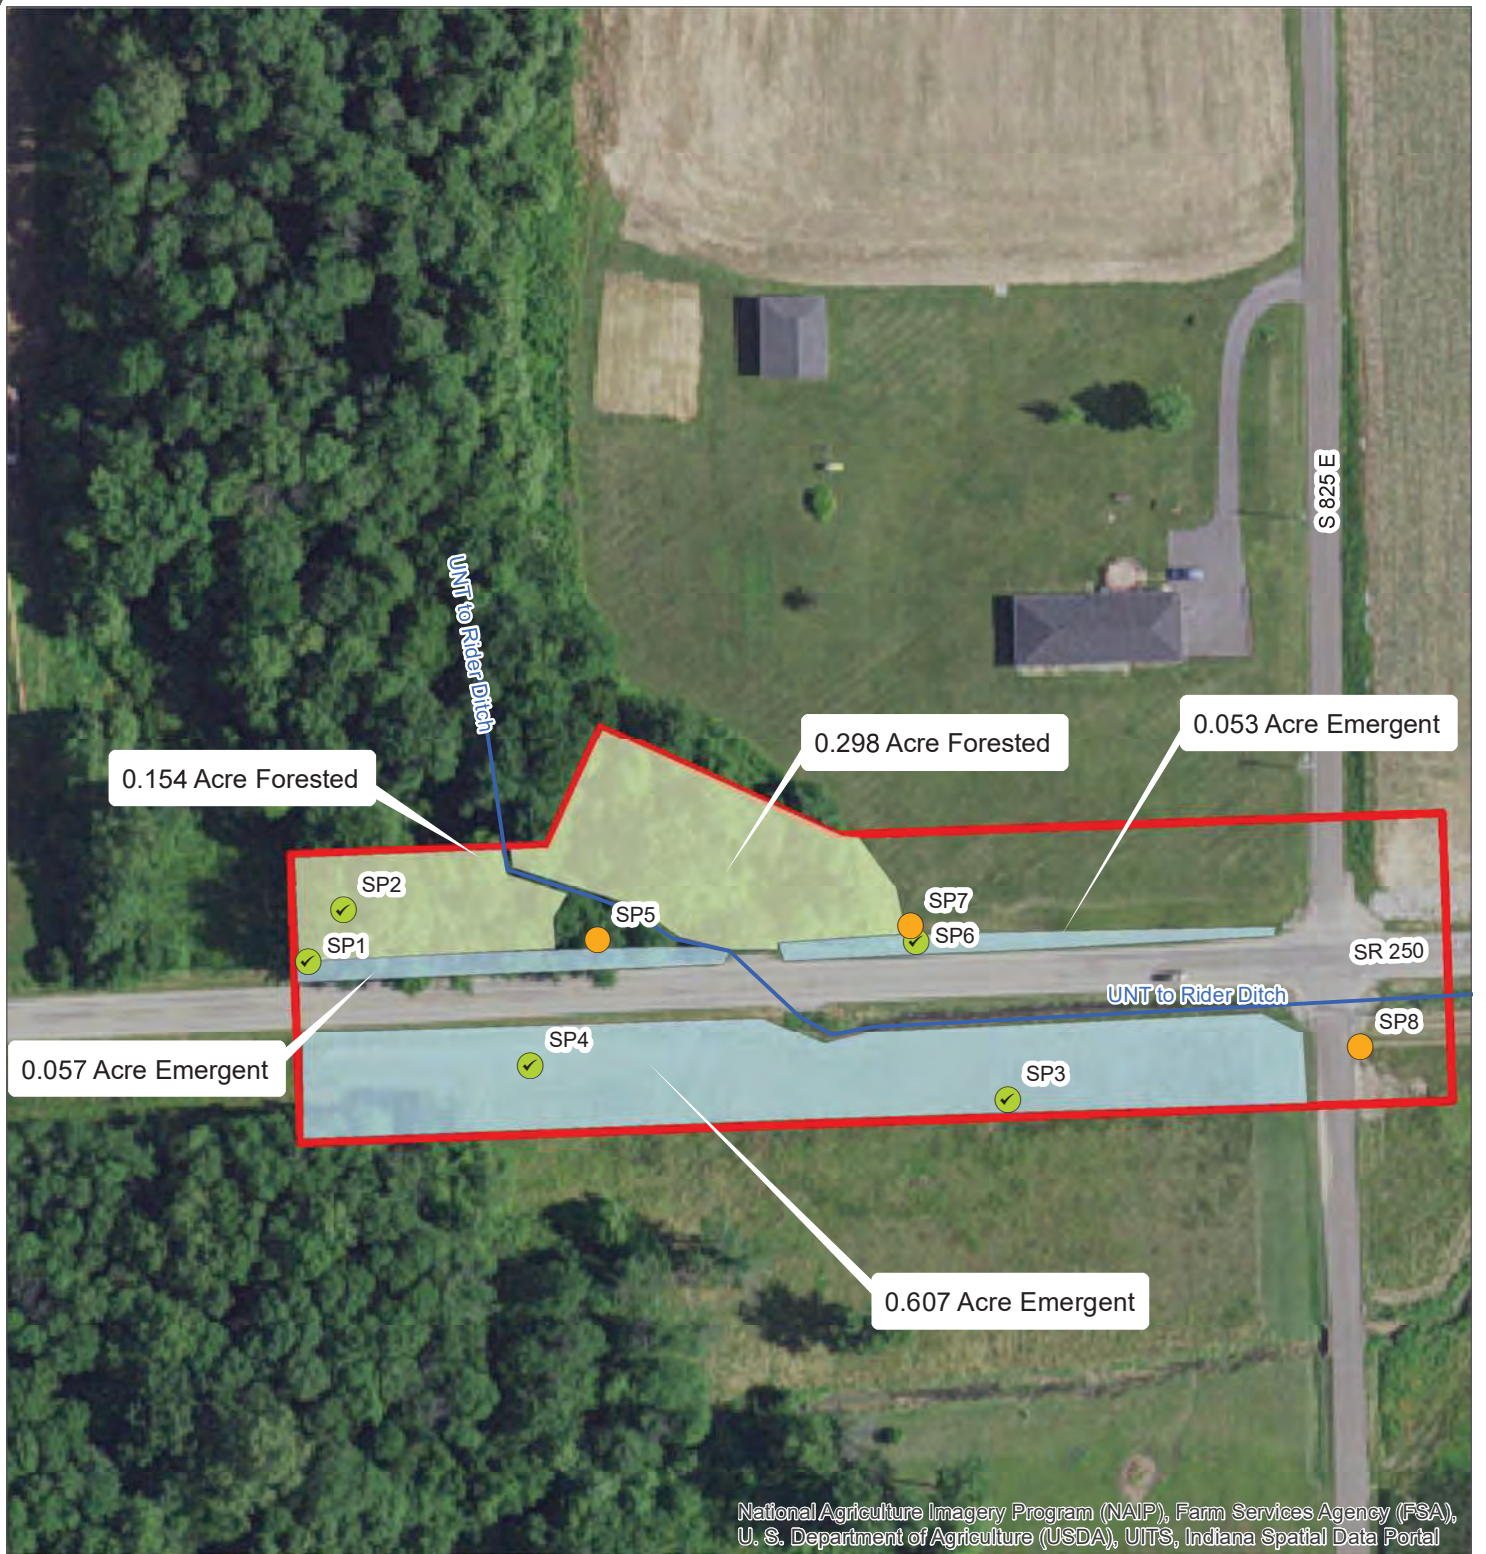
Figure 10: Wetland Map
 Author: Hillary Shaffer
 Small Structure Project
 SR 250 over UNT to Rider Ditch
 Jackson County, Indiana
 Des. No. 1801015

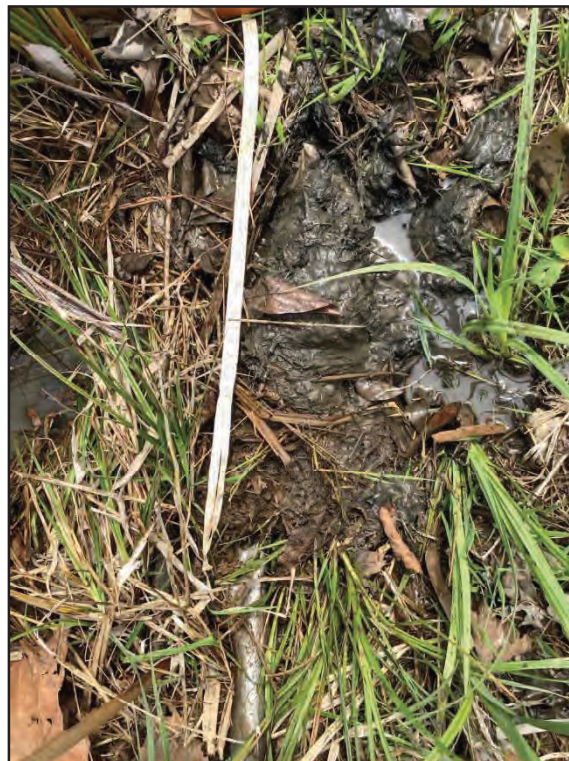
Photo 2: The soil profile of SP1.

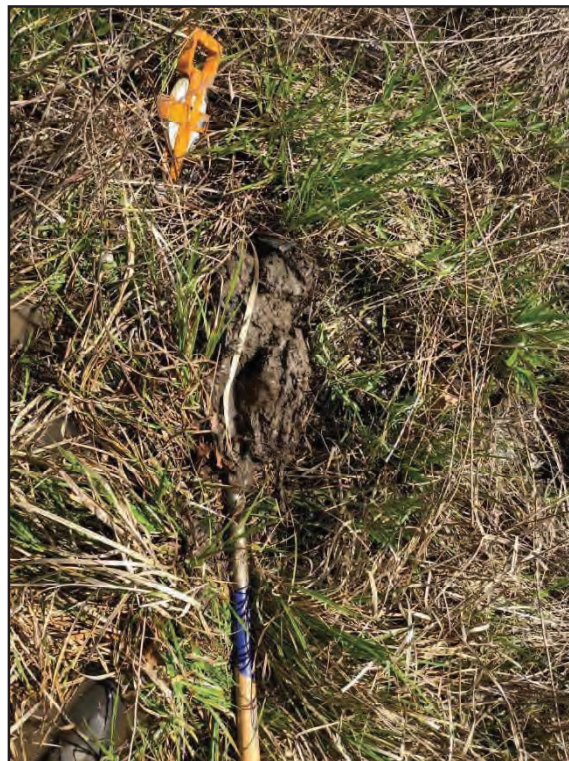
Photo 4: The soil profile of S 2.

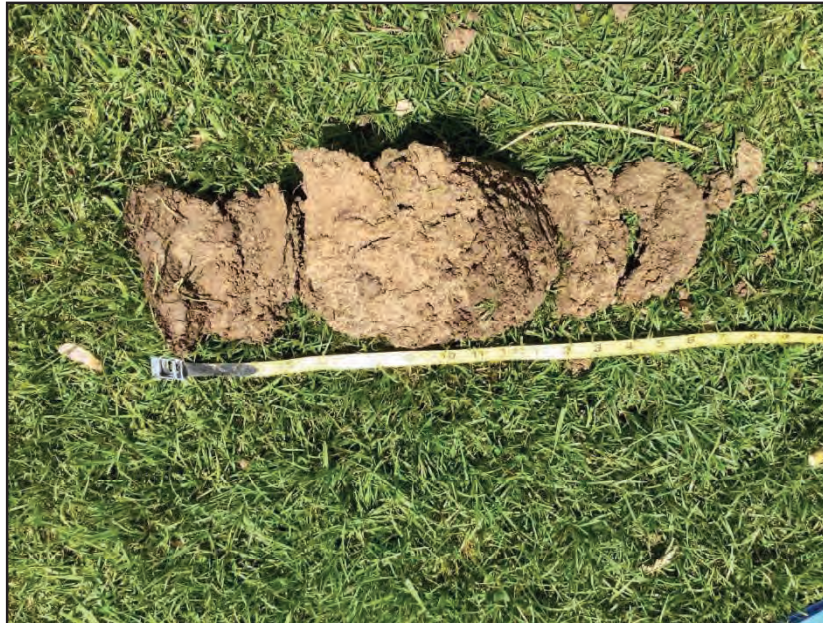
Photo 6: The soil profile of SP3.

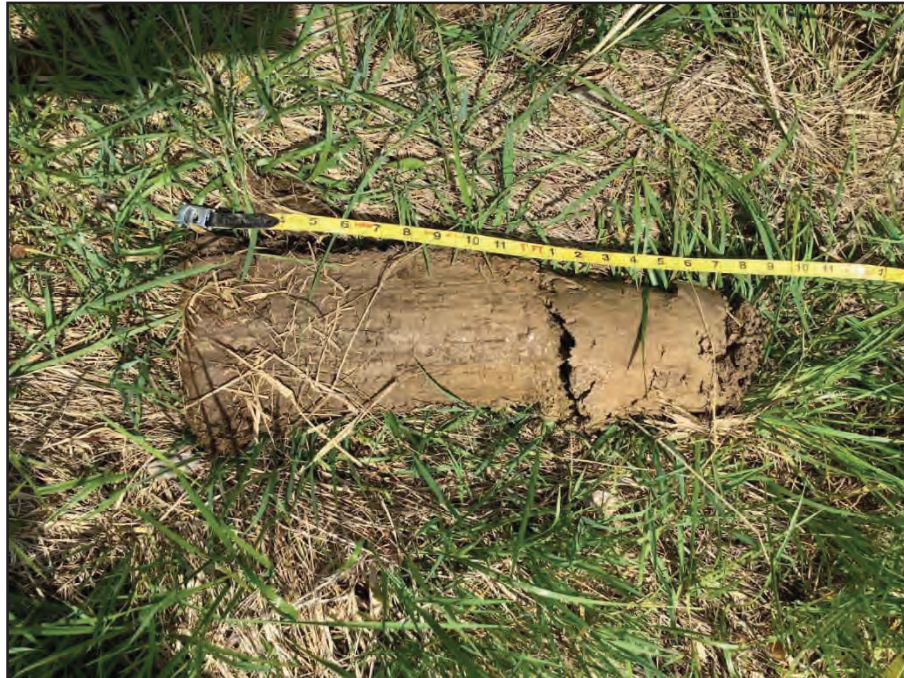
Photo 10: The soil profile of SP4.

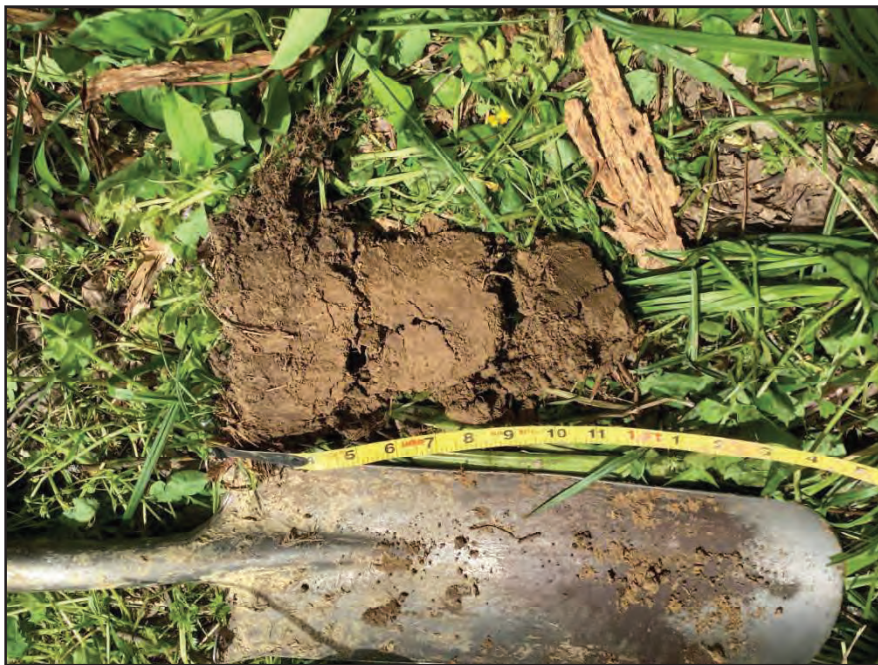
Photo 16: The soil profile of SP5.

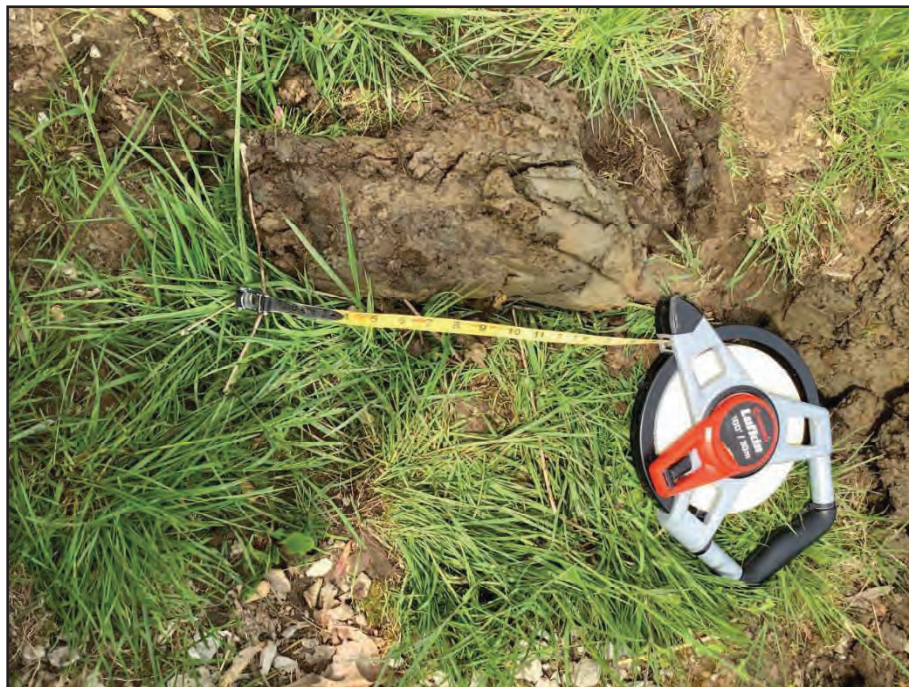
Photo 24: The soil profile of SP6

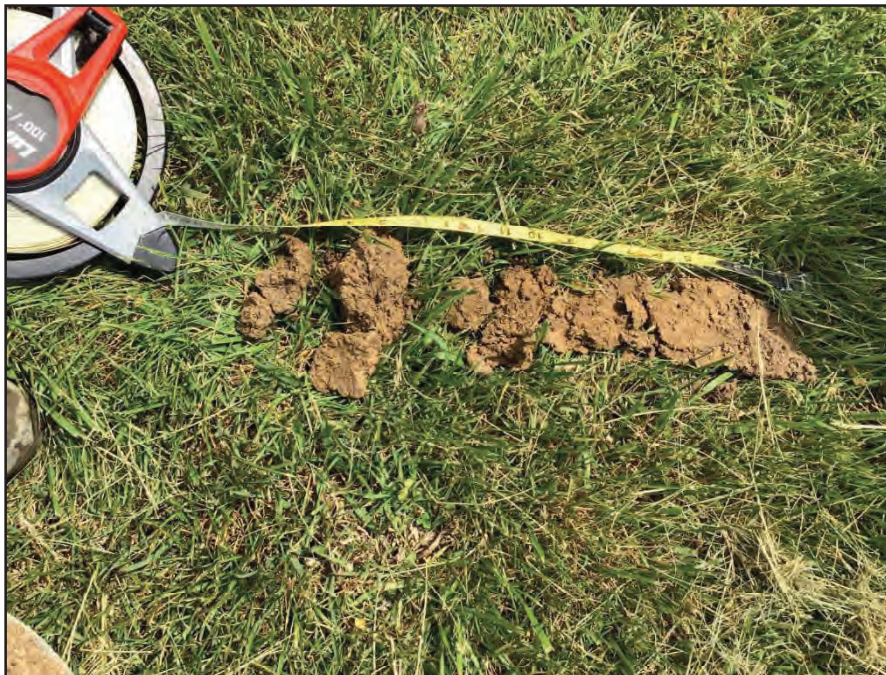
Photo 26: The soil profile of SP 7 .

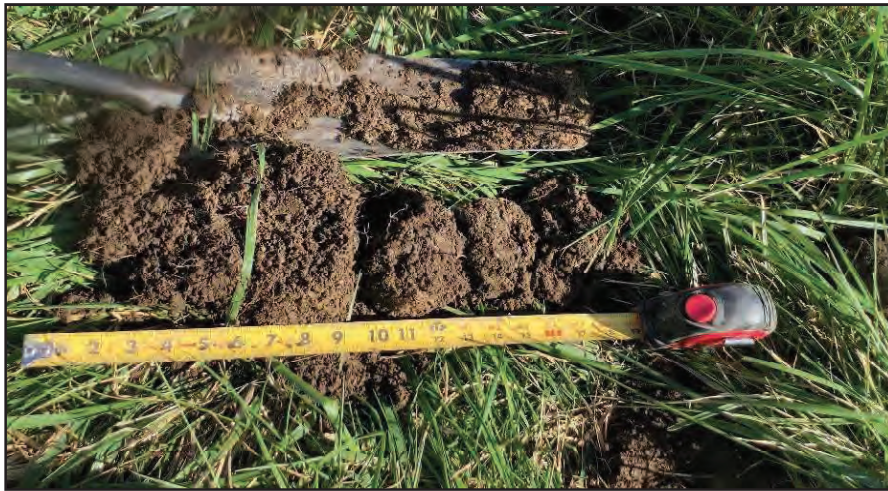
Photo 30: The soil profile of SP8.

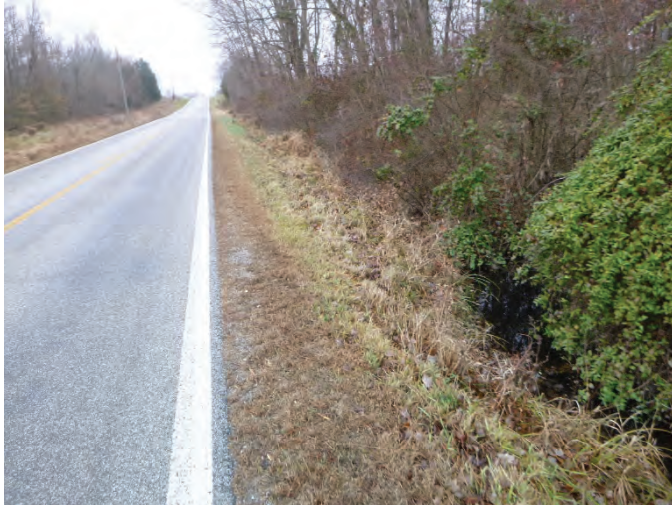
TYPICAL CONDITION OF SHOULDER AT
NORTHWEST CORNER OF STRUCTURE

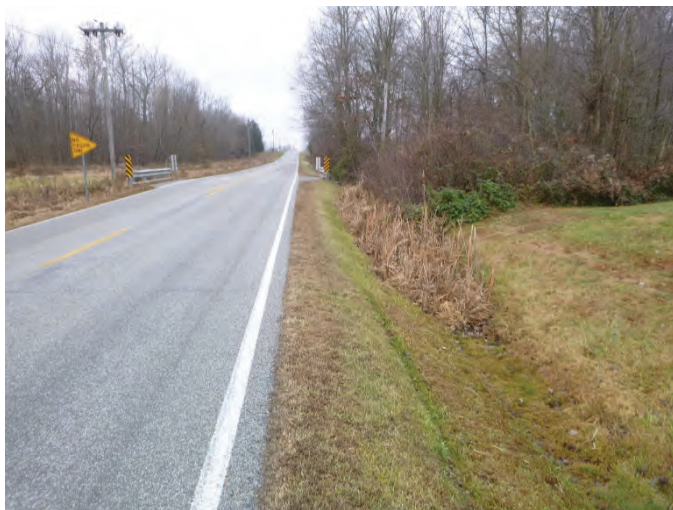
TYPICAL CONDITION OF SHOULDER AT
SOUTHWEST CORNER OF STRUCTURE

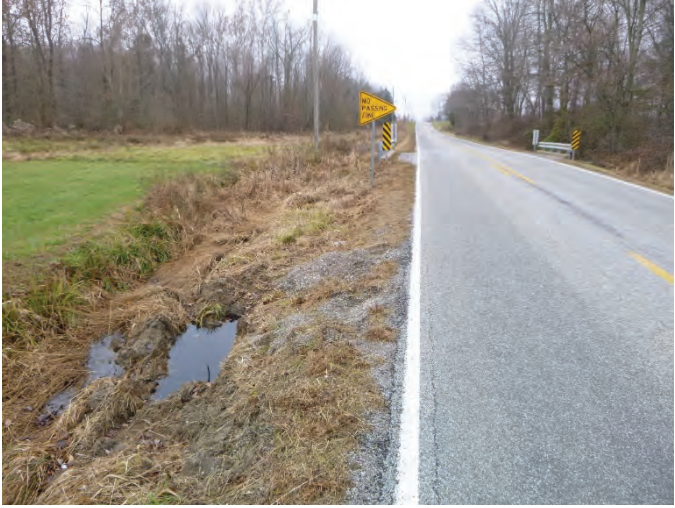
TYPICAL CONDITION OF SHOULDER AT
NORTHEAST CORNER OF STRUCTURE

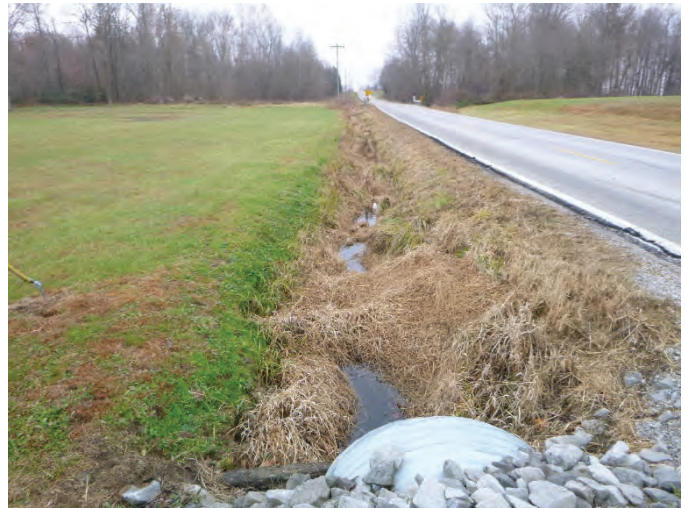
TYPICAL CONDITION OF DOWNSTREAM
CHANNEL LOOKING TOWARDS STRUCTURE

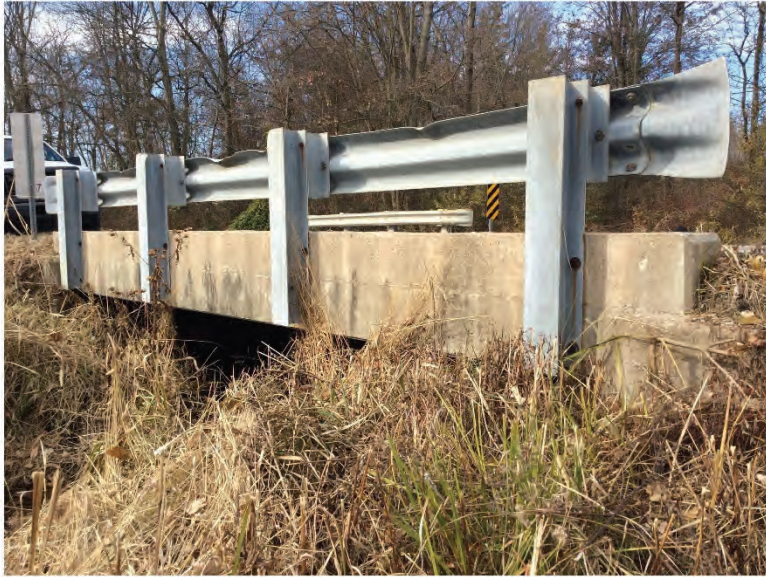
PHOTO 2 Elevation, Condition
Description S side, facing NW

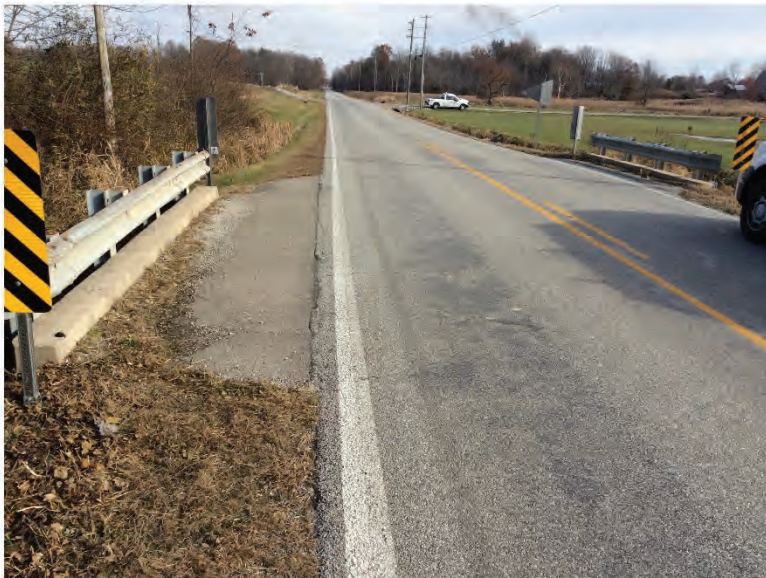
PHOTO 3 Condition
Description Roadway facing East

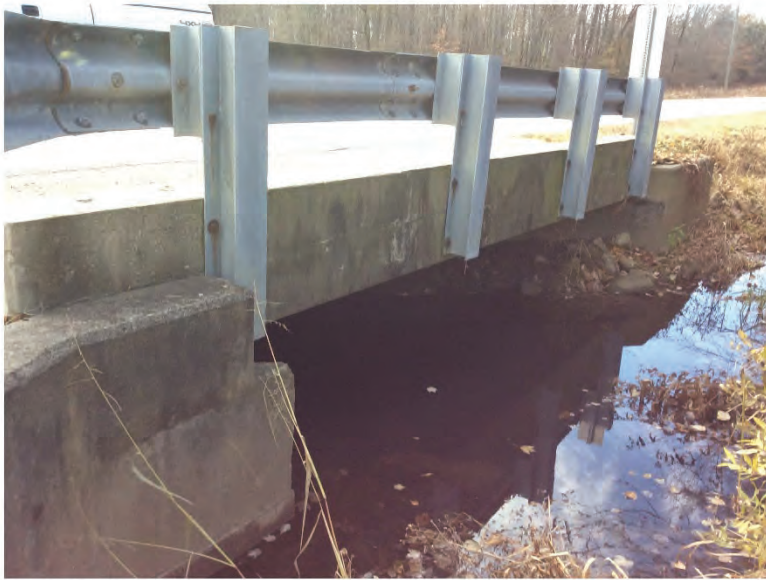
PHOTO 4 Elevation, Condition
Description N side, facing SW

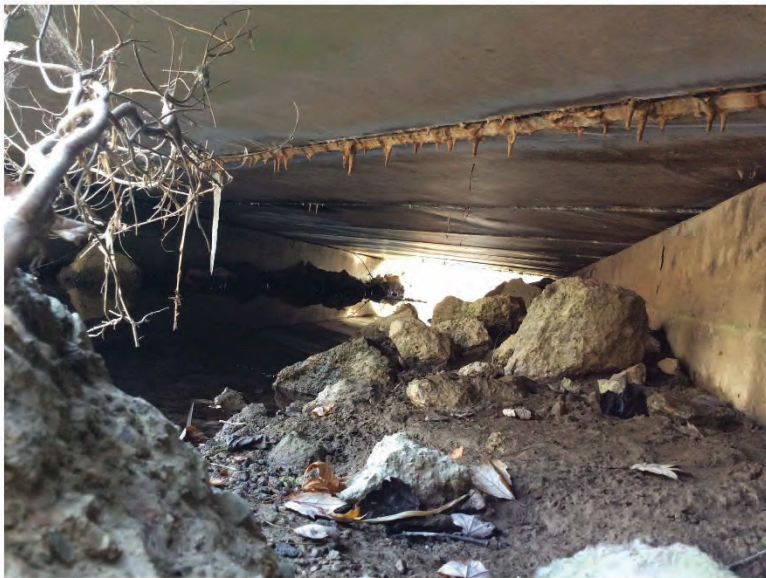
PHOTO 5 Condition
Description Underside facing Southeast

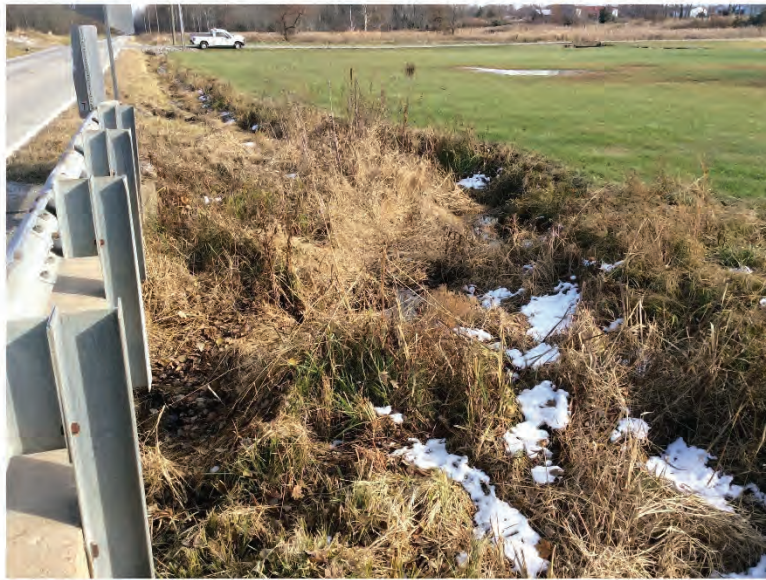
PHOTO 6 Condition
Description S channel, facing e
