FHWA-Indiana Environmental Document CATEGORICAL EXCLUSION / ENVIRONMENTAL ASSESSMENT FORM GENERAL PROJECT INFORMATION

SR 65 / Pike County

Bridge Replacement, Branch of Hardin Creek Approximately 2.16 Miles South of SR 56

SR 65 over Branch of Hardin Creek – Bridge Replacement Pike County, Indiana Des. No. 1700166

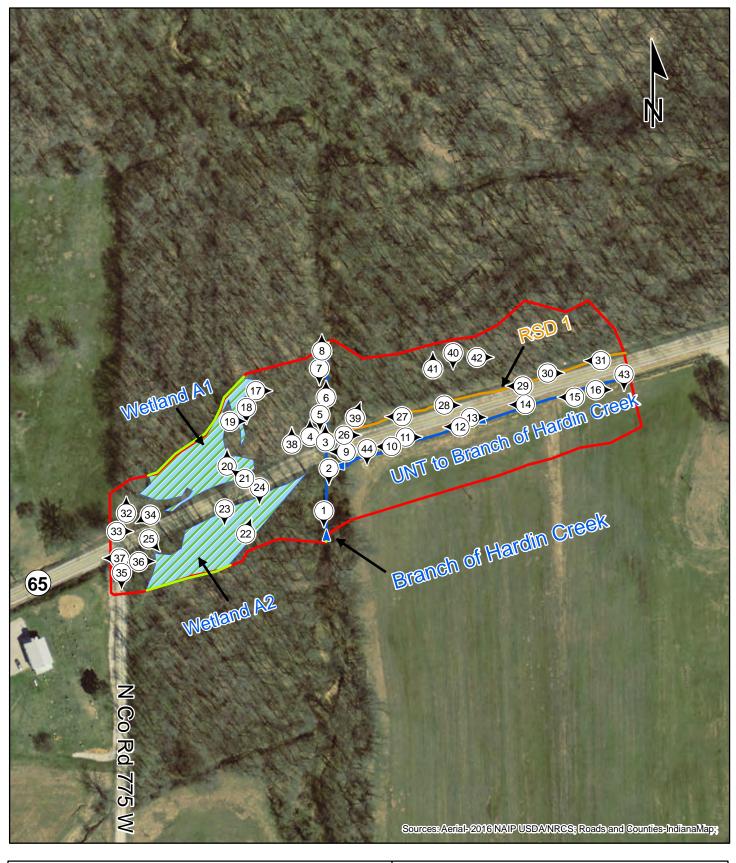
Delineated Streams	Photo Locations	Photo Location Map SR 65 over Branch of Hardin Creek Bridge Replacement Pike County, Indiana		
Roadside Ditches	Investigated Area			
Feature Extends Outside Investigated Area	Delineated Wetland	Des. No. 1700166	HNTB	
	0 100 200 Feet	1 inch = 200 feet	Graphics created by HNTB Corporation (2020)

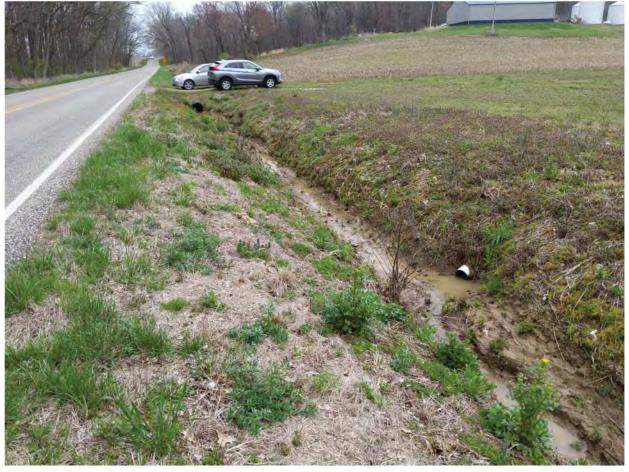
13. View of UNT 1 to Branch of Hardin Creek and investigated area looking east. Note drainage tile

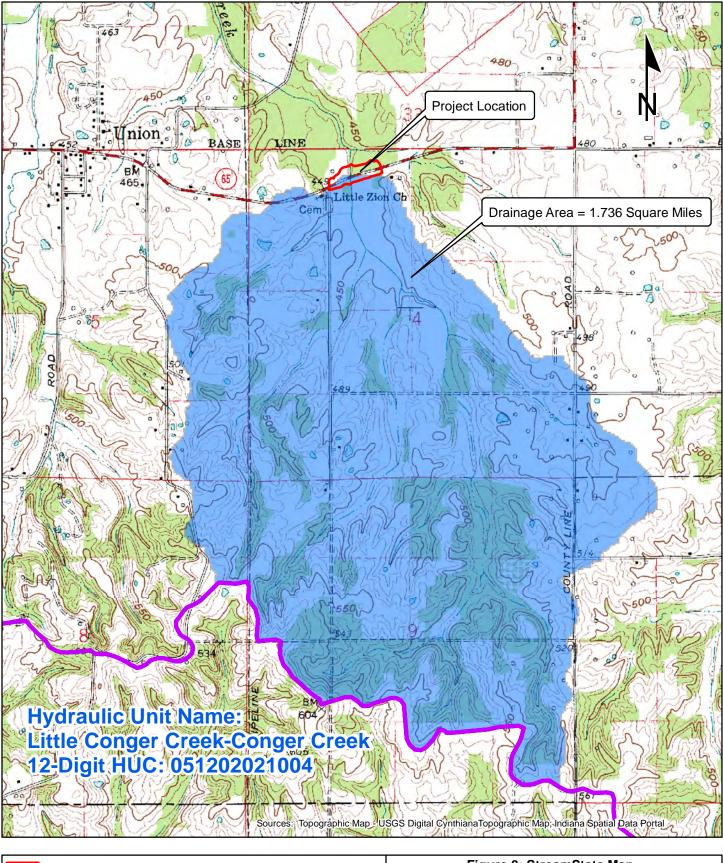
Investigated Area	Figure 8: StreamStats Map SR 65 over Branch of Hardin Creek			
WATERSHEDS HUC12 - 2009				Bridge Replacement
Branch of Hardin Creek Upstream Drainage Area			I	Pike County, Indiana
· · ·			Des. No.1700166	LINTR
0 1	1,000	2,000 Feet	1 inch = 2,000 feet	Graphics created by HNTB Corporation (2020)

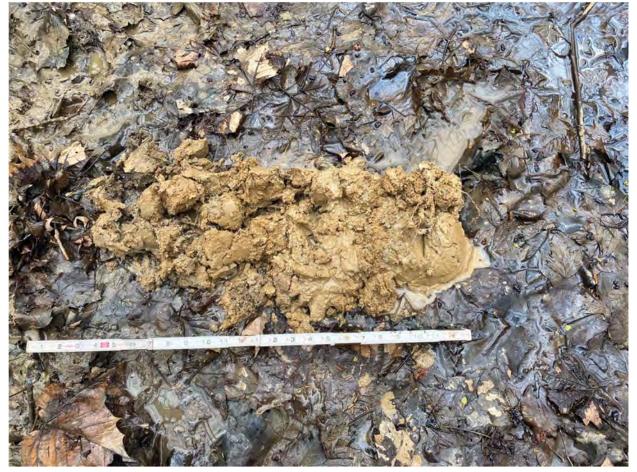
# 1. View of AW1 soil profile

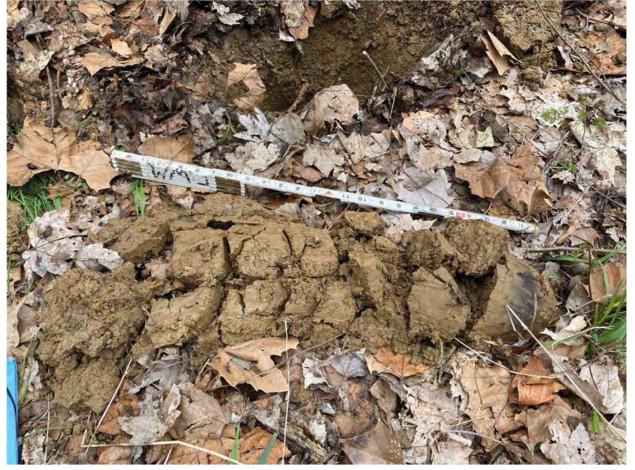
3. View of AD1 soil profile
