**WATERS OF THE U.S.
DETERMINATION REPORT**

**SR 14, Mill & Overlay, Full-Depth Reclamation,
and Culvert Replacements
Pulaski and Fulton Counties, Indiana**

INDOT Des. No. 1800182

Report Date: November 6, 2020

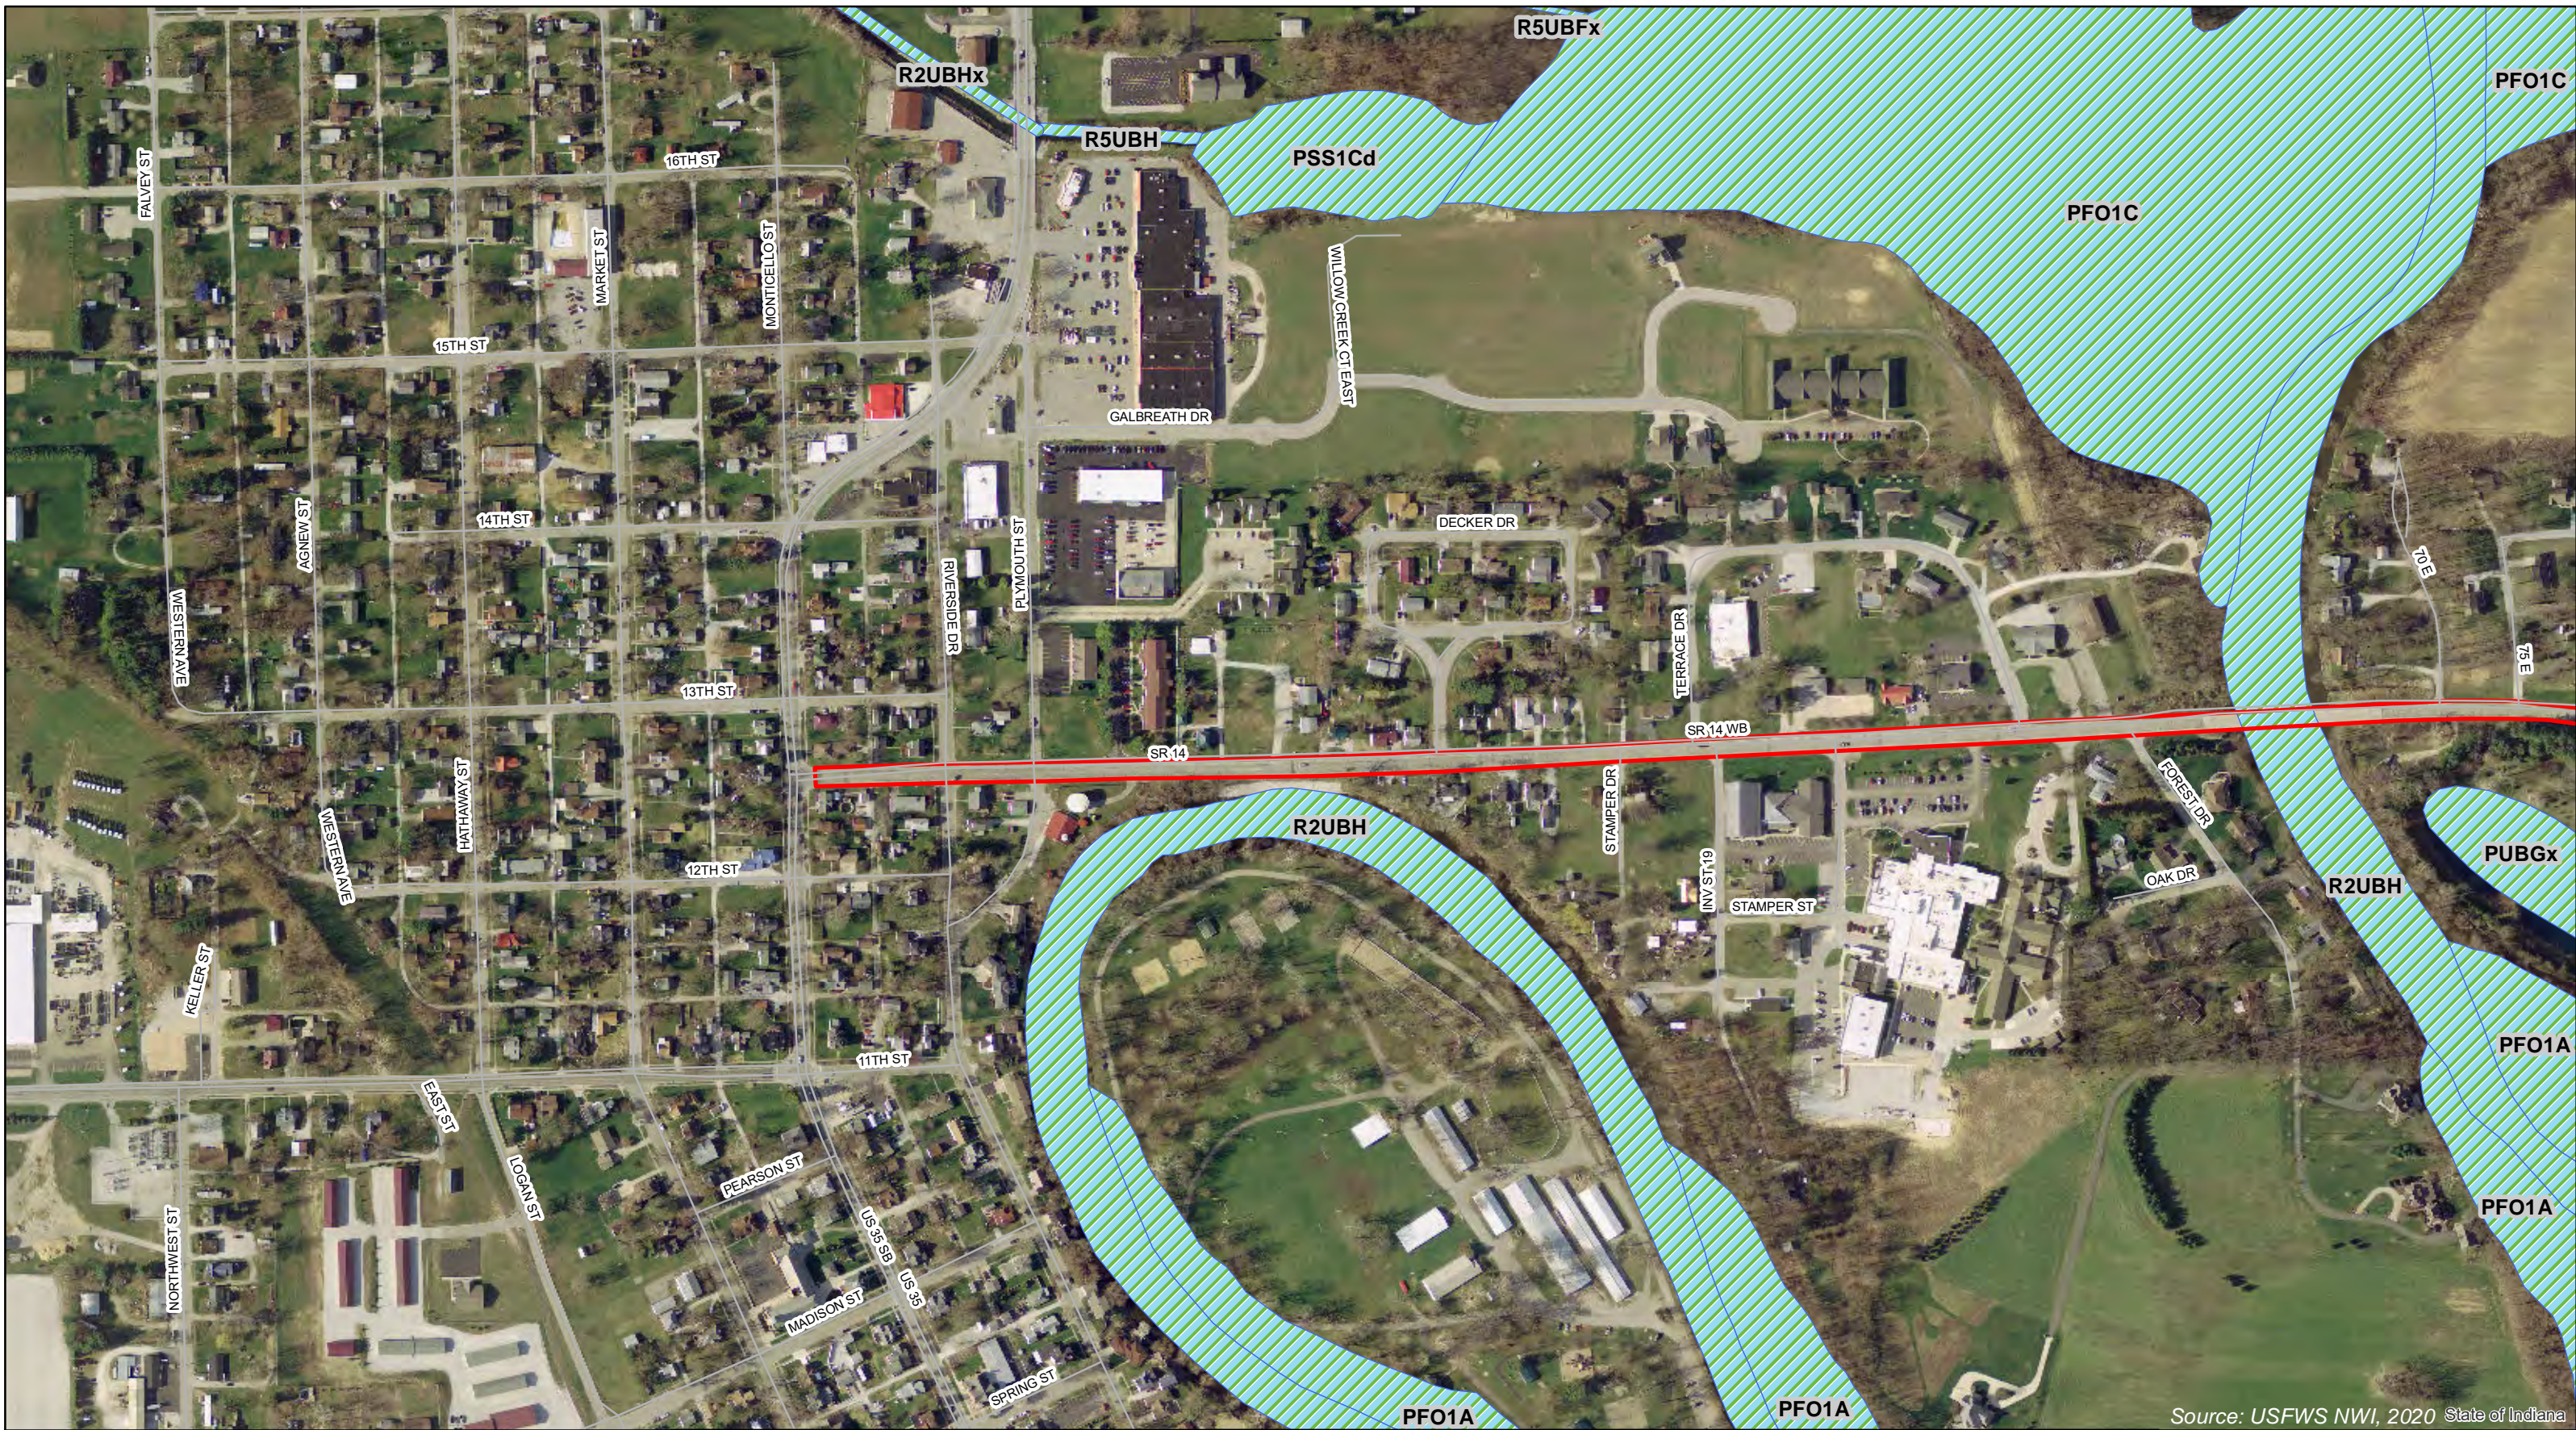
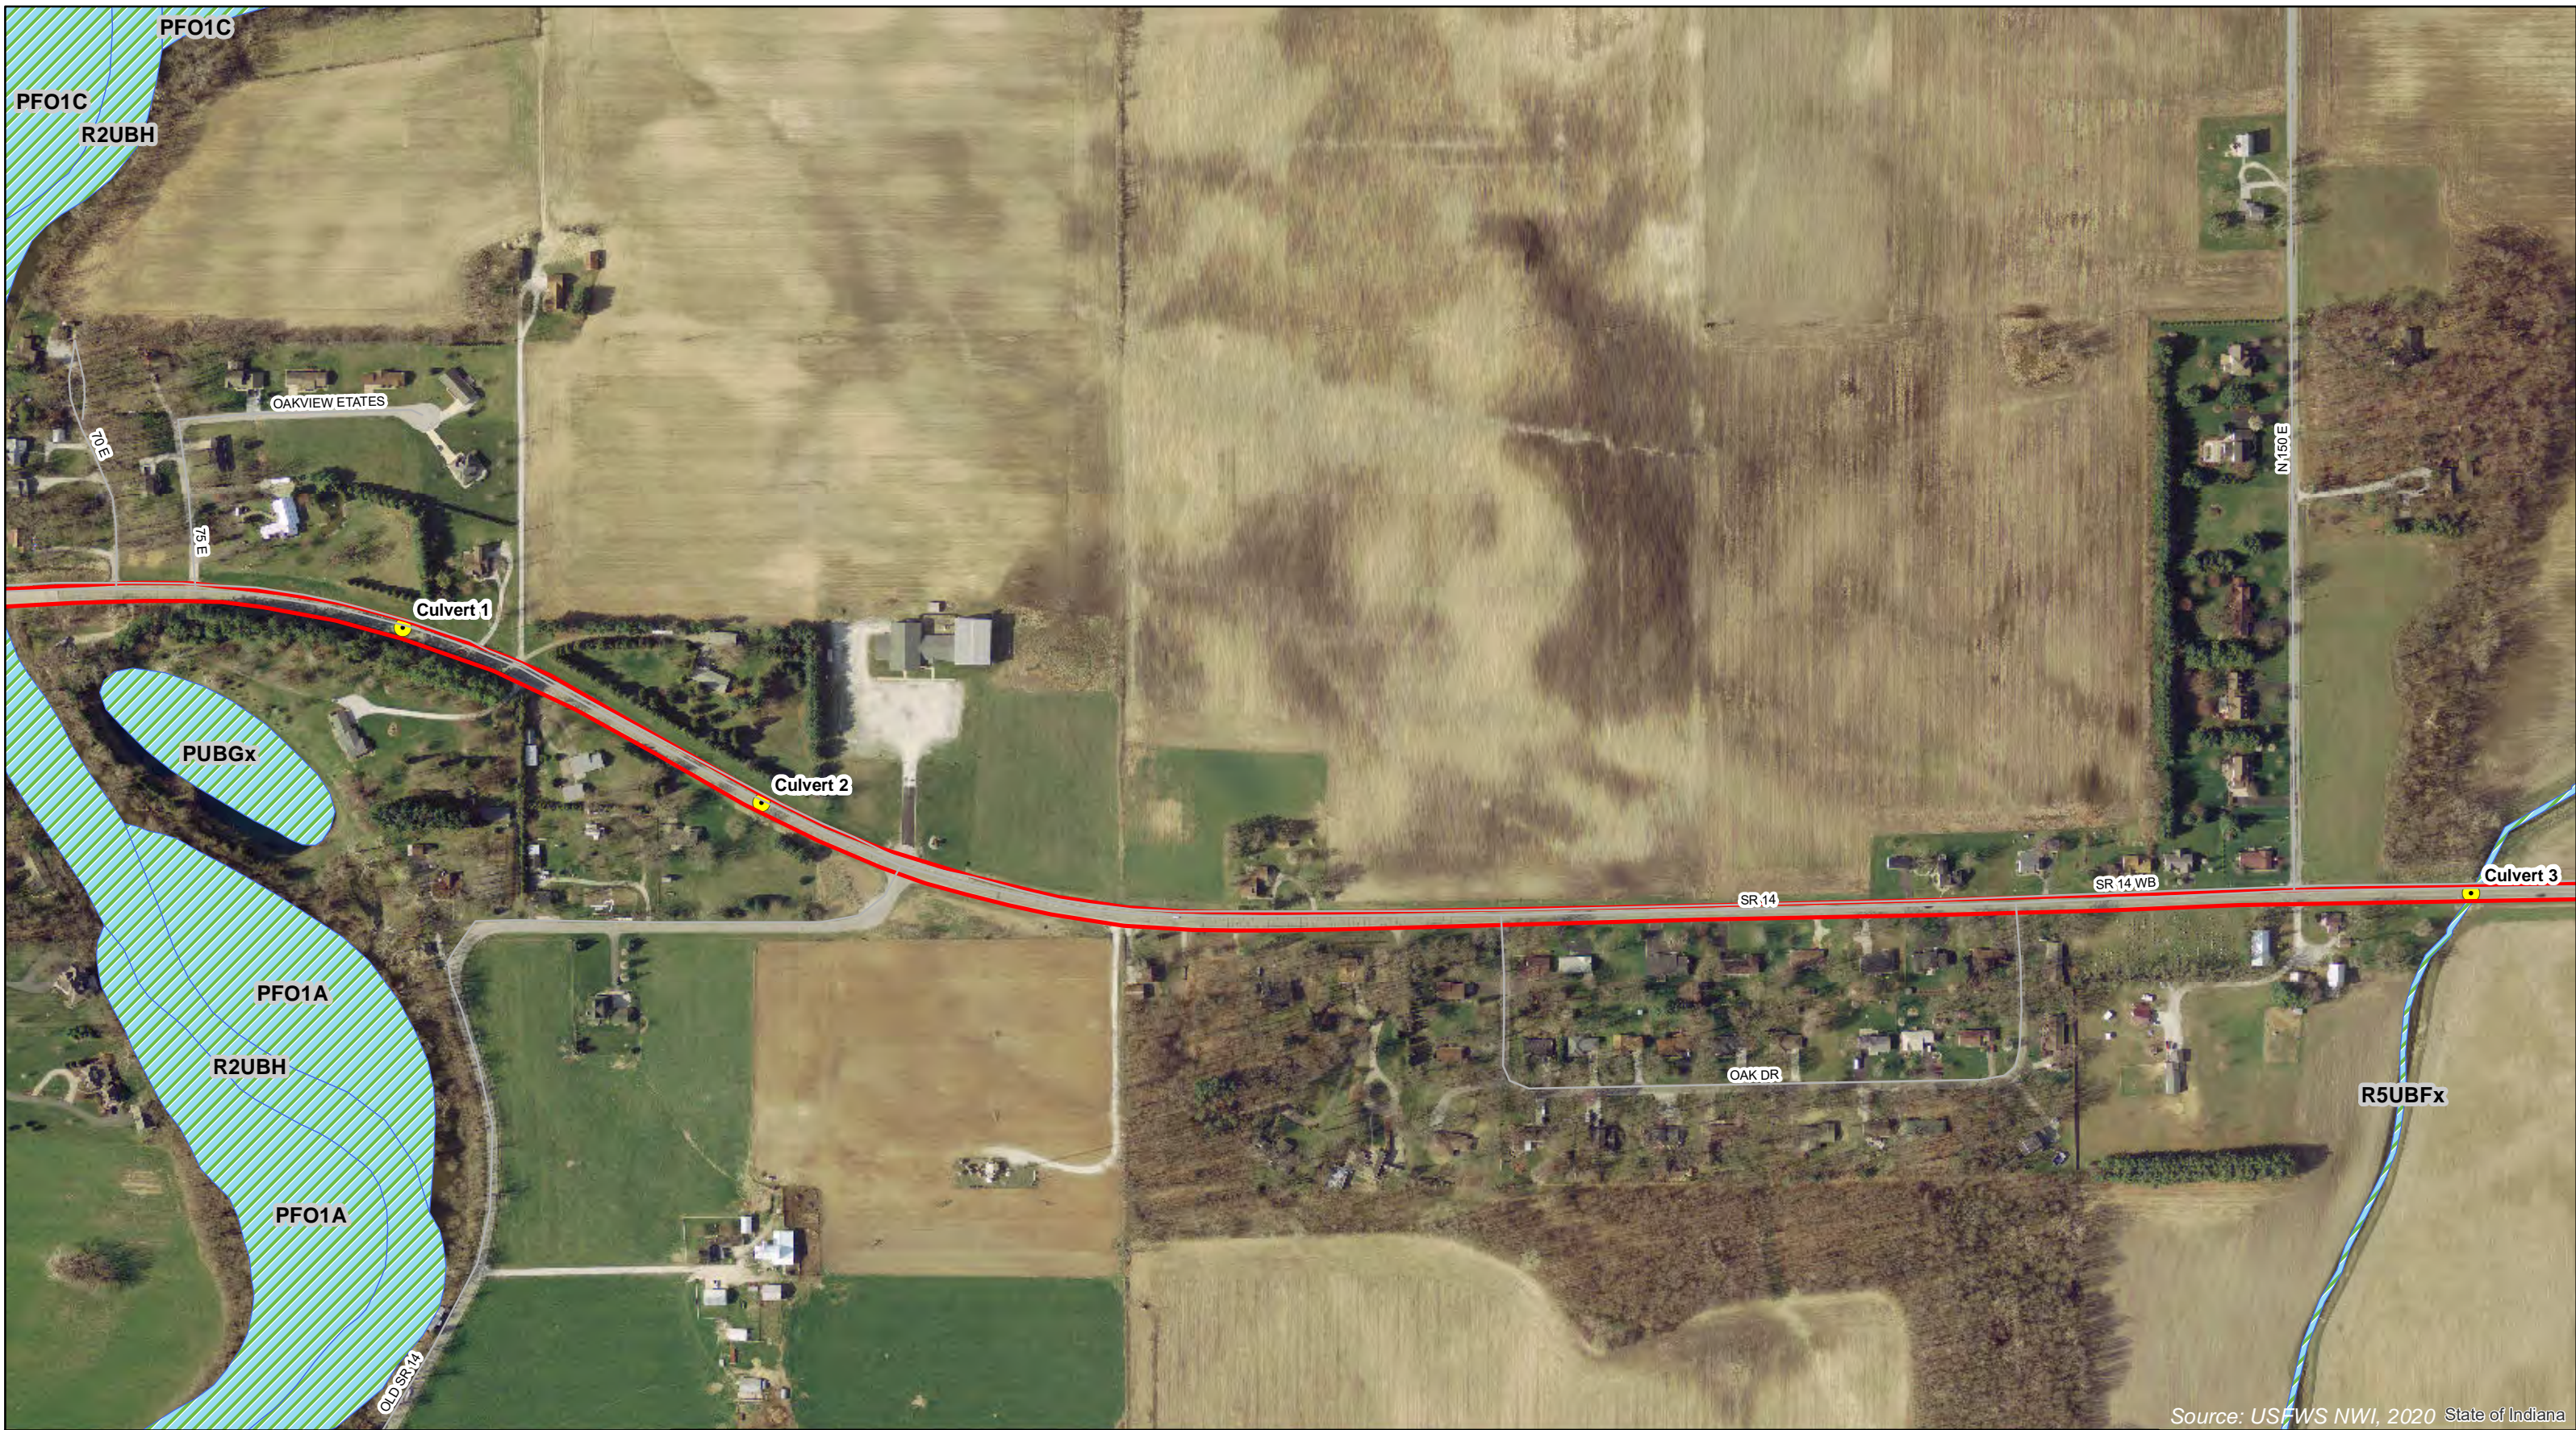
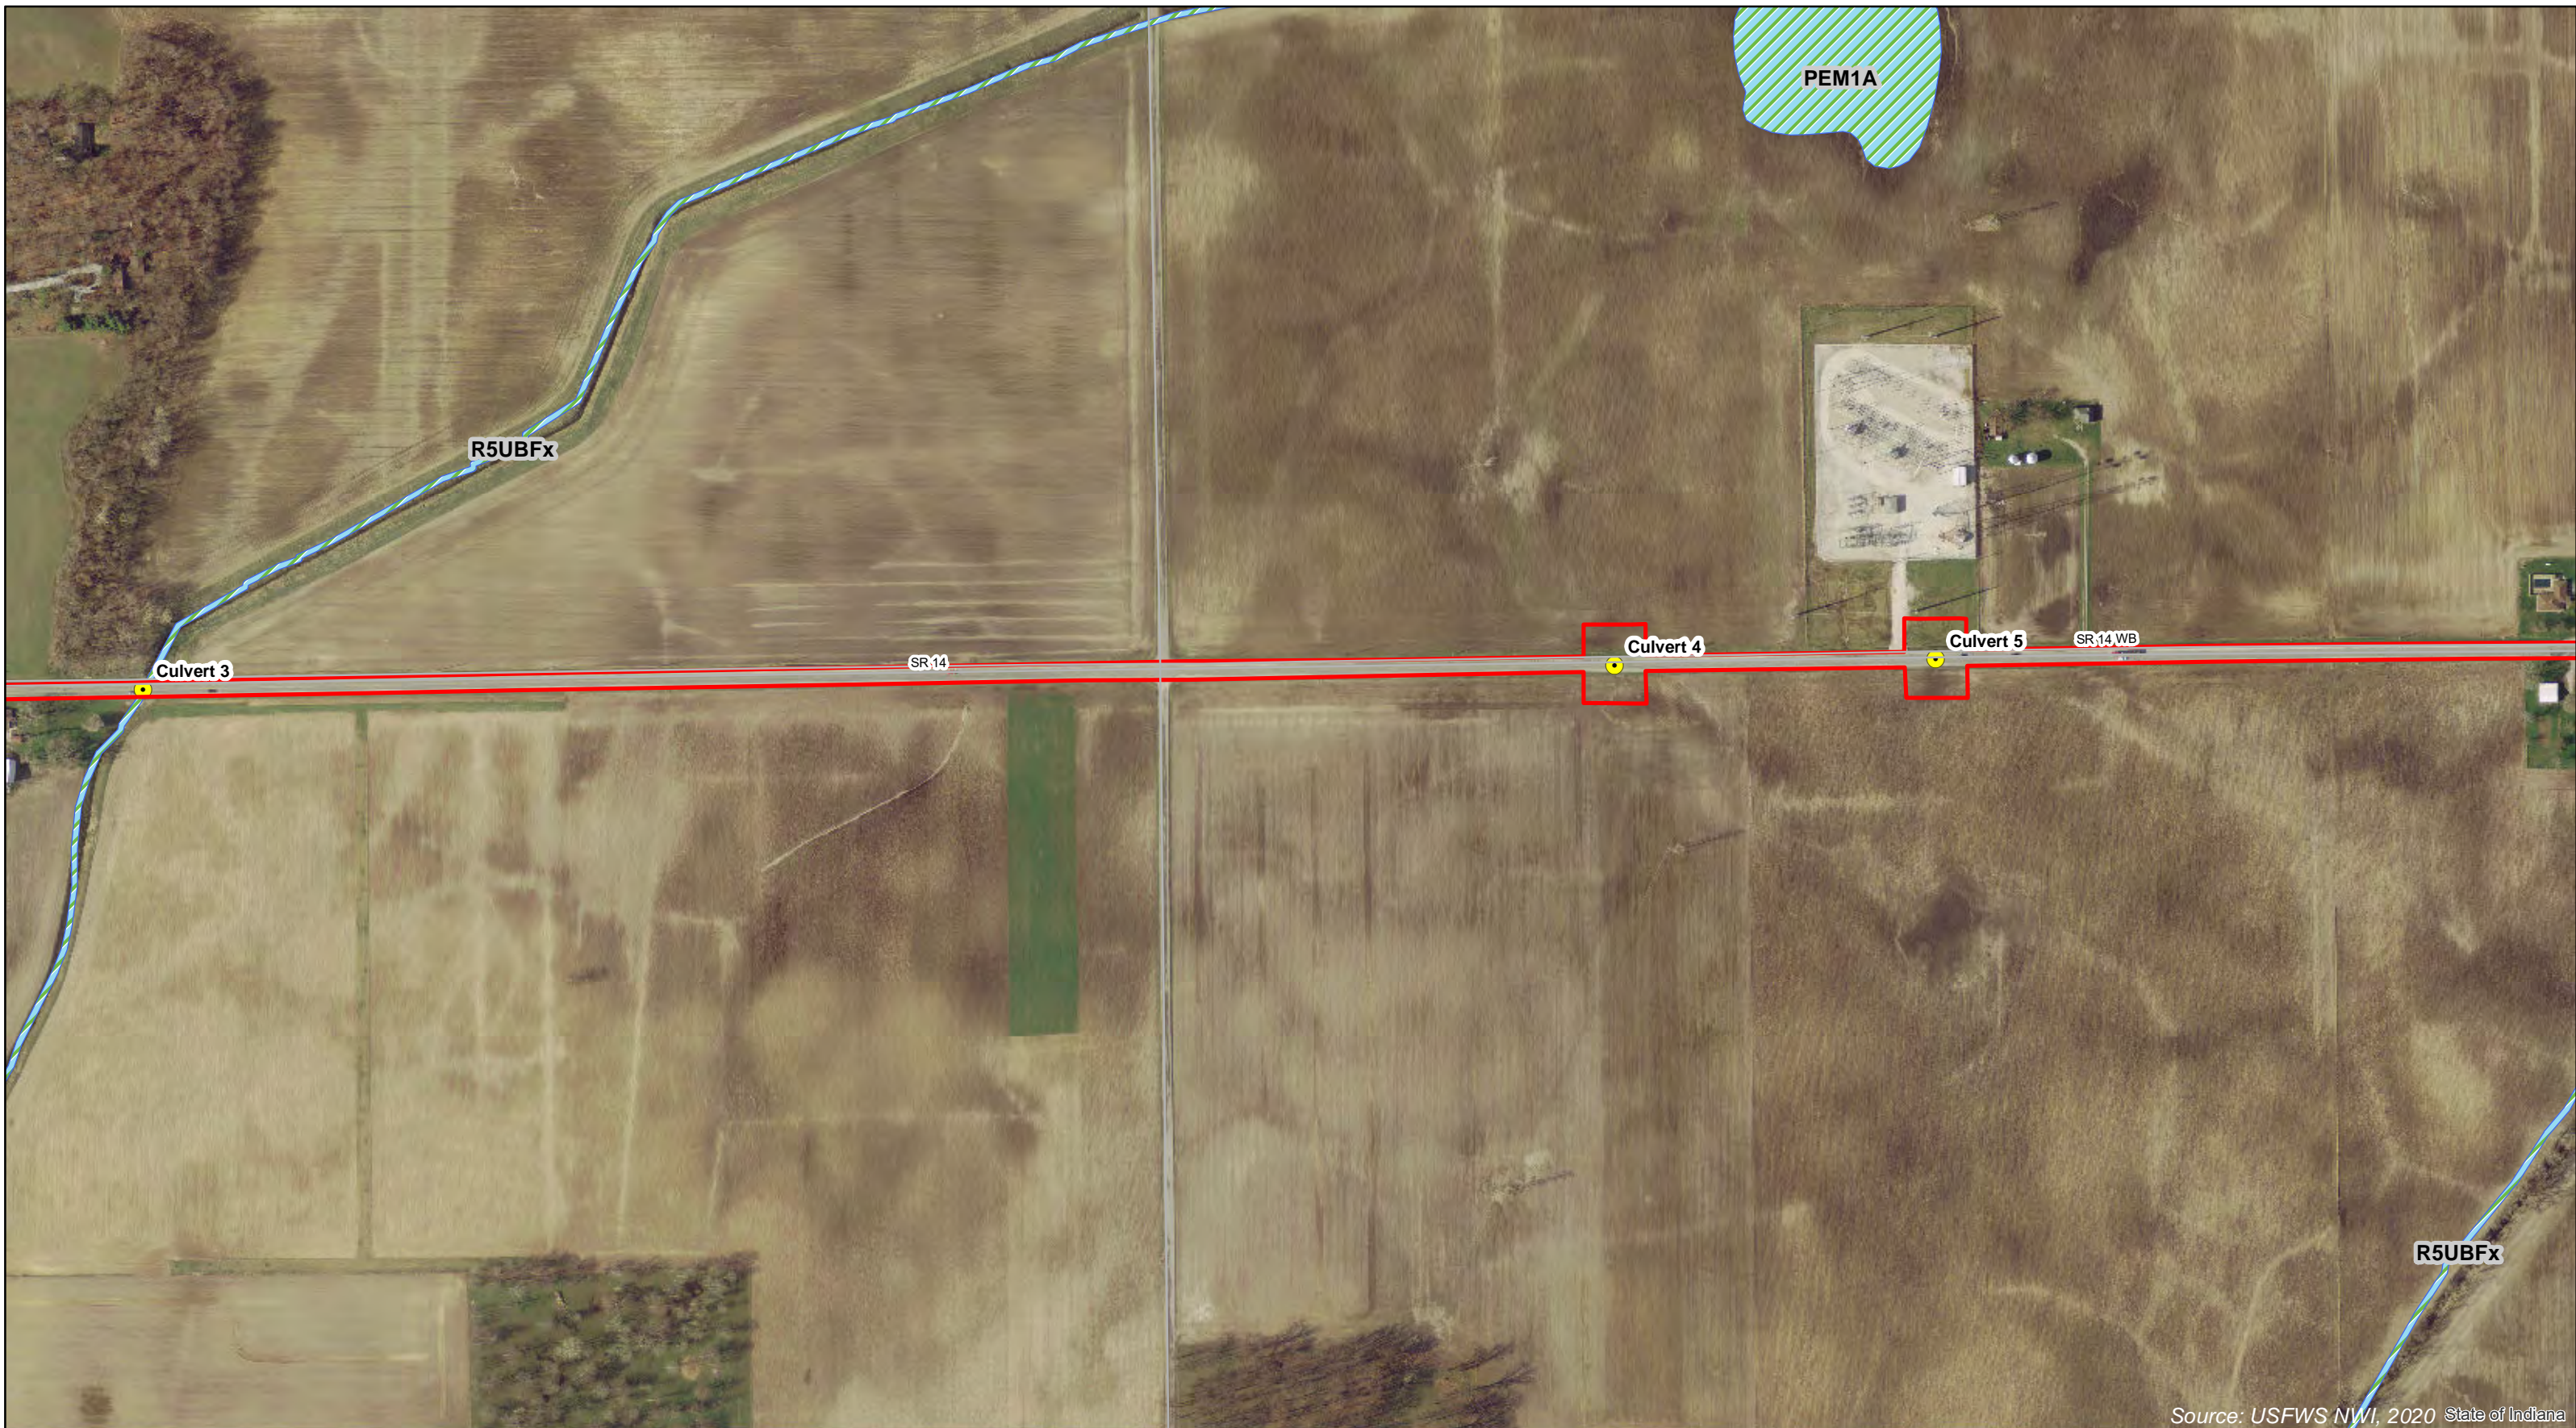
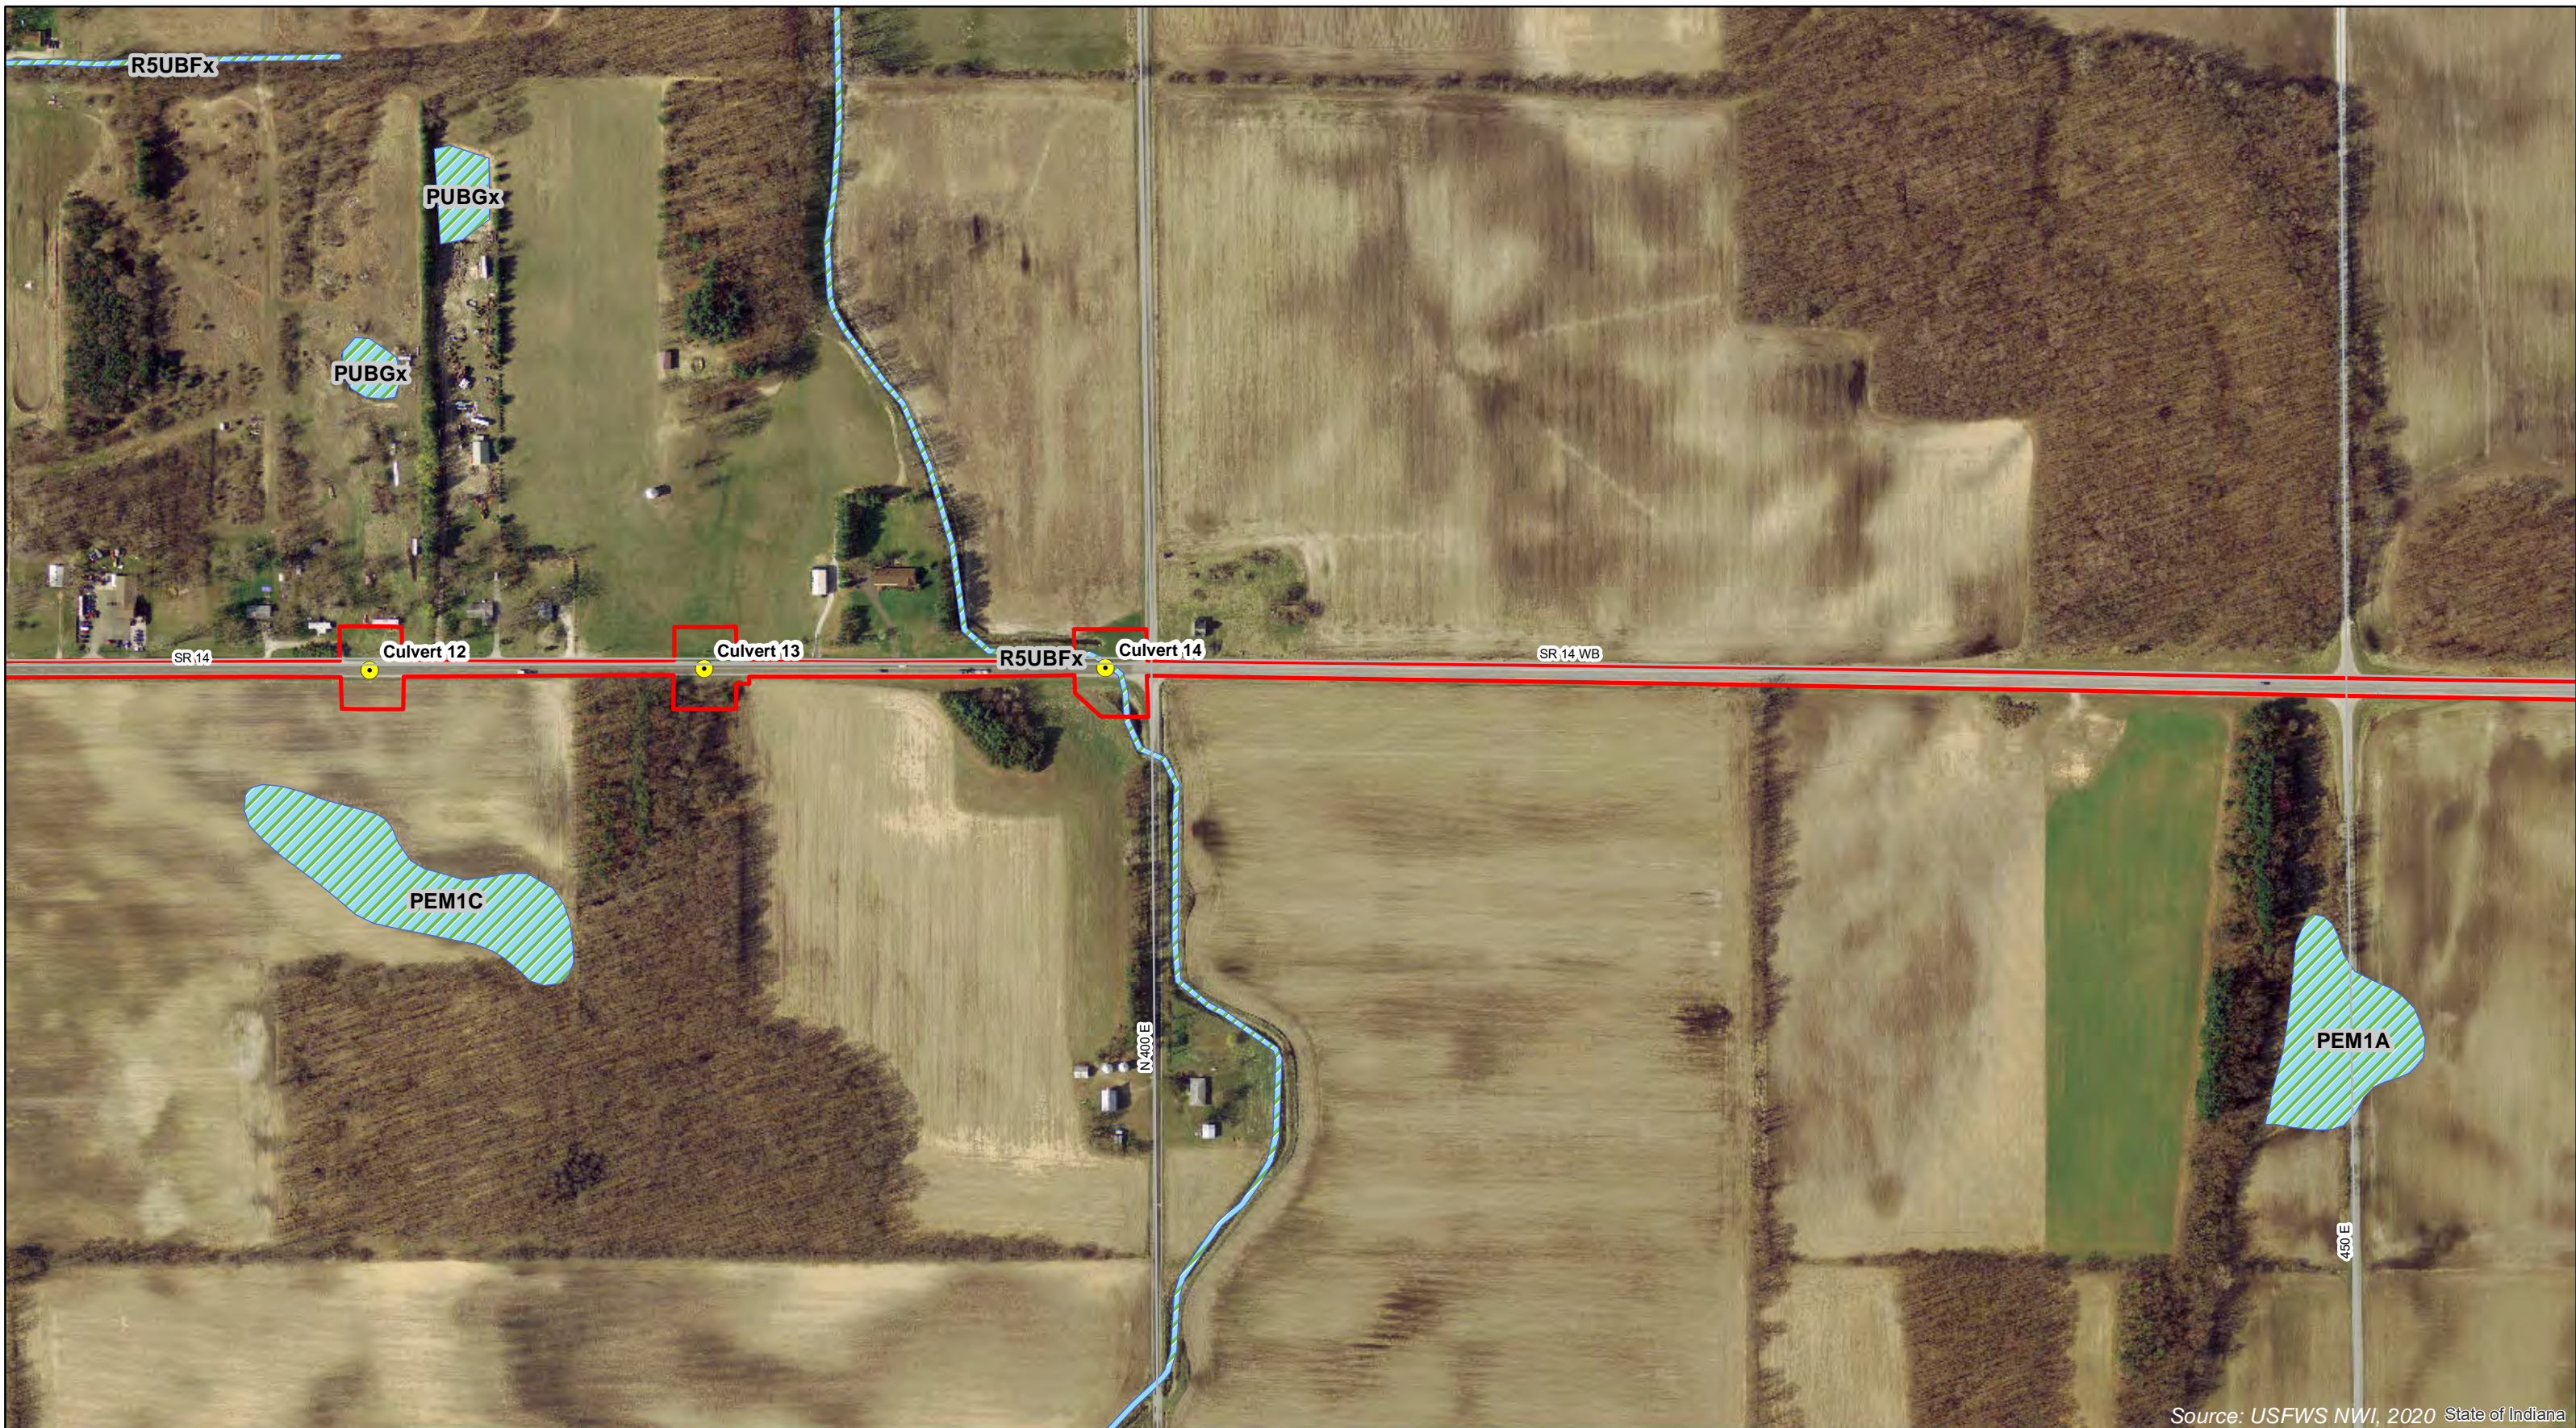
Figure 2
National Wetland Inventory Map
SR 14, Pavement and Culvert Work
Pulaski and Fulton County, IN
Des. 1800182

The NWI map was reviewed for the presence of potential wetlands in, or adjacent to, the investigated area (Figure 2). These are discussed below:

- One wetland, classified as riverine (R2UBH) is located within and directly adjacent to the investigated area, in Winamac. It is associated with Tippecanoe River.
- One wetland, classified as riverine (R5UBFx) is located within the investigated area, just east of County Road (CR) N 150 E. It is associated with Thompson Ditch.
- One wetland, classified as riverine (R5UBFx) is located within the investigated area, approximately 1,500 feet west of CR 300 E. It is associated with Leidendecker Ditch.
- One wetland, classified as riverine (R5UBFx) is located within the investigated area, just west of CR 400 E. It is associated with Breckenridge Ditch.

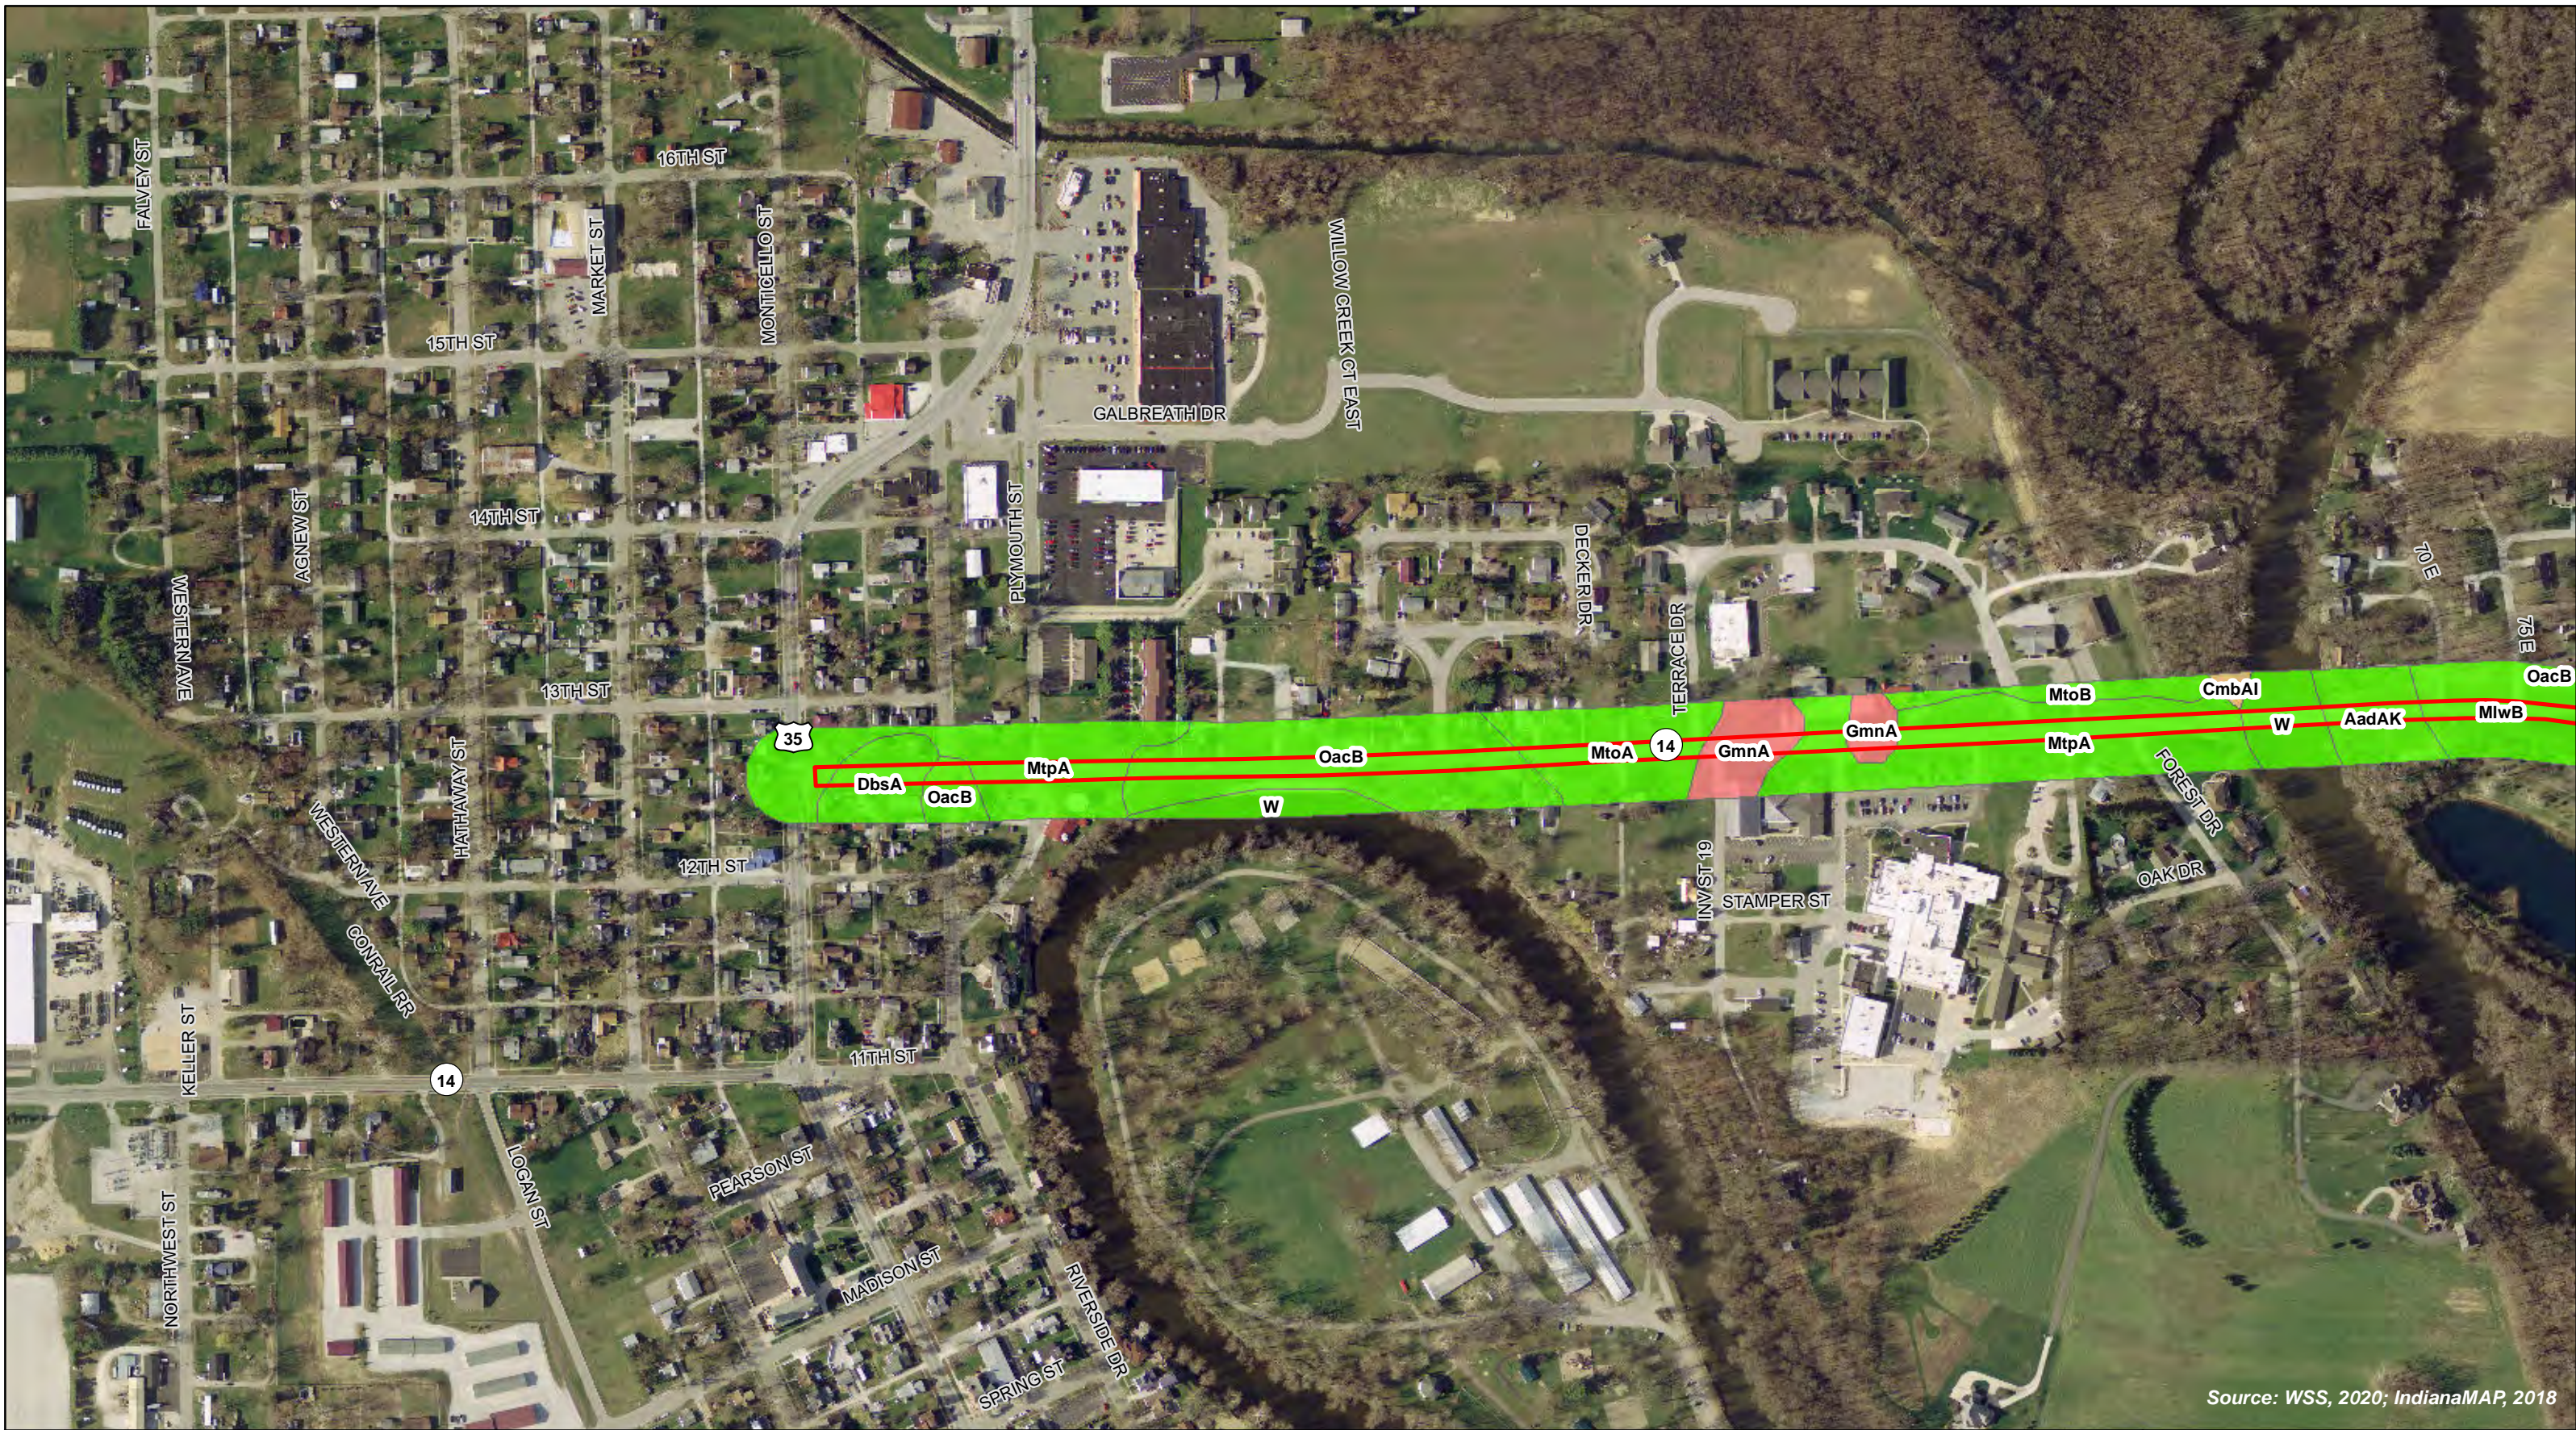
Figure 4
USGS-NRCS Soil Map
SR 14 Pavement and Culvert Work
Pulaski and Fulton County, IN
Des. 1800182

According to the Web Soil Survey geographic database for Pulaski and Fulton Counties, Indiana (USDA- NRCS 2020), the investigated area contains 38 map units (Figure 4, Table 1). Of the 38 map units, 24 are considered hydric (3-100 percent).
