**WATERS OF THE U.S.
DETERMINATION REPORT**

**SR 14, Mill & Overlay, Full-Depth Reclamation,
and Culvert Replacements
Pulaski and Fulton Counties, Indiana**

INDOT Des. No. 1800182

Report Date: November 6, 2020

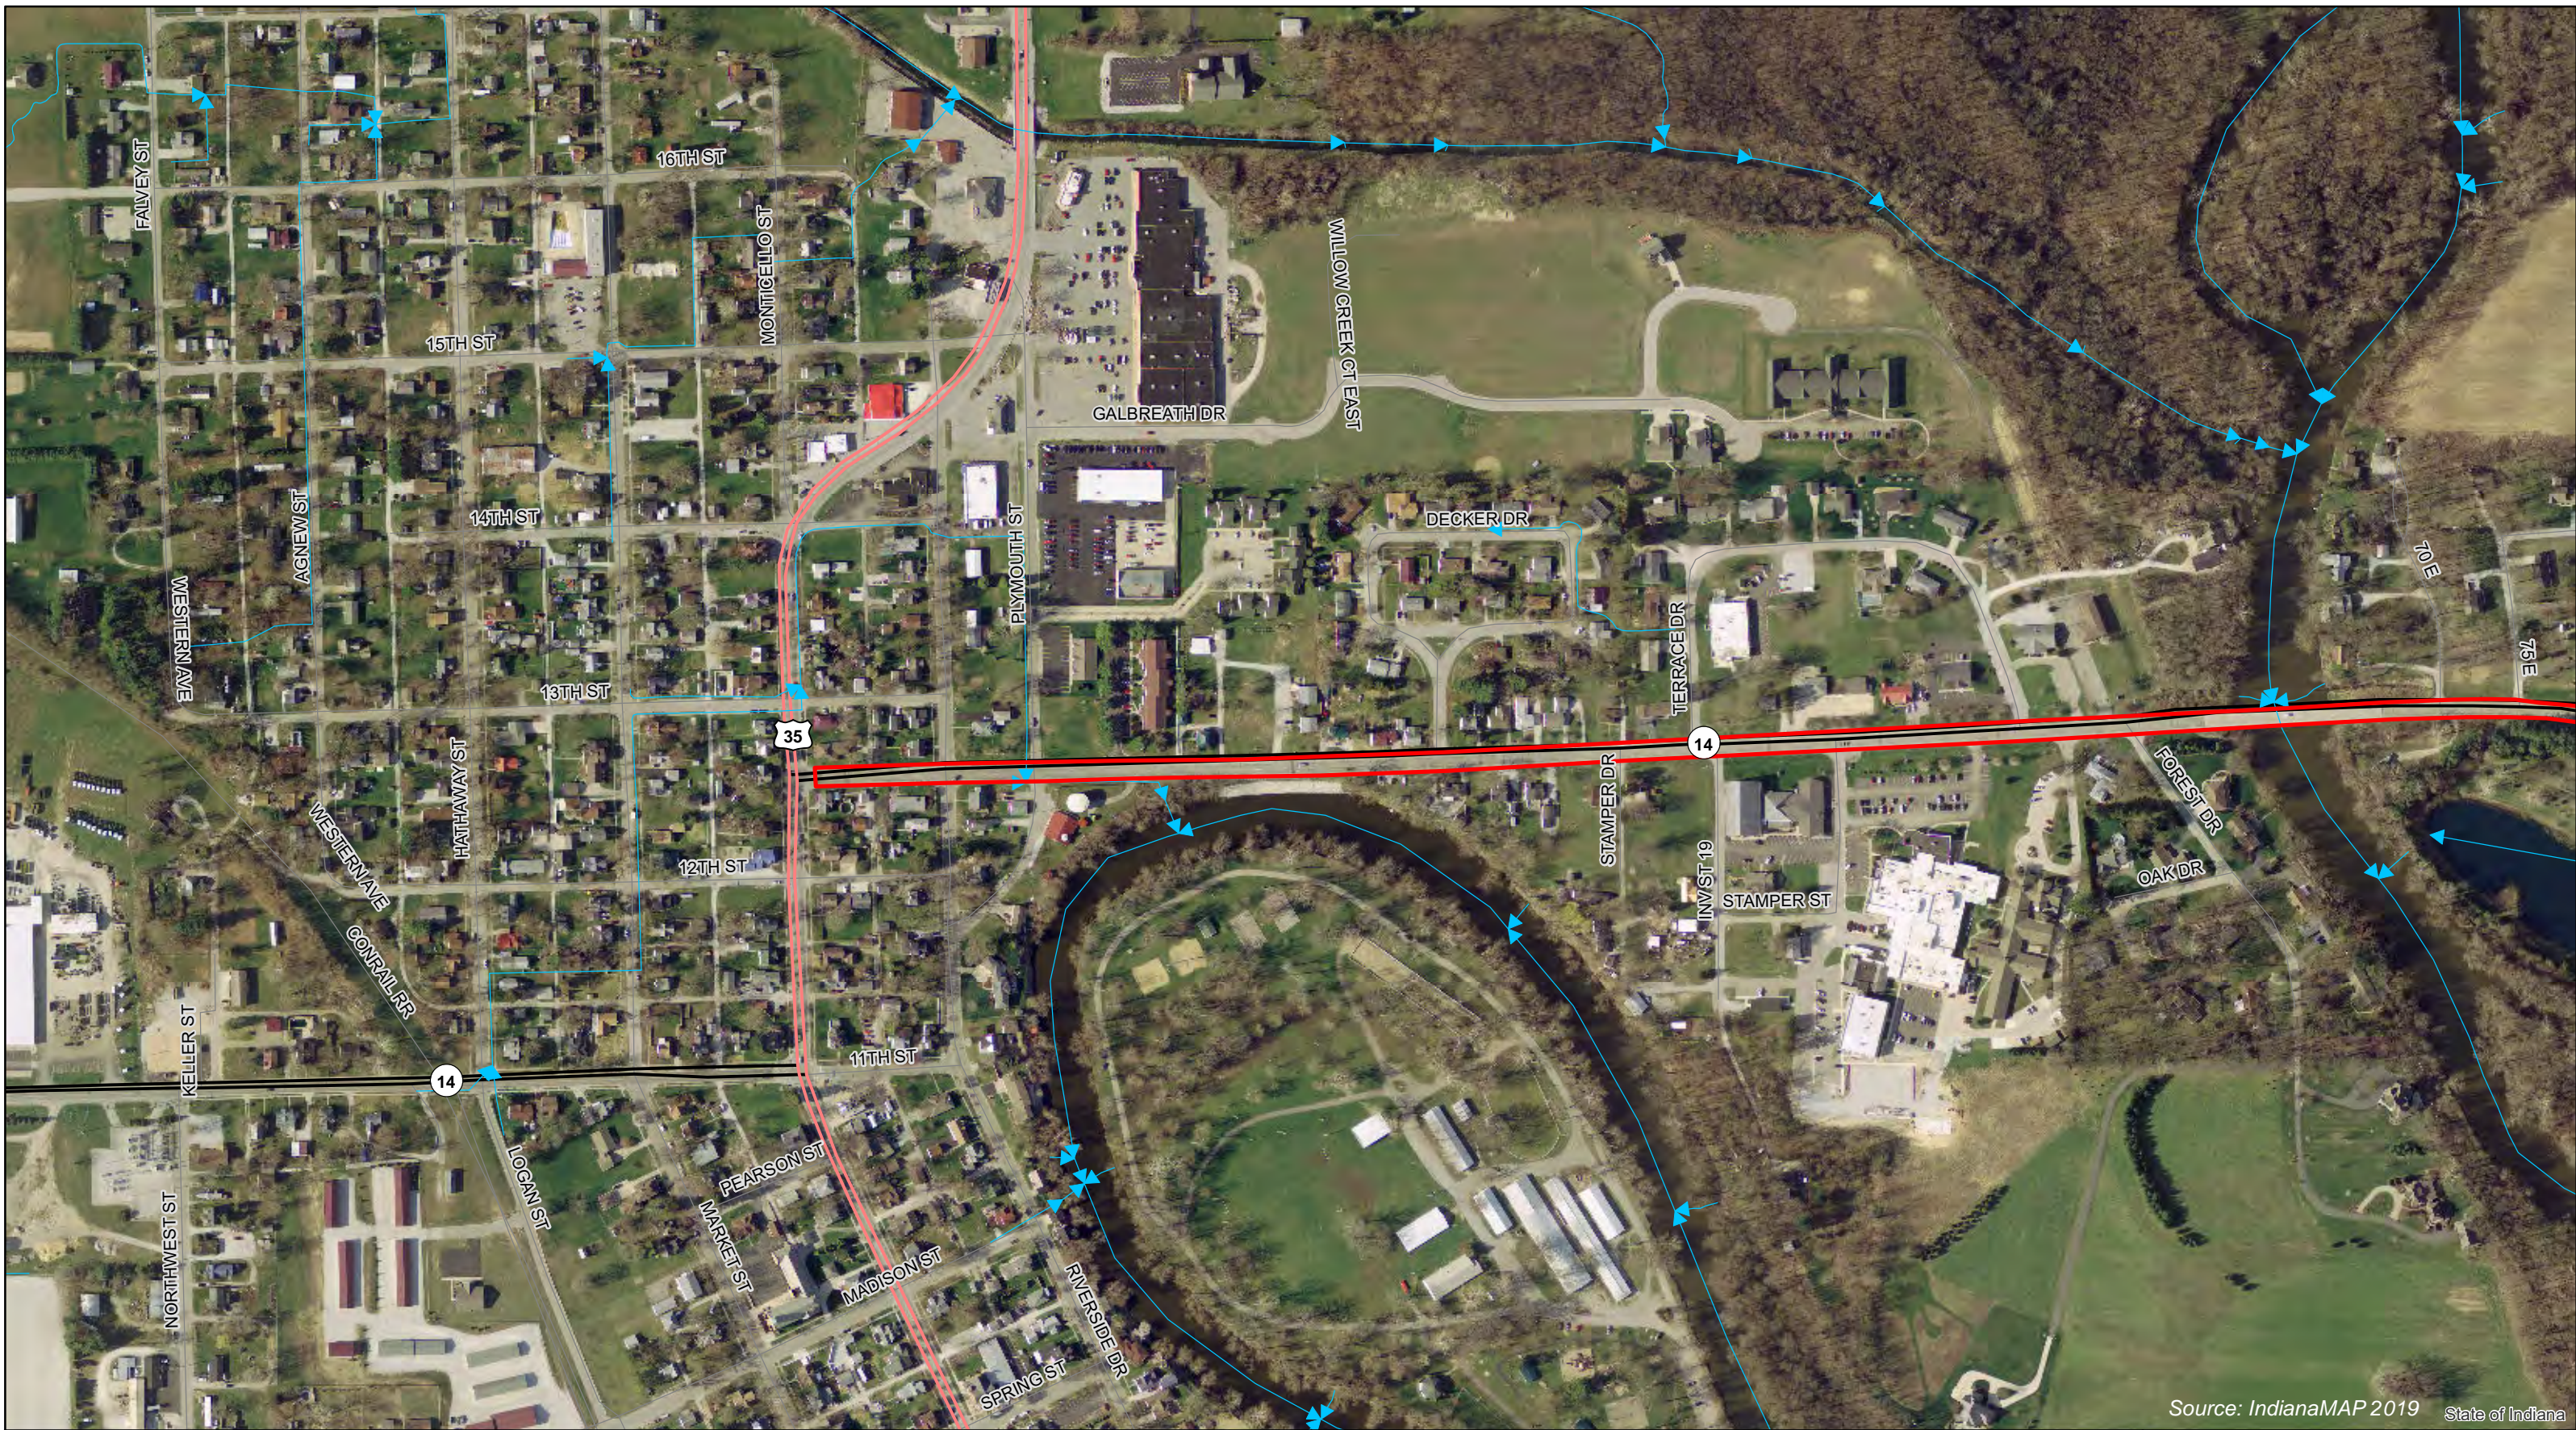
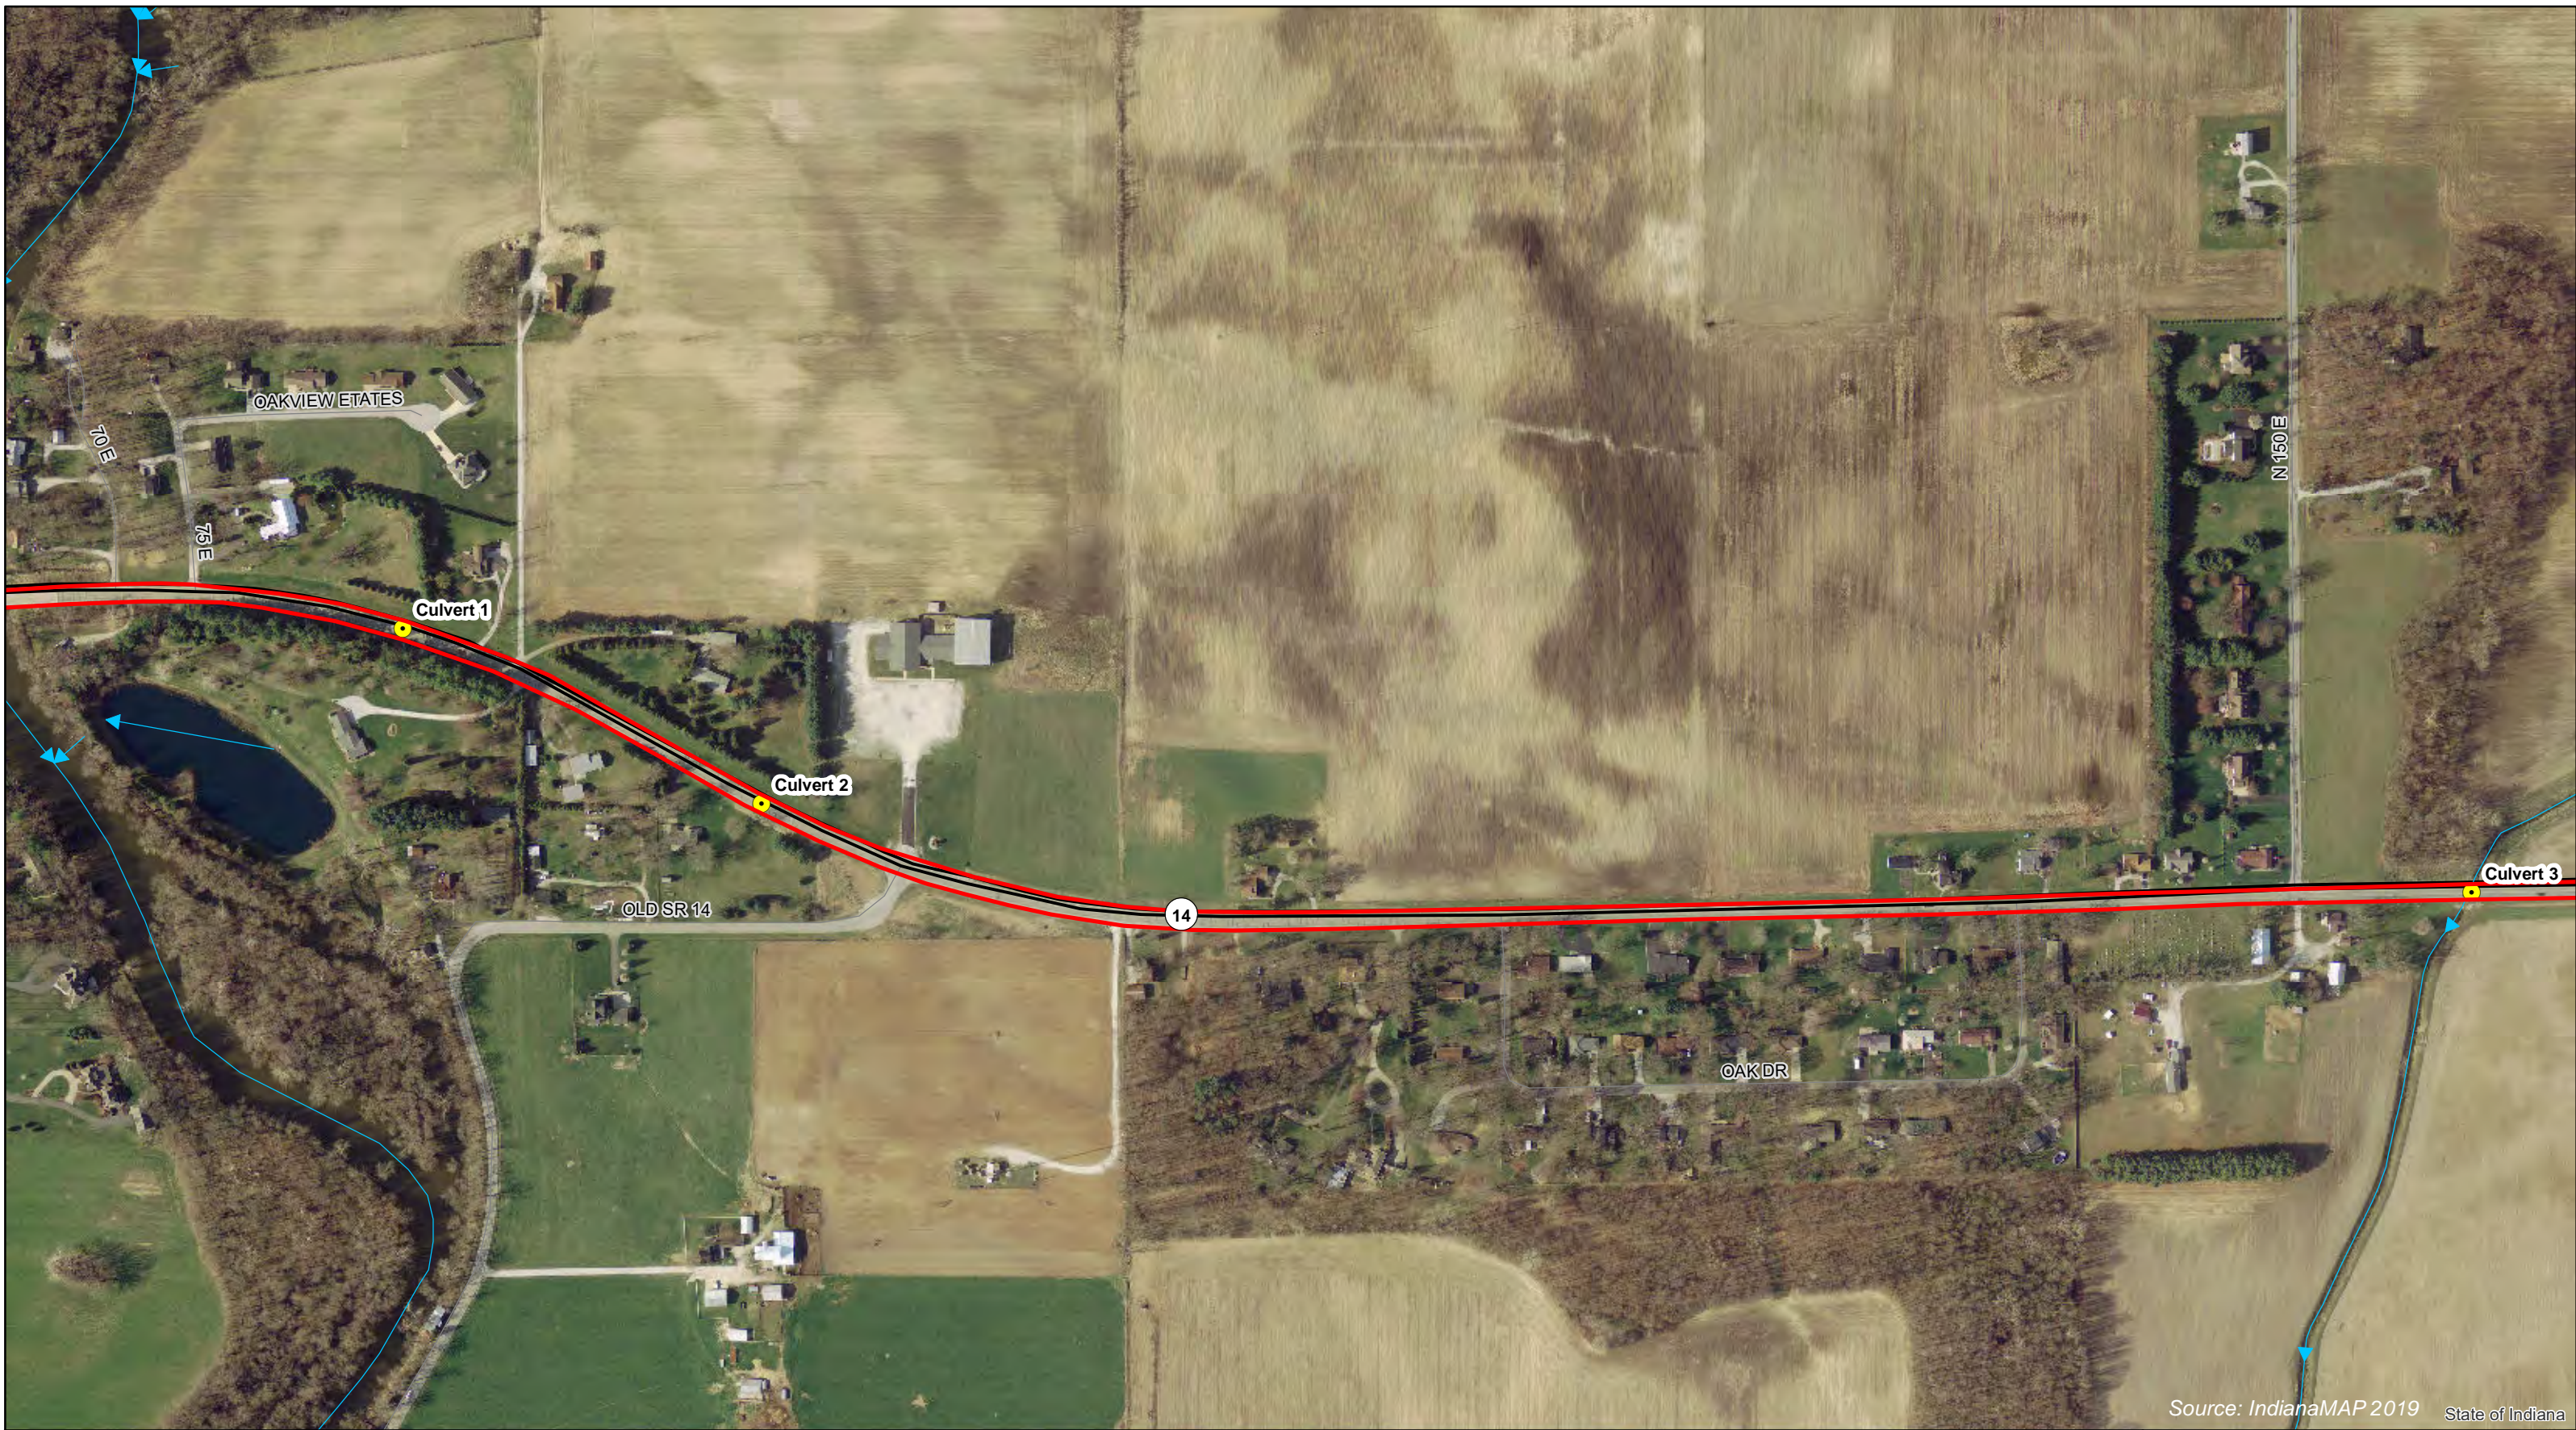
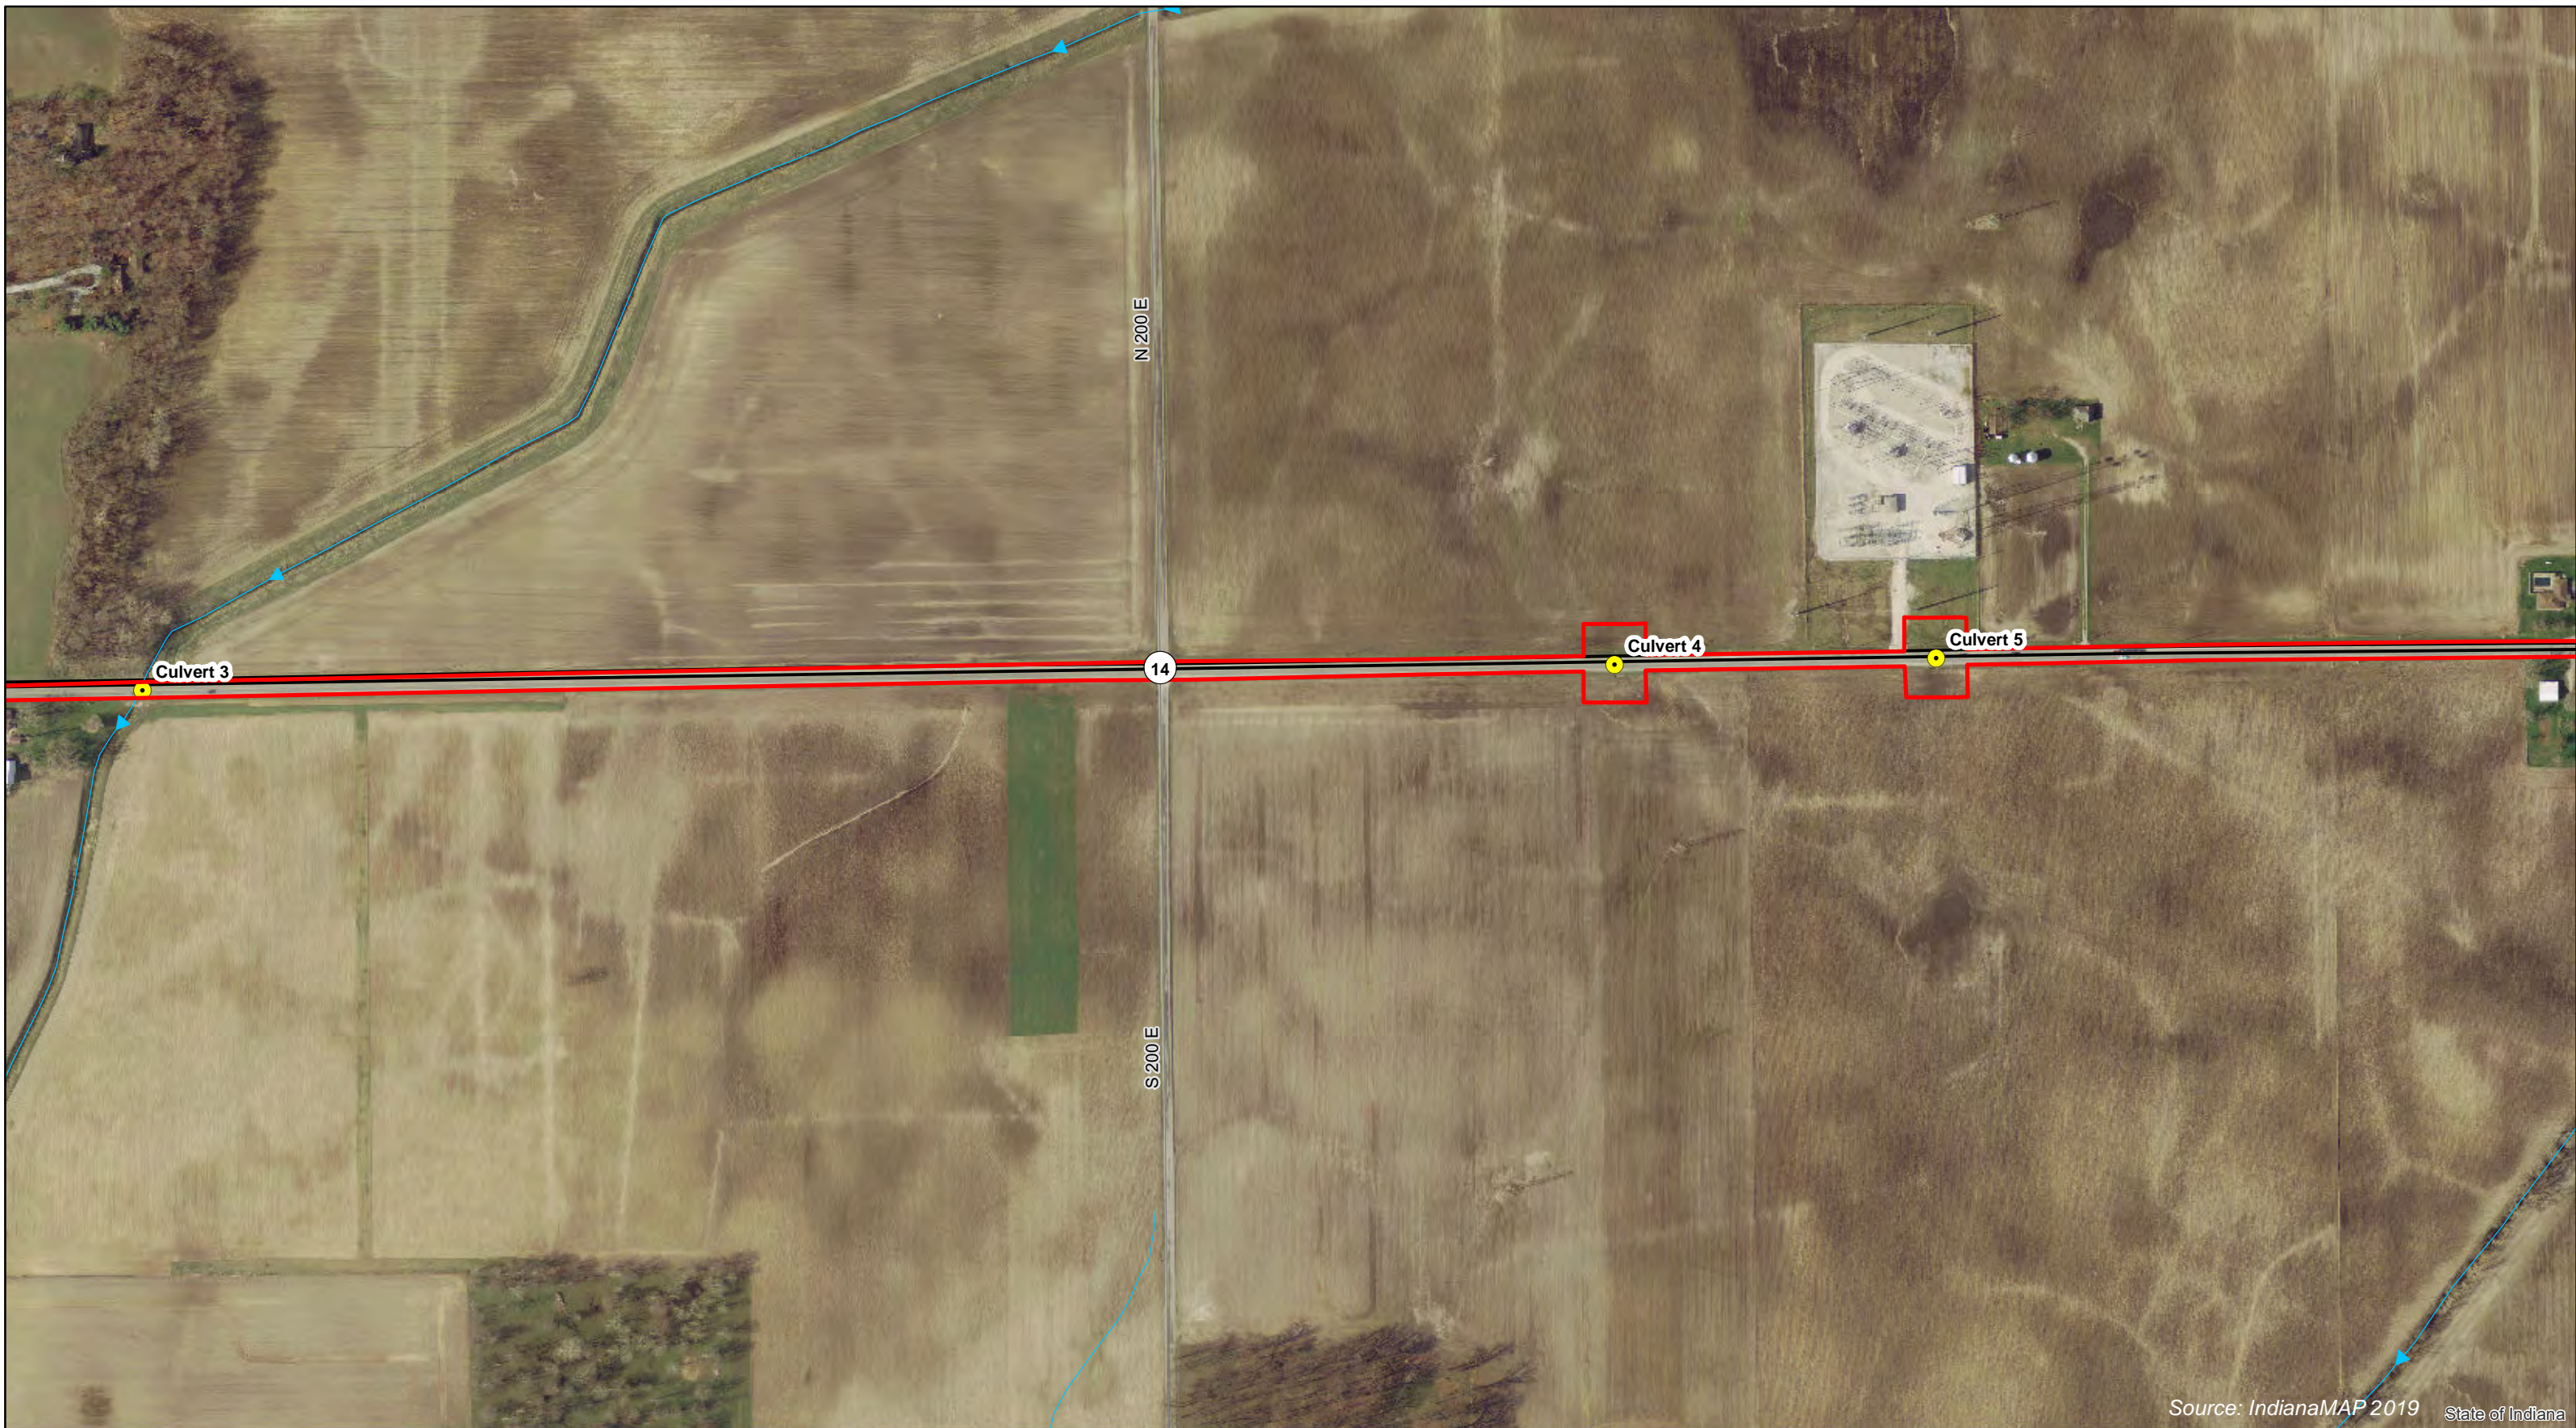
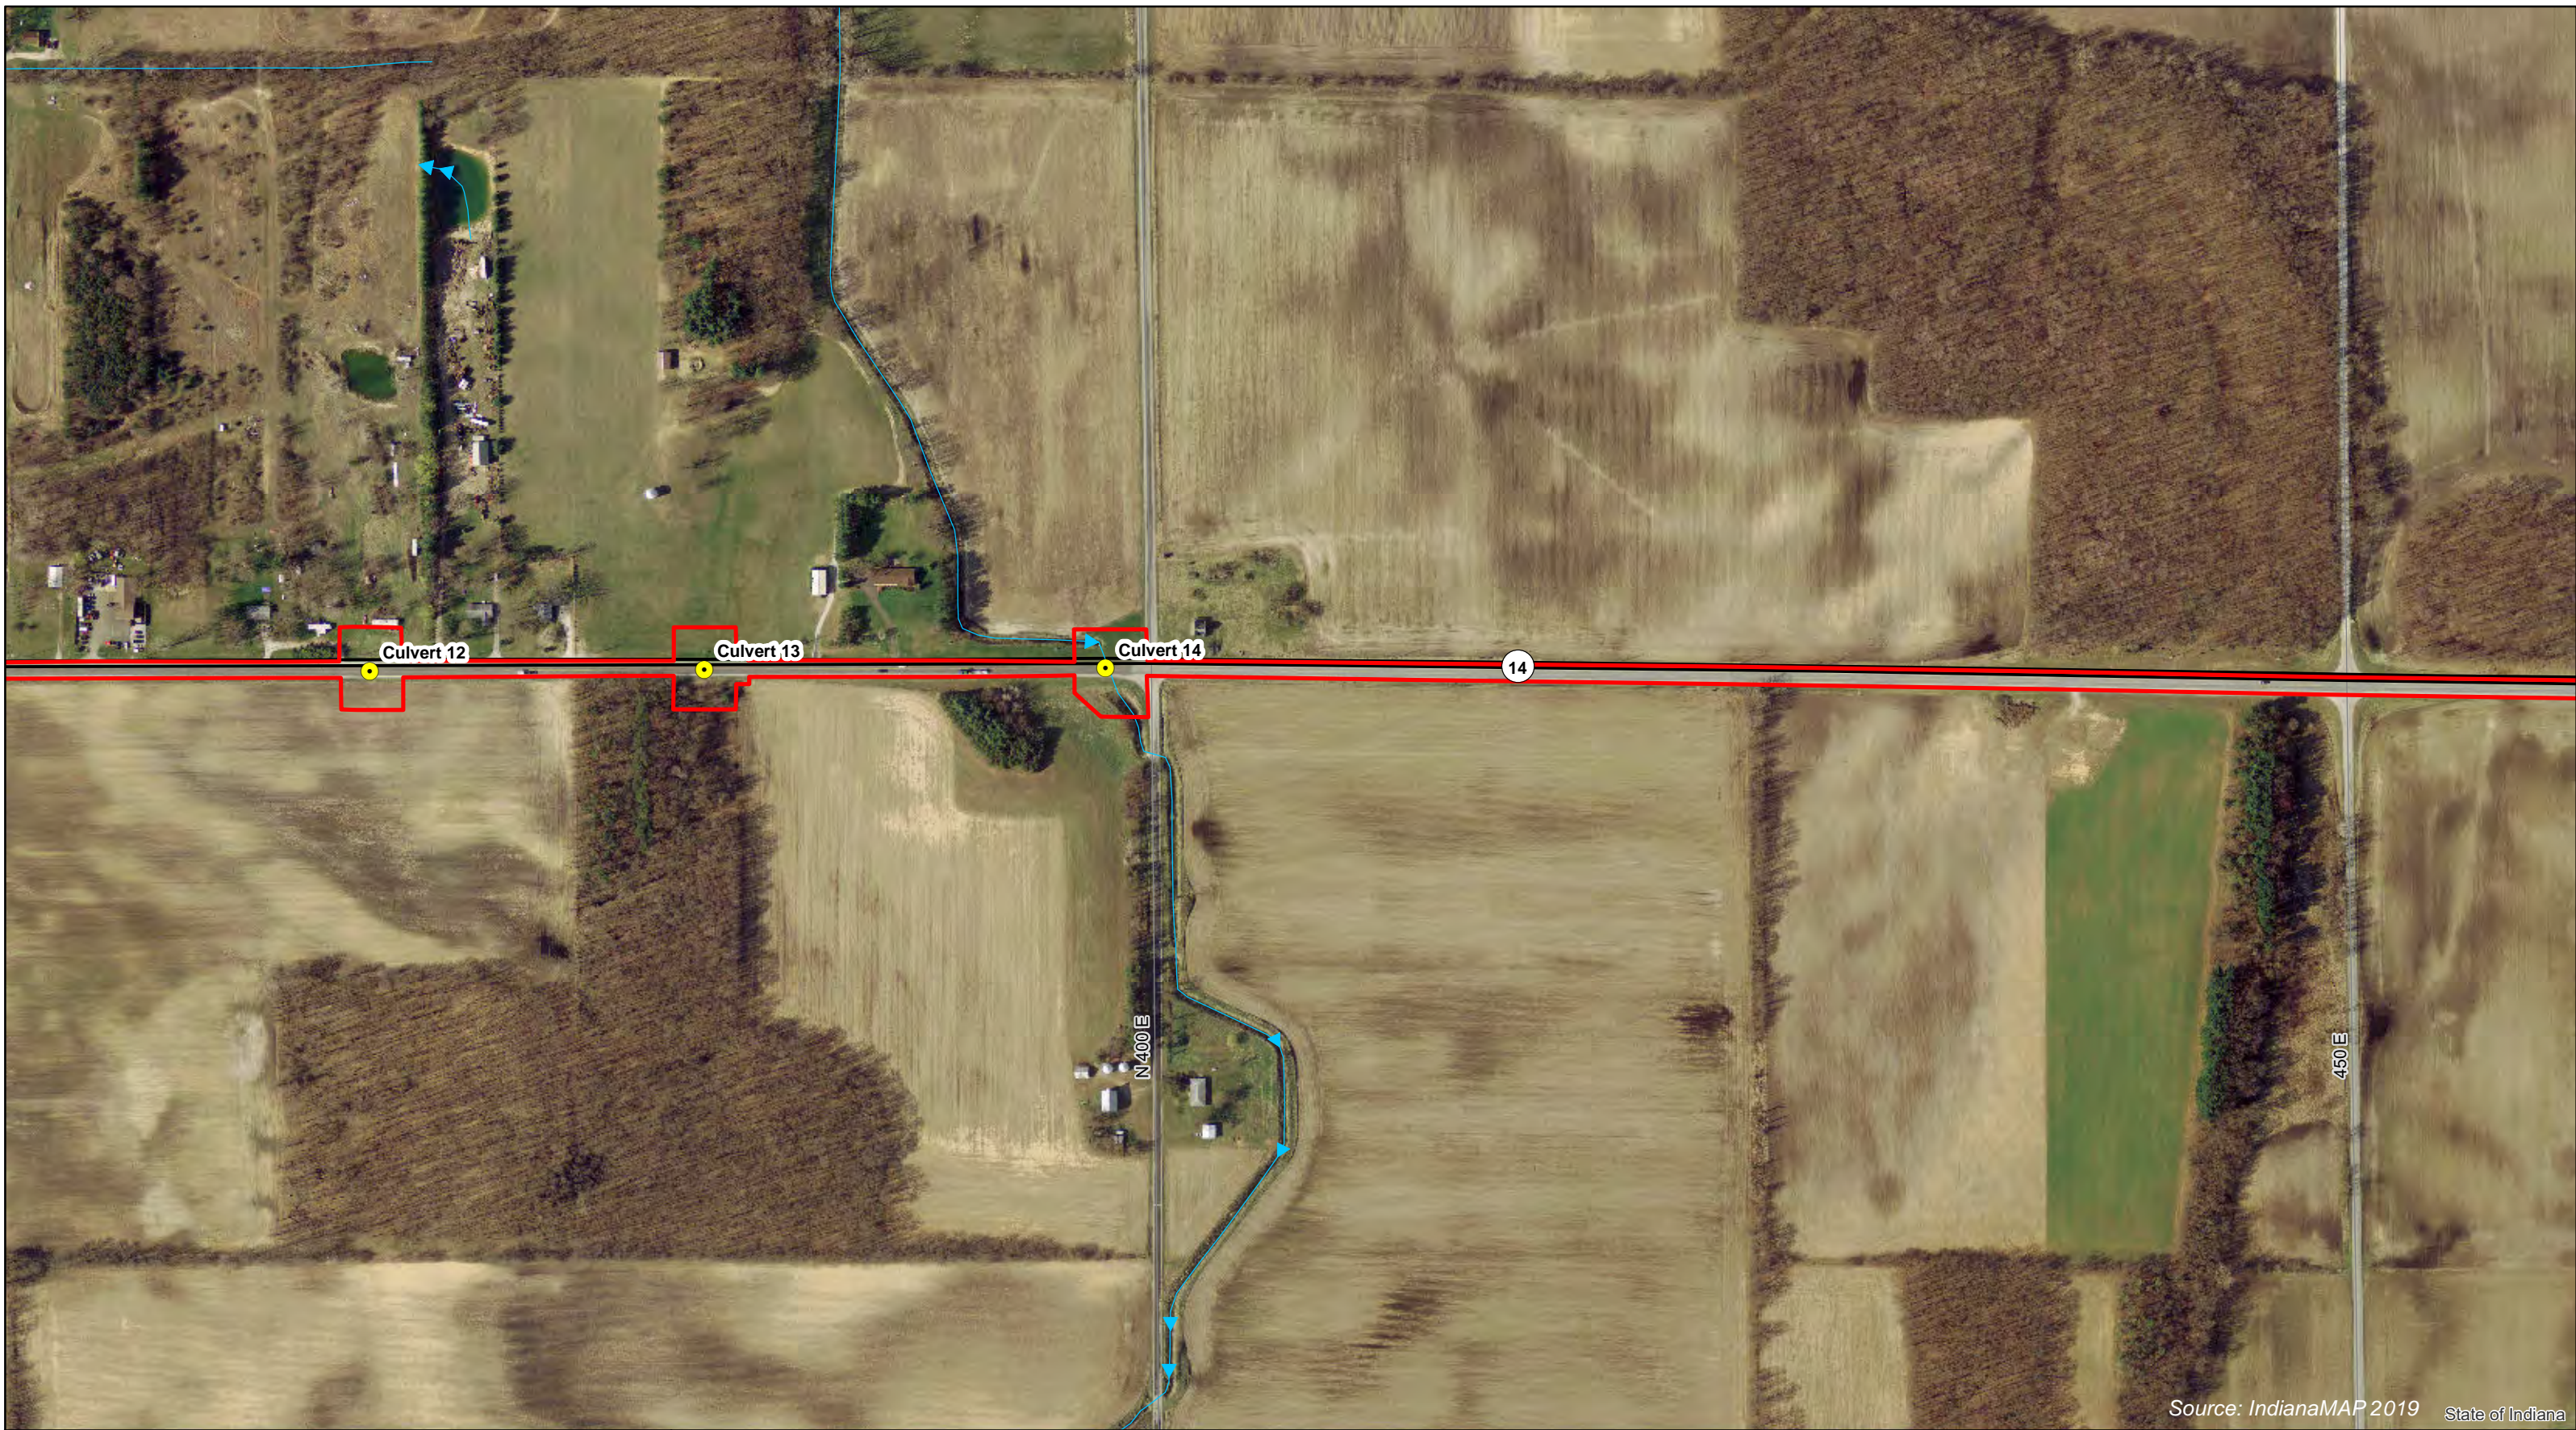
Figure 5
USGS National Hydrography
Data Map
SR 14 Pavement and Culvert Work
Pulaski and Fulton County, IN
Des. 1800182

According to the USGS NHD map (Figure 5), seven flowlines are located in the investigated area. These are discussed below:

- 1) Flows west-east on the south side of SR 14 near Riverside Street into Tippecanoe River.
- 2) Flows north-south along the west side of Plymouth Street, into the feature mentioned above.
- 3) Flows north-south under SR 14, representing Tippecanoe River.
- 4) Flows north-south under SR 14, representing Thompson Ditch.
- 5) Flows north-south under SR 14, representing Leidendecker Ditch.
- 6) Flows east-west north of SR 14, under 300 East.
- 7) Flows north-south under SR 14, representing Breckenridge Ditch.
