**WATERS OF THE U.S.
DETERMINATION REPORT**

**SR 14, Mill & Overlay, Full-Depth Reclamation,
and Culvert Replacements
Pulaski and Fulton Counties, Indiana**

INDOT Des. No. 1800182

Report Date: November 6, 2020

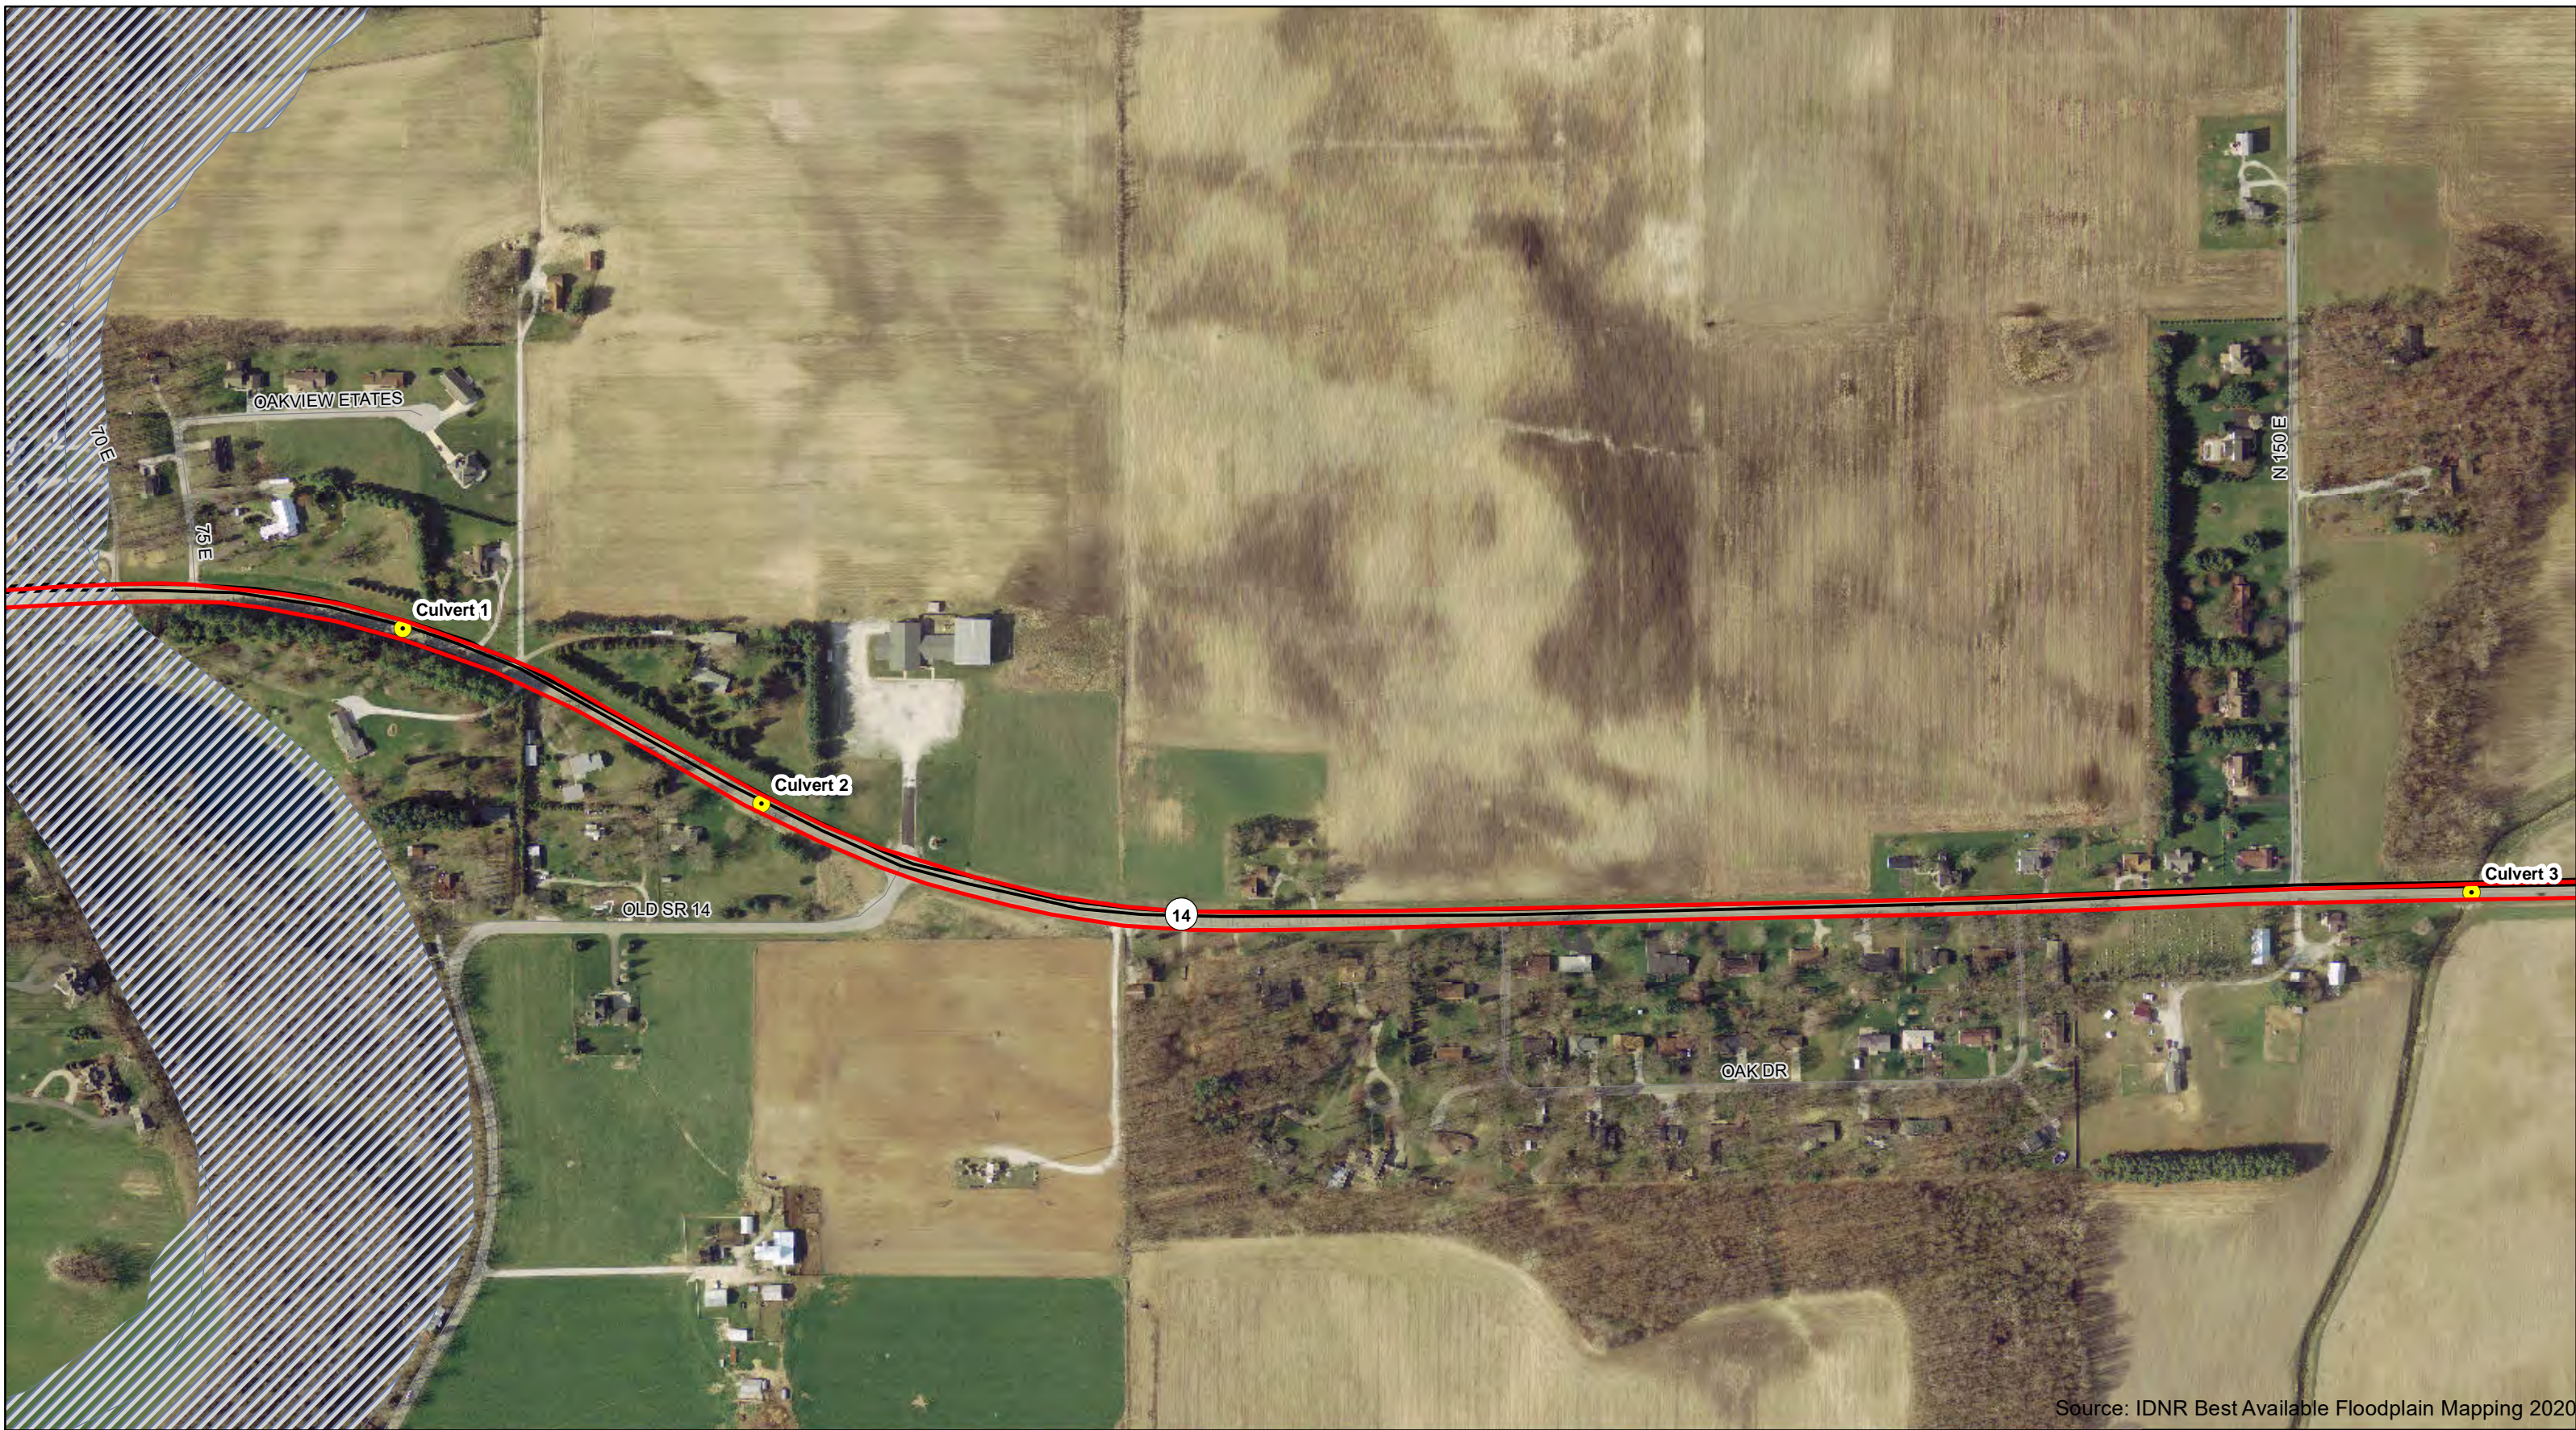
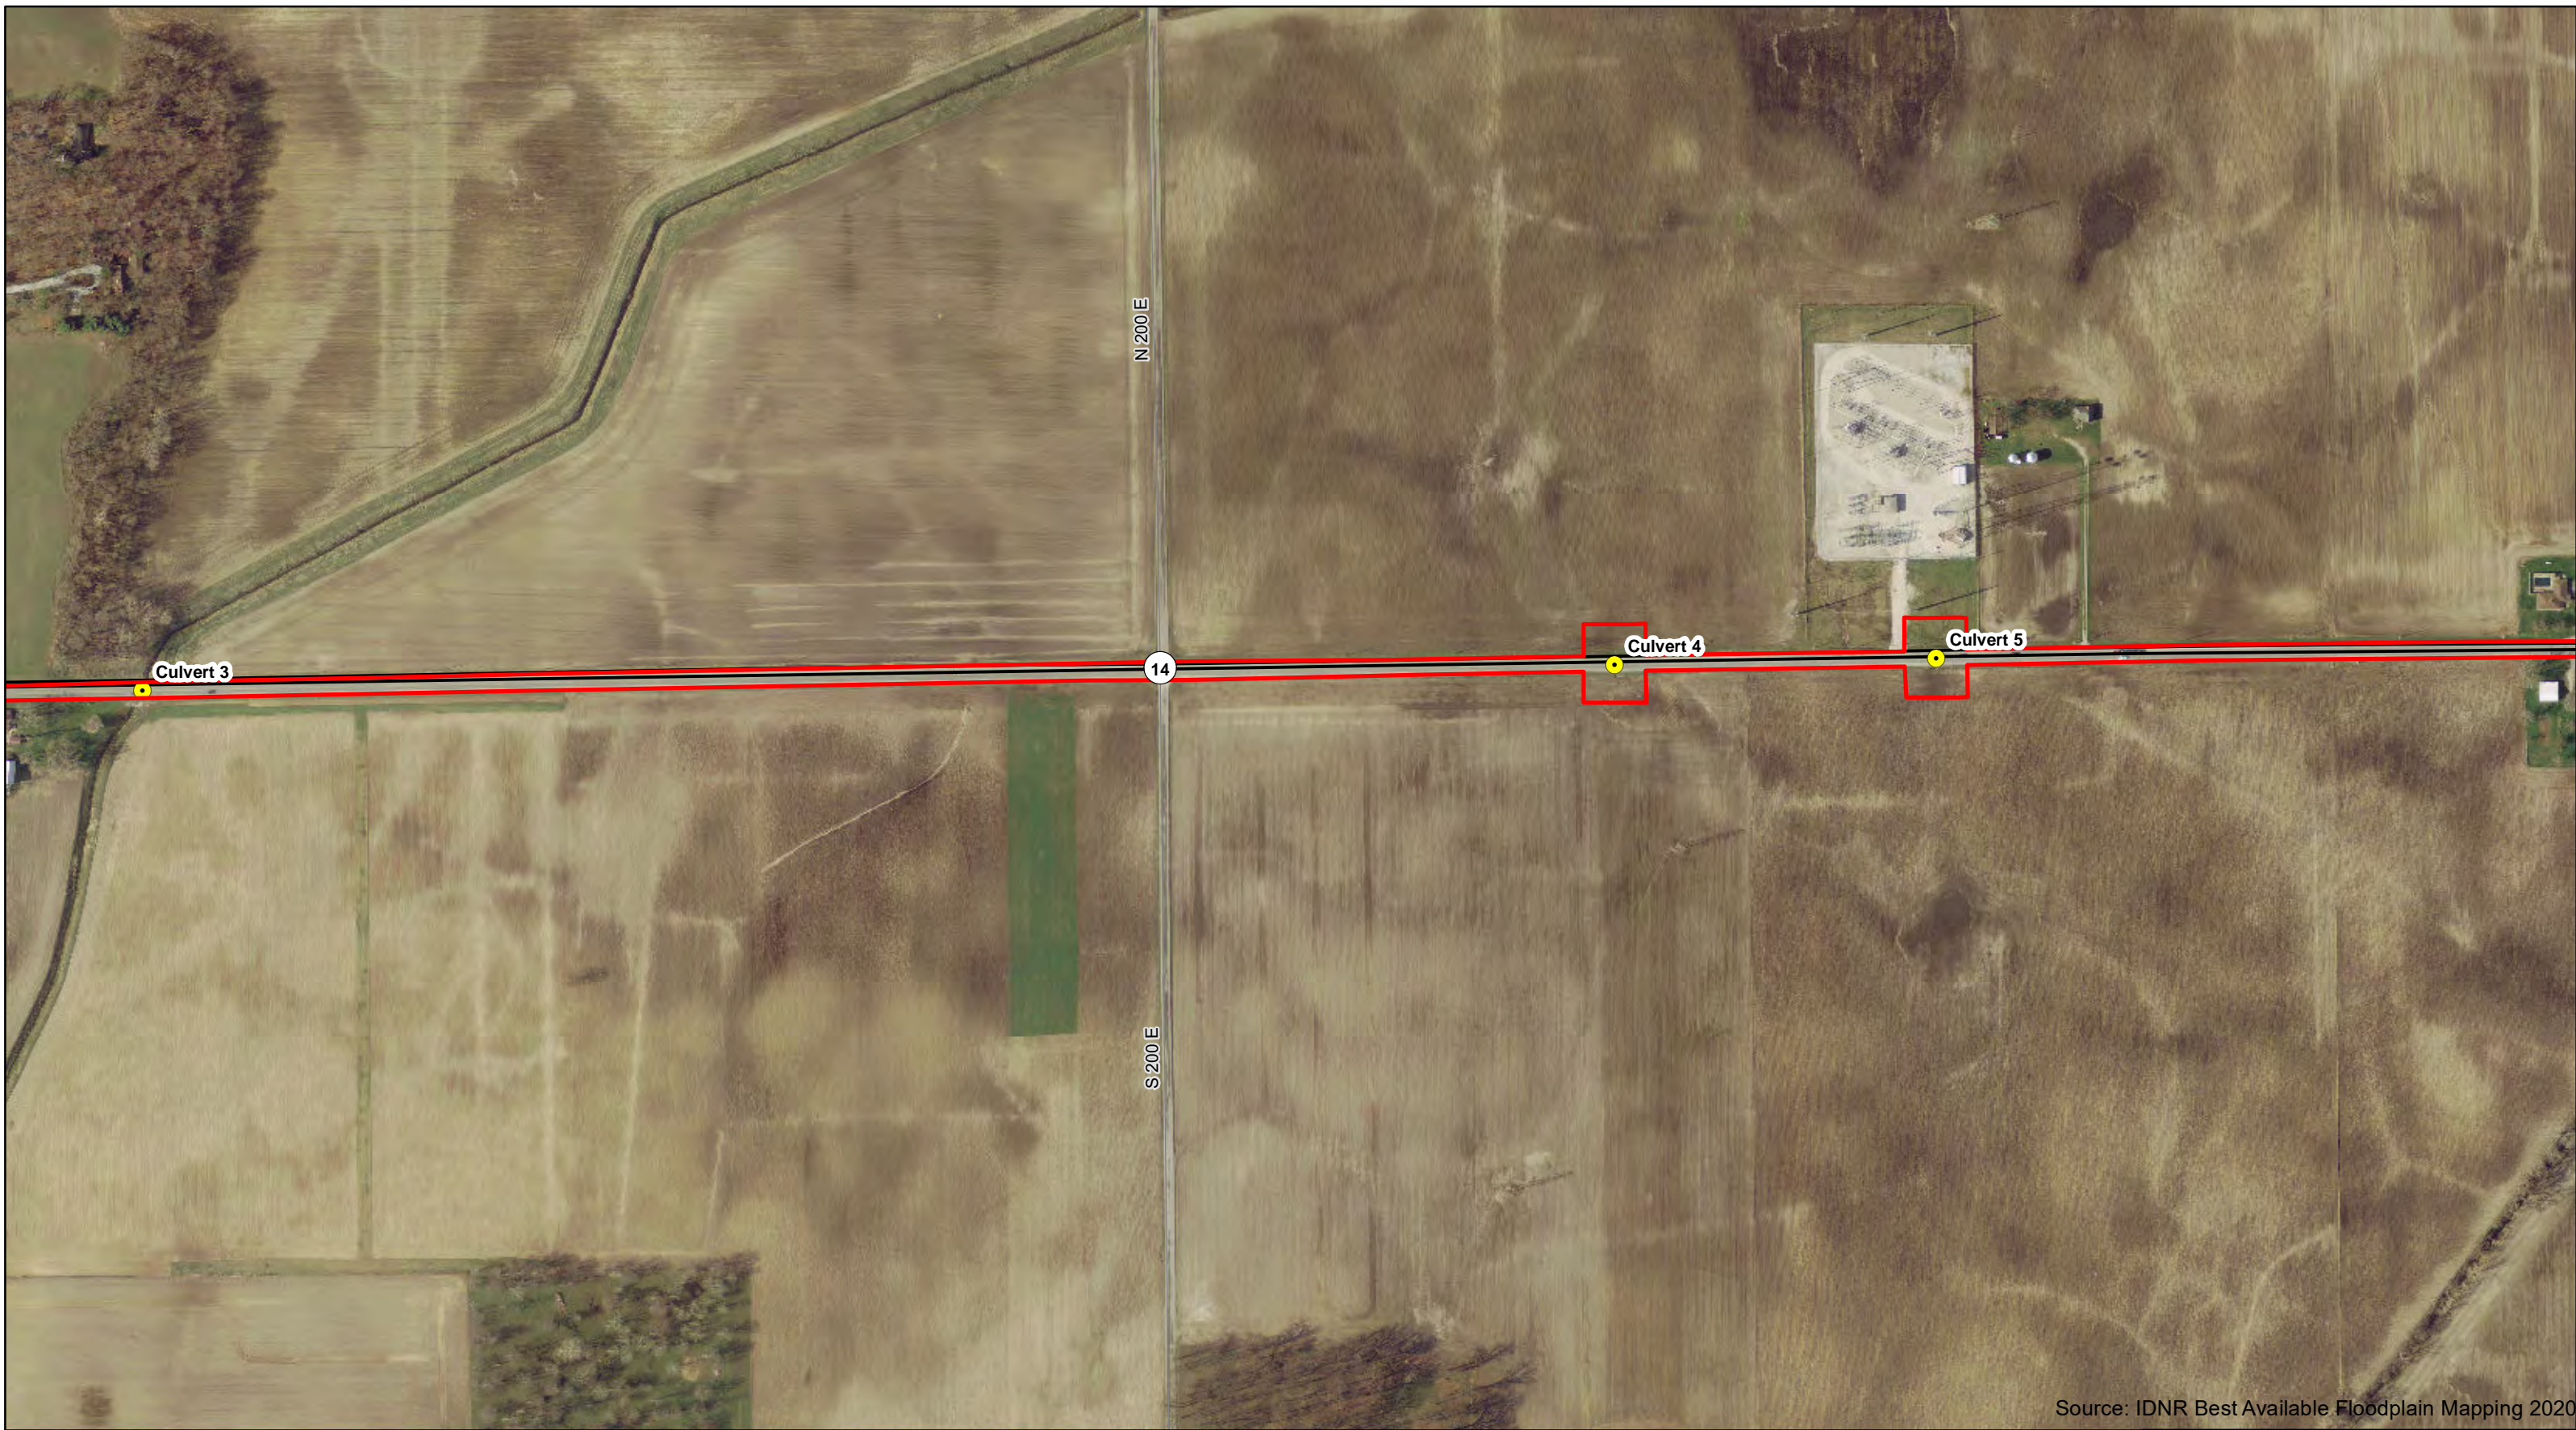
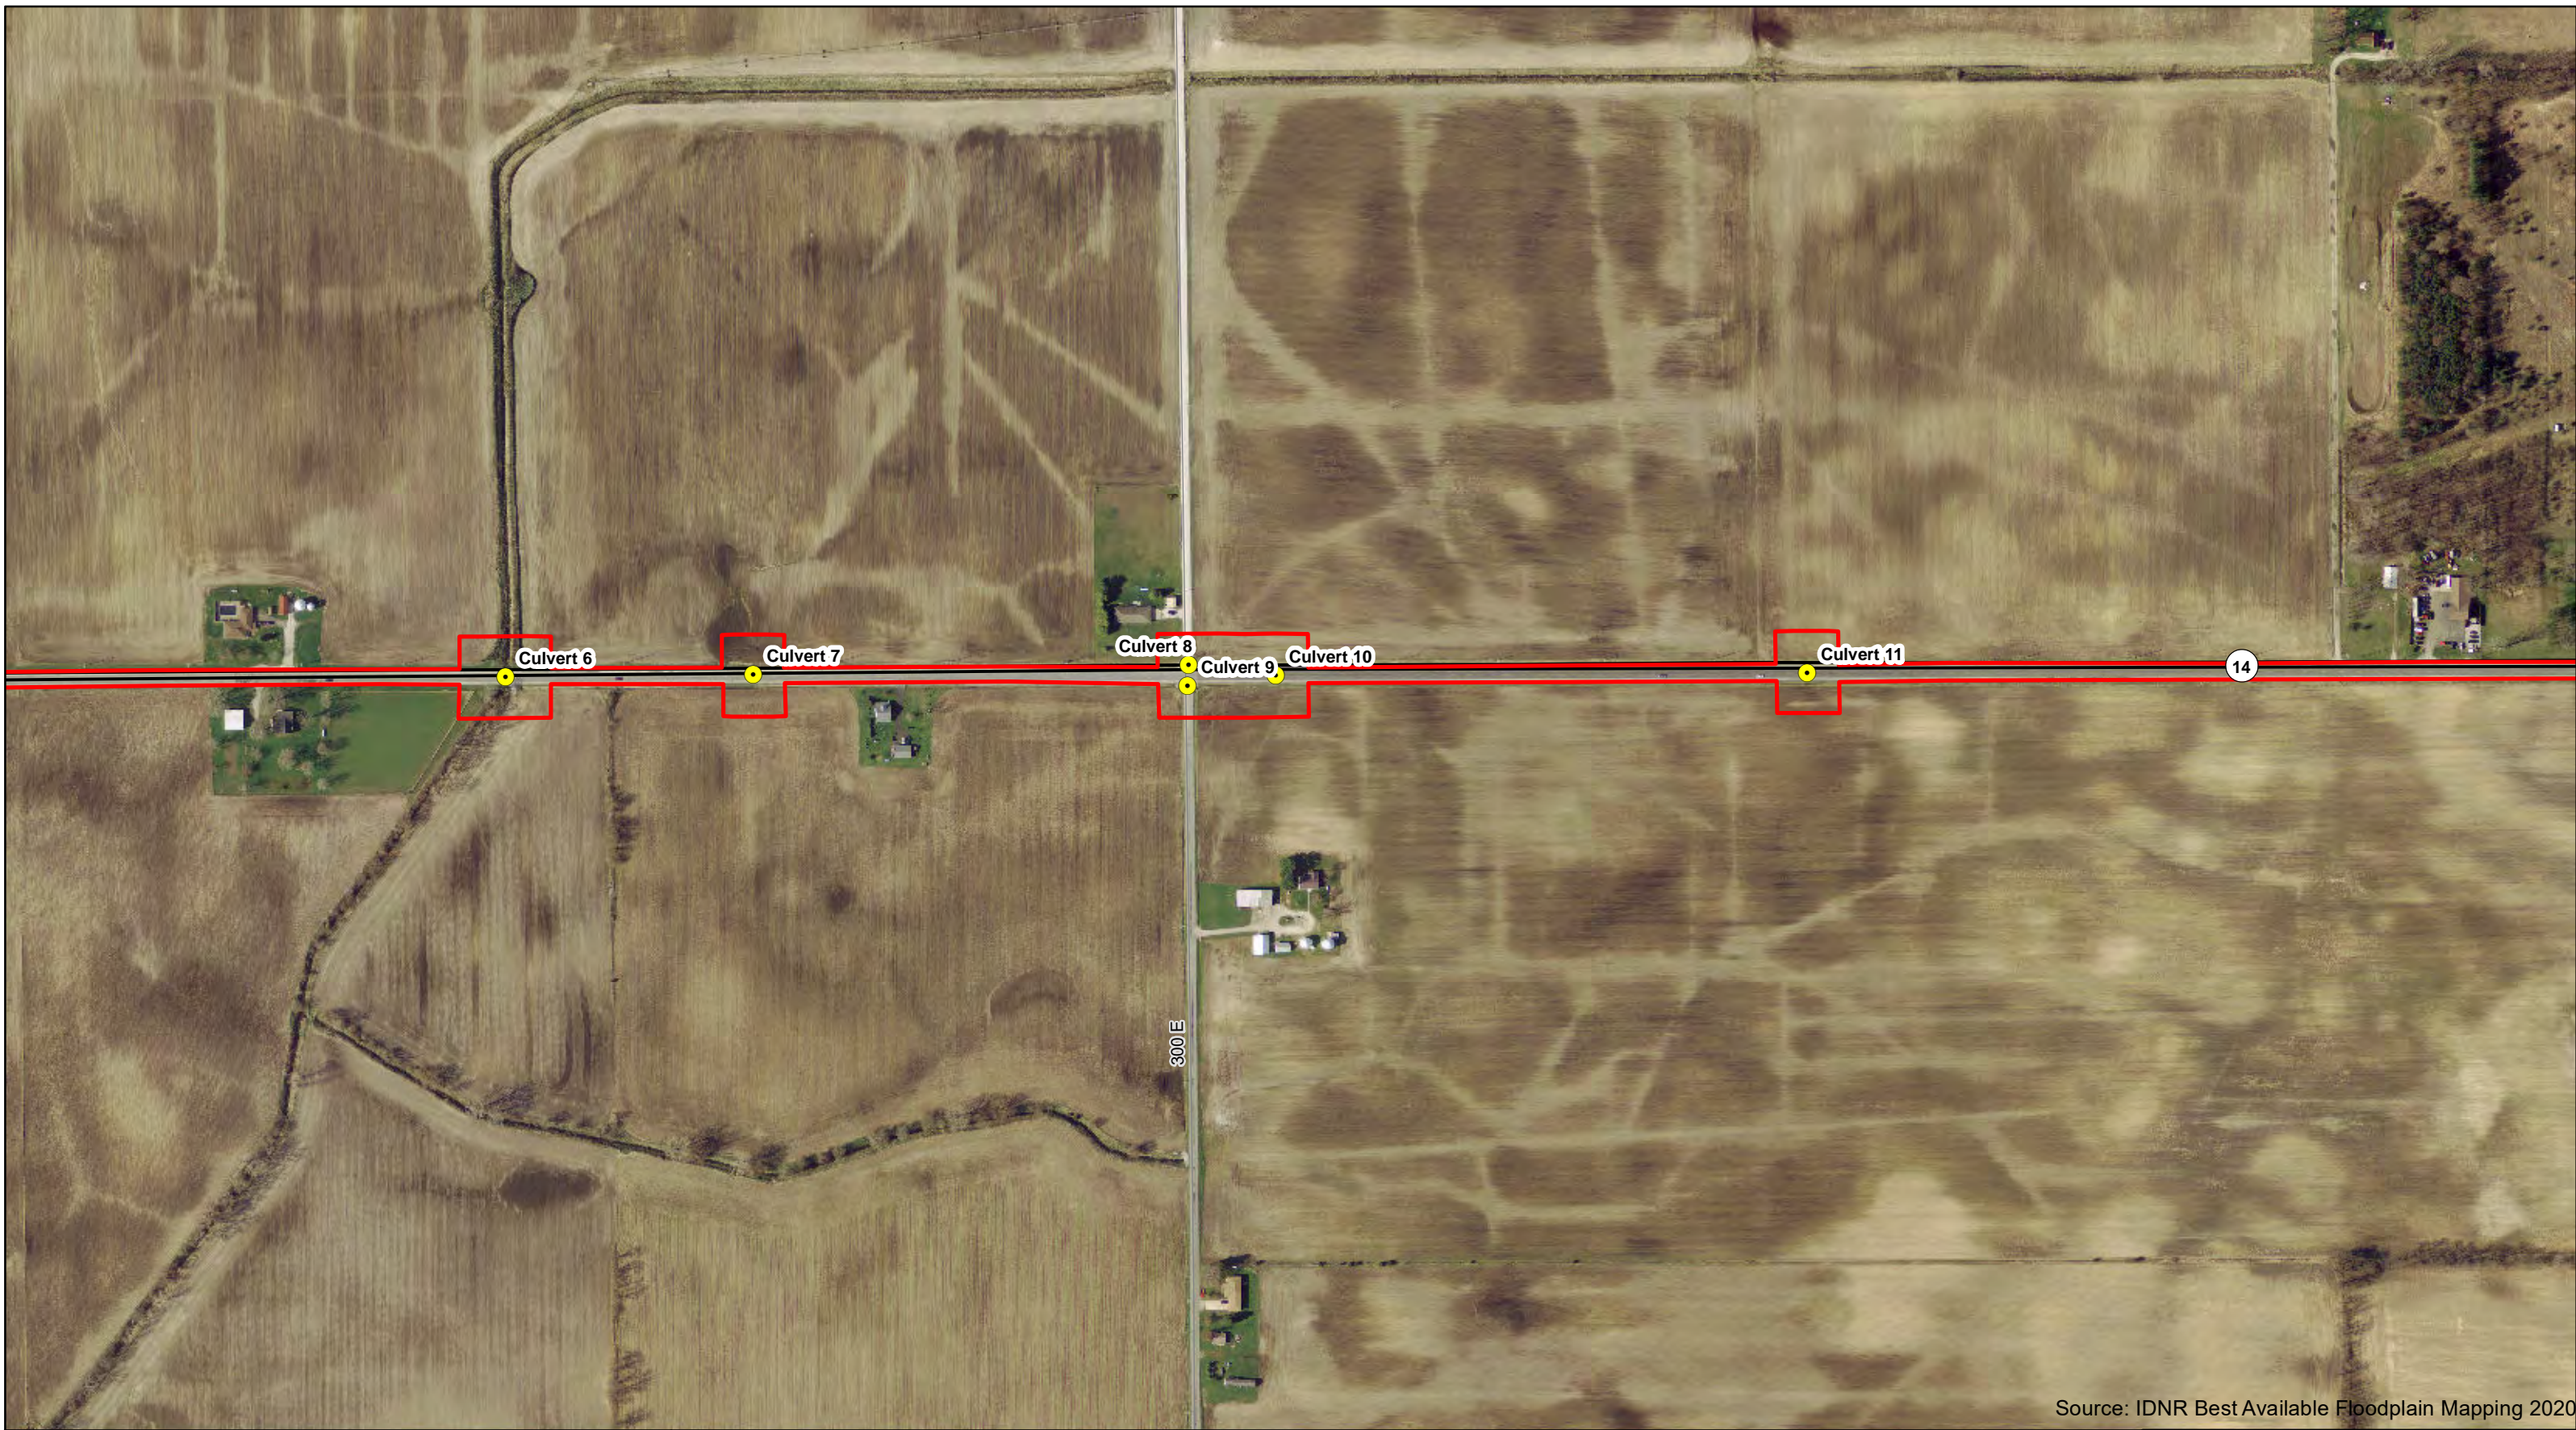
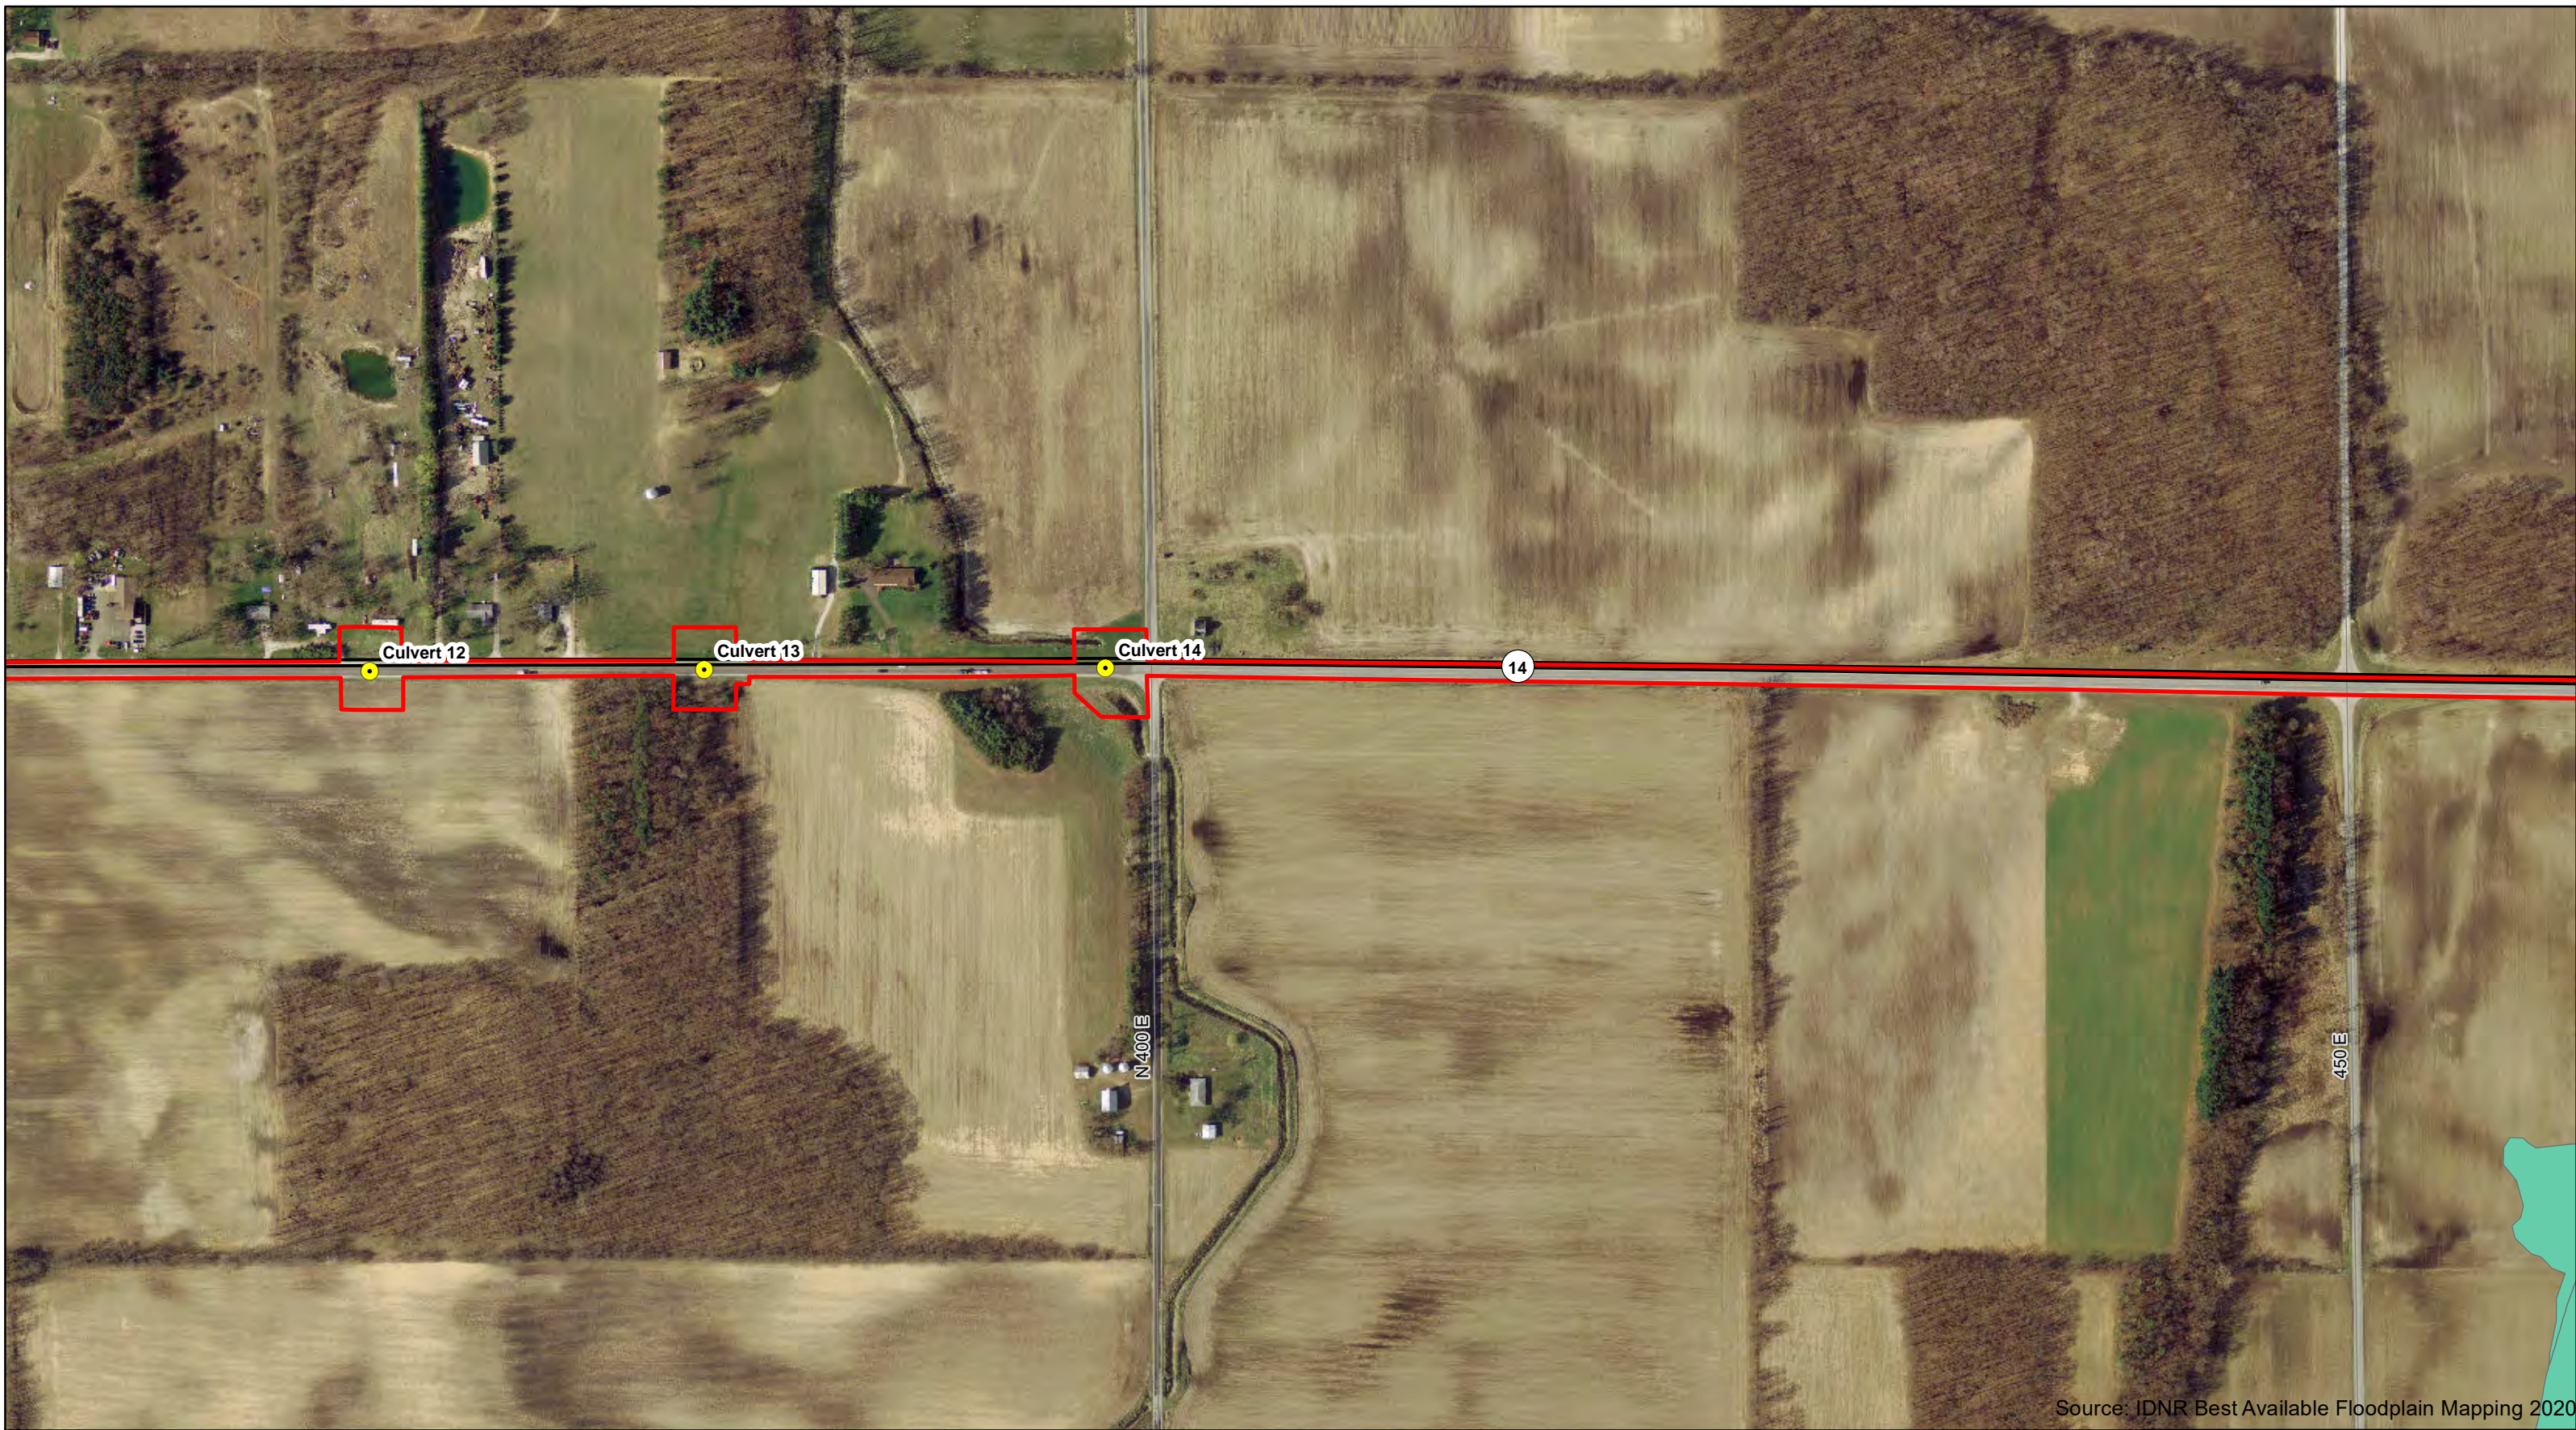
Figure 6
Floodplain Map
 SR 14 Pavement and Culvert Work
 Pulaski and Fulton County, IN
 Des. 1800182

According to the Indiana Department of Natural Resources (IDNR) Best Available Floodplain Layer, there are floodplains located within the investigated area (Figure 6). The floodplains are associated with Tippecanoe River and Little Mill Creek.
