# **Waters Report**

US 6 at Muck Pocket, 0.84 Mile East of SR 51/I-80/94
Bridge Replacement

Des. No.: 1900012, Asset ID#: (6)51-45-01943 B, NBI 018870 Lake County, Indiana

Hanson Professional Services Inc. 6510 Telecom Drive, Suite 210 Indianapolis, IN 46278

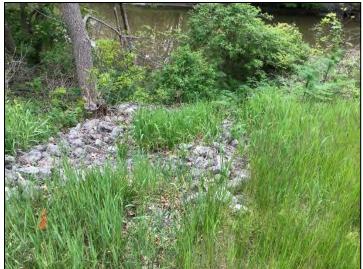
Photo 9. RSD 2 on southwest side of the bridge over Muck Pocket, viewing west, 5/17/2021

Three roadside ditches (RSDs) were observed throughout the study area (see Table 5 and Figures 5 through 5-2). RSD 1 was observed south of the bridge and drains north to the inlet of the small structure. RSD 2 is at the north end of the bridge over Muck Pocket on the west side of the structure. RSD 2 flows west and drains runoff from US 6 to Deep River. RSD 3 is at the north end of the study area on the west side of the bridge over Deep River. RSD 3 flows north and drains runoff from US 6 to Deep River. The RSDs lacked an OHWM and did not have a defined bed and bank; therefore, they would likely be considered non-jurisdictional by the USACE.

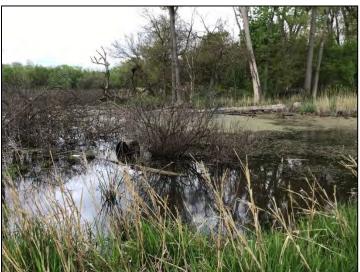
Photo 11. Open Water 1 east of bridge over Muck Pocket, viewing east, 5/17/2021

At the time of the investigation, there was open water present 84 feet northeast of the bridge structure, designated as Open Water 1. Open Water 1 would likely be considered a jurisdictional WOTUS by the USACE due to seasonal flooding from Deep River, which connects to the Little Calumet River, a TNW. Open Water 1 was surrounded by trees, tall vegetation, and shrubs. Vegetation observed along the boundaries with Wetlands A, B, D and E included reed canary grass (*Phalaris arundinacea*), common reed (*Phragmites australis*), broadleaf arrowhead (*Sagittaria latifolia*), and pale yellow iris (*Iris pseudacorus*). The water contained algae and fallen trees. The quality was considered excellent due to the diversity of plant species, hydrologic function within the landscape, and quality habitat for a state endangered species. Open Water 1 would be classified as Palustrine, Aquatic Bed – Floating Vascular/Unconsolidated Bottom, Semipermanently Flooded (PAB4/UBF) under the Cowardin Classification System. The delineated acreage of Open Water 1 is 0.172 acre.

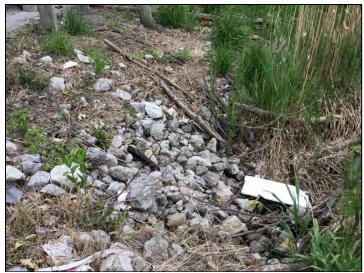
Photo 10. Presumed location of Str. 2 outlet on northwest side of the bridge over Muck Pocket, viewing south, 5/17/2021

An additional investigation was conducted on September 25, 2021, to locate Str. 2 north of the bridge over Muck Pocket (see Photos 10, 55, 56). The location of the structure inlet and outlet was not located. An area of riprap was located northwest of the bridge over Muck Pocket. It is presumed that this is the structure outlet covered by riprap. The area where the inlet of the structure would be located was covered by dense vegetation. Due to the dense vegetation, the inlet of the structure was not located.

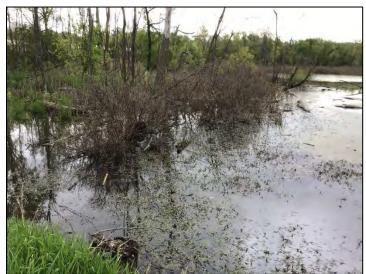
Photo 12. Open Water 1 east of bridge over Muck Pocket, viewing east, 5/17/2021

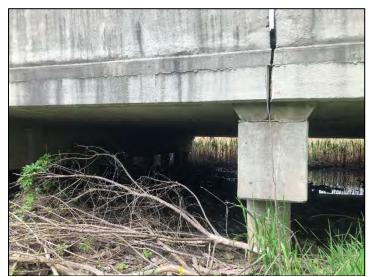
Photo 16. Open Water 2 under bridge over Muck Pocket ((6)51-45-01943 B) with standing water, viewing west, 5/17/2021

At the time of investigation, Lake County had been in drought conditions classified as "Moderate Drought" from April 27 to May 4, 2021, and "Abnormally Dry" from May 5 to May 17, 2021 (NOAA -NWS, 2020). Due to these conditions and water marks on the spans, it was determined that the area under the bridge would have standing water under normal conditions. This area is classified as open water, designated as Open Water 2. Open Water 2 would likely be considered a jurisdictional WOTUS by the USACE due to its significant nexus to Deep River, which connects to the Little Calumet River, a TNW. The area under the bridge had pools of standing water and saturated soil. No vegetation was present under the bridge. The area of Open Water 2 was determined by the lack of vegetation and the spans of the bridge. The quality was considered poor due to the lack of vegetation and silty substrate. Open Water 2 would be classified as Palustrine, Unconsolidated Bottom, Mud, Intermittently Exposed (PUB3G) under the Cowardin Classification System (Wetlands Subcommittee, 2013). The delineated acreage of Open Water 2 is 0.141 acre.

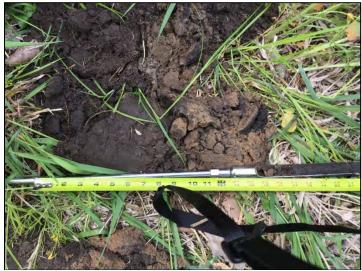
Photo 27. Wetland DP-1 soil profile for Wetland A, 5/17/2021

DP-1 is located on the east side of US 6 approximately 10 feet east of the bridge over Muck Pocket (see Data Form DP-1, Photos 26 and 27). DP-1 represents a vegetated depression. The vegetation was dominated by reed canary grass (*Phalaris arundinacea*, FACW) and garden yellow-rocket (*Barbarea vulgaris*, FAC). The dominance test determined there was a presence of hydrophytic vegetation. Hydric soil was present due to the hydric soil indicator of a depleted matrix (F3). Hydrologic conditions were present due to the primary wetland hydrology indicators of sediment deposits (B2) and drift deposits (B3). Secondary wetland hydrology indicators present were geomorphic

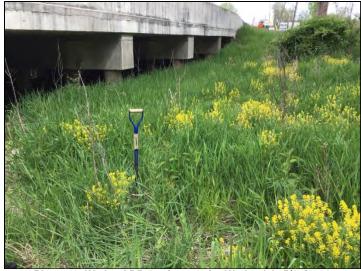
Photo 26. Wetland DP-1 reference for Wetland A, 5/17/2021

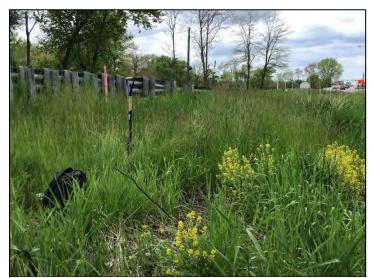
Photo 28. Upland DP-2 reference for Wetland A, 5/17/2021

DP-2 is located on the east side of US 6 at the northeast corner of the bridge over Muck Pocket (see Data Form DP-2, Photos 28 and 29). DP-2 represents a vegetated convex area along the side of the road. Vegetation was dominated by orchard grass (*Dactylis glomerata*) and reed canary grass (*Phalaris arundinacea*). The dominance test determined there was a lack of hydrophytic vegetation. Hydric soil and wetland hydrology indicators were not present. Due to lack of hydrophytic vegetation, hydric soil, and wetland hydrology, DP-2 is not considered a wetland point.

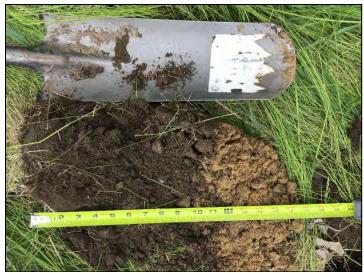
Photo 29. Upland DP-2 soil profile for Wetland A, 5/17/2021

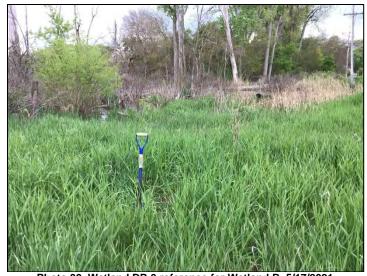
Photo 30. Wetland DP-3 reference for Wetland B, 5/17/2021

DP-3 is located east of US 6, approximately 230 feet northeast of the bridge over Muck Pocket (see Data Form DP-3, Photos 30 and 31). DP-3 represents a vegetated depression with saturated soil. The vegetation was dominated by reed canary grass (*Phalaris arundinacea*). The rapid test for hydrophytic vegetation determined there was a presence of hydrophytic vegetation. At the second site visit on June 14, 2021, more plant species were observed since it was later in the growing season but were not documented on a data sheet. These species included broadleaf cattail (*Typha angustifolia*) and broadleaf arrowhead (*Sagittaria latifolia*). Hydric soil was present due to the hydric soil indicator of depleted below a dark surface (A11). Hydrologic conditions were present due to wetland hydrology indicators of a high water table (A2) and saturation (A3). Due to the presence of hydrophytic vegetation, hydric soil, and wetland hydrology, DP-3 is considered a wetland point.

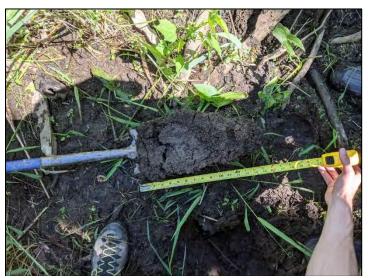
Photo 39. Wetland DP-7 soil profile for Wetland D, 6/14/2021

DP-7 is located east of US 6, approximately 88 feet northeast of the bridge over Muck Pocket (see Data Form DP-7, Photos 38 and 39). DP-7 represents a vegetated depression with trees and shrubs. Vegetation was dominated by eastern cottonwood (*Populus deltoides*), white mulberry (*Morus alba*), reed canary grass (*Phalaris arundinacea*), and common reed (*Phragmites australis*). The dominance test determined there was a presence of hydrophytic vegetation. Hydric soil was present due to the hydric soil indicator of depleted below a dark surface (A11). Hydrologic conditions were

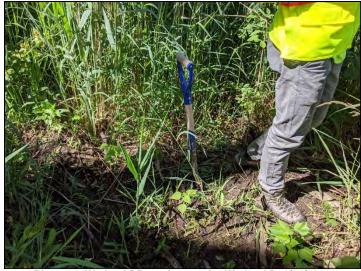
Photo 38. Wetland DP-7 reference for Wetland D, 6/14/2021

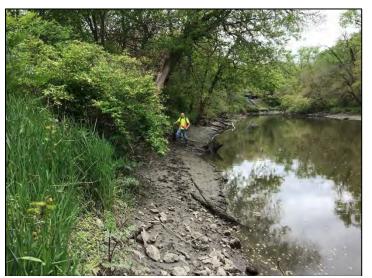
Photo 44. OWHM measurement along eastern bank of Deep River, viewing southwest, 5/17/2021

At the time of the investigation, flow was observed in the stream channel. The OHWM was measured outside the influence of the structure at longitude 41.571348°, latitude -87.239948°, approximately 26 feet west of Str. 2. The OHWM depth was 6 feet, and the OHWM width ranged from 95 to 160 feet. The quality of the stream was classified as poor. The water level was low due to drought conditions revealing trash and large items in the river. The water was turbid and there was no visibility to the bed of the stream. The substrate of the stream was silt. The stream feature had a small amount of canopy cover towards the northernmost and southernmost ends of the study area.

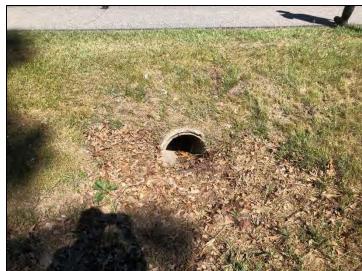
Photo 45. Inlet of Str. 1 south of bridge over Muck Pocket, viewing west, 6/14/2021

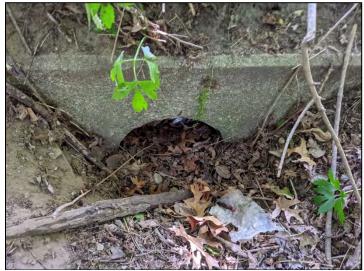
Photo 47. Outlet of Str. 1 west of US 6, viewing east, 6/14/2021

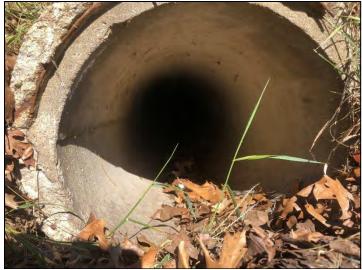
Photo 46. Viewing through inlet of Str. 1, viewing west, 6/14/2021

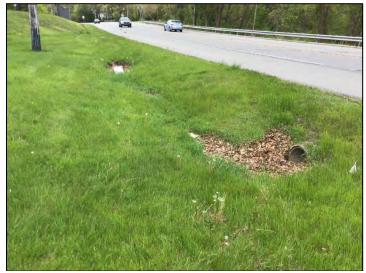
Photo 48. RSD 1 with Str. 1 south of bridge over Muck Pocket, viewing southwest, 5/17/2021

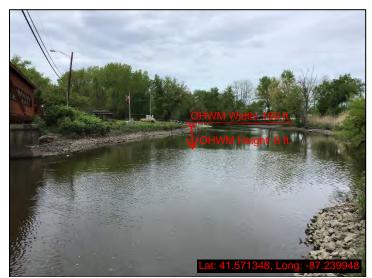
Photo 52. OHWM of Deep River, viewing northwest, 5/17/2021

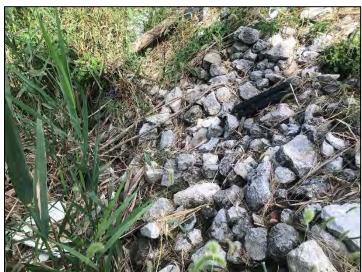
Photo 55. Presumed outlet of Str. 2 north of bridge over Muck Pocket, viewing north, 9/25/2021

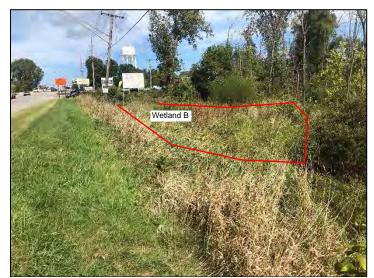
Photo 56. Presumed area of Str. 2 inlet covered by dense vegetation with Wetland B, viewing north, 9/25/2021
