Categorical Exclusion

Appendix E

Red Flag and Hazardous Materials

Re: RED FLAG INVESTIGATION
DES # 1700155, State Project
Bridge Replacement
SR 450, 6.30 mile north of US 50
Martin County, Indiana

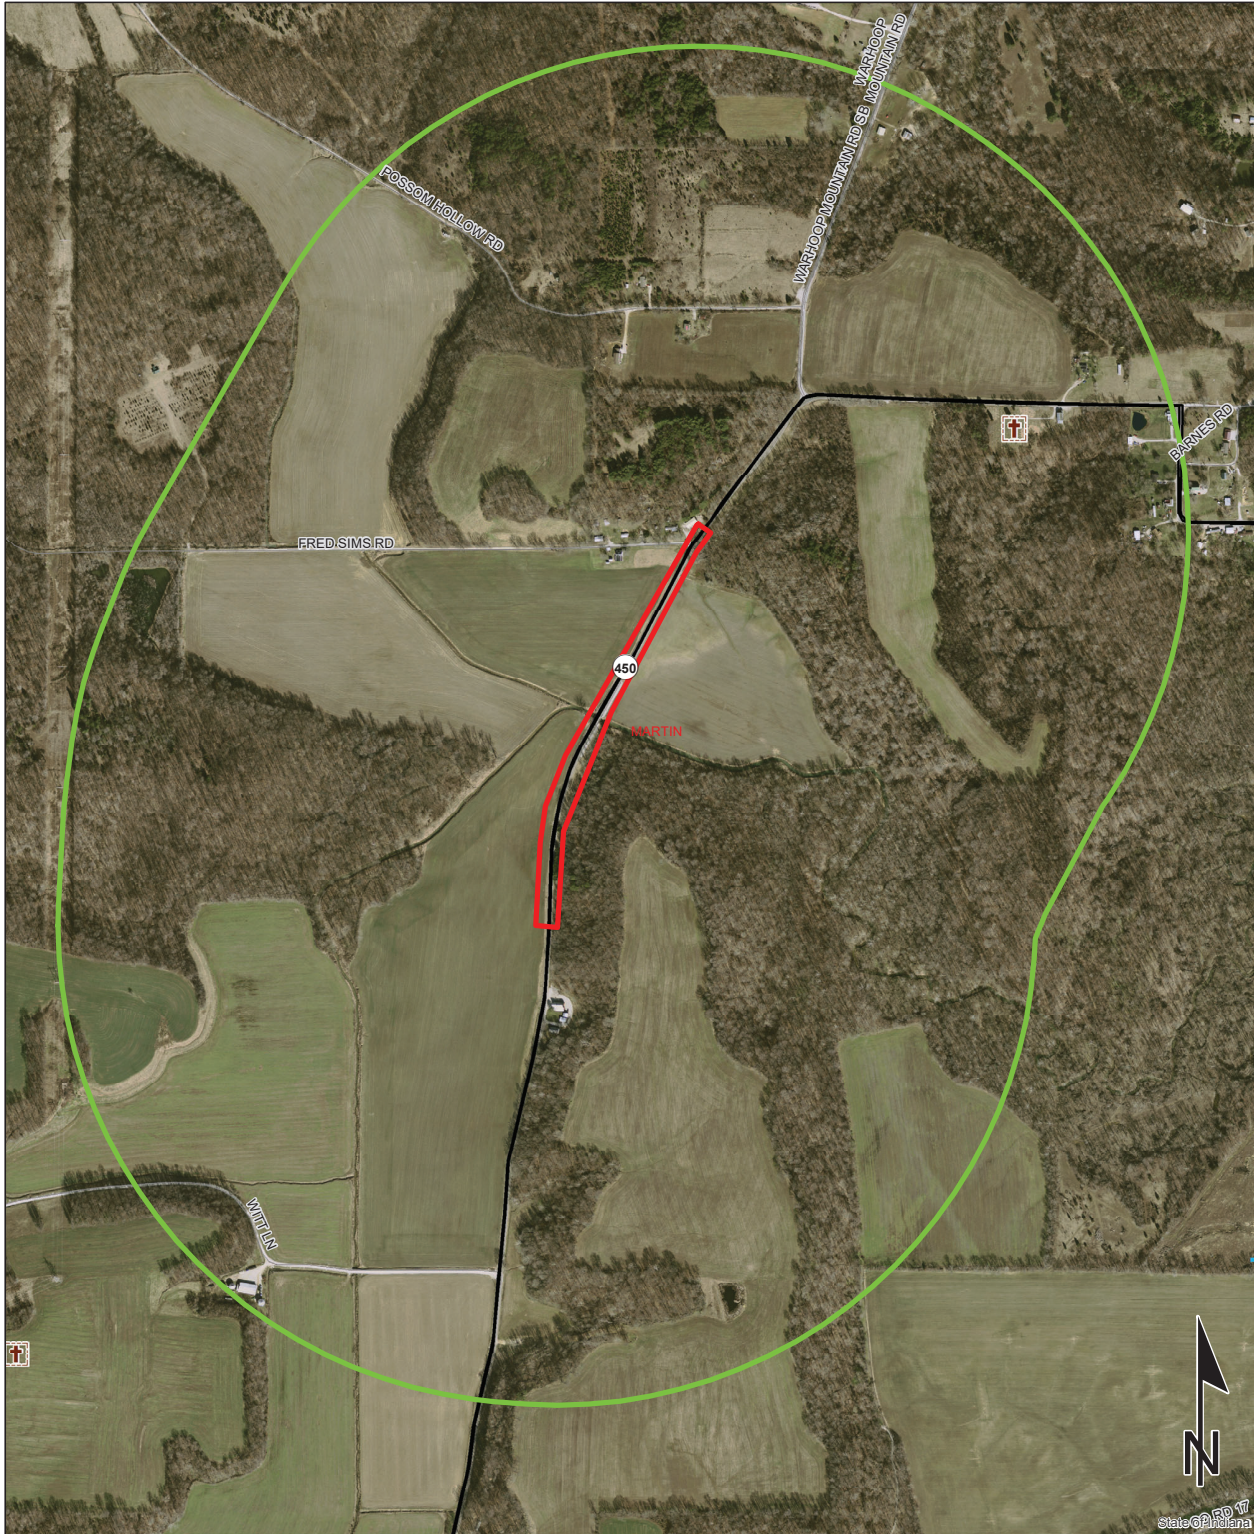
Red Flag Investigation - Infrastructure
 SR 450, 6.30 miles north of US 50
 Des. No. 1700155, Bridge Replacement
 Martin County, Indiana

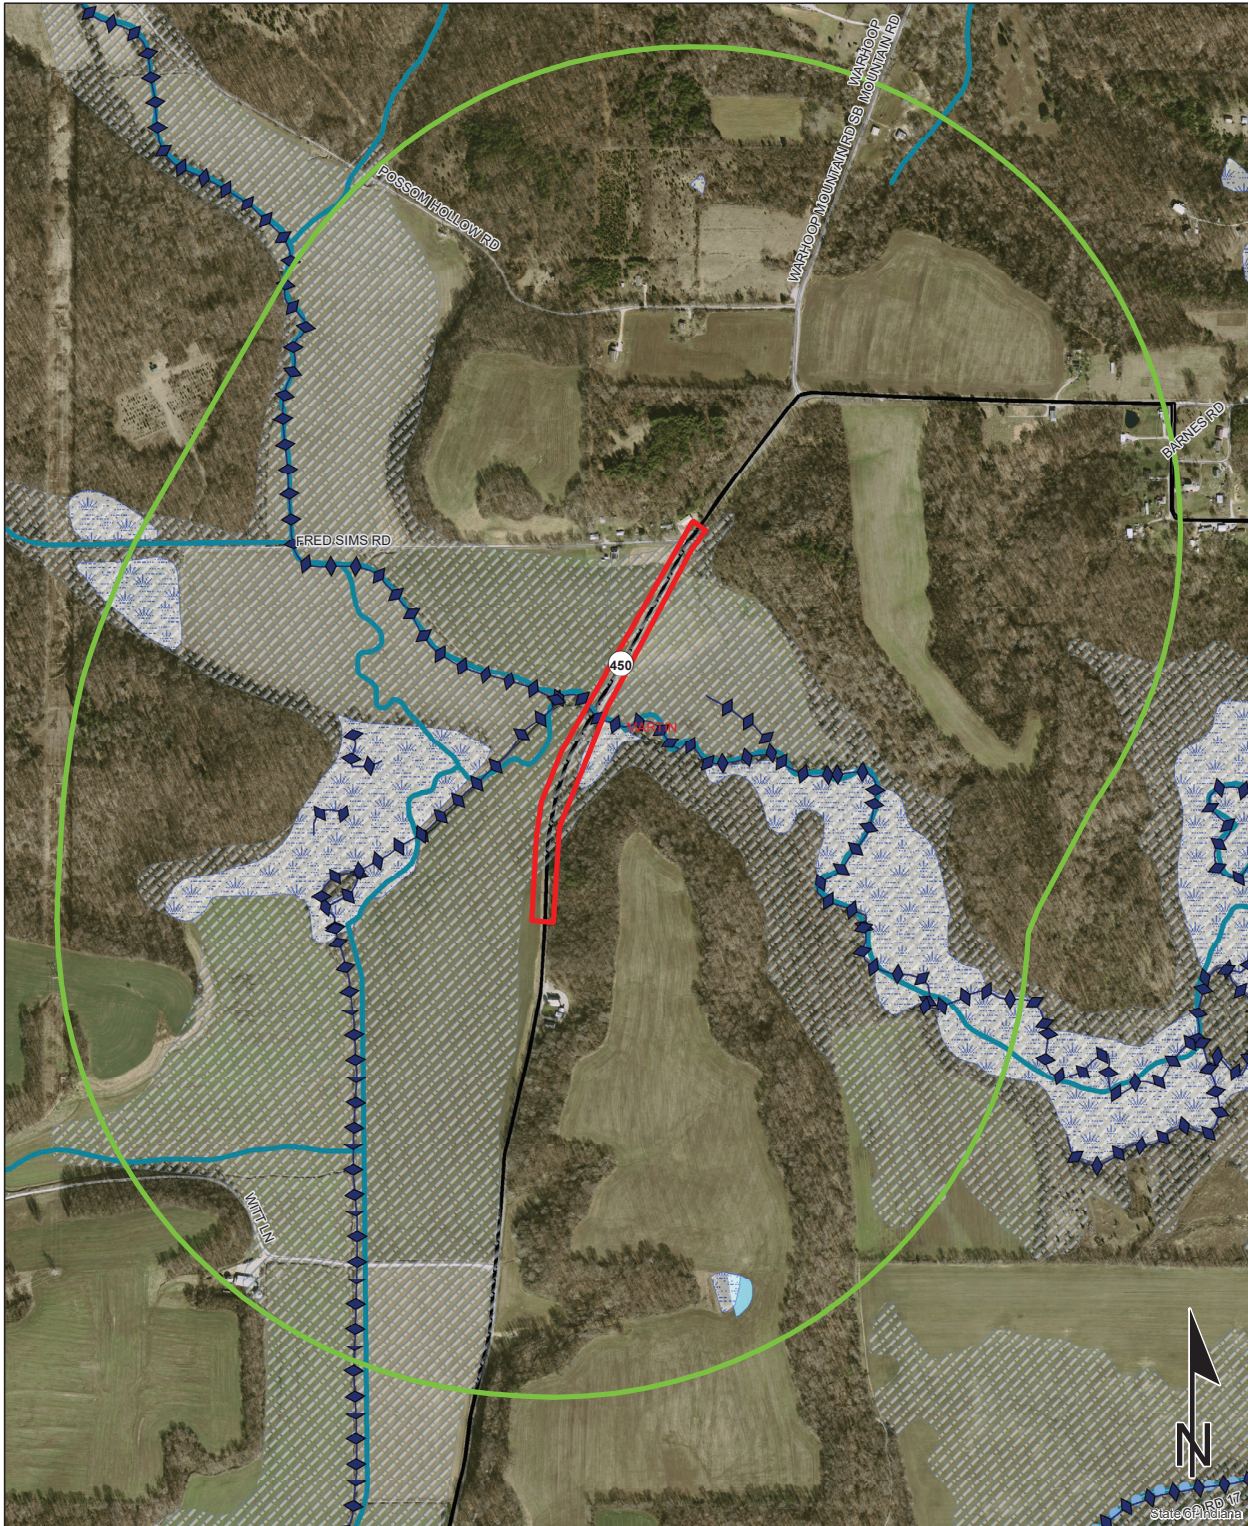
Red Flag Investigation - Water Resources
 SR 450, 6.30 miles north of US 50
 Des. No. 1700155, Bridge Replacement
 Martin County, Indiana

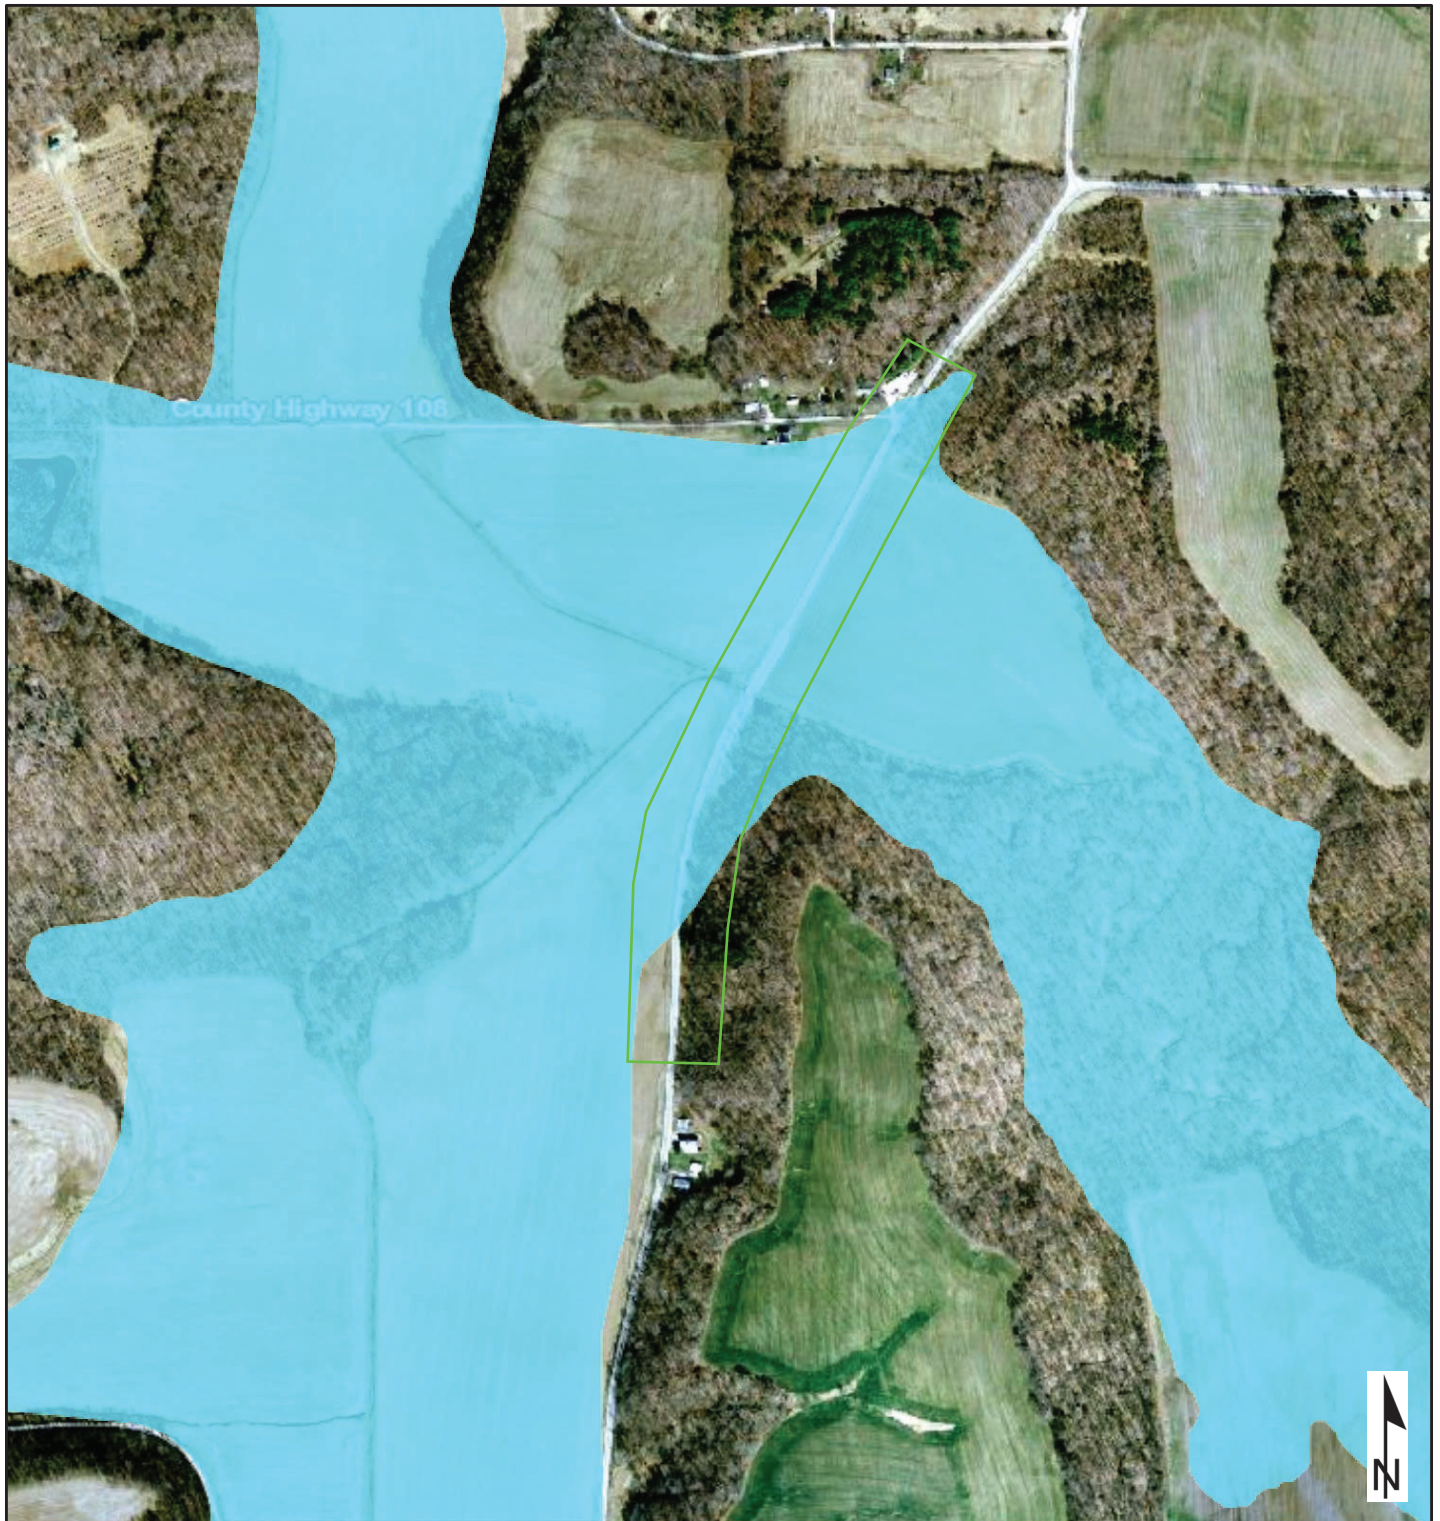
Figure 8

FEMA FIRM Map
 SR 450, Martin County, Indiana
 Des No. 1700155; Bridge Replacement

The site is located SR 450, 6.30 miles east of US 50 (38.753240, -86.776489). The investigated area boundaries are as follows: 100 feet northwest/southeast of the centerline of SR 450; 1,250 feet northeast of the center point of 450-51-06447 B; and 1,200 feet southwest of the center point of 450-51-06447 B. Surrounding land use includes agricultural, forested, and residential properties. One stream, one wetland, and three roadside ditches (RSDs) were identified during the field visit on August 28, 2019 and September 3, 2019. Overhead utility lines were noted running through the investigated area along SR 450. A heavy rain event had occurred within seven days of the field investigations. No evidence of birds or bats were seen within the bridge. The investigated area does lie within the floodplain of Flat Creek (Figure 8).

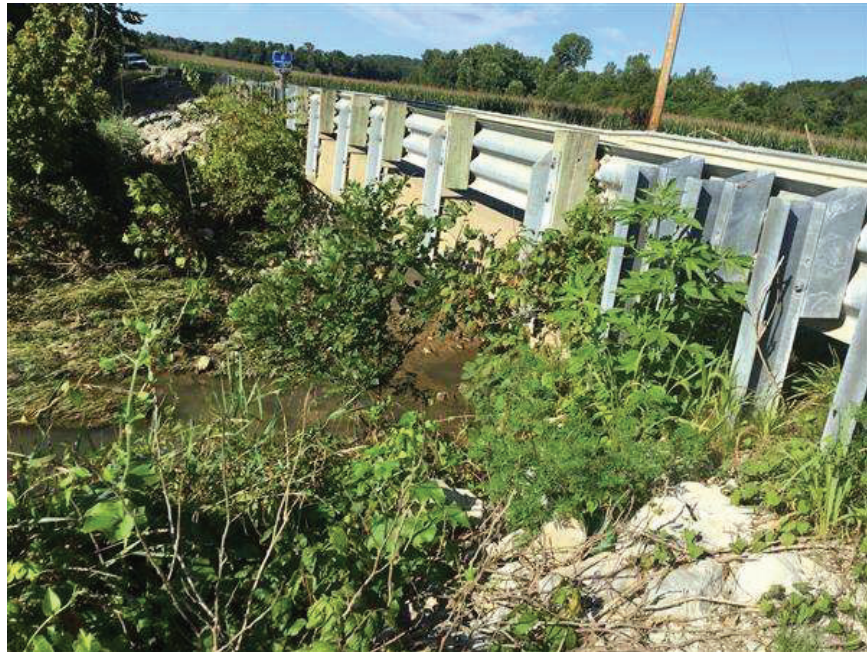
Bridge Inspection Report

450-51-06447 B
SR 450
over
FLAT CREEK

Rehabilitation done in 1980 placed new, variable depth concrete deck with single layer of epoxy-coated reinforcing. Isolated minor spall with exposed reinforcing on South curb. Deck underside is not visible due to adjacent beam configuration; however, no moisture staining visible along joints between adjoining beams.

Approximately 1 LFT spall with exposed reinforcing on Beam 3 over West abutment. Small diameter spalls with exposed reinforcing on Beams 7 and 8 near East abutment. Minor spalls on outside of fascia beams due to old guardrail attachments.

Heavy scaling at corners of abutments causing minor loss of bearing area. Both abutments have longitudinal and vertical cracking with minor to moderate efflorescence.
