Appendix G
Waters of the U.S. Determination
Form

US 31 at SR 28

New Interchange Construction

Designation Number(s) 1382317

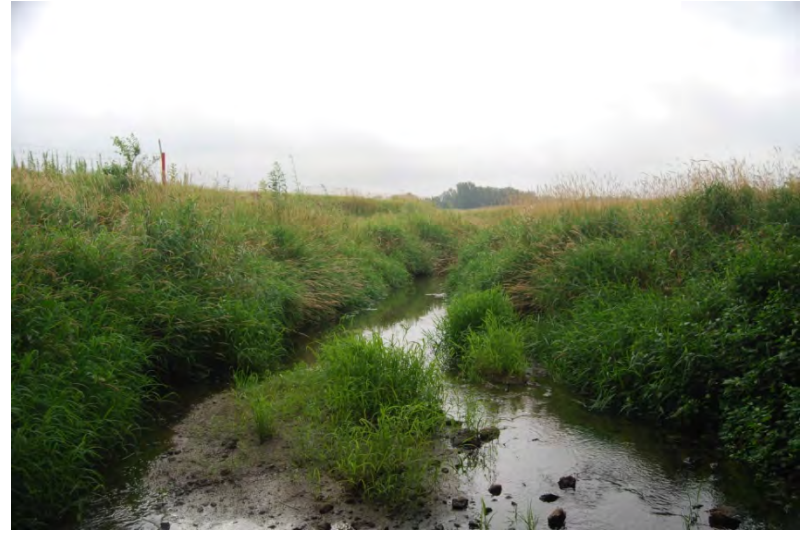
005 – View of riprap bottom of ditch in NE quad of Dixon Cr, E of NB US 31.

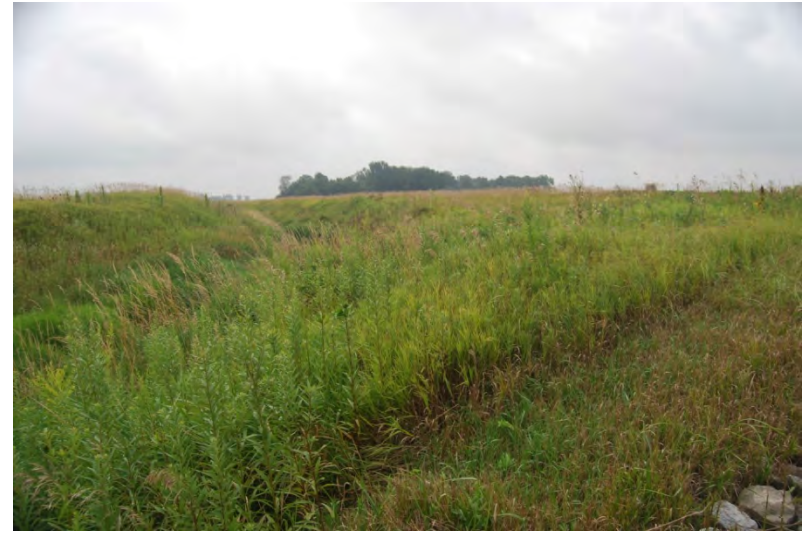
009 – View N of Dixon Cr from E side of NB US 31.

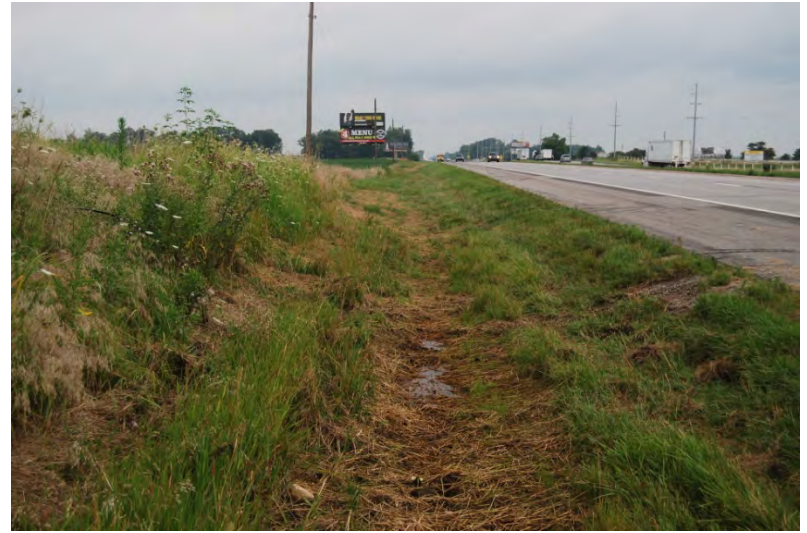
085 – View of Roadside Ditch C, showing typical vegetation and residue.

Roadside Ditch C (0.0329 acre) is located on the east side of the northbound lane of US 31 0.5 miles north of SR 28. It is approximately 0.0329 acre in size. Data Point C1 was dominated with wetland vegetation (predominantly *Persicaria pensylvanica* Pinkweed). Two wetland hydrology secondary indicators were present – Surface Soil Cracks and Geomorphic Position. The soil profile contained soils with a matrix of 10YR 4/1 to seven inches, 10YR 5/1 with 10YR 4/6 redox features to eleven inches and 10YR 3/1 with 10YR 6/2 and 10YR 6/6 redox features to twelve inches. Even though this data point meets the three wetland criteria it is wholly contained within a non-jurisdictional roadside ditch. It appears to meet the classification of a roadside ditch. See photos 73-85. Data Point C2 contained upland species, non-hydric soil and did not exhibit wetland hydrology indicators. This data point doesn't appear to be within a wetland.

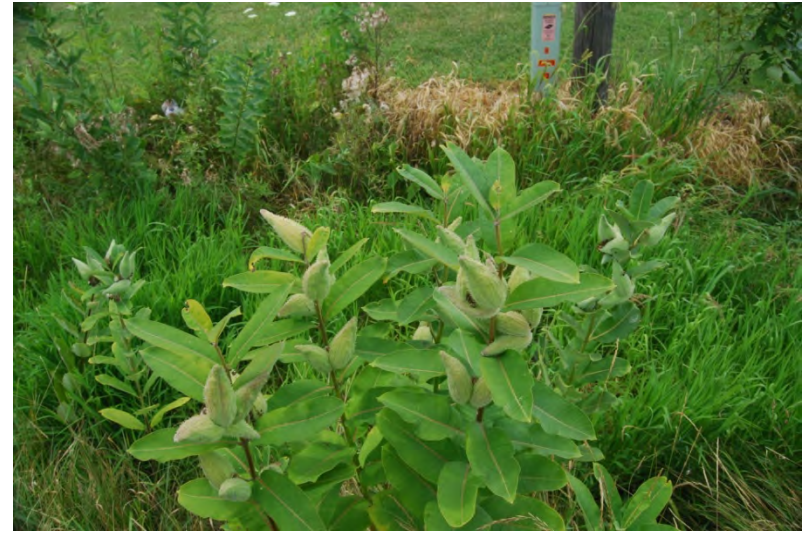
153 – View S of typical Roadside Ditch G vegetation.

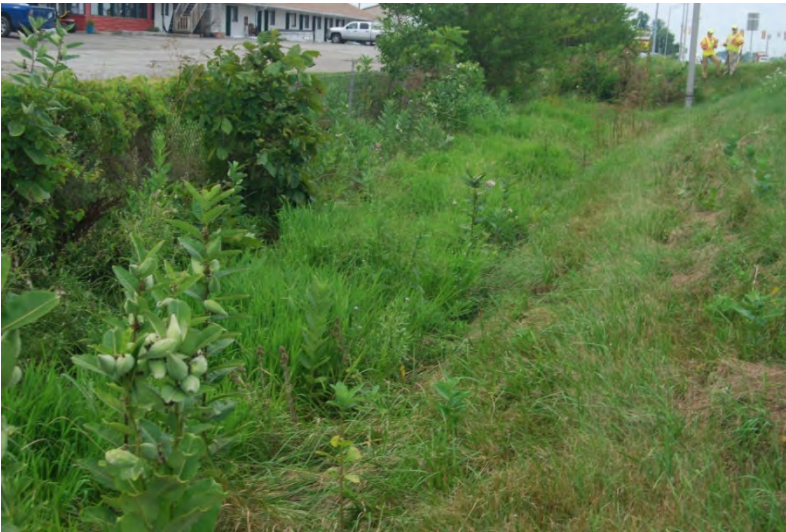
154 – View of milkweed found in Roadside Ditch G.

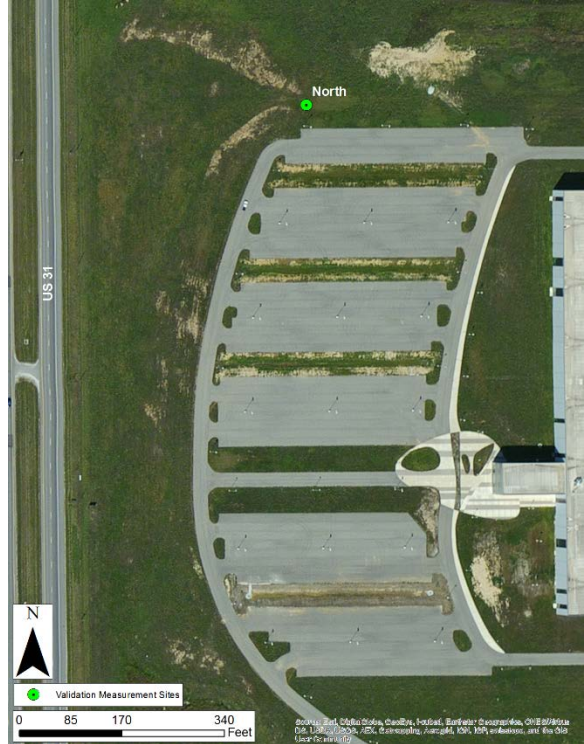
This measurement was taken at the north end of the Chrysler parking lot, approximately 420' off of U.S. 31. This site was selected to represent the single family home north of the Chrysler property, however that property will be taken as part of the project. This site was still useful in validating the TNM2.5 noise model.

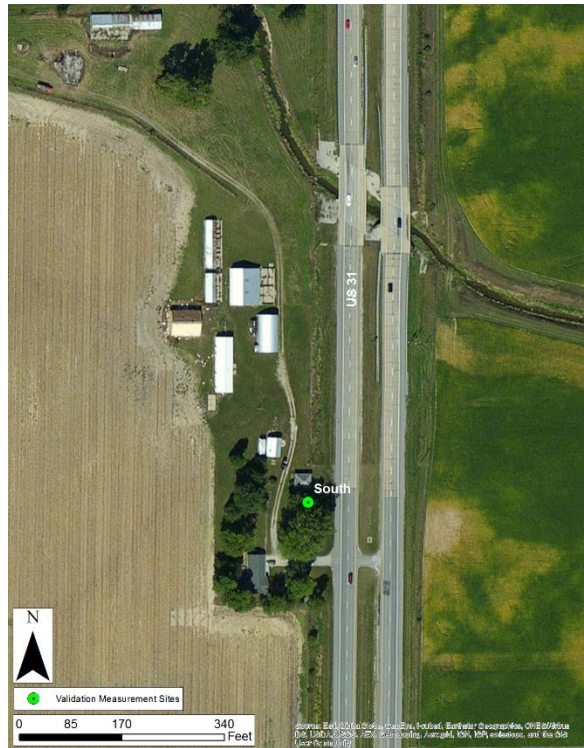
This measurement was taken approximately 50' off of U.S. 31 in the side yard of the single family home on this property. The location was chosen because it was the least intrusive location on the property.

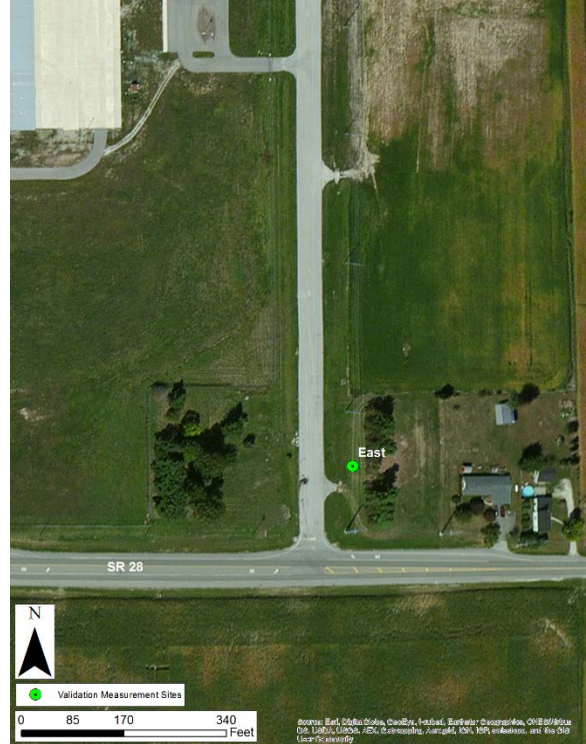
This measurement was taken approximately 120' off of SR 28 next to the Chrysler Plant's service drive. This measurement represents two single-family homes immediately to the east.

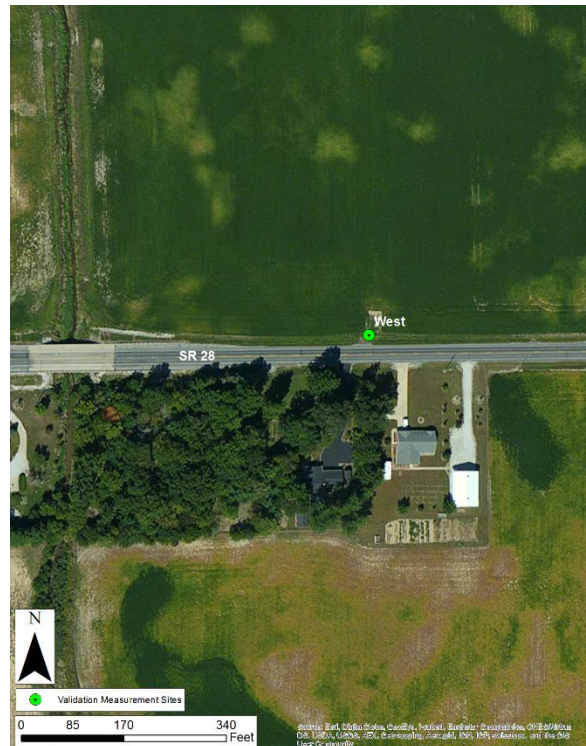
This measurement was taken approximately 30' off of SR 28 directly across from two single-family homes. This site was chosen because it was less intrusive than measuring across the road in yards. The measurement represents three single-family homes on the south side of SR 28.
