DES 1900321

Appendix F

Water Resources

**Waters Report  
Des 1900321  
SR 58 Small Structure Replacement  
Jackson County, Indiana  
Small Structure Project  
CV 058-036-096.15**

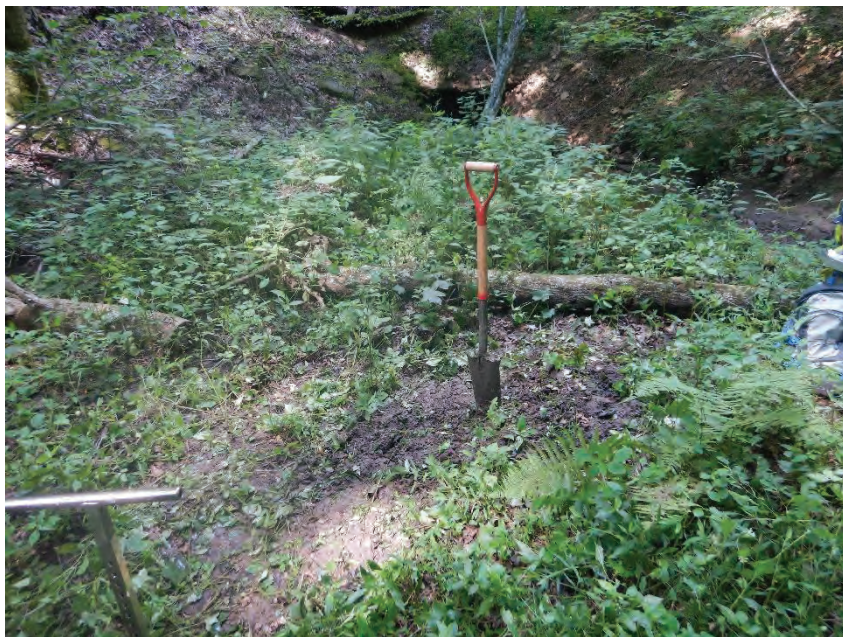
Photo 3: SP 1/Wetland 1 Facing Northeast Towards UNT 1 to Tipton Creek and Structure

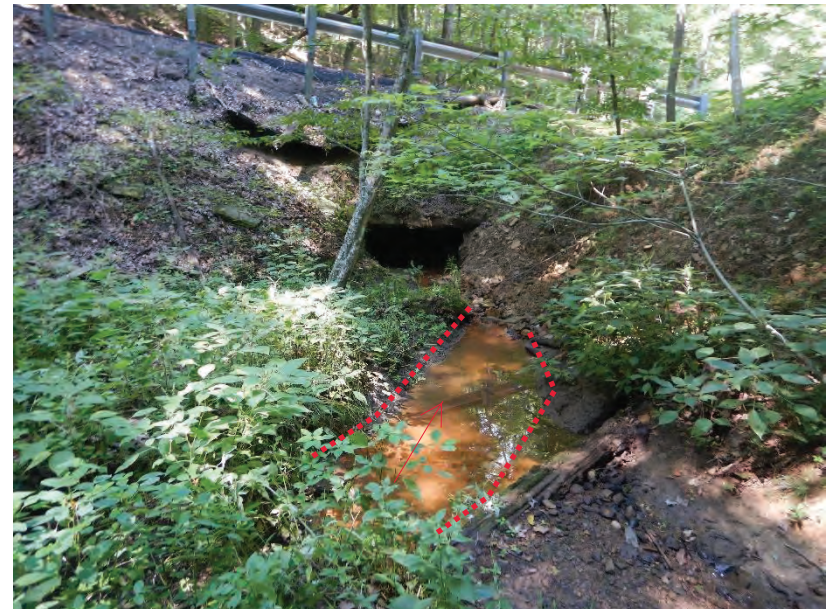
Photo 12: Within UNT 1/Wetland 1 to Tipton Creek Facing Northeast Towards Structure on Southside of SR 58

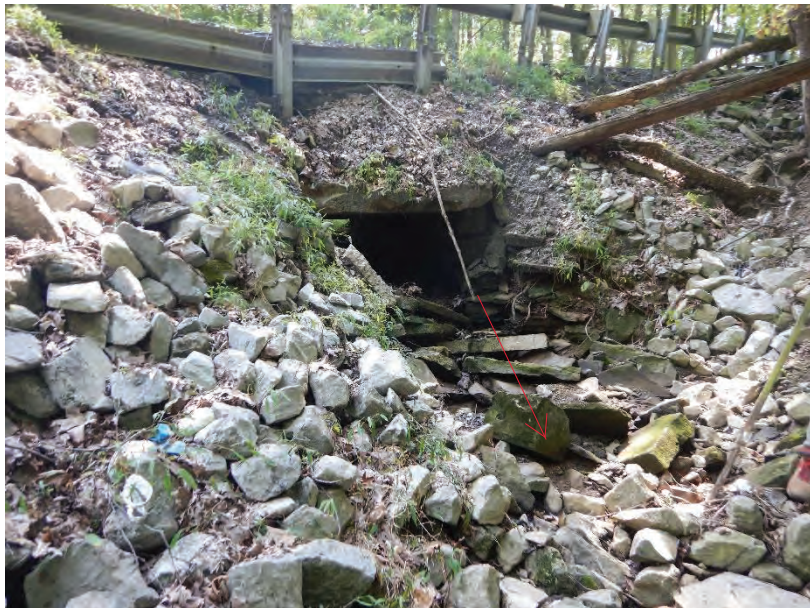
Photo 15: Within UNT 1 to Tipton Creek Facing South  
Towards Structure on Northside of SR 58
