**MEMORANDUM OF AGREEMENT
BETWEEN FEDERAL HIGHWAY ADMINISTRATION
AND THE INDIANA STATE HISTORIC PRESERVATION OFFICER
SUBMITTED TO THE ADVISORY COUNCIL ON HISTORIC PRESERVATION
PURSUANT TO 36 CFR § 800.6(b)(iv)
REGARDING THE STATE ROAD 46 GRADE SEPARATION PROJECT
IN THE CITY OF COLUMBUS, COLUMBUS TOWNSHIP,
BARTHOLOMEW COUNTY, INDIANA
DES. NO.: 1700139**

Red Flag Investigation - State Location
SR 46 Grade Separation
Carrying SR 46 over Louisville & Indiana Railroad
Bartholomew County, Indiana
Des. No.: 1700139

Exhibit 1 - Location Map
 S.R. 46 Interchange
 Intersection Improvement Project
 Columbus Township, Bartholomew County, Indiana
 Des. No. 1700139
 Metric Project No. 17-0057-1

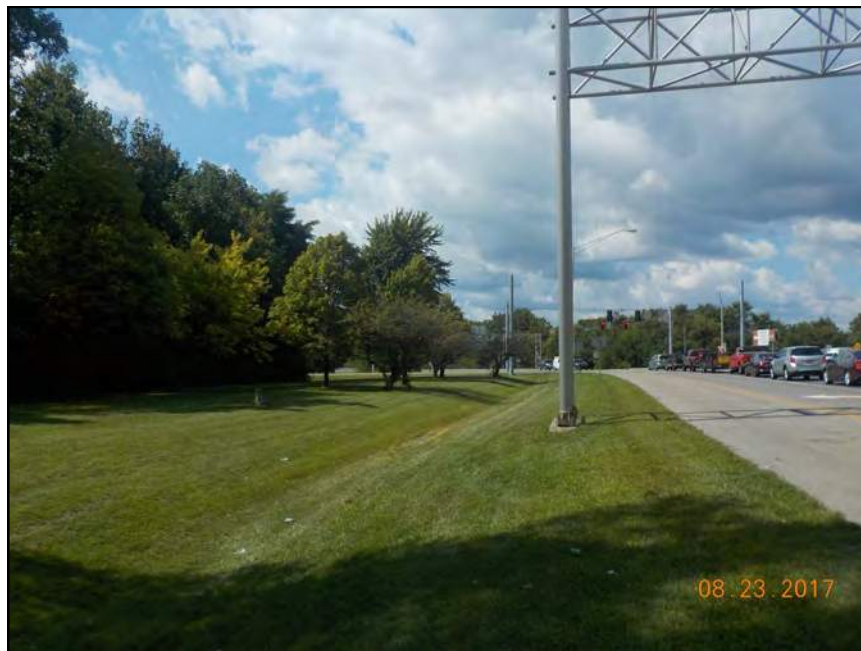
the floodplain of the Flatrock River to the east. No OHWM was observed within RSD 4. This feature is not likely jurisdictional.

34. View from southern side of S.R. 46 West looking southwest at S.R. 46 right-of-way and RSD 4.

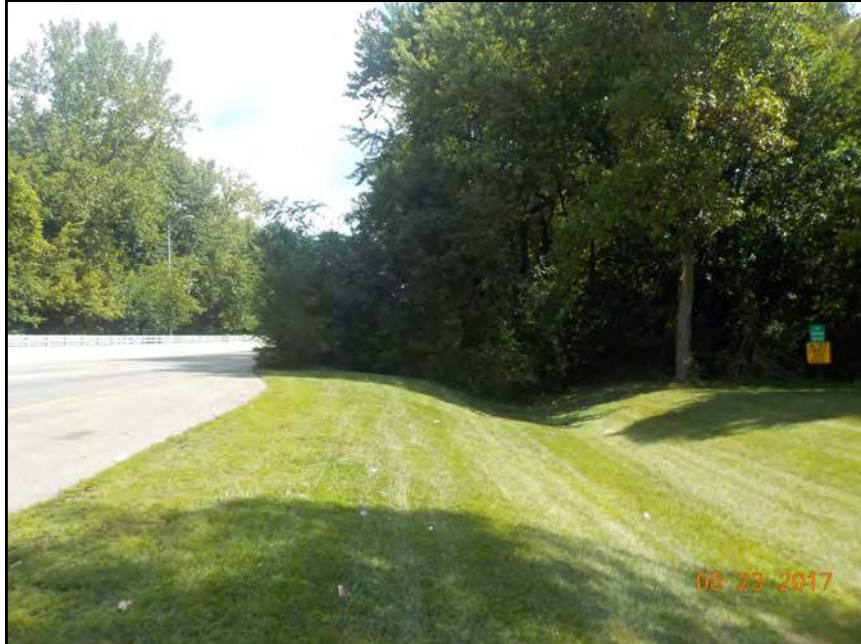
35. View from southern side of S.R. 46 West looking northeast at S.R. 46 right-of-way and RSD 4.

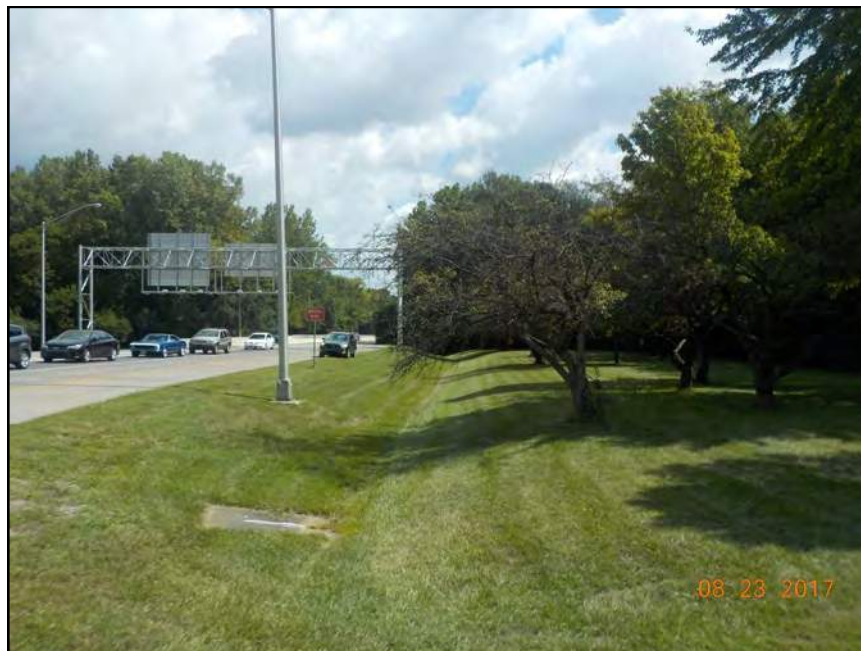
38. View from S.R. 46 interchange looking northeast at S.R. 46 West right-of-way and RSD 4.

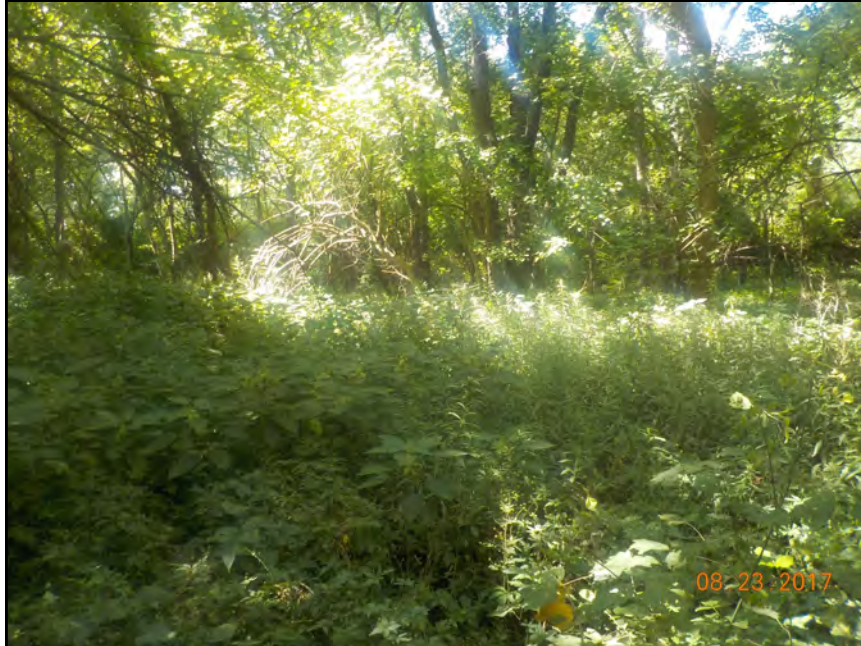
45. View of Wetland A in the northern portion of the project study limits looking northwest.

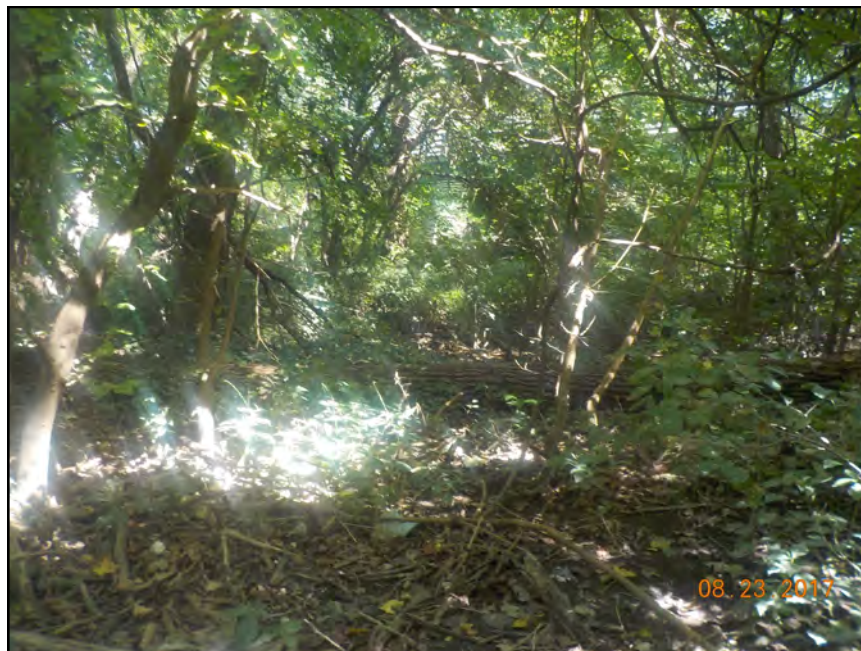
46. View of Wetland A in the northern portion of the project study limits looking southeast.

Two wetlands, Wetland A (PFO1A) and Wetland B (PEM1A), totaling 2.579 acres, were identified within the project study limits. Every effort should be taken to avoid or minimize impacts to these waterways. If impacts are necessary, mitigation may be required. The final determination of jurisdictional waters is ultimately made by the USACE. This report is our best judgment based on the guidelines set forth by USACE.

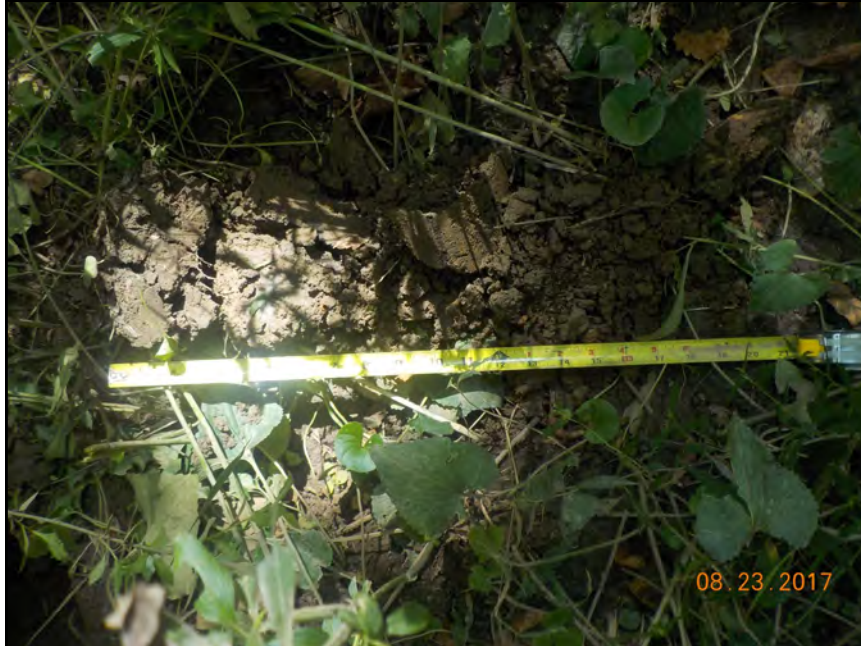
47. View of SP-A1, Wetland A, soil profile.

Depth (inches)	Matrix		Redox Features				Texture	Remarks
	Color (moist)	%	Color (moist)	%	Type ¹	Loc ²		
0-15	10YR 4/2	45	10YR 5/6	5	C	M	SL	Prominent Mottles
	10YR 4/3	50					SL

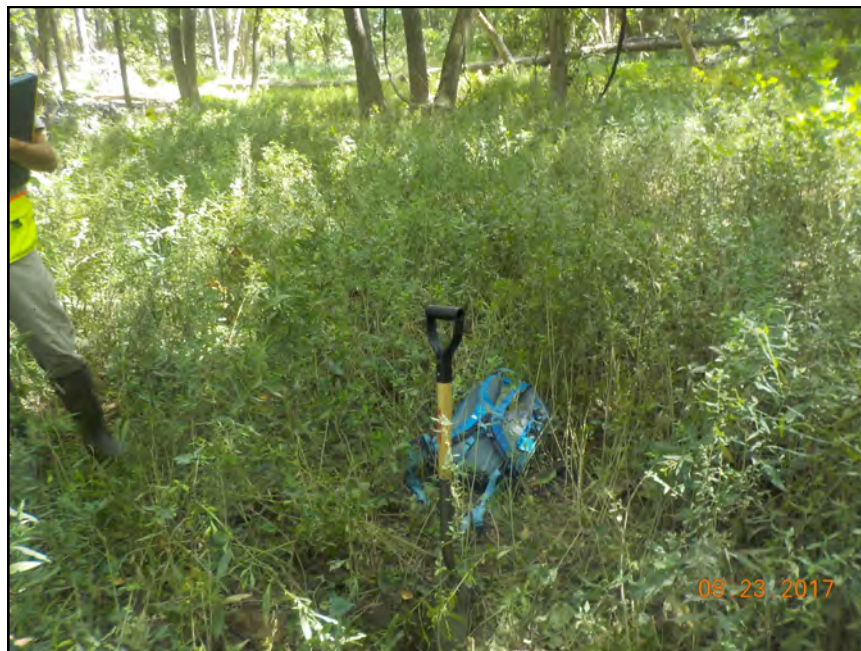
48. View of SP-A1, Wetland A, looking northwest.

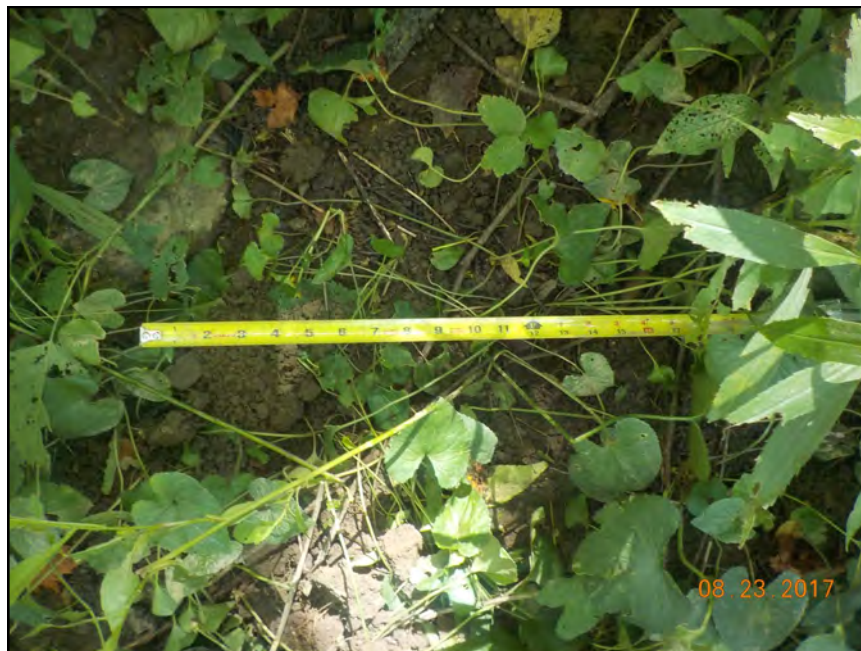
50. View of SP-A2, Wetland A upland, soil profile.

Depth (inches)	Matrix		Redox Features				Texture	Remarks
	Color (moist)	%	Color (moist)	%	Type ¹	Loc ²		
0-2	10YR 4/2	50					SL	
	10YR 3/2	50					SL

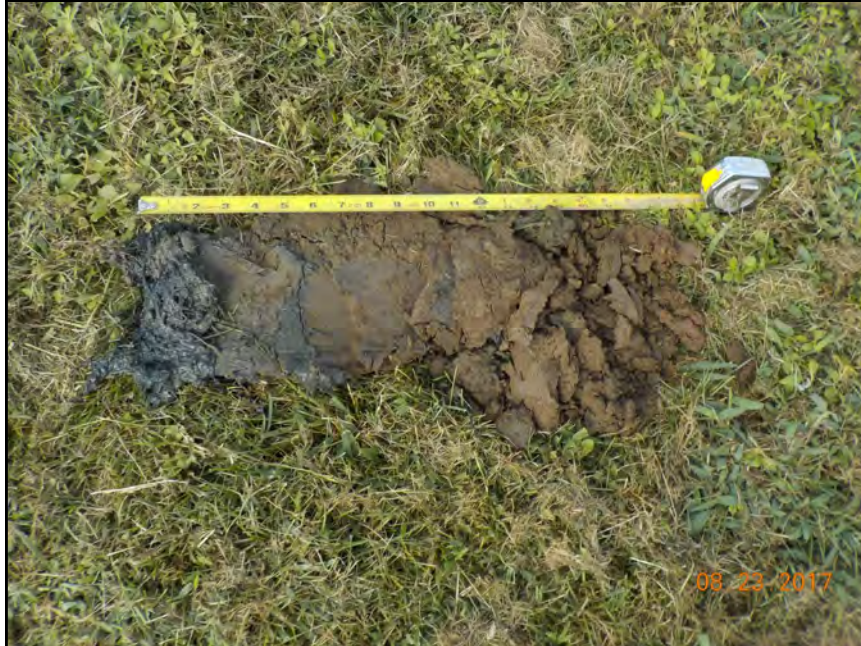
53. View of SP-B1, Wetland B, soil profile.

Depth (inches)	Matrix		Redox Features				Texture	Remarks
	Color (moist)	%	Color (moist)	%	Type ¹	Loc ²		
0-5	10YR 4/1	75	10YR 4/4	20	C	M	SiCL	Distinct Mottles
			10YR 4/6	5	C	M	SiCL	Prominent Mottles
5-20	10YR 4/3	90	10YR 5/4	10	C	M	SiCL	Faint Mottles

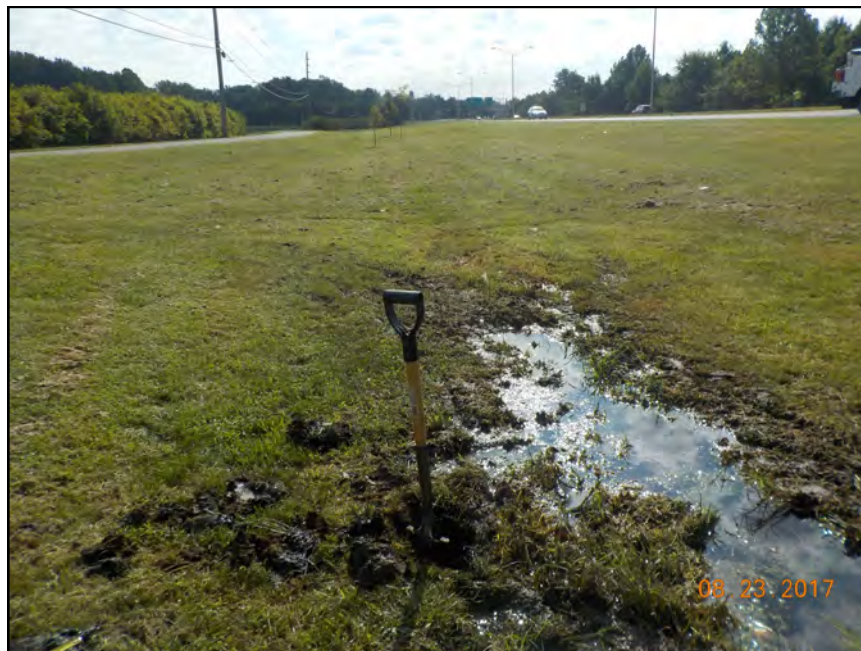
54. View of SP-B1, Wetland B, looking east.

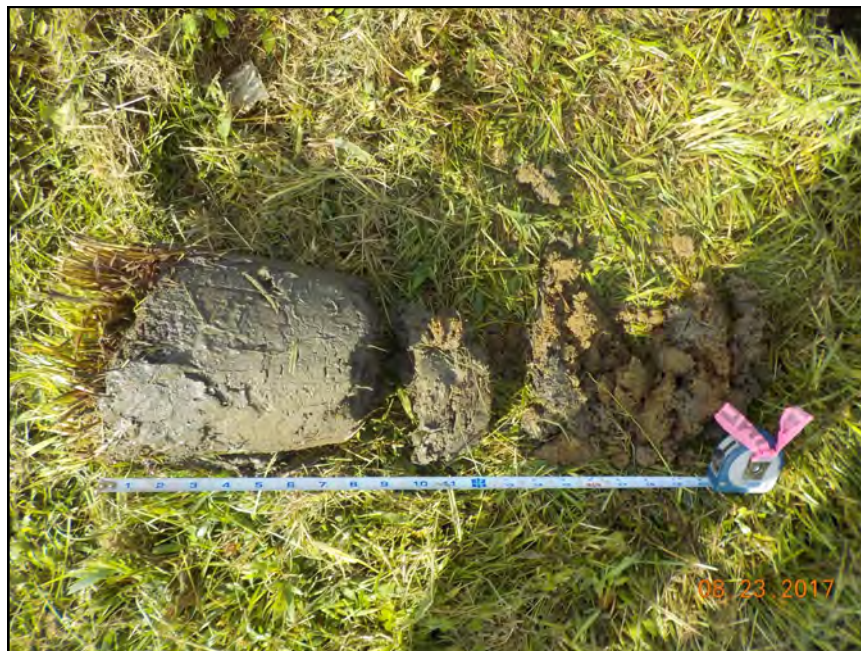
56. View of SP-B2, Wetland B upland, soil profile.

Depth (inches)	Matrix		Redox Features				Texture	Remarks
	Color (moist)	%	Color (moist)	%	Type ¹	Loc ²		
0-12	10YR 3/1	100					SCL	Gravel mixed in
12-20	10YR 4/3	100					SL	Gravel mixed in

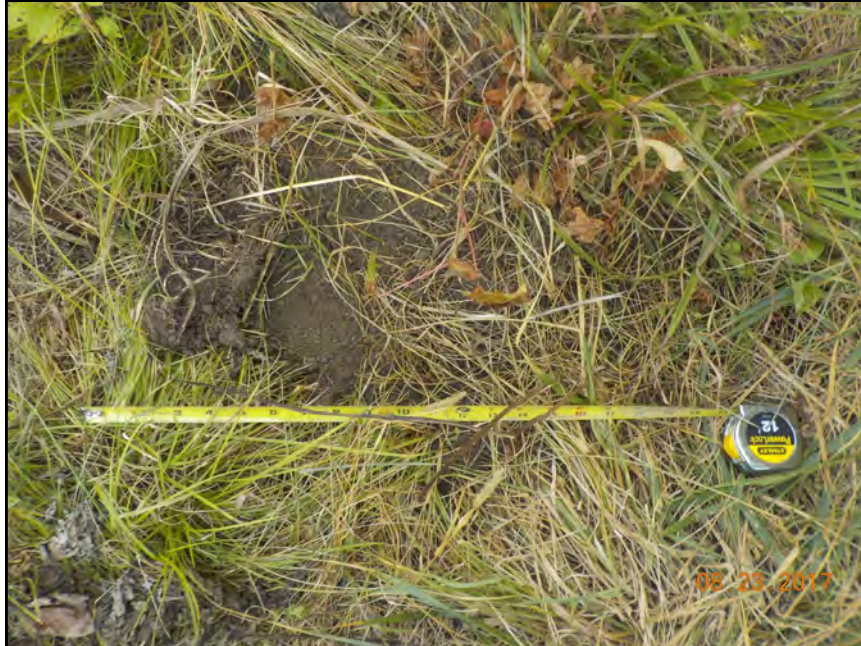
59. View of SP-1 soil profile.

Depth (inches)	Matrix		Redox Features				Texture	Remarks
	Color (moist)	%	Color (moist)	%	Type ¹	Loc ²		
0-4	10YR 4/2	100					SiL

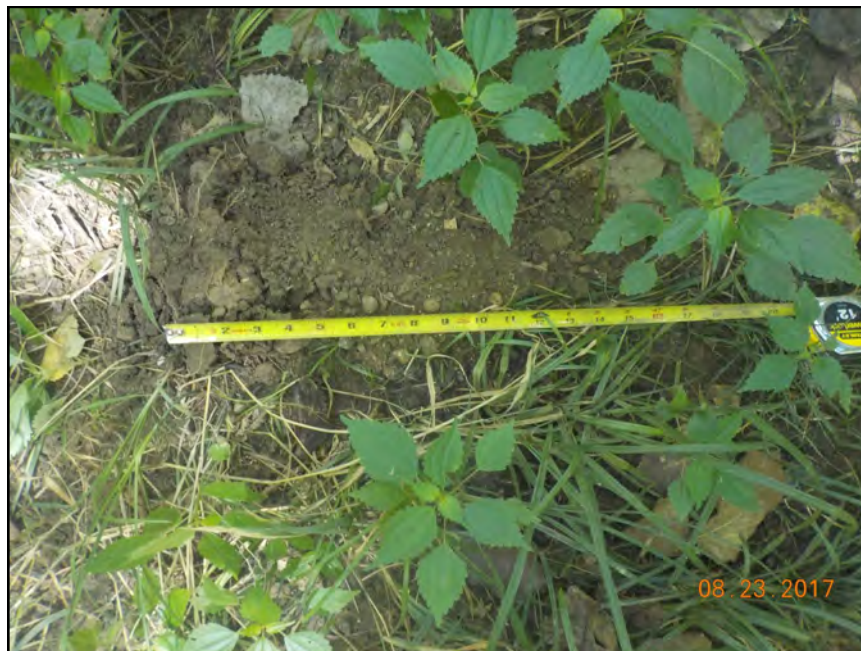
62. View of SP-2 soil profile.

Depth (inches)	Matrix		Redox Features				Texture	Remarks
	Color (moist)	%	Color (moist)	%	Type ¹	Loc ²		
0-15	10YR 3/2	50					SL	
	10YR 4/2	50					SL

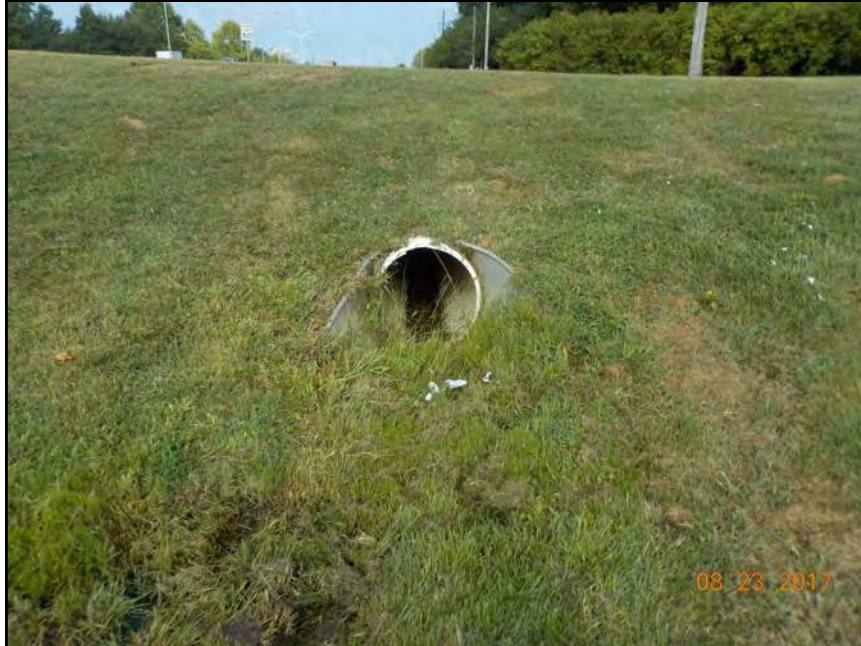
65. View of culvert draining into RSD 1.

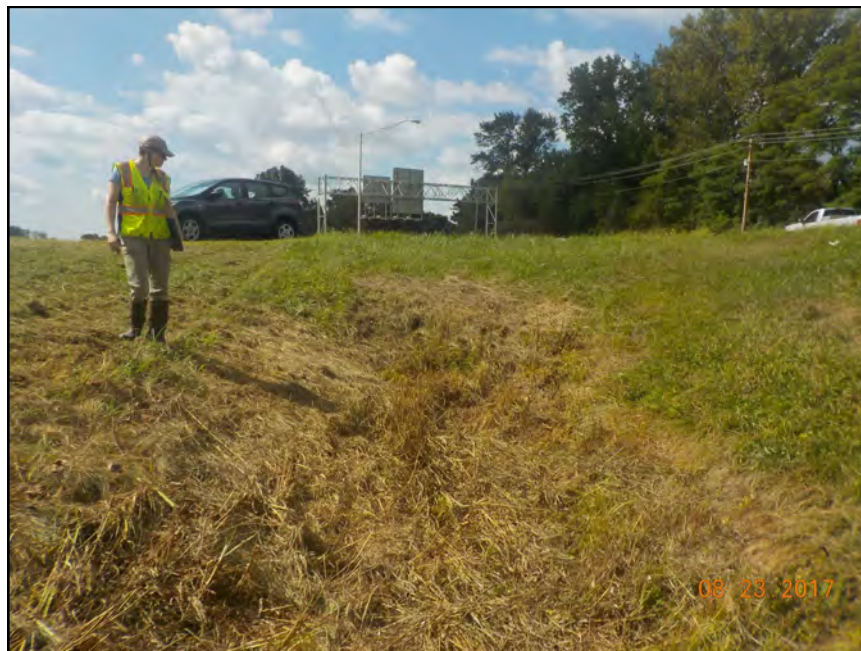
RSD 3 is located on the east side of S.R. 11 and appears to flow north into a culvert that leads under S.R. 11. It is a vegetated drainage swale adjacent to agricultural land and mowed right-of-way. The feature is approximately 178 LFT in length within the project study limits. No OHWM was observed within RSD 2. This feature is not likely jurisdictional.

66. View of RSD 3 looking south.

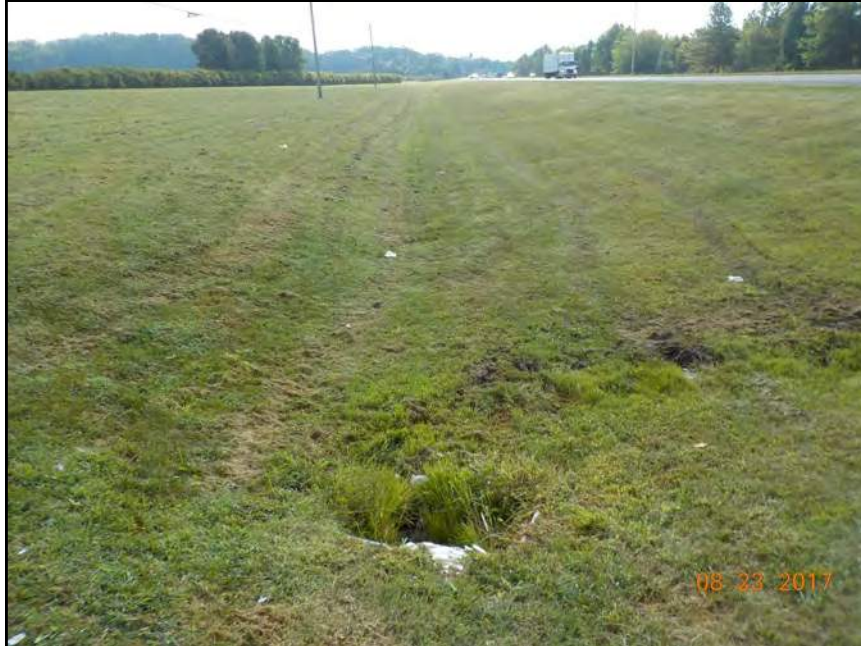
67. View of RSD 1 looking east.

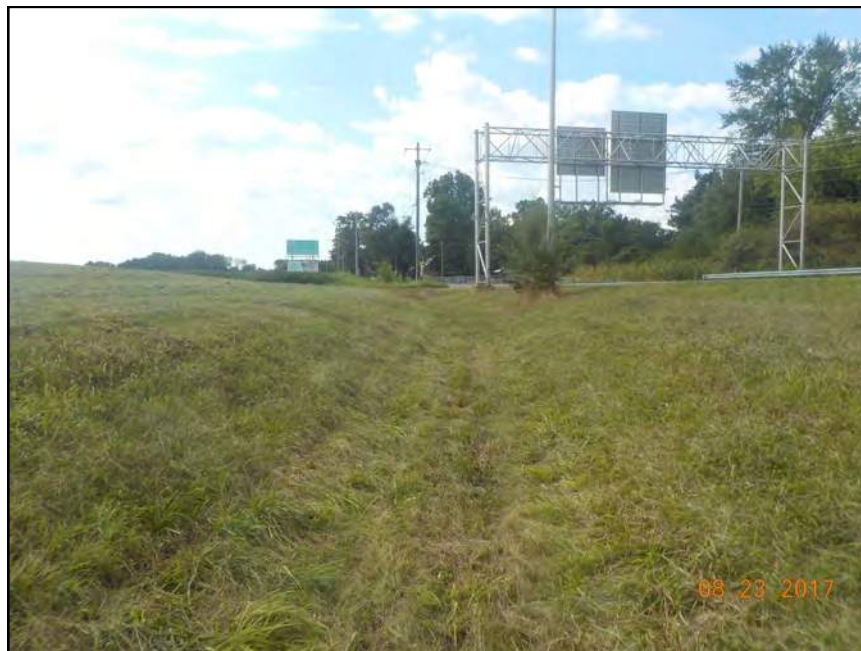
RSD 2 is located on the east side of S.R. 11 and appears to flow north through a culvert and into RSD 3. It is a vegetated drainage swale adjacent to agricultural land and mowed right-of-way. The feature is approximately 202 LFT in length within the project study limits. No OHWM was observed within RSD 2. This feature is not likely jurisdictional.

68. View of RSD 2 looking south.

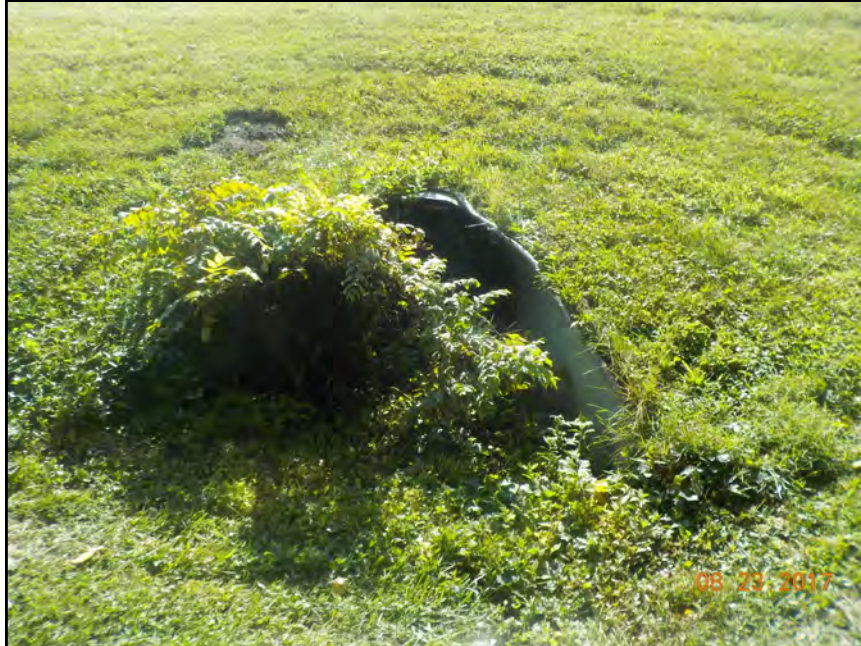
69. View of Culvert on western side of S.R. 11 looking southeast.
