# 1996-2020 Indiana Forestry Best Management Practices

Monitoring Results for State Forest Properties

By: Jennifer Sobecki & Duane McCoy

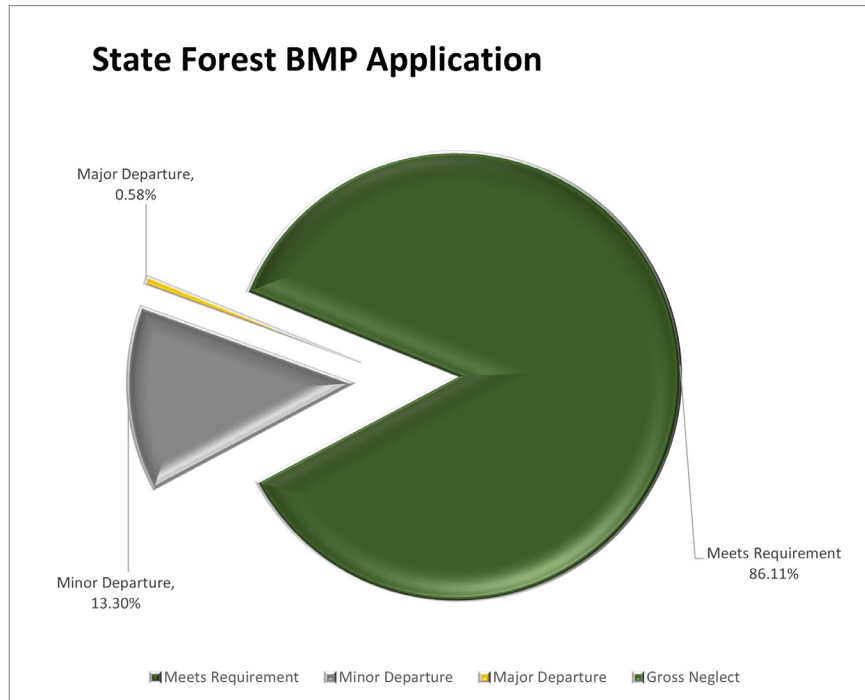
Figure 3. BMP application for 707 State Forest sites monitored from 1996-2020.

The application and effectiveness rates for BMPs used to protect sites after timber harvests are excellent for the 707 State Forest sites monitored since 1996. The overall application rate is 86.11%, and the overall effectiveness rate is 91.95%.

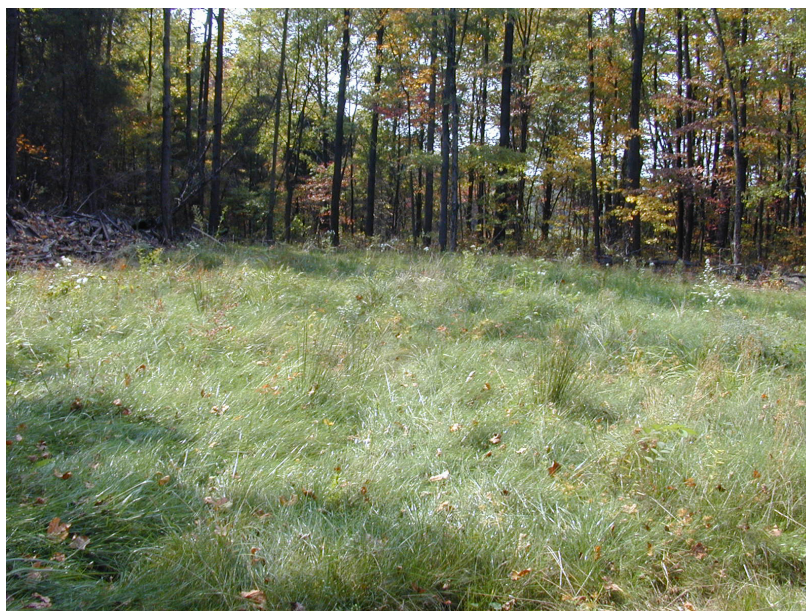
*A well-vegetated log landing several years after harvest.*

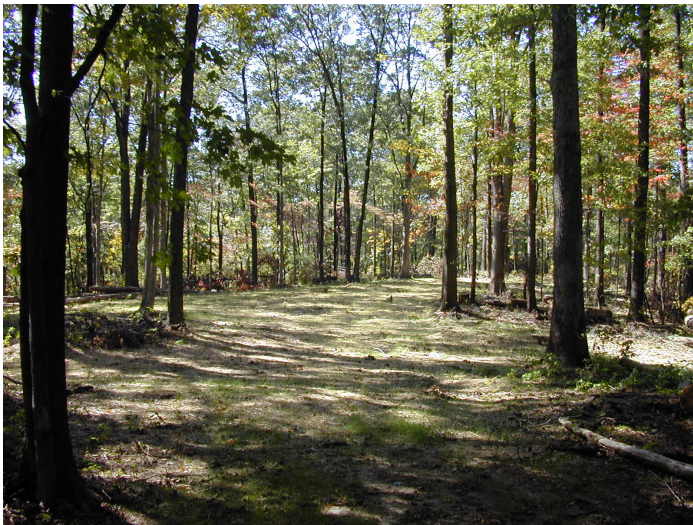
*A well-closed-out skid trail covered with straw and seed, beginning to grow.*

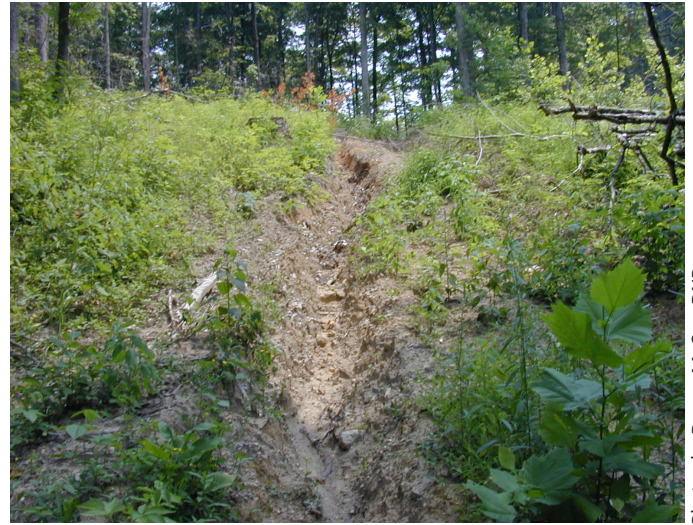
*Vegetation alone is not enough to prevent erosion on skid trails with slopes. Adding water diversions to this skid trail could have prevented this gully erosion.*

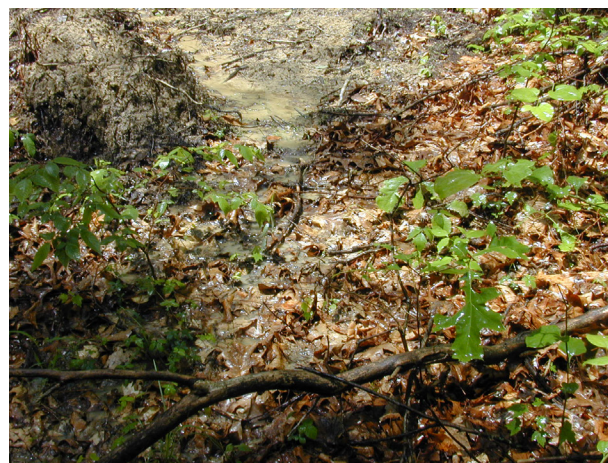
*Water-bar outlet conveying runoff on to the stable forest floor.*

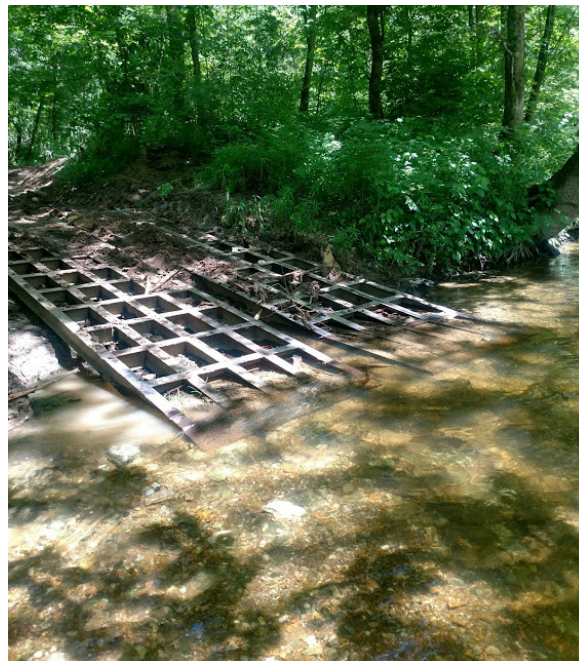
*A metal grate bridge used to armor a stream bank for a crossing.*

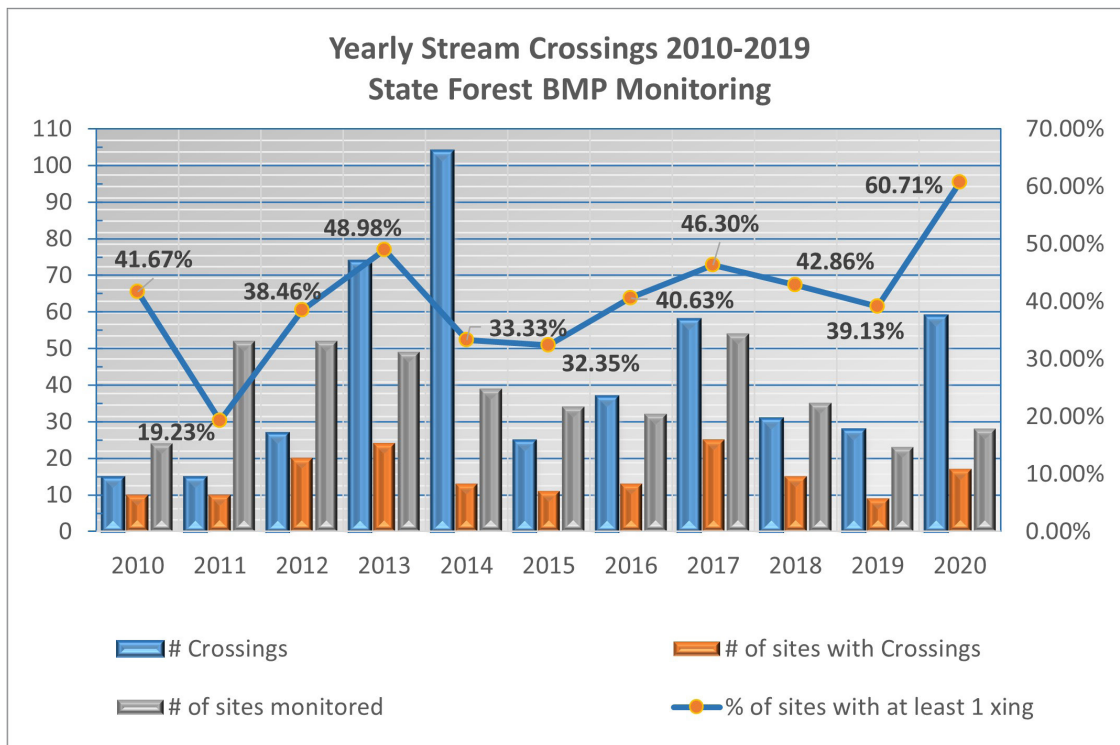
Figure 10. Stream crossing statistics from 2010-2020.

The number of crossings monitored on State Forests since 2010 is seen below in Figure 8. The graph also shows the number of sites per year with at least one crossing and the percentage of sites with crossings per year. 2014 had an elevated number of crossings due to one site. There was a large tornado salvage harvest (800 acres) at Clark State Forest that accounted for 60 crossings. Due to numerous obstructions from the tornado, multiple crossings were necessary in order to access the area.

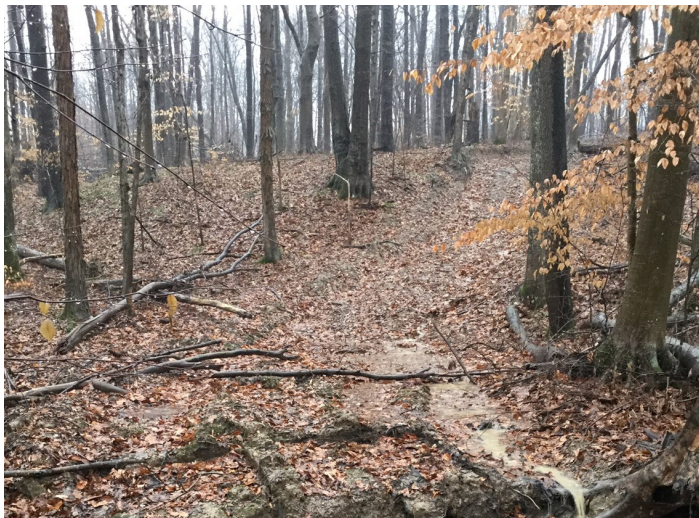
*On private lands, a skid trail leading to an intermittent stream crossing has no diversions. As a result, runoff is flowing down the trail and depositing sediment-laden runoff into the stream.*

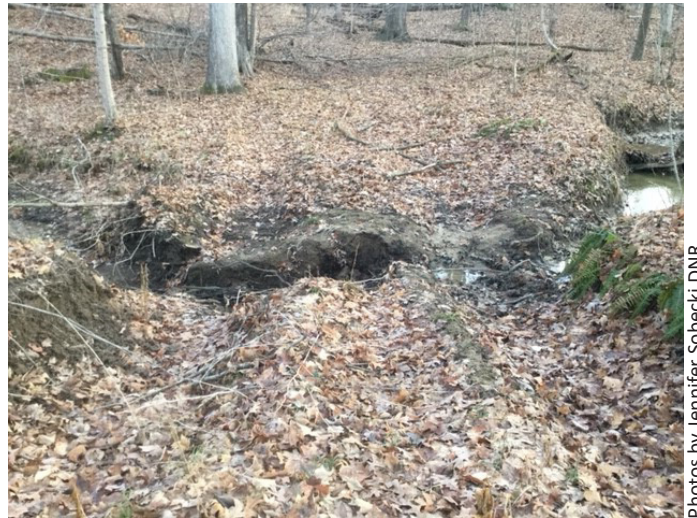
*Soil was used to make a “bridge” for stream crossing on this private site and never removed, creating sediment and erosion problems up and downstream from the crossing, problems that will persist for many years.*

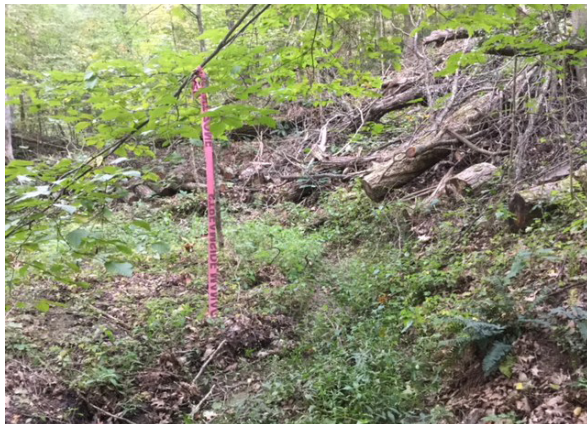
*An RMZ in Morgan-Monroe State Forest that has been marked by a forester, and had debris removed from a small intermittent stream.*

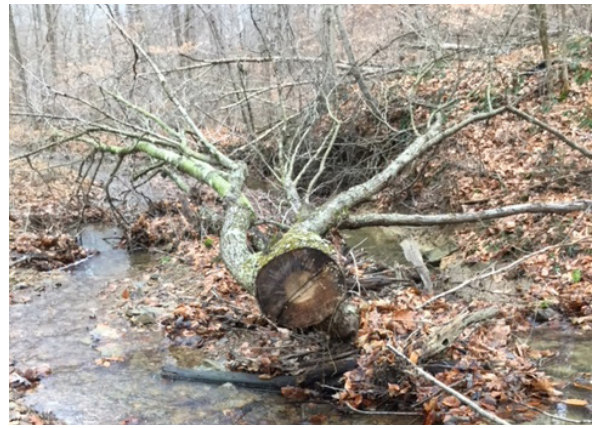
*Logging debris in streams can obstruct stream flow, leading to the stream carving a new bank, which results in erosion and sediment going directly into the stream.*

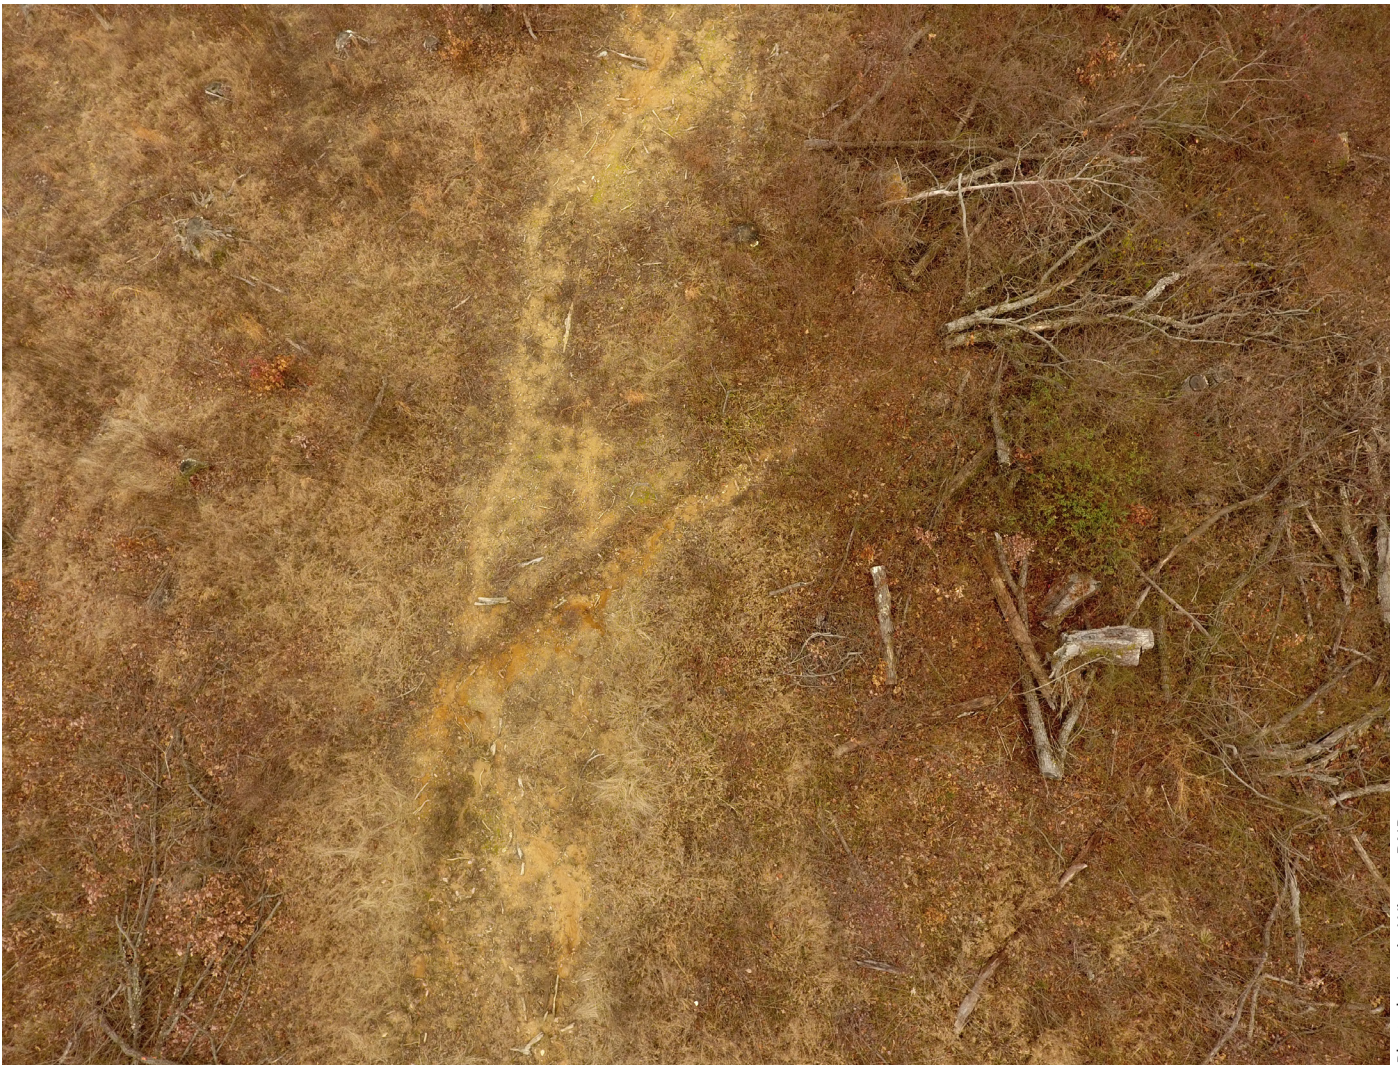
*Aerial photo taken by drone of a water bar on a skid trail.*
